MINERALS PROGRAM INSPECTION REPORT
PHONE: (303) 866-3567

MINE NAME: Saddlebrook Pit	MINE/PROSPECTING ID#: M-2020-021	MINERAL: Gravel	COUNTY: Mineral
INSPECTION TYPE: Surety-Related Inspection	WEATHER: Clear	INSP. DATE: March 8, 2023	INSP. TIME: 10:32
OPERATOR: Wolf Creek Rock and Gravel LLC	OPERATOR REPRESENTATIVE: None	TYPE OF OPERATION: 110c - Construction Limited Impact	
REASON FOR INSPECTION: Surety Related	BOND CALCULATION TYPE:	BOND AMOUNT: \$54,939.00	
DATE OF COMPLAINT: NA	POST INSP. CONTACTS: None	JOINT INSP. AGENCY: None	
INSPECTOR(S): Lucas West	INSPECTOR'S SIGNATURE:

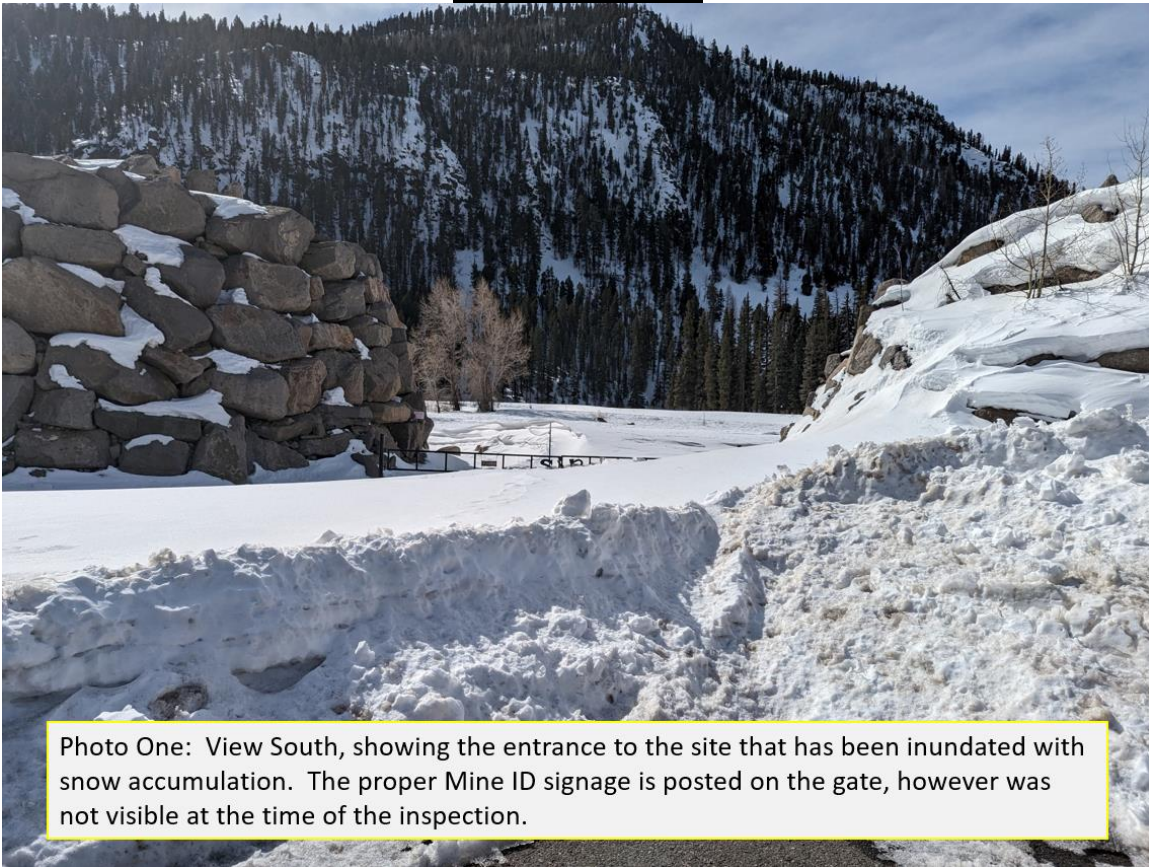
The main focus of this inspection was to verify the conditions on the site had not changed since the Division's last inspection in August of 2022. Access to the site was attempted, however the main gate has become snowed in due to excessive snowfall this winter. Photo One shows the snowed in entrance. Several attempts to gain access to the site were made, however the depth of snow made site access difficult. From the vantage point of Colorado Highway 160, enough of the site was visible to confirm that the site conditions have not changed. A view of the main stockpile on site can be seen in Photo Two. Conversations with the Operator also support that no significant work has been completed on site and that conditions remain unchanged.

Photo One: View South, showing the entrance to the site that has been inundated with snow accumulation. The proper Mine ID signage is posted on the gate, however was not visible at the time of the inspection.

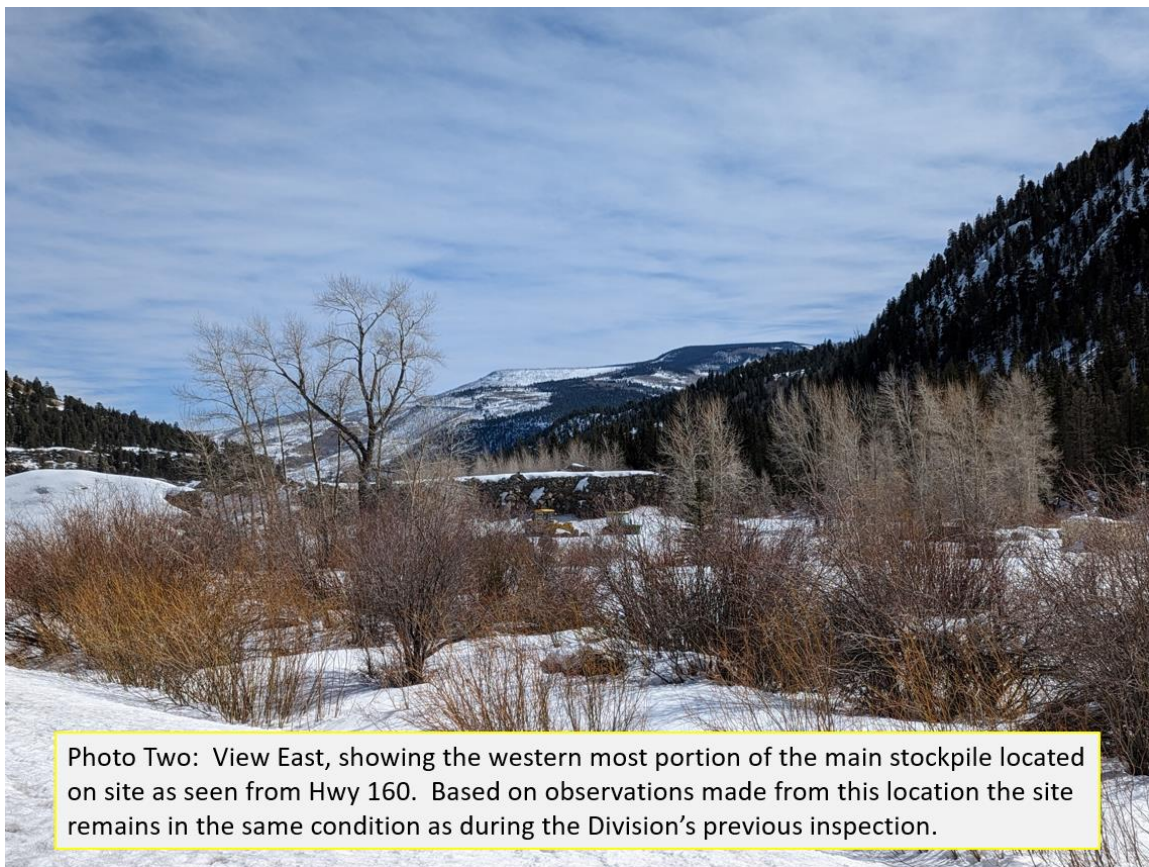
Photo Two: View East, showing the western most portion of the main stockpile located on site as seen from Hwy 160. Based on observations made from this location the site remains in the same condition as during the Division's previous inspection.
