MINERALS PROGRAM INSPECTION REPORT
PHONE: (303) 866-3567

MINE NAME: Overlook Mine	MINE/PROSPECTING ID#: M-2006-075	MINERAL: Sand and gravel	COUNTY: Grand
INSPECTION TYPE: Monitoring	WEATHER: Snowing	INSP. DATE: March 23, 2023	INSP. TIME: 10:00
OPERATOR: GRCO LLC	OPERATOR REPRESENTATIVE: None	TYPE OF OPERATION: 112c - Construction Regular Operation	
REASON FOR INSPECTION: Normal I&E Program	BOND CALCULATION TYPE:	BOND AMOUNT: \$57,000.00	
DATE OF COMPLAINT: NA	POST INSP. CONTACTS: None	JOINT INSP. AGENCY: None	
INSPECTOR(S): Peter Hays	INSPECTOR'S SIGNATURE:

March 23, 2023 Inspection Report
TR1 - Blasting

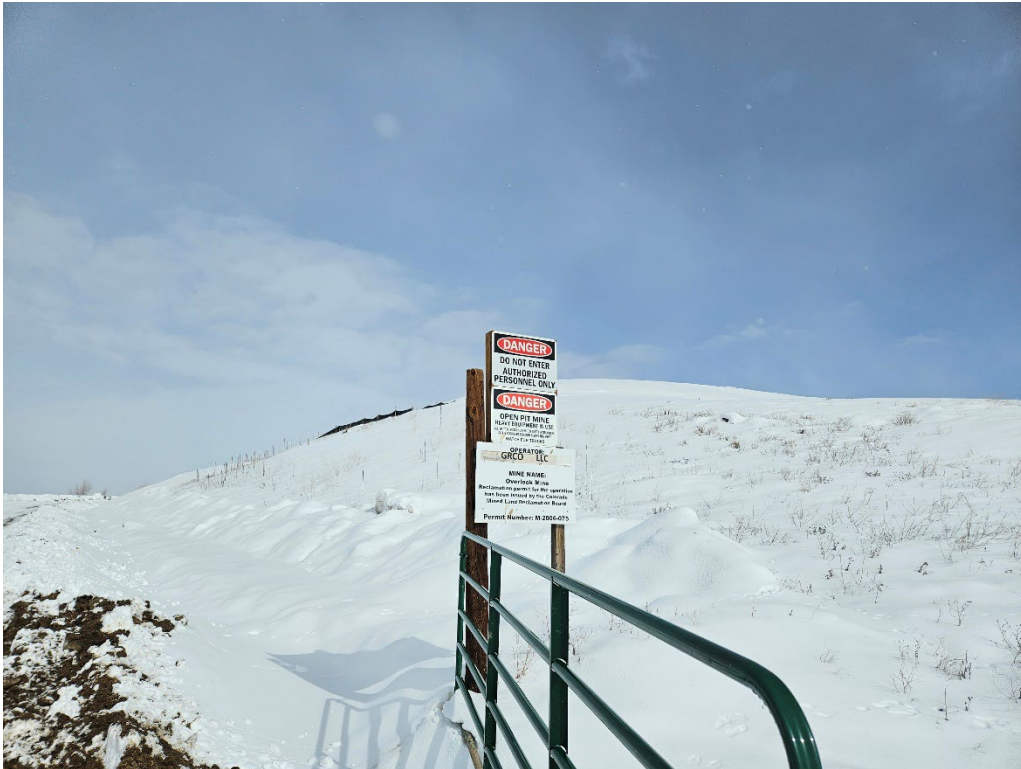
Overlook Mine sign at the entrance gate

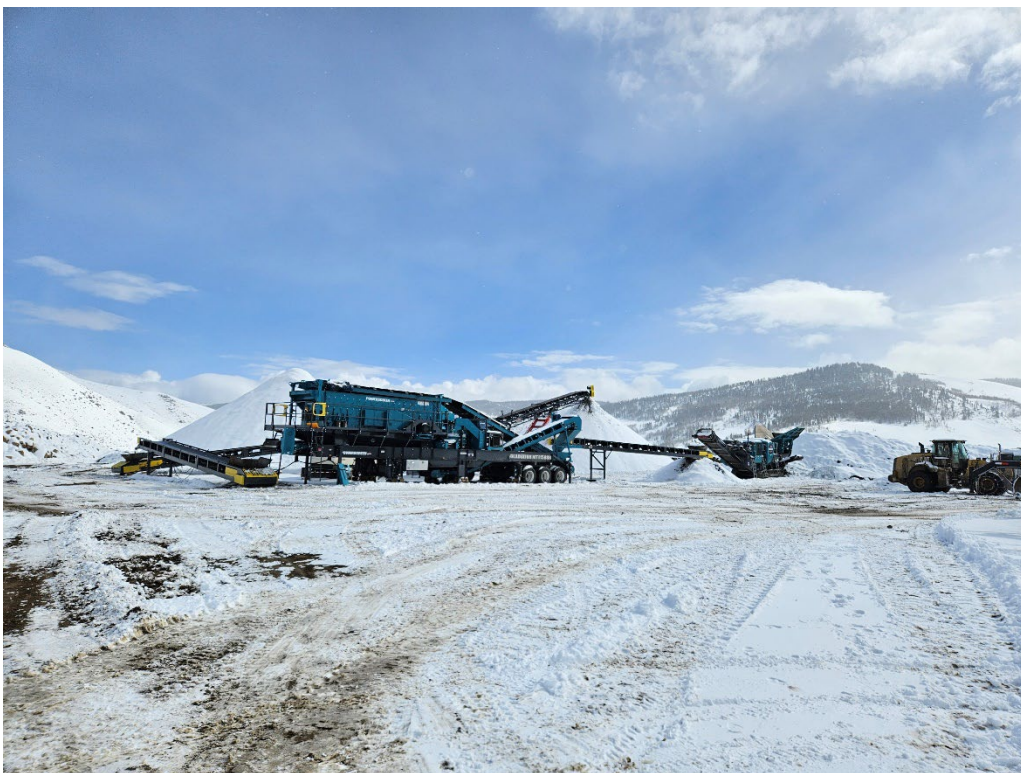
View of the crusher and screen on the pit floor

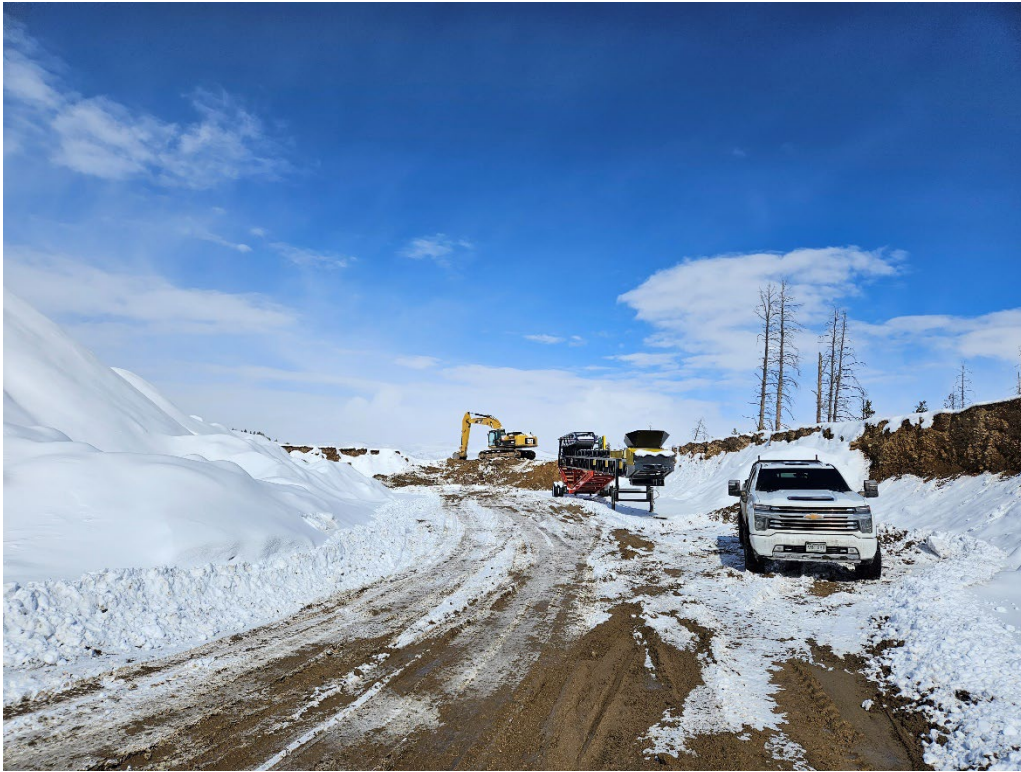
View of the excavation activity in the north side of the site

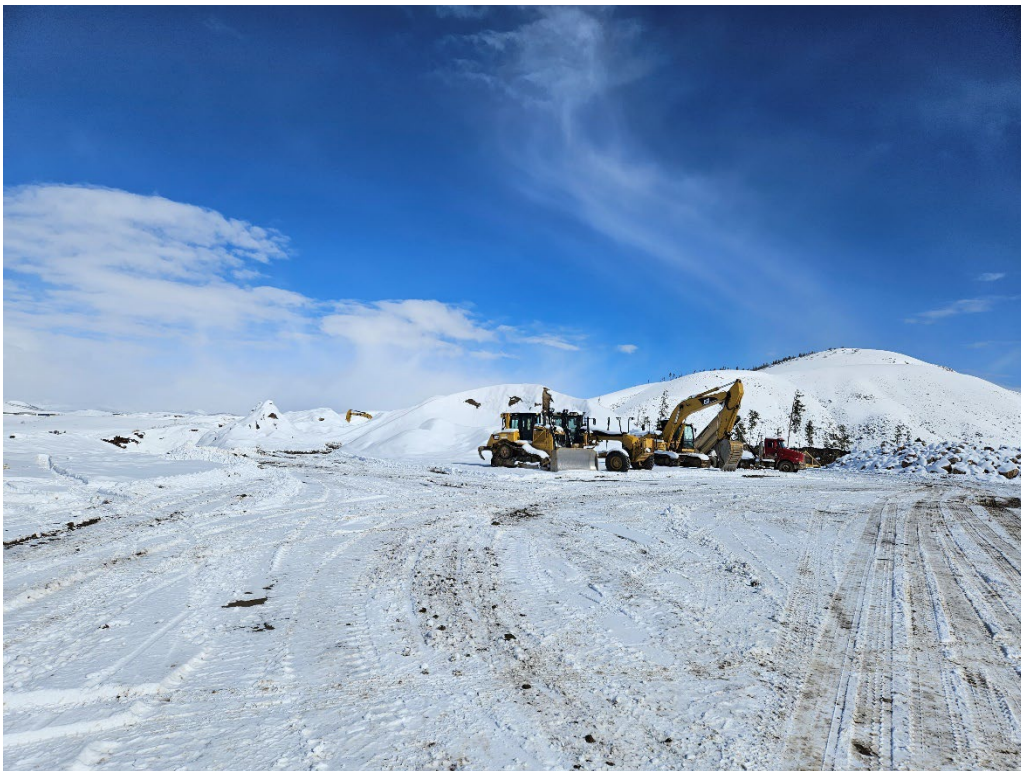
View of the site from the entrance looking northeast

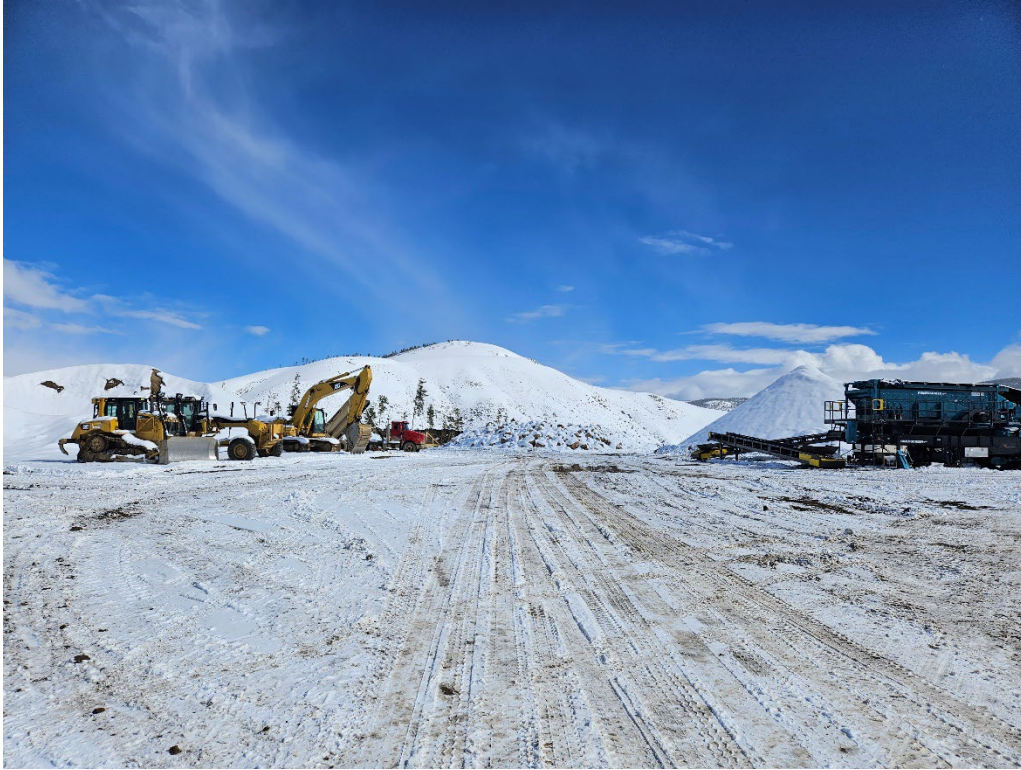
View of the site from the entrance looking east

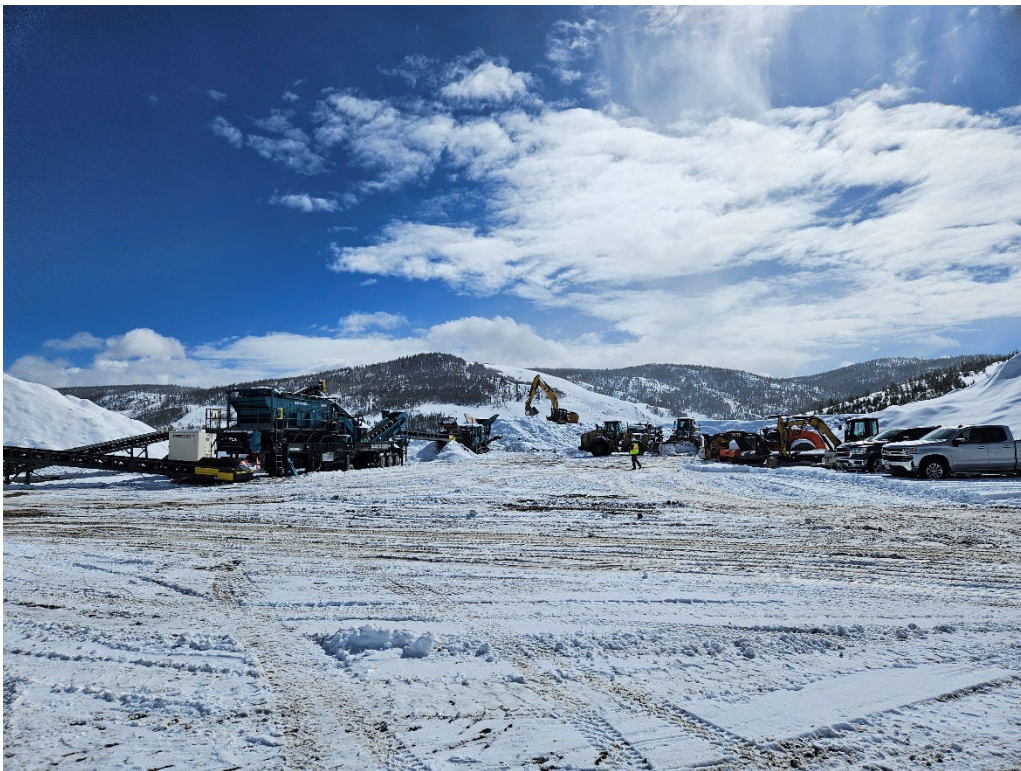
View of the site from the middle of the pit floor looking south
