## QUARTERLY SEDIMENTATION POND INSPECTION REPORT

Mine: New Elk

Inspection Period: First Quarter 2023

**QUARTERLY SEDIMENTATION POND INSPECTION REPORT**  
**New Elk Mine- March 14, 2023**

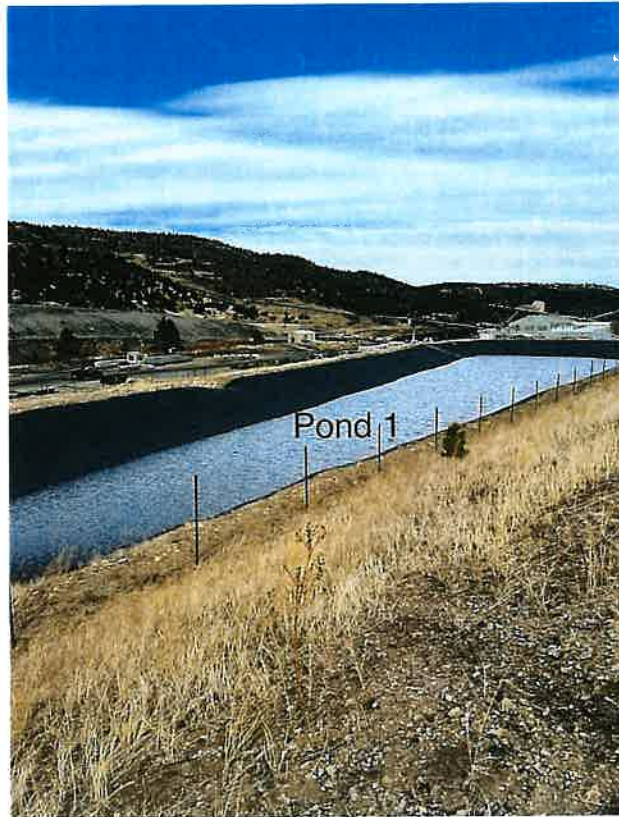
**Pond 1**

Pond liner is in good working condition at time of inspection. Pond was holding water at time of  
inspection. The mine is putting water into the pond. No issues observed.

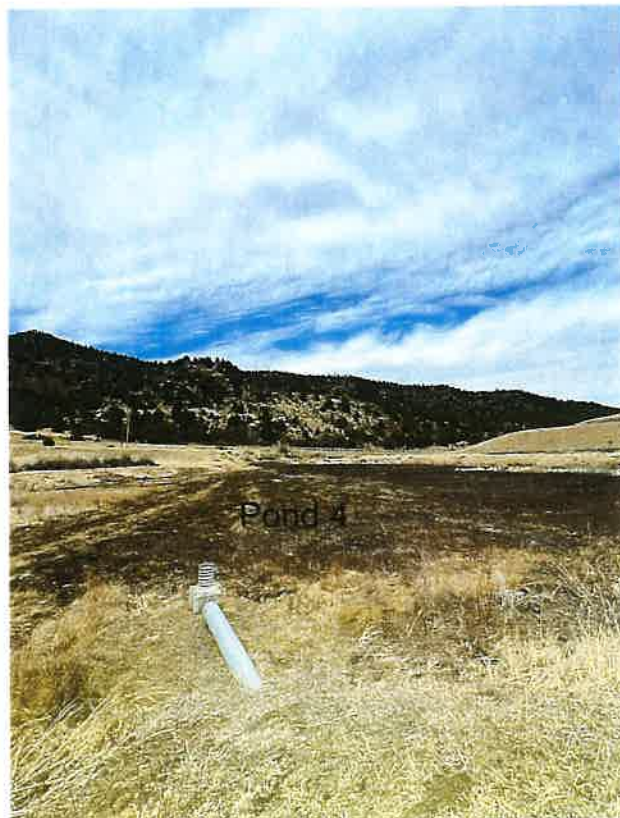
**Pond 4**

Pond was empty at the time of inspection. Willows have been removed from the pond recently.

No issues.

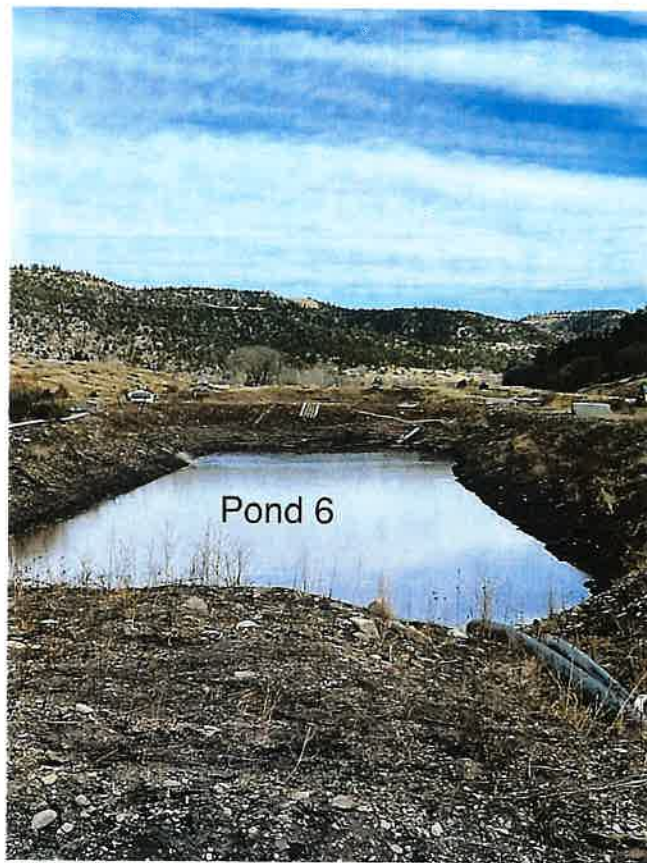
Pond 6

Pond is holding water, but it is not close to full. Flume box needs to be cleaned.

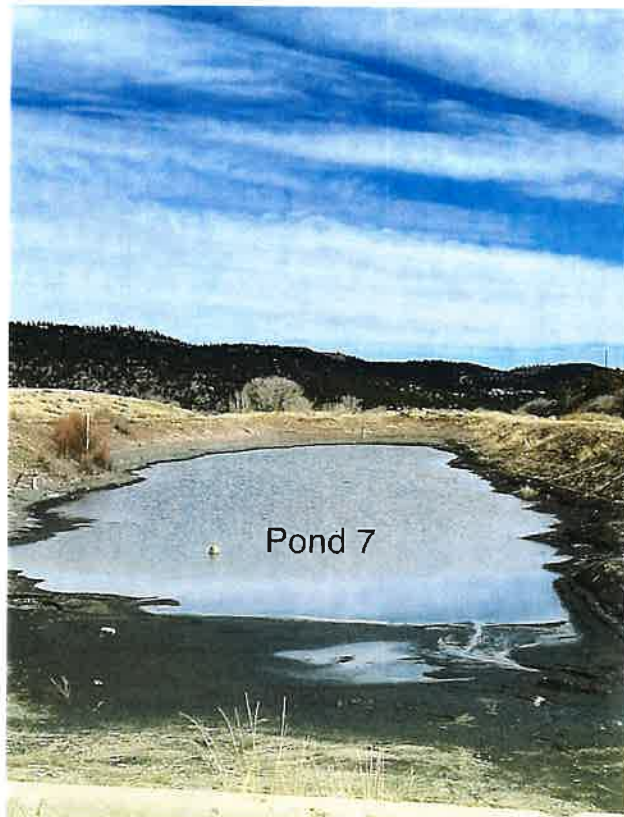
Pond 7

Pond is holding water, water level is lower than previously observed. No issues

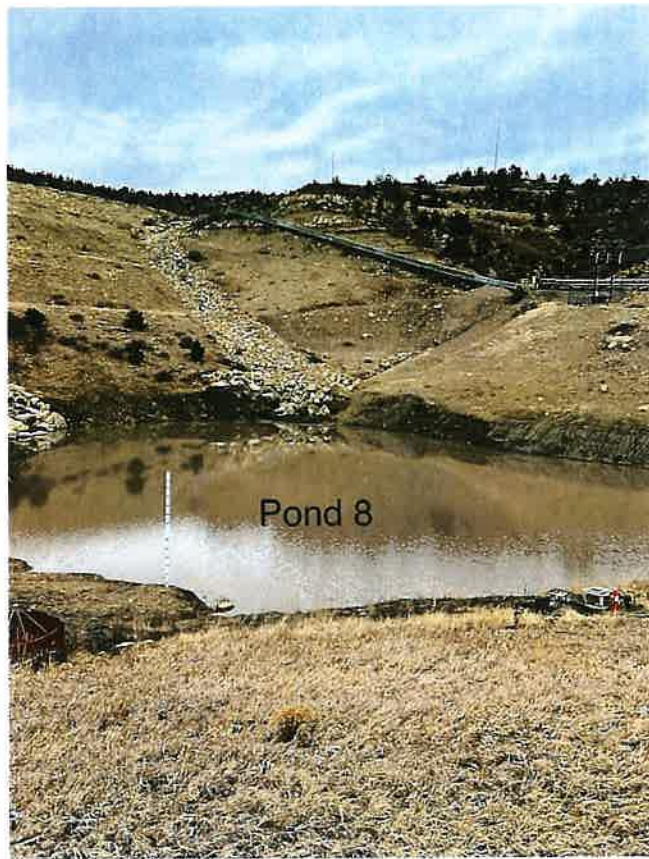
Pond 8

Pumping water from pond 8 to pond 6 during inspection. No issues were observed.

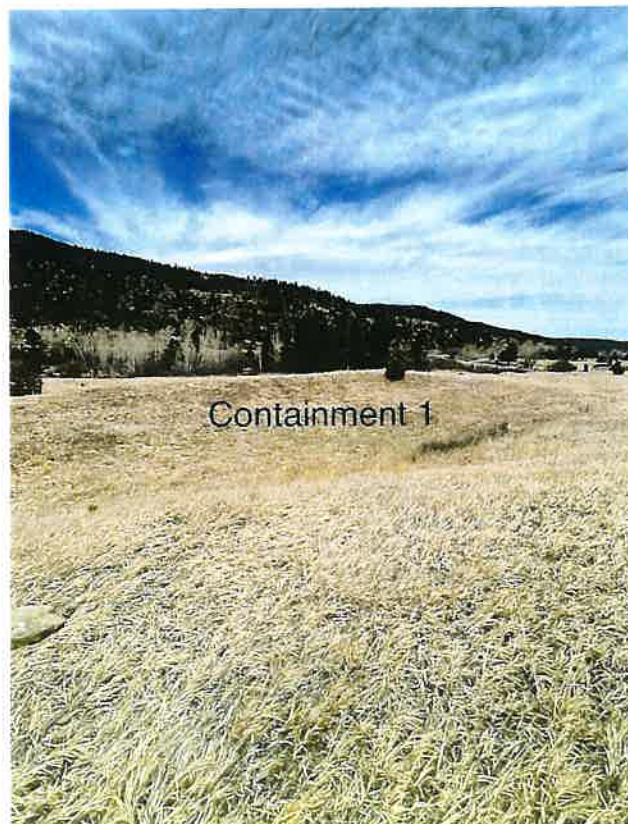
Containment Area #1

Containment was empty at the time of inspection.

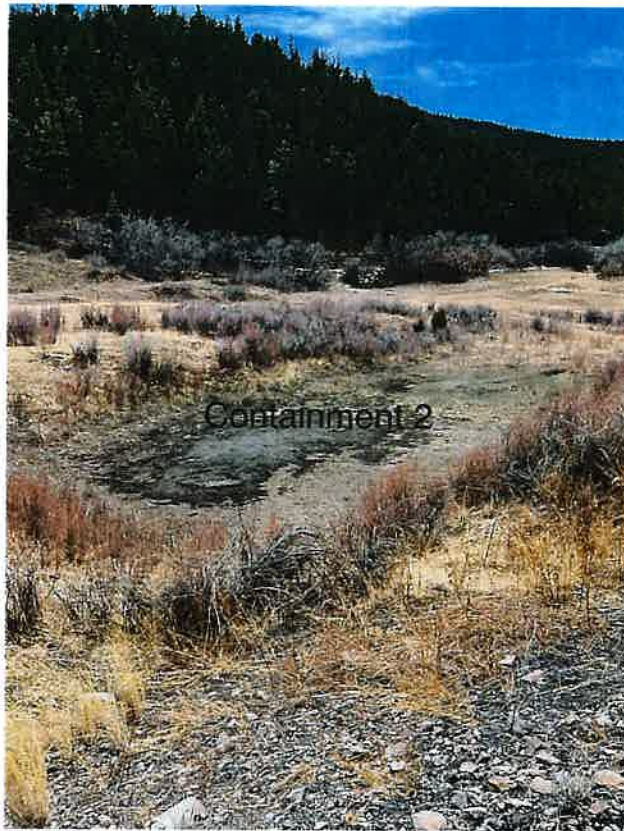
**Containment Area #2**

Containment was empty at time of inspection.

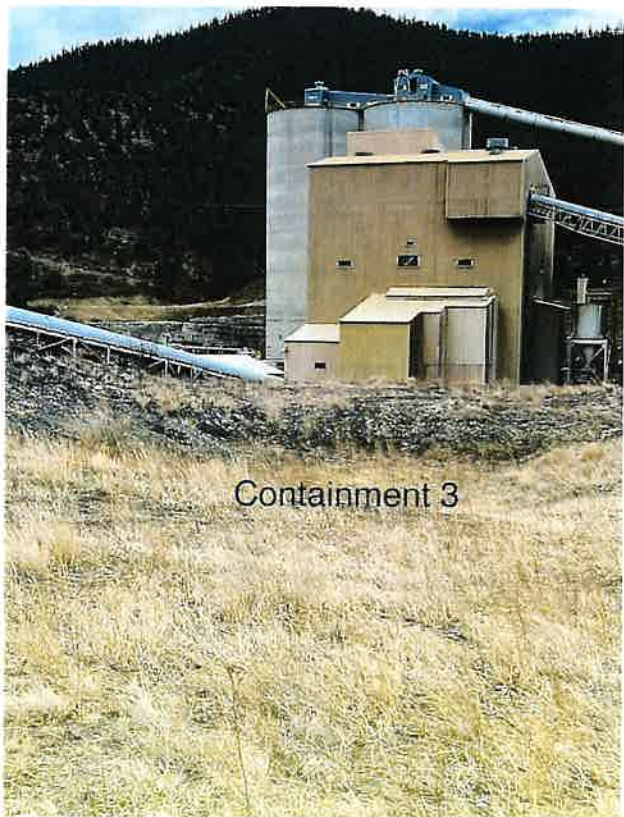
**Containment Area #3**

Containment Area was dry at time of inspection.

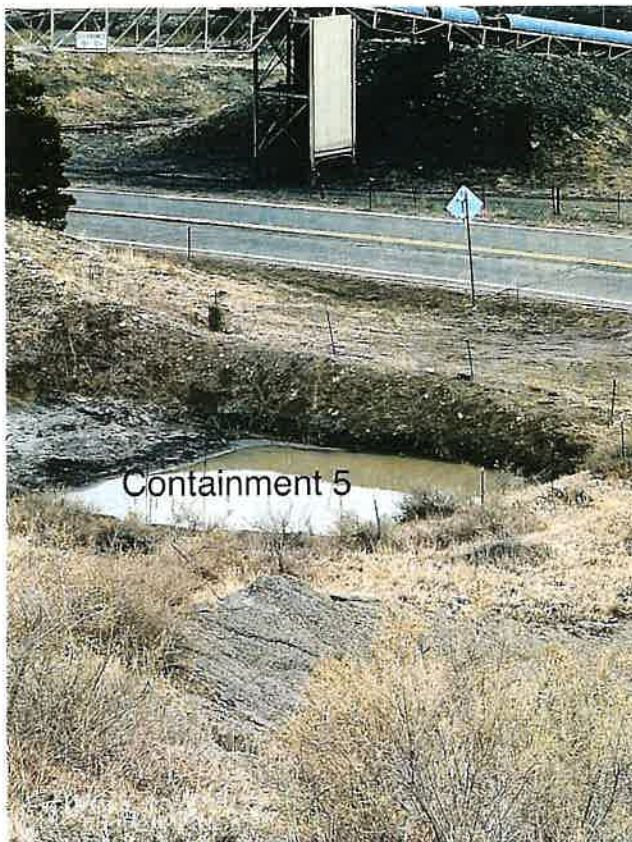
Containment 5

Containment Area was holding water. Cleaned in 2022. No issues
