**LORENCITO CANYON MINE**  
**Permit No. C-1996-084**

**INSPECTION OF EXCESS SPOIL-FILLS 7, 8, & 9**  
**March 14, 2023**

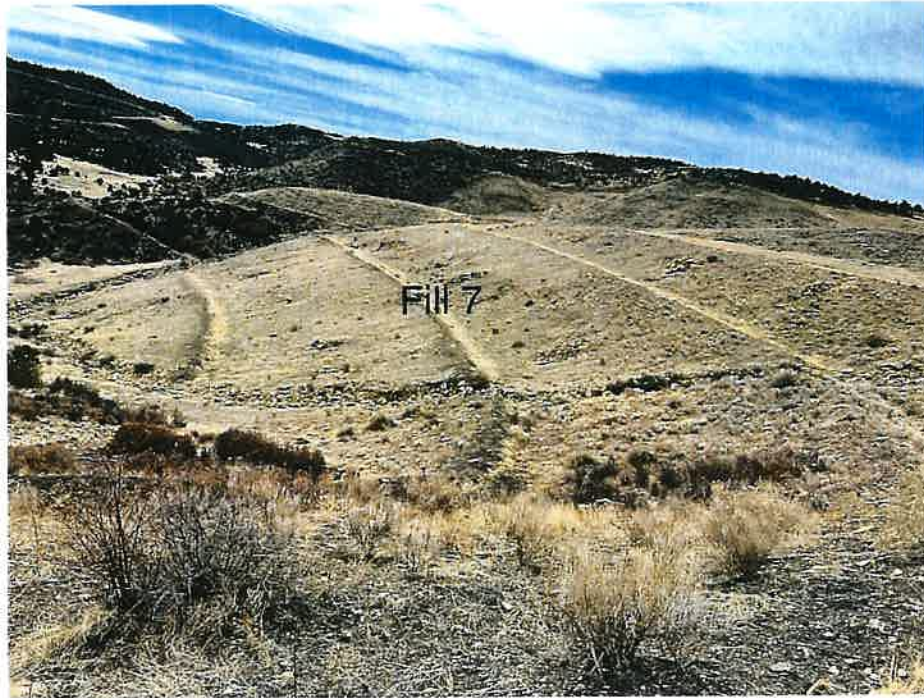
Fill #7

The entire excess spoil fill facility was examined for signs of failure and instability such as tension cracks, ground movement, springs and seeps, and standing water. There was no indication of potential instability at time of inspection.

East armored down drain needs to be monitored and might need a spot that is washed out to be re-armored. All else looks good.

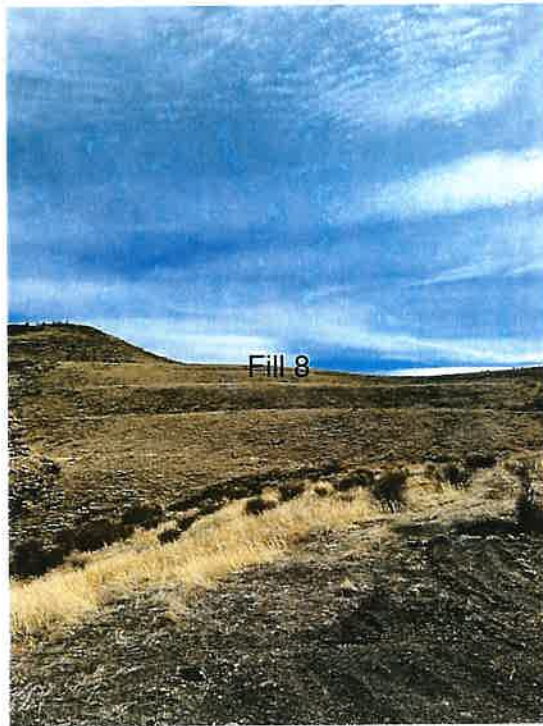
**Fill #8**

The entire excess spoil fill facility was examined for signs of failure and instability such as tension cracks, ground movement, springs and seeps, and standing water. There was no indication of potential instability at time of inspection.

Lower portion of East down drain needs to be monitored and may need additional rock in bare spots. All else is in good condition.

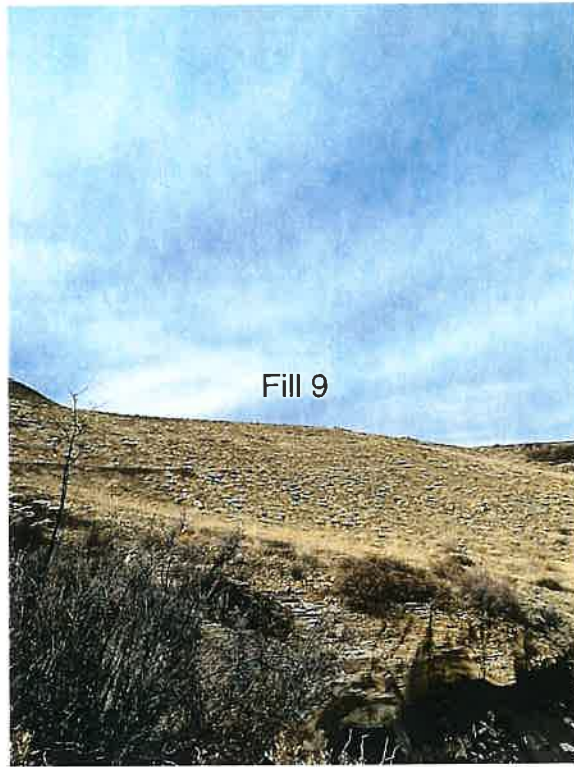
Fill #9

The entire excess spoil fill facility was examined for signs of failure and instability such as tension cracks, ground movement, springs and seeps, and standing water. There was no indication of potential instability at time of inspection.

Overall the site is in good condition.
