QUARTERLY SEDIMENTATION POND INSPECTION REPORT

Mine: Lorencito
NPDES ID. No.: Pond #5
Inspection Period: First Quarter 2023
Inspection Date: 3/14/2023

QUARTERLY SEDIMENTATION POND INSPECTION REPORT
Lorencito Canyon Mine- March 14, 2023

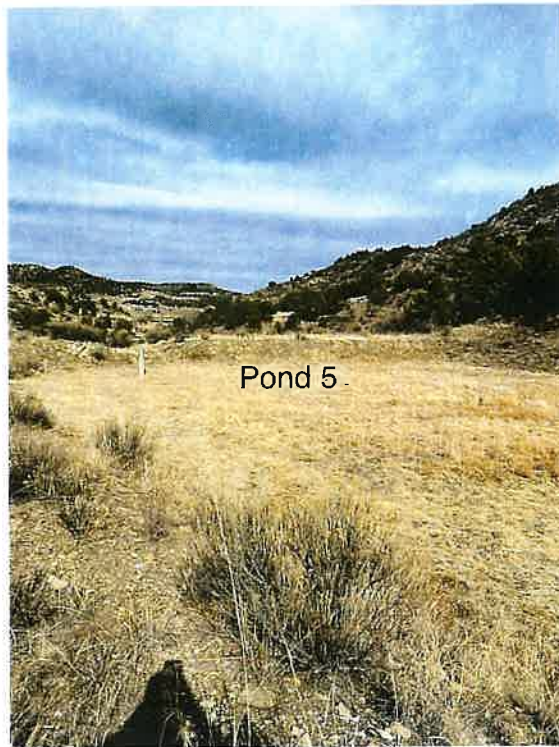
Pond 5

Explain: Sediment in pond does not appear to be over capacity by visual inspection.

Pond was empty at time of inspection.

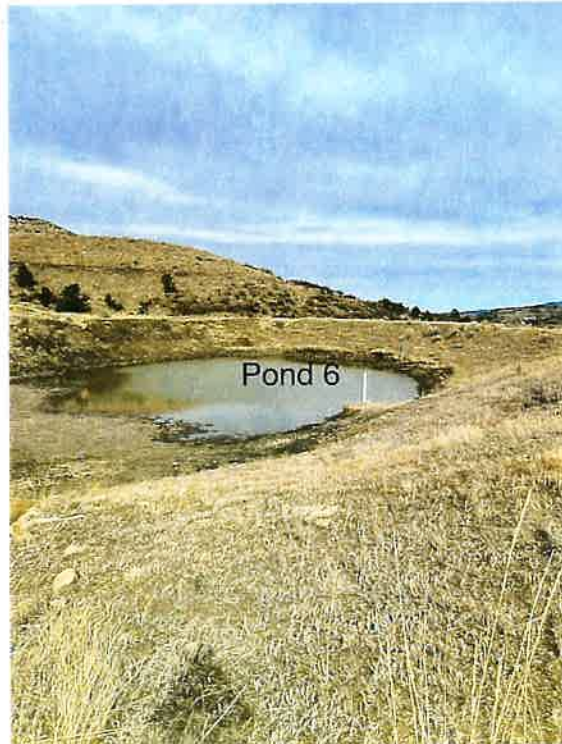
Pond 6

Pond was holding minimal water at time of inspection. Flume box needs to be cleaned.

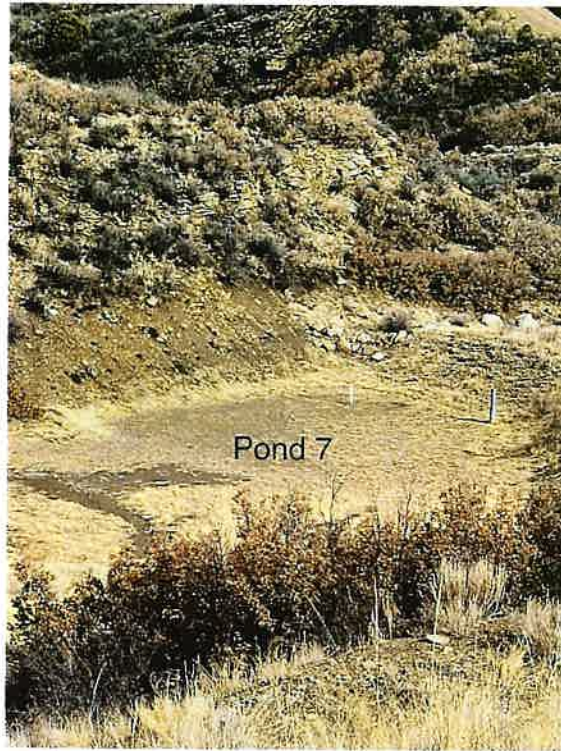
Pond 7

Pond was dry at time of inspection.

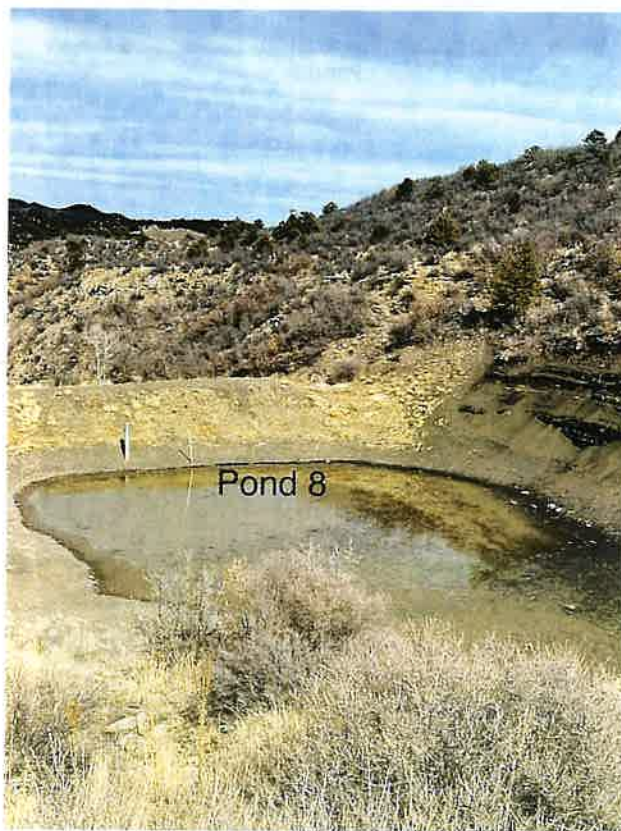
Pond 8

Pond was holding a little water at time of inspection. Flume box needs to be cleaned.
