MINERALS PROGRAM INSPECTION REPORT
PHONE: (303) 866-3567

MINE NAME: Arnold Gulch	MINE/PROSPECTING ID#: M-1998-091	MINERAL: Sand and gravel	COUNTY: Chaffee
INSPECTION TYPE: Monitoring	WEATHER: Clear	INSP. DATE: February 10, 2023	INSP. TIME: 09:54
OPERATOR: Joseph L and Arlene Cogan DBA B.B.L. COO	OPERATOR REPRESENTATIVE: Bruce and Brian Cogan	TYPE OF OPERATION: 110c - Construction Limited Impact	
REASON FOR INSPECTION: Normal I&E Program	BOND CALCULATION TYPE:	BOND AMOUNT: \$17,500.00	
DATE OF COMPLAINT: NA	POST INSP. CONTACTS: None	JOINT INSP. AGENCY: None	
INSPECTOR(S): Lucas West	INSPECTOR'S SIGNATURE:

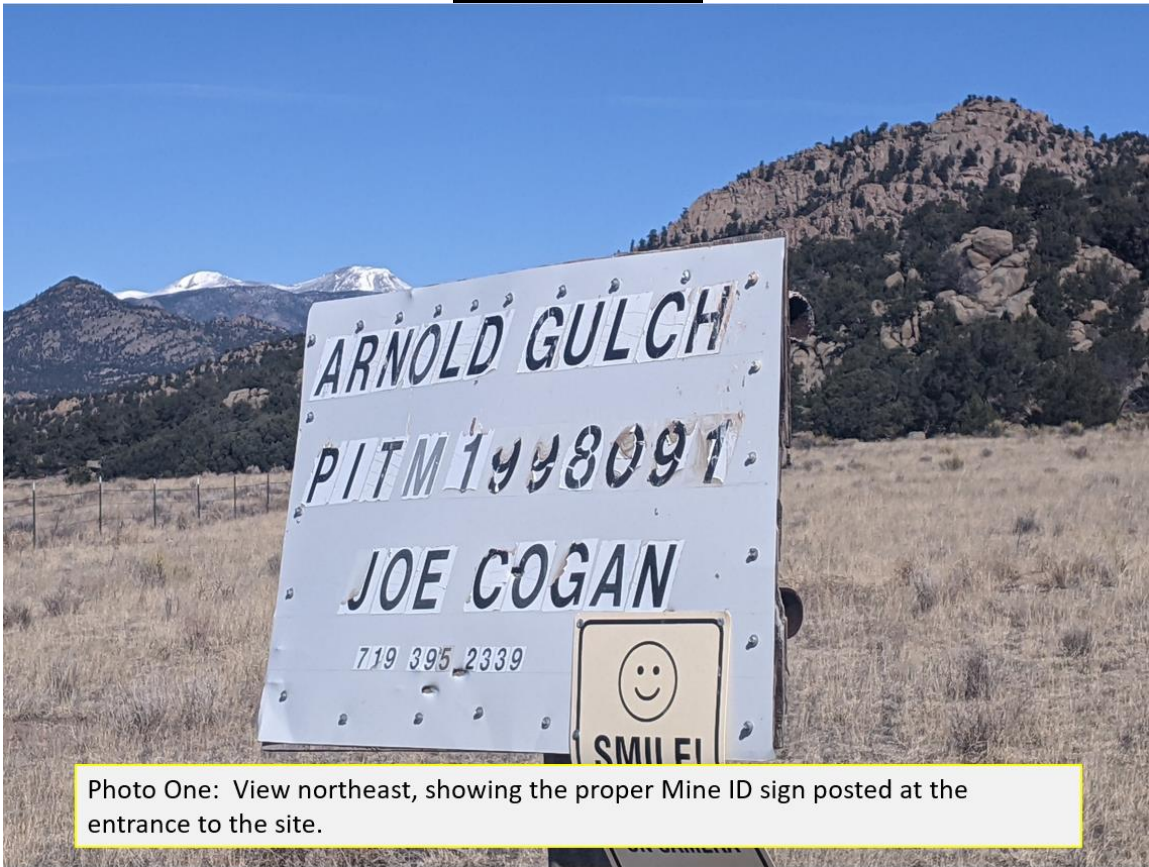
The Proper Mine Identification signage was posted at the entrance to the site as seen in Photo One. Active reclamation activities were not being conducted at the time of the inspection due to the winter season and no equipment was present on site. The affected area is marked by t-posts and clearly visible to delineate the affected area. The pit follows a west flowing drainage and covers approximately 6.6 acres. All stockpiles have been removed from the site, and most of the earth work has been conducted. All highwalls have been reduced to a 2H:1V or 3H:1V. Examples of the grading and earthwork can be seen in Photos Two through Six. Throughout the pit, the areas that have been graded show no signs of settling or slumping on only a few areas of very minor erosion was noted. The erosion appears to be caused by sheet flow coming from unaffected areas into the pit. On site discussions covered preventative measures and practices to prevent erosion as well as methodology of revegetation efforts. The work that has been conducted to date has achieved a high level of success, and only minor finish dressing of slope areas remains in regards to dirt work. Aside from the finish dressing, revegetation is the only reclamation task that remains.

Photo One: View northeast, showing the proper Mine ID sign posted at the entrance to the site.

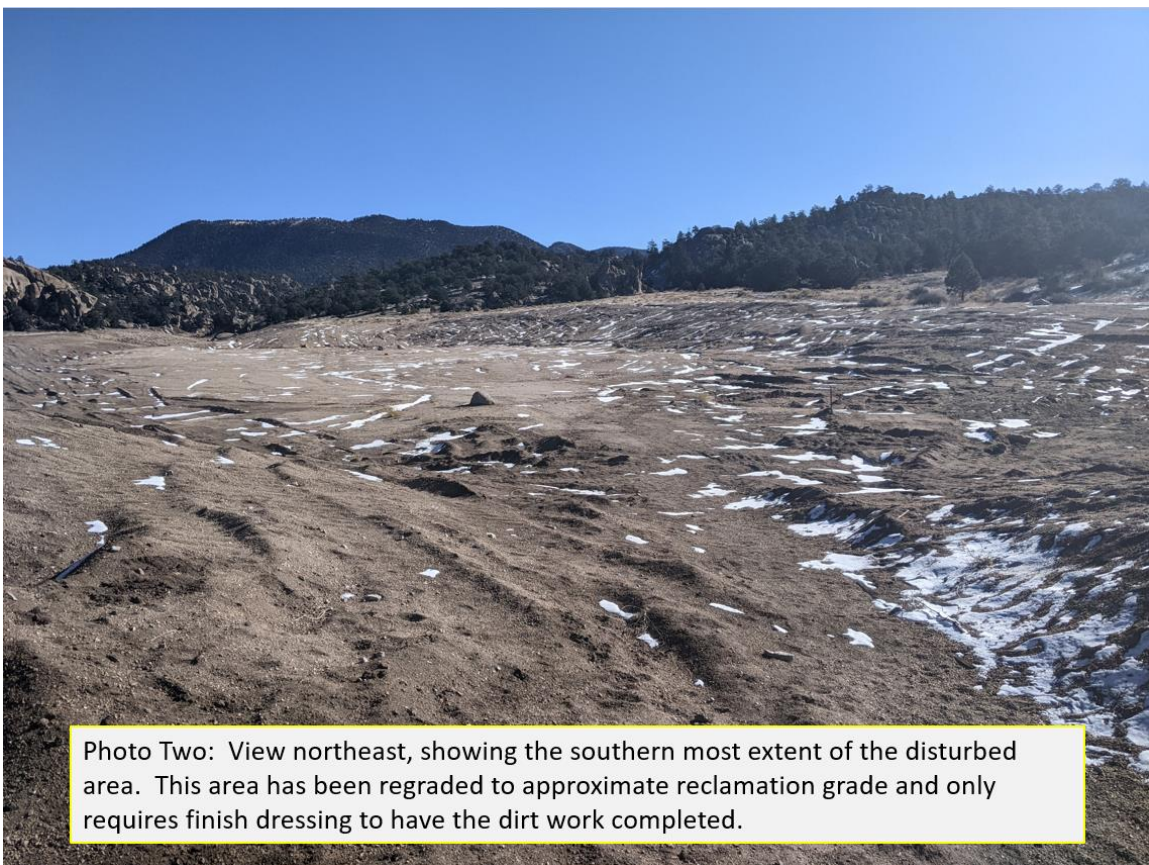
Photo Two: View northeast, showing the southern most extent of the disturbed area. This area has been regraded to approximate reclamation grade and only requires finish dressing to have the dirt work completed.
