**NEW ELK MINE**  
**Permit No. C-1981-012**

**QUARTERLY COAL WASTE BANK INSPECTION REPORT**  
**March 14, 2023**

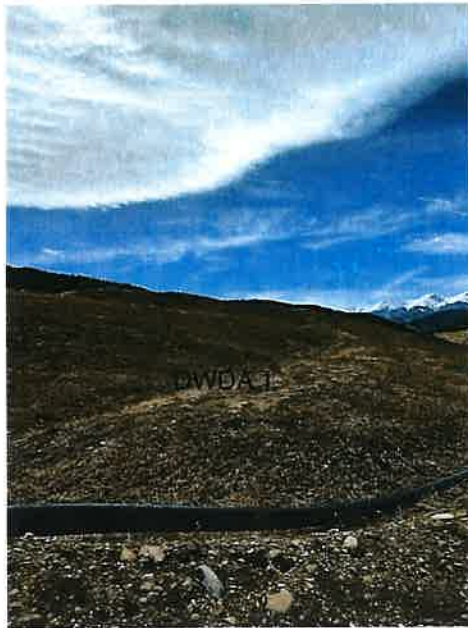
DWDA #1

Overall the disposal area is in good condition.

None at this time.

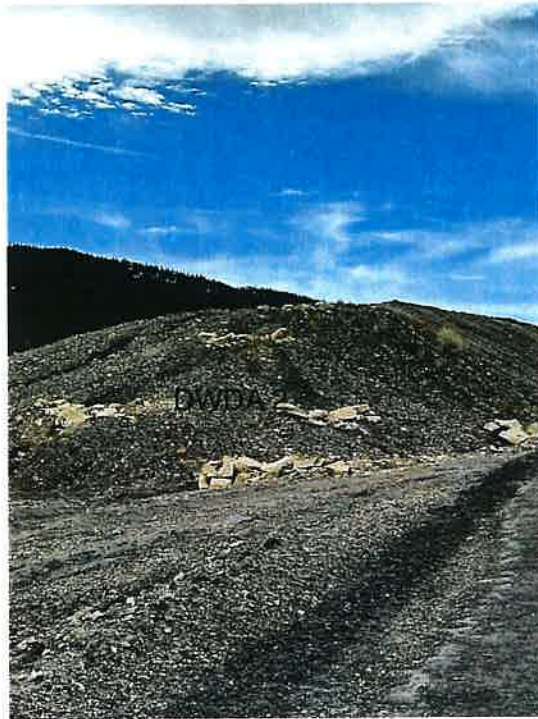
**DWDA #2**

Surface and out slopes of the pile were inspected for visible signs of potential failure or instability. There was some surface erosion but not enough to make the area unstable. In all no signs of failure or instability were observed.

Overall the disposal area is in good condition. The sign with the name of the area was recently replaced.

The Rills are being monitored and have not gotten any bigger and there is no sediment loading. Operator is evaluating either reclamation of the area or permitting alternative uses of the land north of the Purgatoire River and south of Highway 12. The sump at the end of the area was being cleaned as annual maintenance.
