MINERALS PROGRAM INSPECTION REPORT
PHONE: (303) 866-3567

MINE NAME: Kokes Gravel Pit	MINE/PROSPECTING ID#: M-1978-249	MINERAL: Sand and gravel	COUNTY: Logan
INSPECTION TYPE: Surety Release Inspection	WEATHER: Clear, chilly	INSP. DATE: March 14, 2023	INSP. TIME: 10:00 a.m.
OPERATOR: Logan County	OPERATOR REPRESENTATIVE: Jeff Reeves	TYPE OF OPERATION: 112c - Construction Regular Operation	
REASON FOR INSPECTION: Surety Release Requested	BOND CALCULATION TYPE: None	BOND AMOUNT: No Bond Held	
DATE OF COMPLAINT: NA	POST INSP. CONTACTS: None	JOINT INSP. AGENCY: None	
INSPECTOR(S): Nikie Gagnon	INSPECTOR'S SIGNATURE:

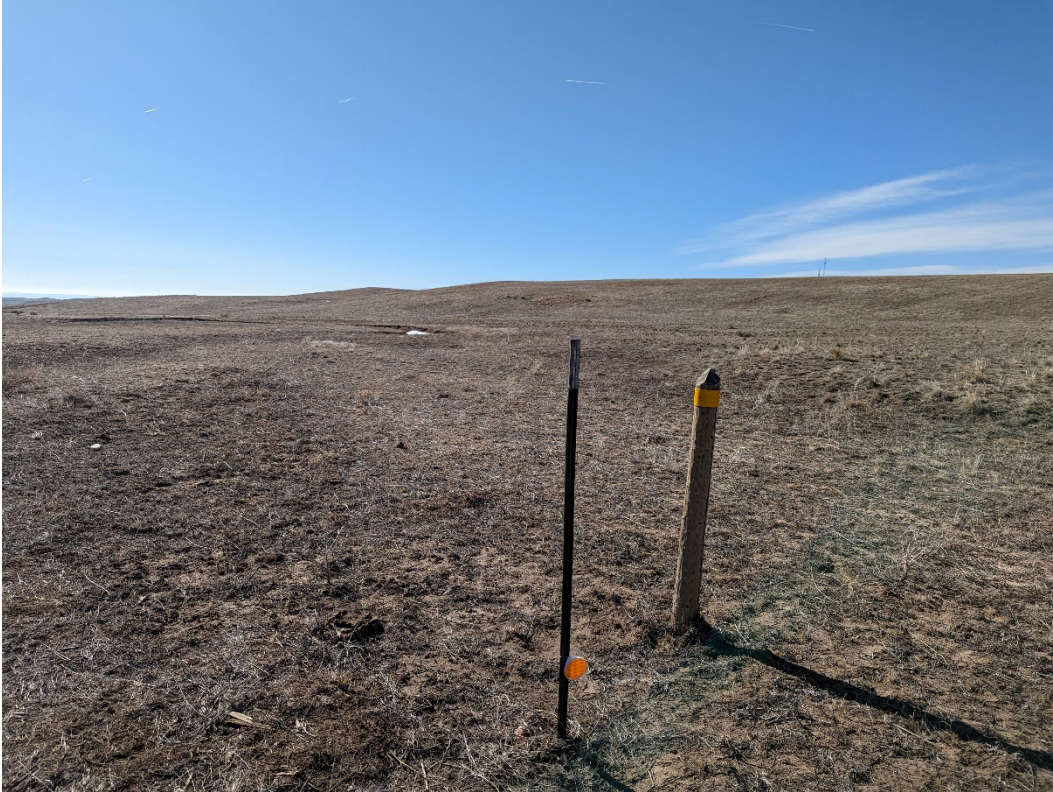
Photo 1. Looking south from boundary marker in the northeast corner of the permit area.

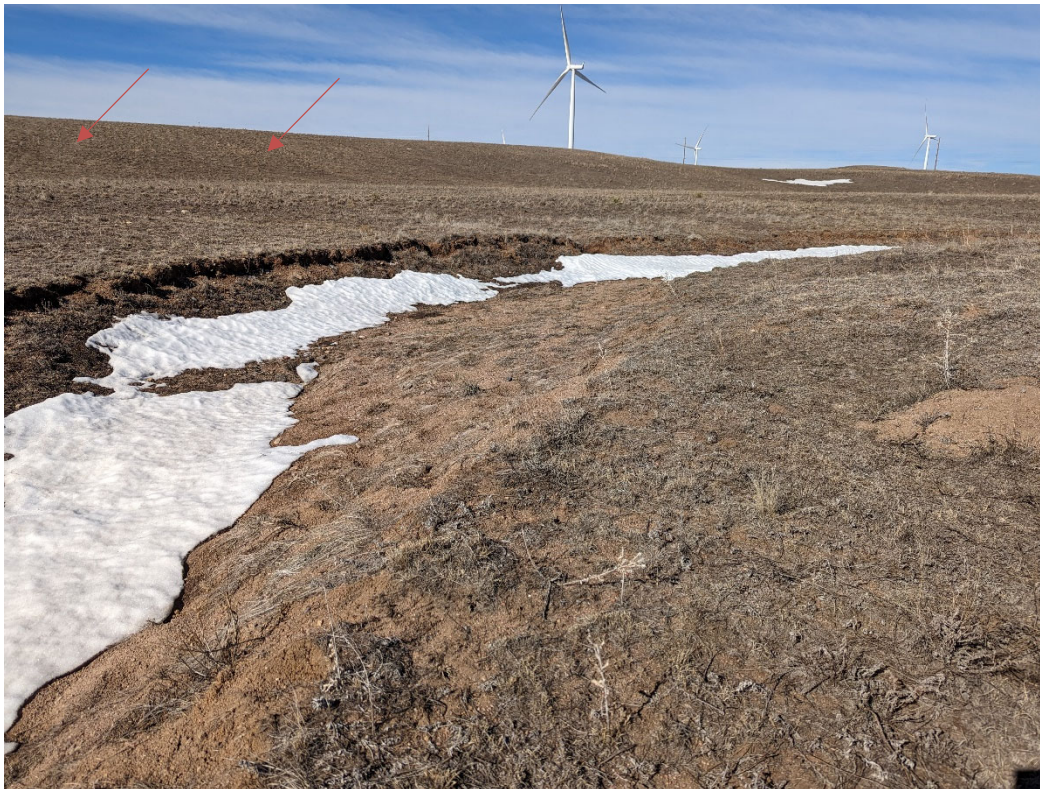
All reclamation has been completed. Mining occurred on a hillside above an intermittent creek. The affected area has been backfilled and graded leaving a gentle slope that appears to be set at a 3H:1V angle or less and blends into the topography of the surrounding area. Erosion rills and gullies were not observed.

Photo 2. Looking northwest from the intermittent stream that runs along the bottom of the permit area. Red arrow points to reclaimed slope.

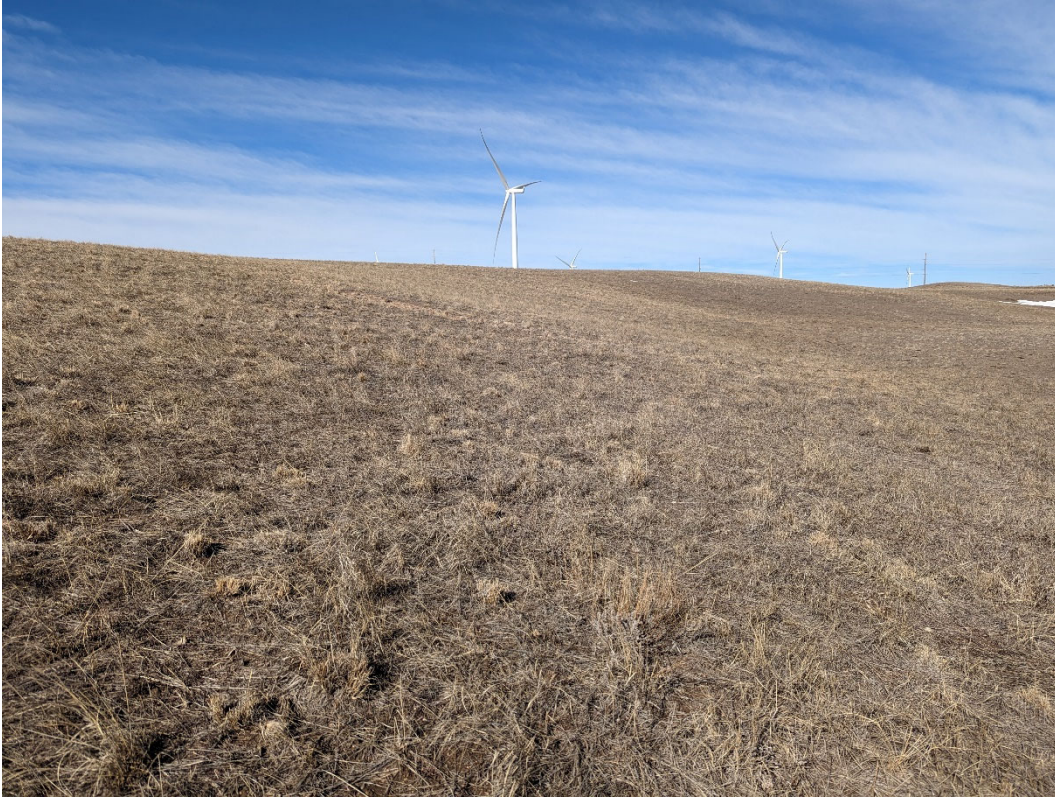
Photo 3. Looking north across the slopes in the permit area. Grasses established throughout the reseeded area.

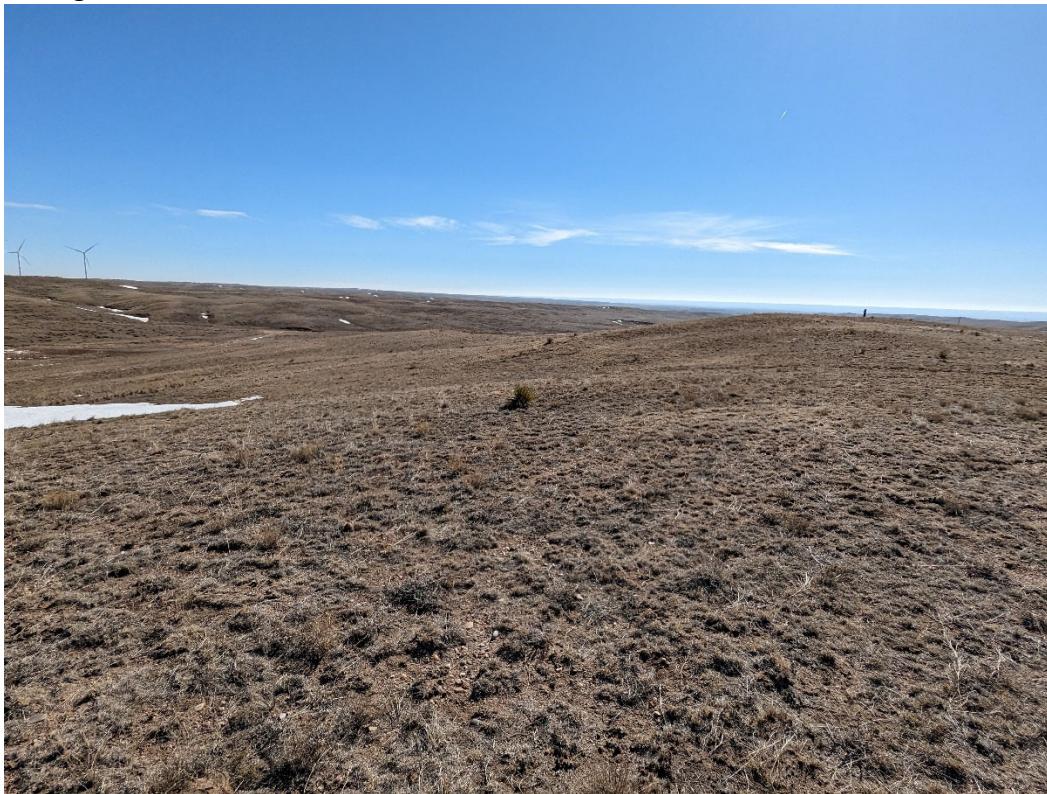
Photo 4. Looking south across the slopes in the permit area. Grasses established throughout the reseeded area.

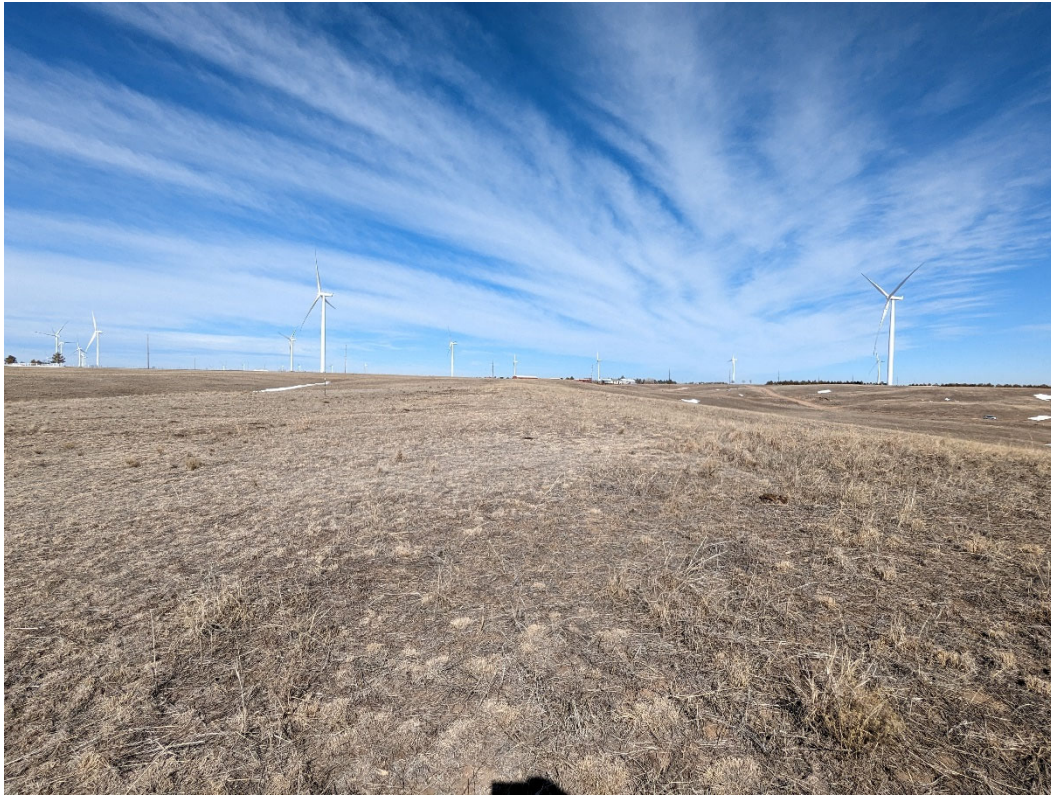
Photo 5. Looking north across the top of the slopes. Grasses are patchy in spots here but continue to fill in across the area of disturbance.

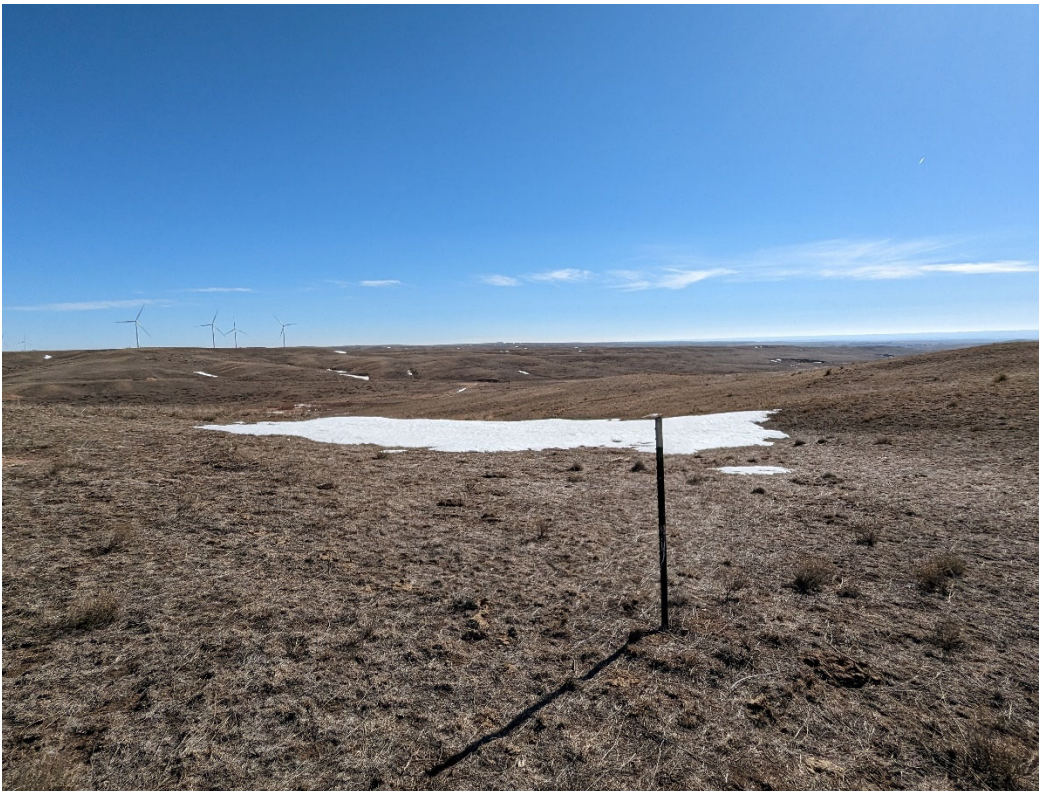
Photo 6. Looking north from the southwest corner of the permit area. This area remains undisturbed.
