MINERALS PROGRAM INSPECTION REPORT
PHONE: (303) 866-3567

MINE NAME: Carbon Valley Resource	MINE/PROSPECTING ID#: M-2001-017	MINERAL: Sand and gravel	COUNTY: Weld
INSPECTION TYPE: Monitoring	WEATHER: Cloudy	INSP. DATE: March 30, 2023	INSP. TIME: 09:45
OPERATOR: L. G. Everist, Incorporated	OPERATOR REPRESENTATIVE: Lynn Mayer-Shultz	TYPE OF OPERATION: 112c - Construction Regular Operation	
REASON FOR INSPECTION: Normal I&E Program	BOND CALCULATION TYPE: Complete Bond	BOND AMOUNT: \$1,025,000.00	
DATE OF COMPLAINT: NA	POST INSP. CONTACTS: None	JOINT INSP. AGENCY: None	
INSPECTOR(S): Eric Scott	INSPECTOR'S SIGNATURE:

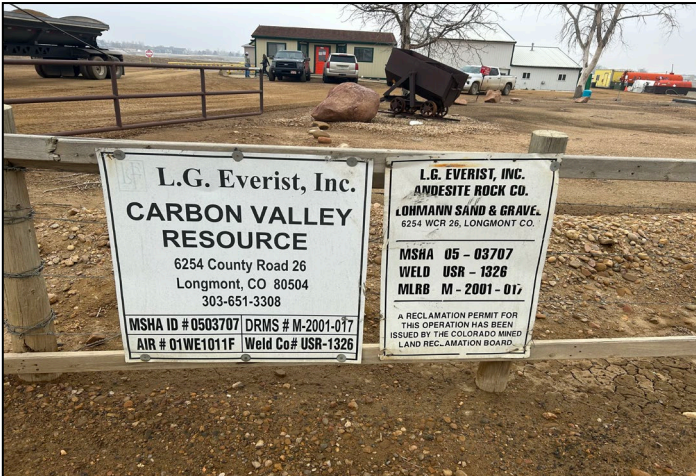
This was a routine monitoring inspection for an active 112c sand and gravel operation conducted by Eric Scott of DRMS for the Carbon Valley Resource site operated by LG Everist. DRMS met with permittee representative Lynn Mayer Shults at the site at approximately 09:45 and toured the site. This site is approximately 58 acres located near the SE corner of Weld County Roads 13 and 26. The site identification sign was observed at the site entrance in front of the site office on the south side of WCR 26 (photo 1).

Photo 1 – Site identification signs at site entrance on south side of WCR 26.

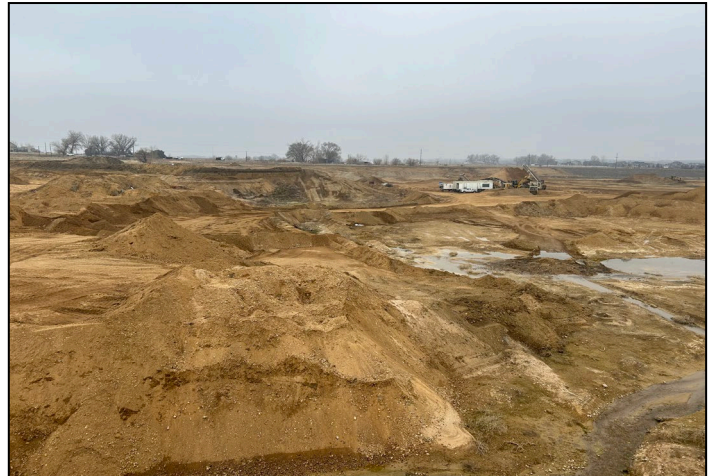
Mining at the time of this inspection was taking place on the south and southeast portion of the permit area (photo 2), the plant and product stockpiles are located within the pit near the center of the pit floor (photo 3). Much of the outer pit slope earthwork has been completed, primarily on the northern half of the excavation (photo 4). Two gas/oil wells located in the southwest corner of the permit are in the process of being abandoned and removed at this time. A Technical Revision to the final pit configuration will be required if LGE intends to mine through this area when the wells are removed to expand the final reservoir capacity.

Photo 2 – Active mining area on south end of pit. Looking west across pit area.

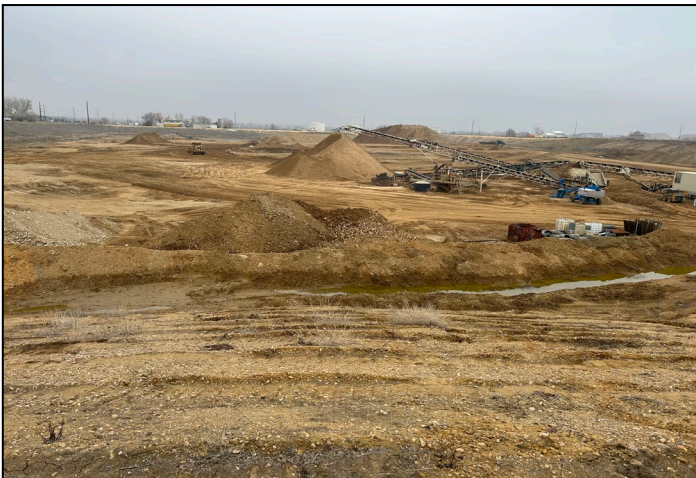
Photo 3 – Plant and stockpile area in center of pit. Looking north into pit from area of abandoned wells.

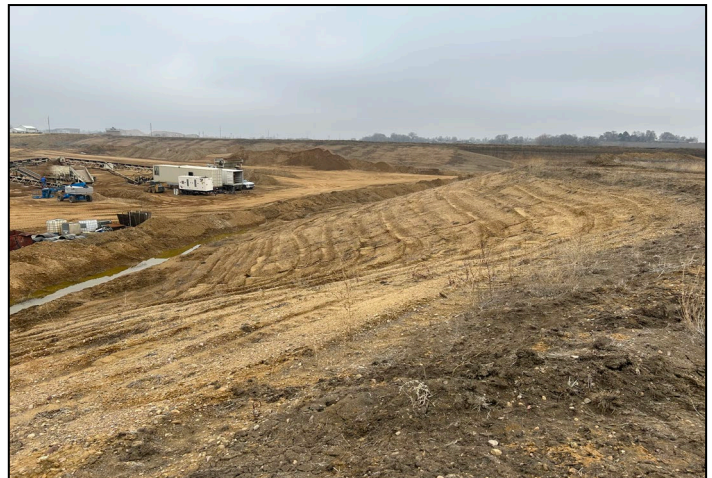
Photo 4 – Looking at representative area of re-sloped outer pit perimeter. Most of the north half of the pit perimeter has been re-sloped at this time.
