MINERALS PROGRAM INSPECTION REPORT
PHONE: (303) 866-3567

MINE NAME: Lascar Pit	MINE/PROSPECTING ID#: M-2023-005	MINERAL: Aggregate	COUNTY: Huerfano
INSPECTION TYPE: Preoperation Inspection	WEATHER: Windy	INSP. DATE: March 28, 2023	INSP. TIME: 14:10
OPERATOR: Siete, Inc.	OPERATOR REPRESENTATIVE: Jodi Schreiber	TYPE OF OPERATION: 111 - Construction by Government Agency

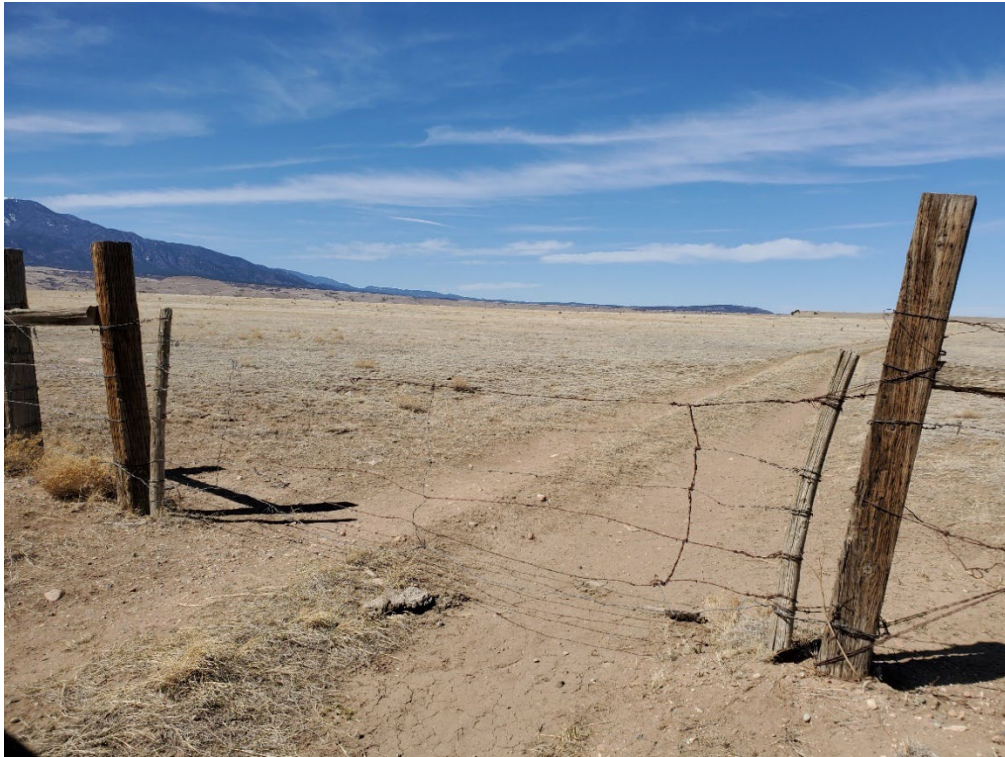
There is currently an existing small access road leading from County Road 650 to the mining area of the proposed site (see Photos 1 and 2 below). The originally proposed access road was to be constructed over this existing road to create improved access for the mining equipment and vehicles. This was to be accomplished by removing topsoil to a width of 30 feet. The majority of this pre-existing road will still be improved with the construction of a new access road. The new access road is anticipated to connect with the pre-existing road after providing road access from County Road 650 at the east side of Section 36, and cutting across the section from east to west (see Map 1 below).

Photo 1: Looking north-west at the entrance to the pit currently proposed in the Special Operations 111 application.

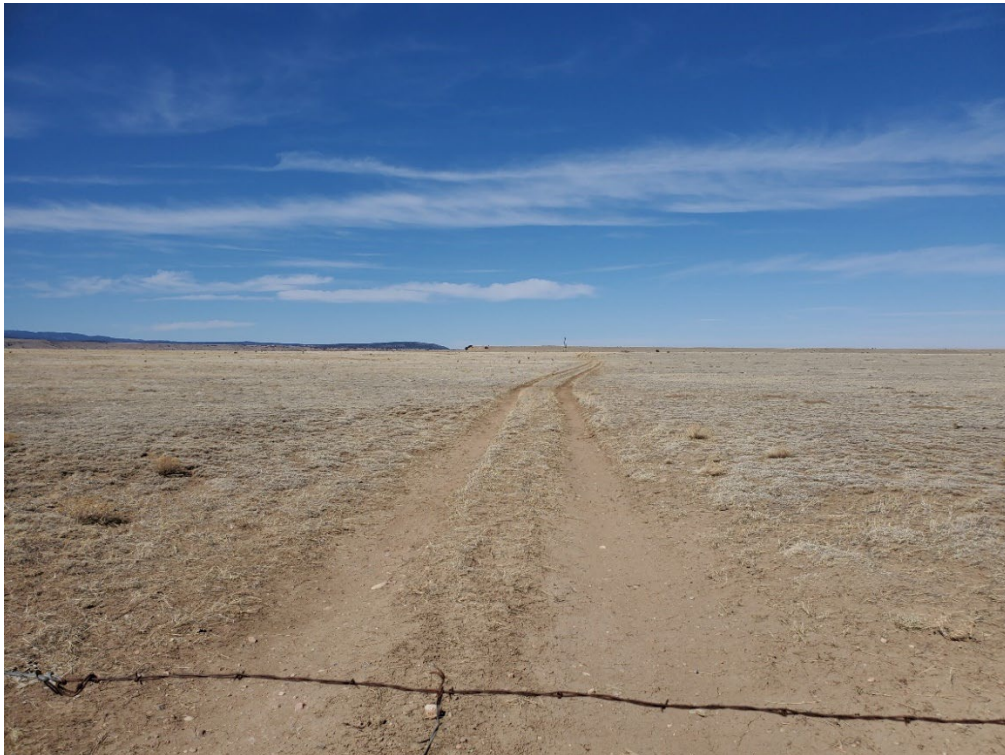
Photo 2: Looking north at the current entrance road present prior to mining operations, leading to the pit currently proposed in the Special Operations 111 application.

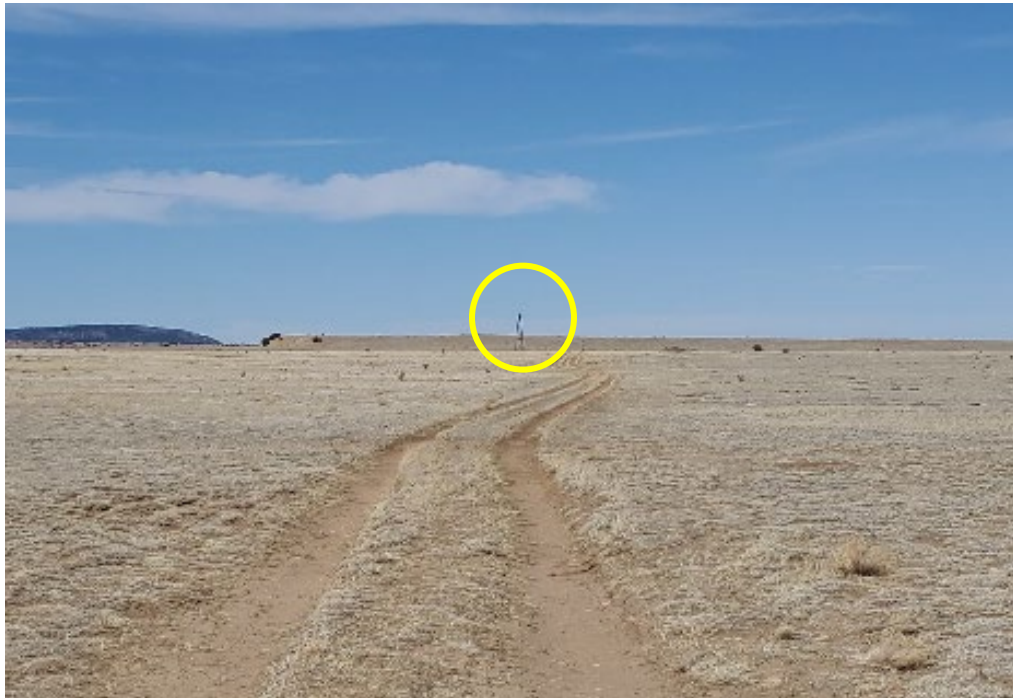
A windmill is noted as a structure within 200 feet of the permit area on the Applicant's Existing Conditions Exhibit E map. However, the windmill is not located on the map. The windmill was observed from the outside of the currently proposed site entrance (see Photo 3 below). The Applicant stated that they will include this structure on the new maps that they will be submitting through their Technical Revision.

Photo 3: Looking north at the proposed permit area. Circled is a windmill that is mentioned on the Applicant's current Existing Conditions Exhibit E map, but is not located on the map.

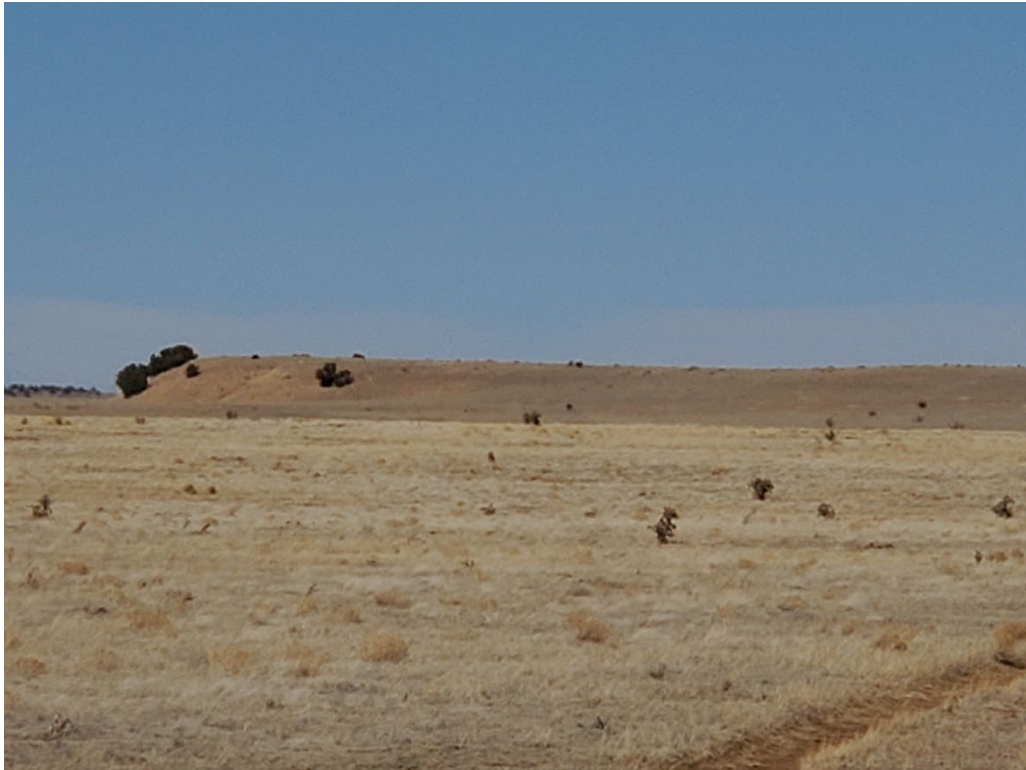
The Division was unable to access the proposed site beyond the currently proposed entrance gate. The gate was secured with barbed wire, and without cutting the wire, it was unable to be opened. From the entrance, the Applicant reiterated the mining plan proposed in the application, and stated that the processing area will be in the south-west portion of the main permit area, and mining will progress north-eastward and eastward from the processing area throughout the project. The Applicant also pointed out the mesa that can be seen from the road, and explained that it will be mined to reduce impacts on visual effects from Interstate 25 South (see Photo 4, Map 2, and Map 3 below).

Photo 4: Looking north at the southern side of a mesa proposed to be mined.

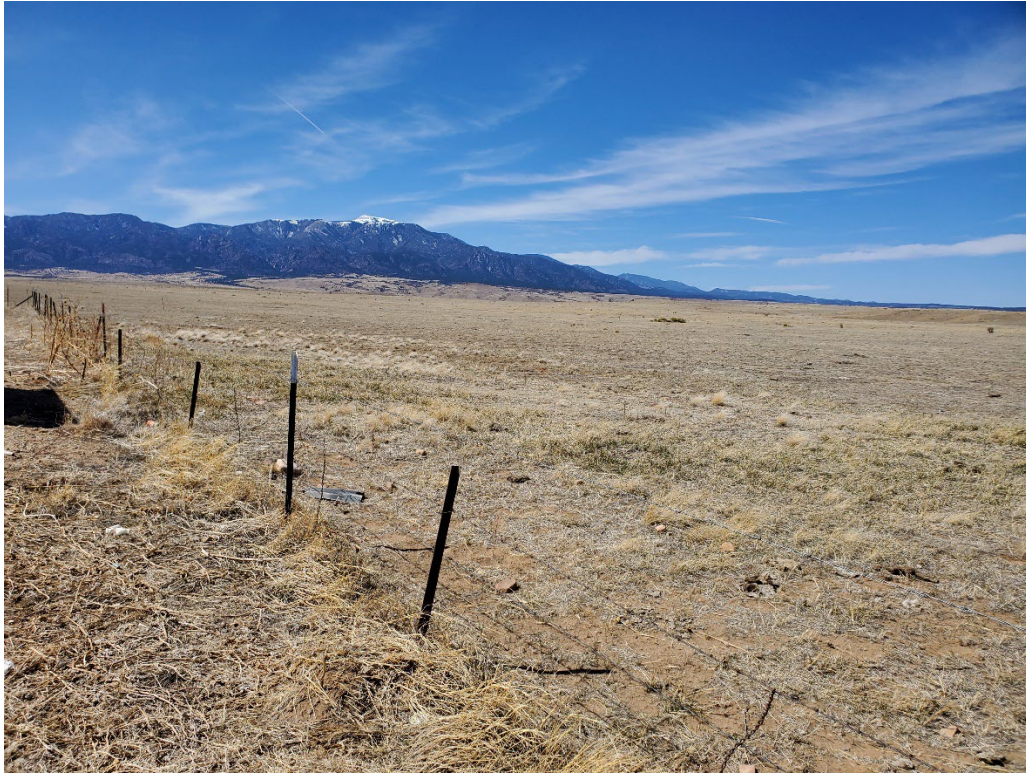
The powerlines, fence, and County Road 650 from the Exhibit E map were also observed from outside the proposed permit area (see Photos 5-8 below). Because we were unable to access the main proposed permit area, the waterline and stock tank could not be observed.

Photo 5: Looking west at land adjacent to the proposed site.

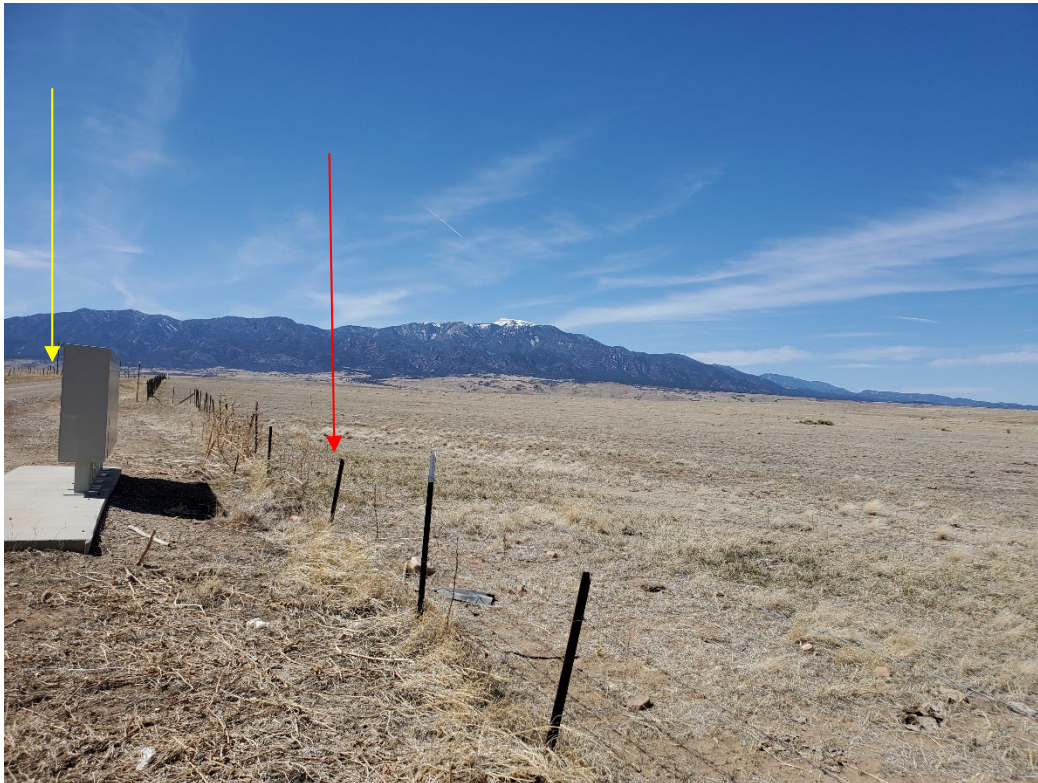
Photo 6: Looking west at land adjacent to the proposed site. The yellow arrow indicates the location of Huerfano County Road 650. The red arrow highlights the southern portion of the fence located in the Applicant's Existing Conditions Exhibit E map.

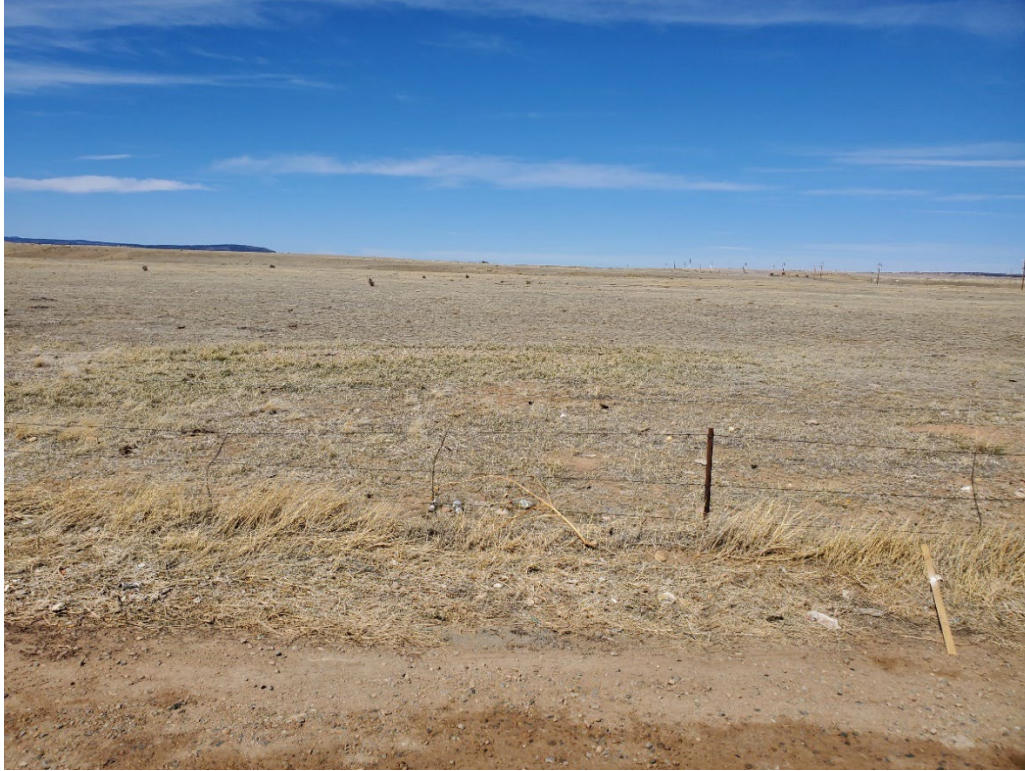
Photo 7: Looking north across the property surrounding the proposed mine site.

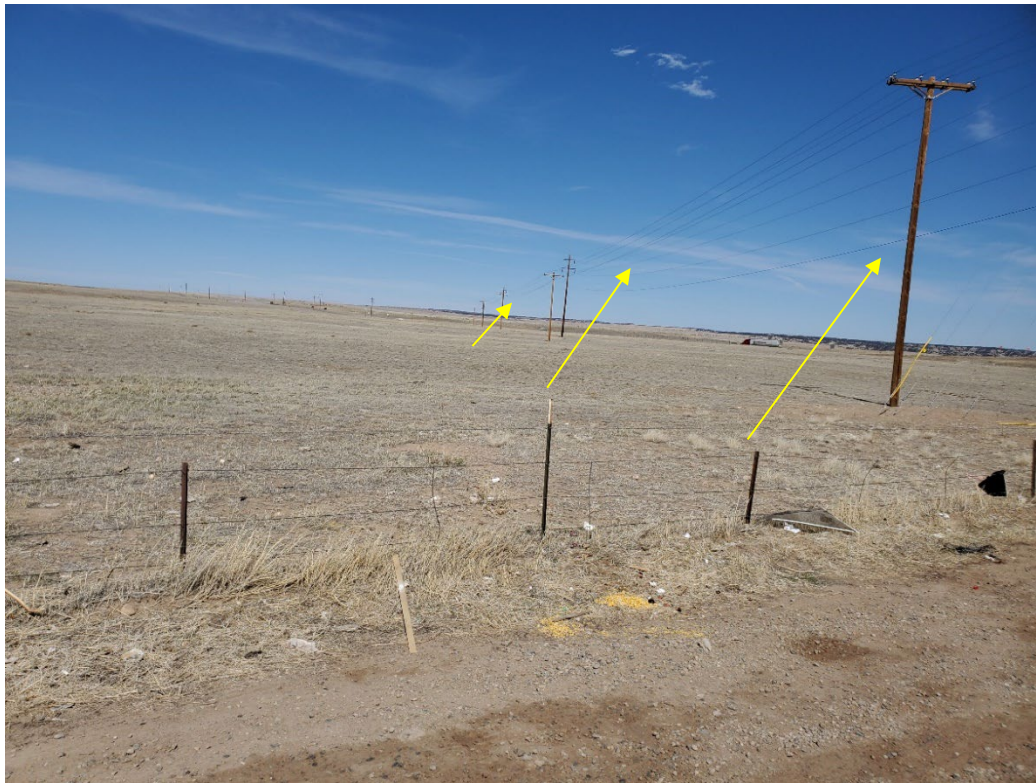
Photo 8: Looking east at land adjacent to the proposed site. From a discussion with the Applicant, the new access road will begin near this spot (see Map 1 below). The yellow arrows indicate the location of

the powerlines located in the south-eastern corner and expanding to the north-eastern side of the Applicant's Existing Conditions Exhibit E map.

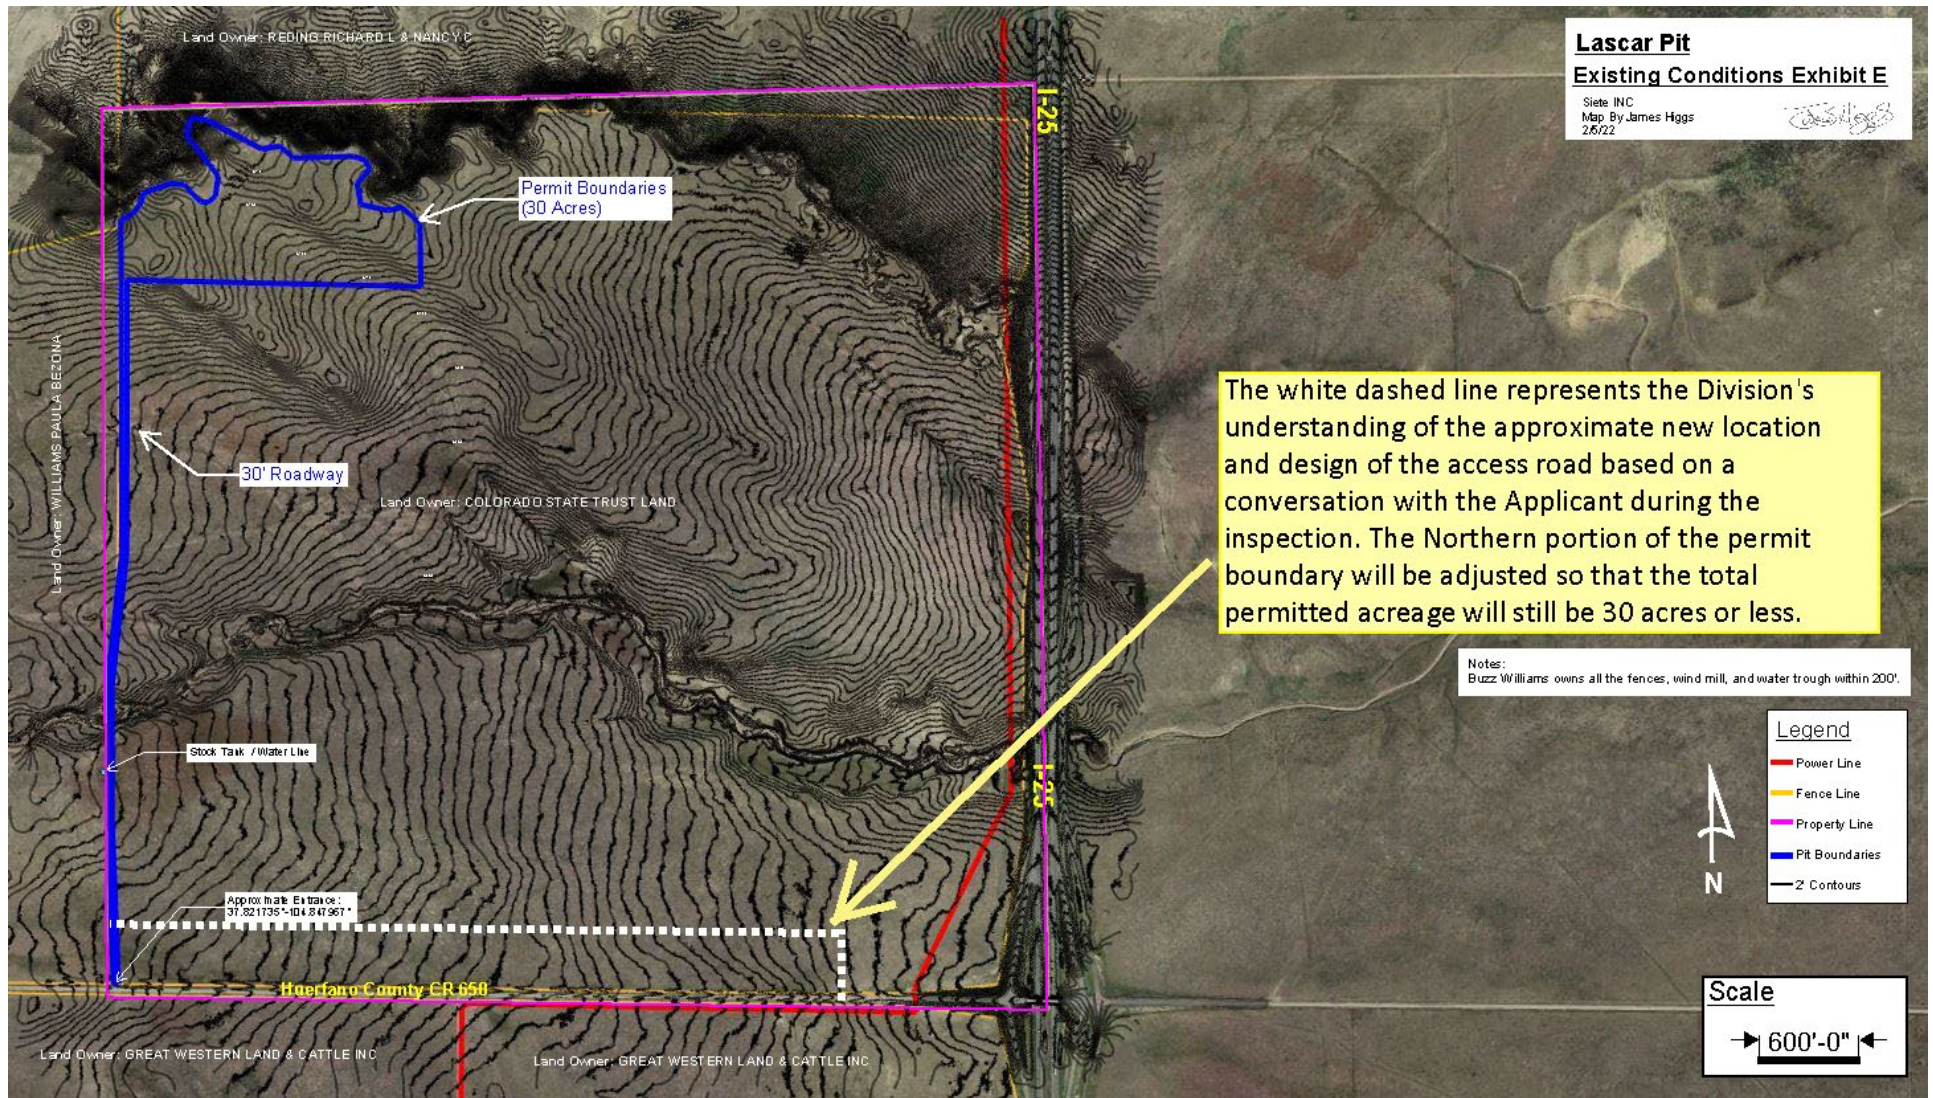
Map 1: Map edited by the Division from the Applicant's most recent adequacy responses. The Division's edits include the yellow text box, yellow arrow, and white dashed line. This map notes a windmill as a structure in a text box, but does not have the structure labeled on the map, this was discussed with the Applicant in the field and it was agreed that the new maps submitted with a Technical Revision will include the windmill's location.

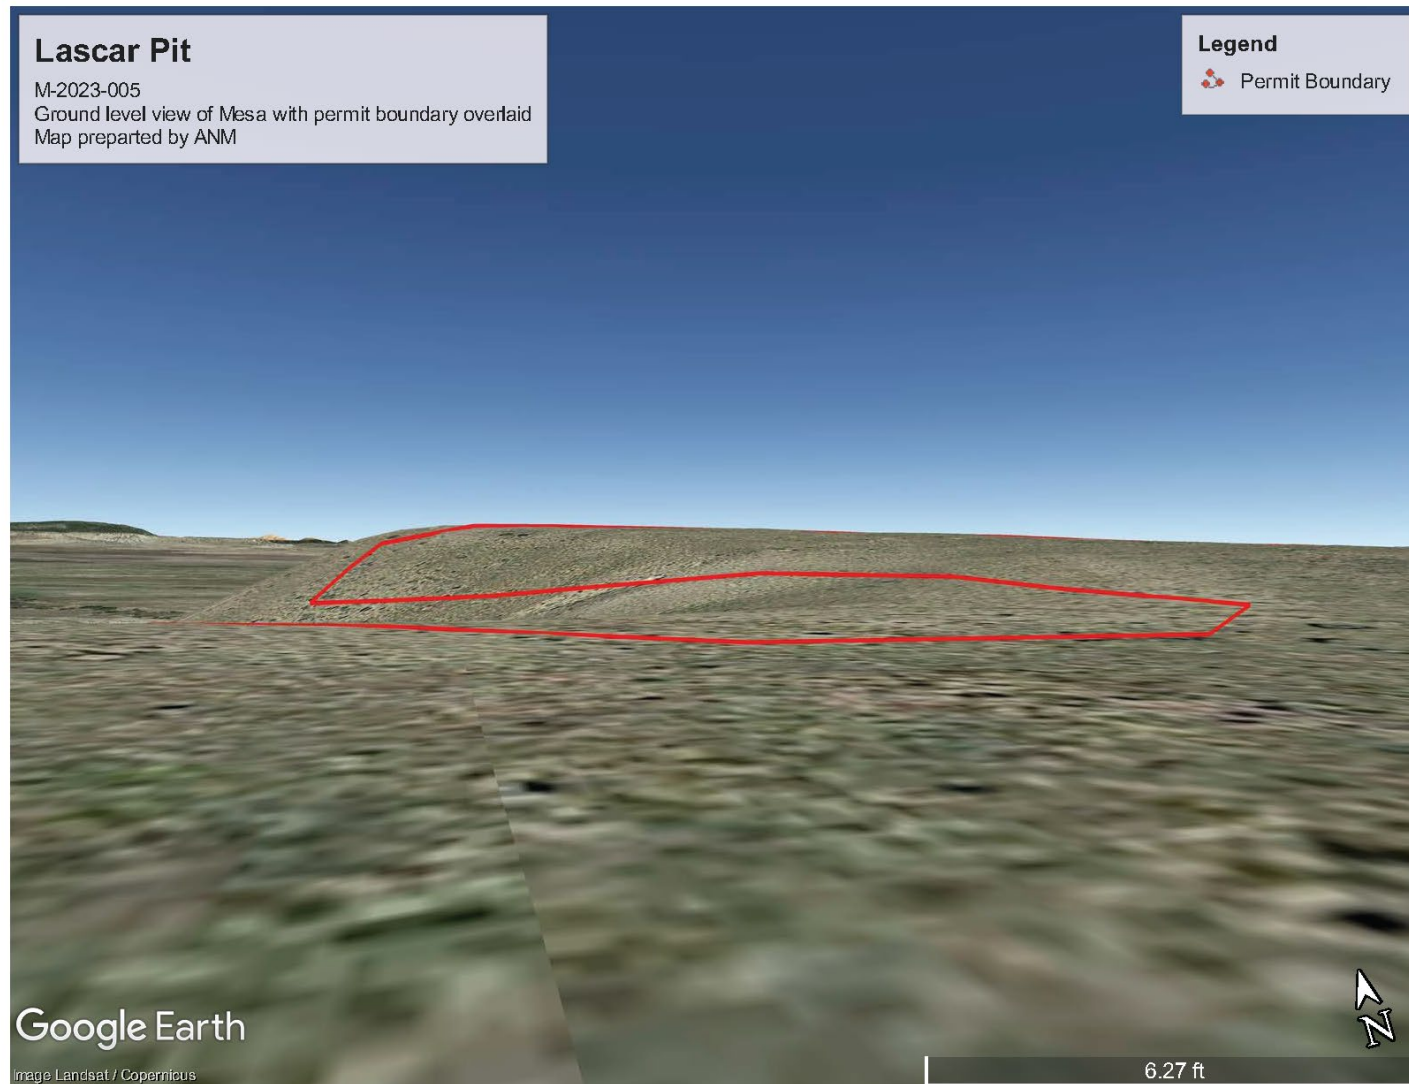
Map 2: Map generated from Google Earth Pro. Map shows ground level view of mesa featured in Photo 4 with the currently proposed permit boundary overlain.

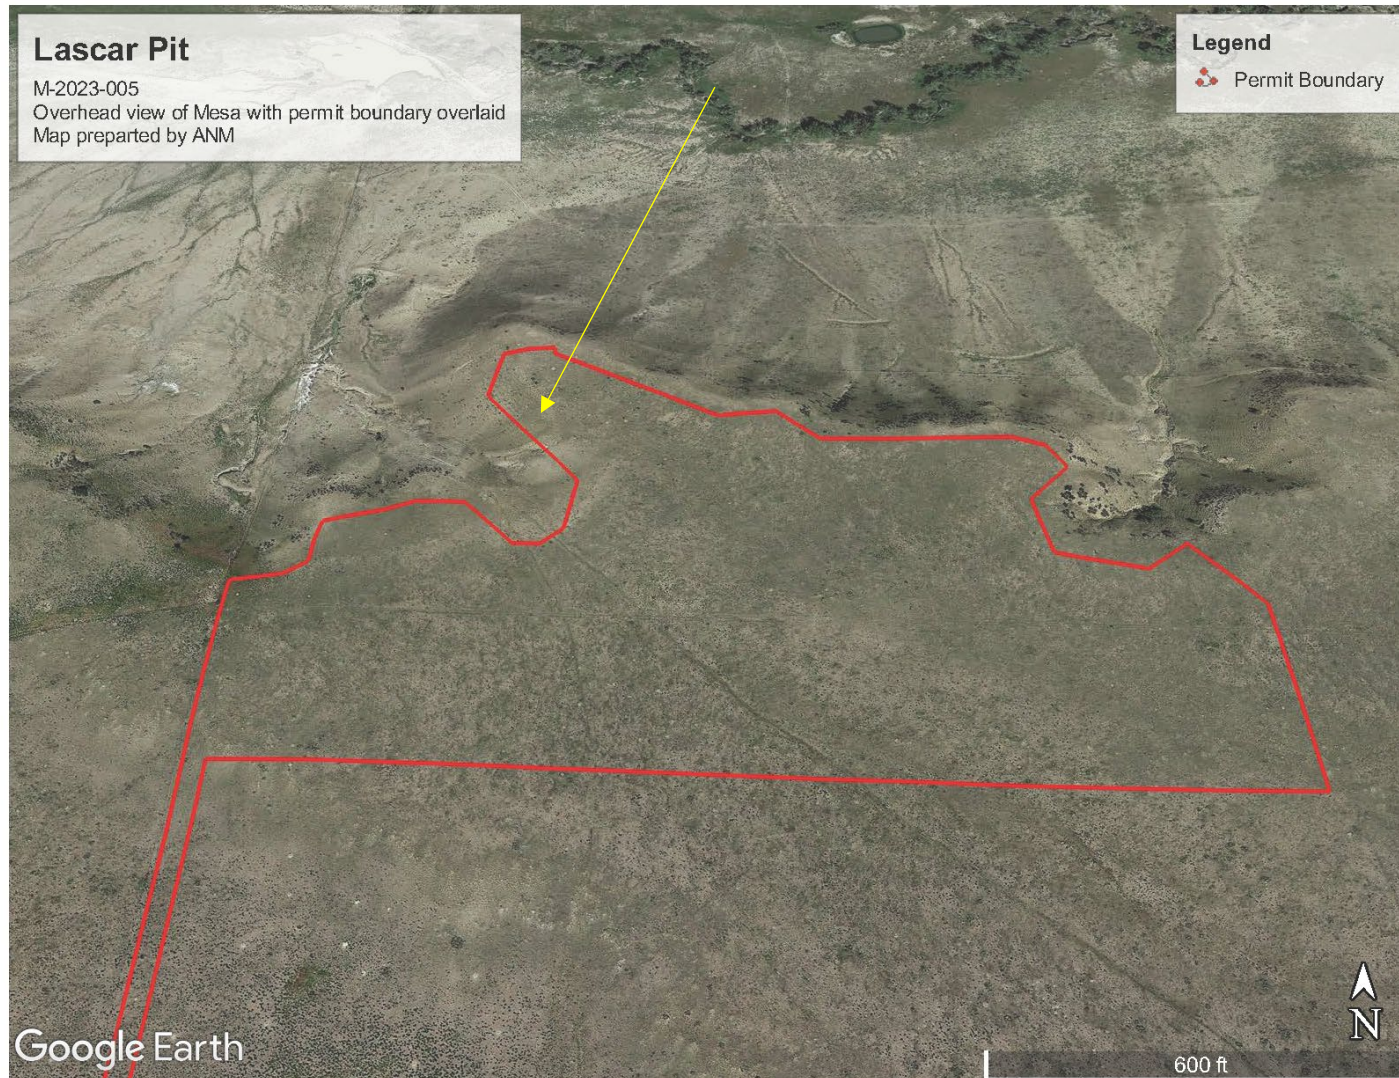
Map 3: Map generated from Google Earth Pro. Map shows an overhead view of mesa featured in Photo 4 with the currently proposed permit boundary overlain. Yellow arrow delineates area seen in the ground level view on Map 2.
