## Foidel Creek Mine Inspection Report

<b>Permit Number:</b> C-1982-056 <b>Mine Name:</b> Foidel Creek Mine <b>Operator:</b> Twentymile Coal, LLC <b>Operator Address:</b> Ms Miranda Kawcak 29515 Routt County Road No. 27 Oak Creek, CO 80467	<b>County:</b> Routt <b>Operation Type:</b> Underground <b>Permit Status:</b> Active <b>Ownership:</b> Private
	<b>Operator Representative Present:</b>  Kevin Copeland
<b>Operator Representative Signature: (Field Issuance Only)</b>

<b>Inspection Start Date:</b> March 30, 2023 <b>Inspection Start Time:</b> 09:30 <b>Inspection End Date:</b> March 30, 2023 <b>Inspection End Time:</b> 11:30		<b>Inspection Type:</b> Coal Complete Inspection <b>Inspection Reason:</b> Normal I&E Program <b>Weather:</b> Clear/Cloudy	
<b>Joint Inspection Agency:</b>  None		<b>Joint Inspection Contacts:</b>  	
<b>Post Inspection Agency:</b>  None		<b>Post Inspection Contacts:</b>  	
<b>Inspector(s):</b>  Hunter Ridley  Michael Cunningham	<b>Inspector's Signature:</b>

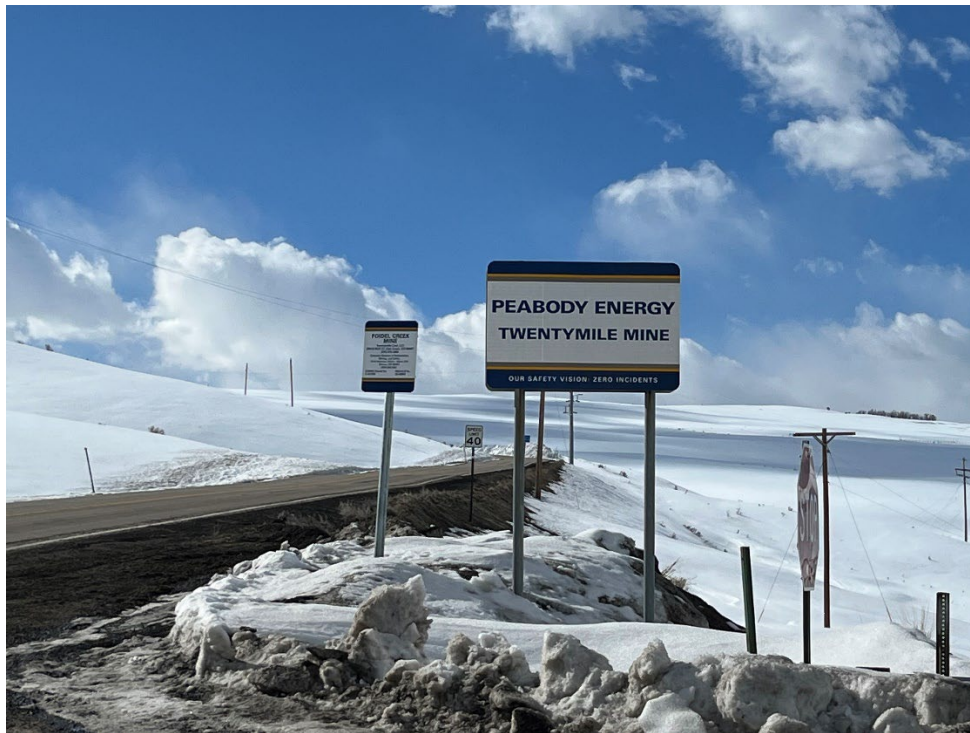
Mine identification markers were observed throughout the site (Photo 1 and 2). Topsoil piles were marked. All information for compliance was present. The missing phone number information on mine signs for HG Loadout and Peabody Sage Creek Mine (see related inspection reports dated March 30, 2023) was discussed with the TC representative. **Please update the division when signage has been appropriately amended.**

Photo 1: Appropriate signage is posted at the entrance to the Foidel Creek Mine.

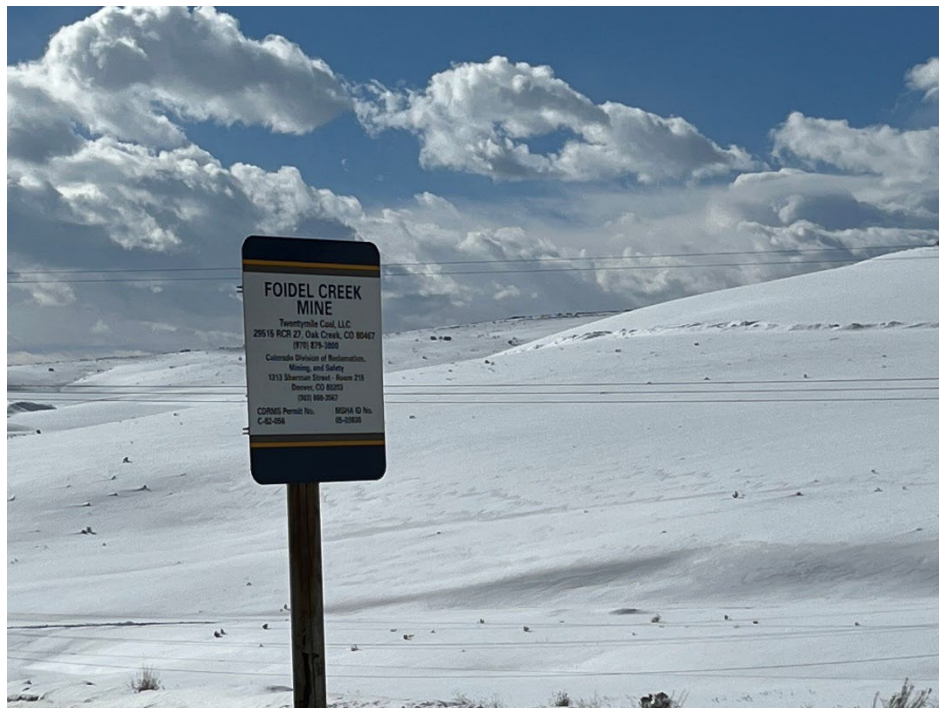
Photo 2: Mine signs are also posted wherever the Foidel Creek operation crosses a public road.

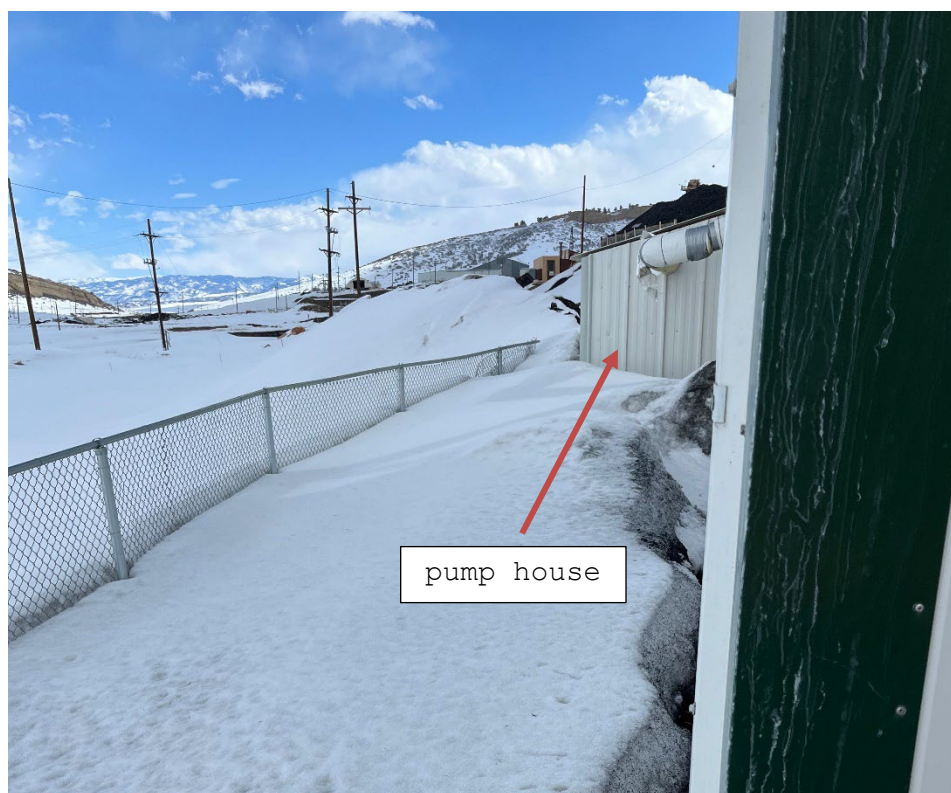
Surface drainage around the stocker coal truck loadout appears to be controlled. Drainage reports to a pump house directly connected to the stoker loadout building (Photo 3). Excess water from this building (Photo 4) which flows to sediment ponds is collected in a series of three ditches located behind the building (Photo 6). Straw bales have been placed on the upgradient side of the ditches to further aid in sediment control (Photo 5).

Photo 3: View behind the stoker building. Three ditches are built behind this building and in front of the fence. Drainage from the stoker building reports to the pump house visible to the East in this photo.

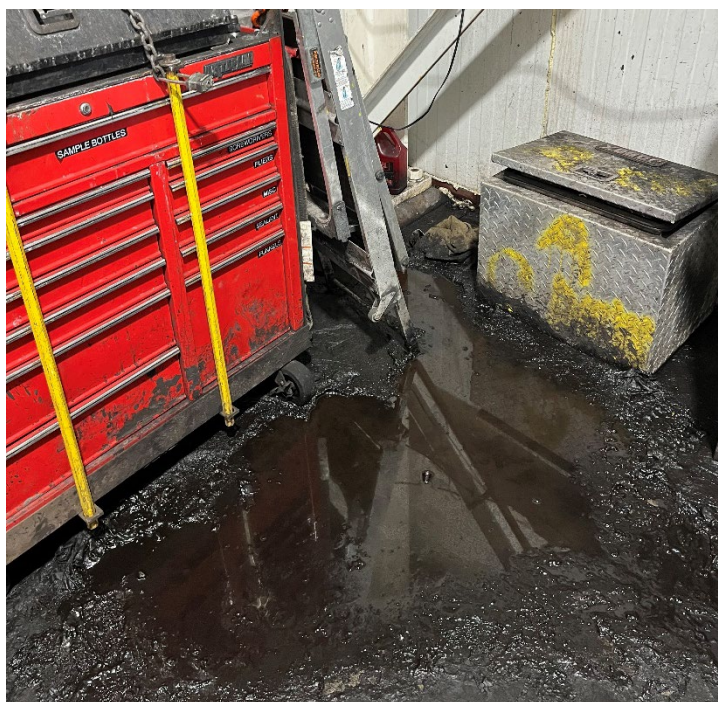
Photo 4: View inside the coal stoker loadout building. This building will be sealed in the spring to control drainage from this facility.

to report to existing sumps and ponds. This stoker coal support building near the Wash plant will be sealed in 2023. This drainage will then be pumped into Pond E.

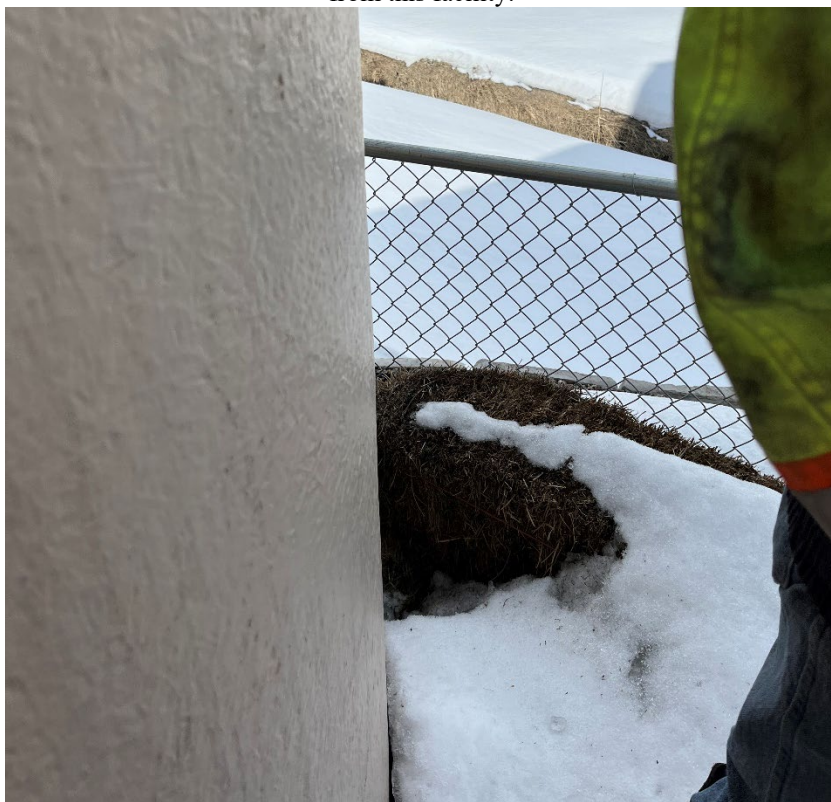
Photo 5: Straw bales placed upgradient of the three ditches located behind the coal stoker loadout building.

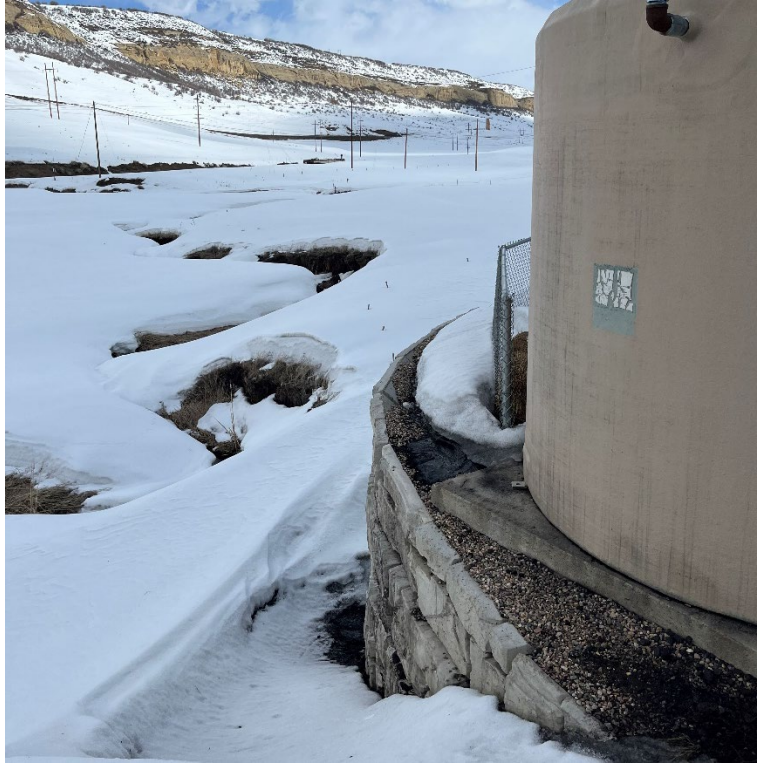
Photo 6: Foidel Creek is located behind and very near to the coal stoker loadout facility. Extra care should be taken to ensure that drainage from this facility is reporting to the appropriate ponds and or pump house areas.

The drainage from this area and the road on either side of the loadout building should be reporting to existing ponds and the gradient should be maintained to ensure any runoff from the area or cleanup of the building is able

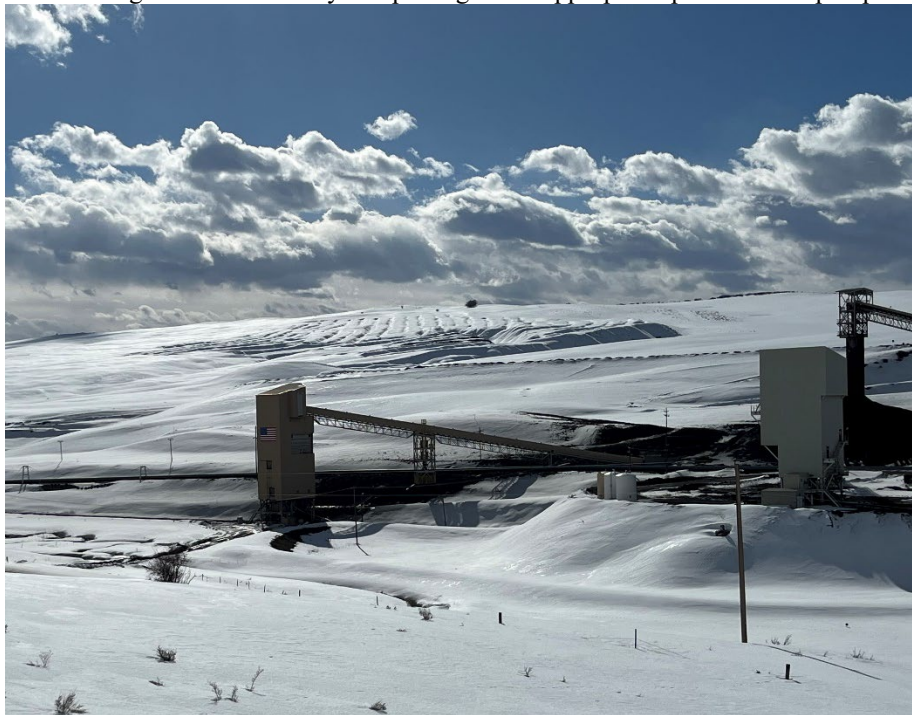
The accompanying TC representative stated that Elk frequent surrounding areas of the mine (Photo 7). Waterfowl were present in several ponds across the site.

Photo 7: View South of the operation from Highway 27. Large gullies visible in the far distance are a historic part of the previously reclaimed surface mine and have been kept in place for wildlife purposes. The accompanying TC representative said that elk frequent the area.

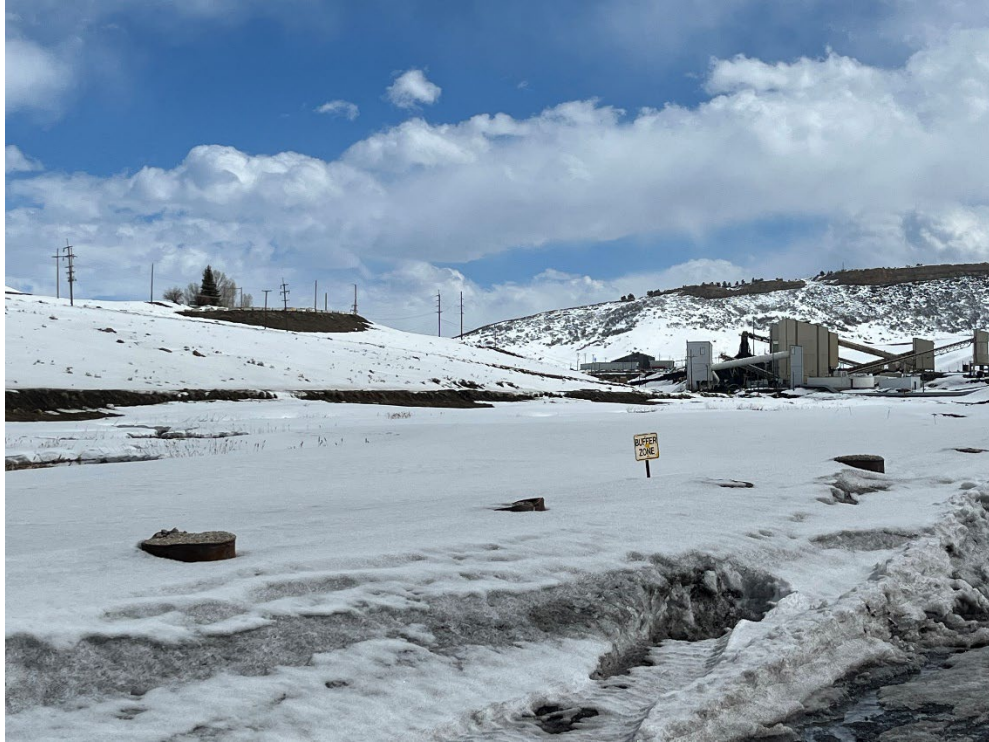
Buffer zones appear to be maintained. Vegetation was present within these zones and appropriate signage delineated the edge of the buffer zone which protects Foidel Creek (Photo 8).

Photo 8: The buffer zone for Foidel Creek is marked by appropriate signage. Some vegetation is visible through the snow in the buffer zone.

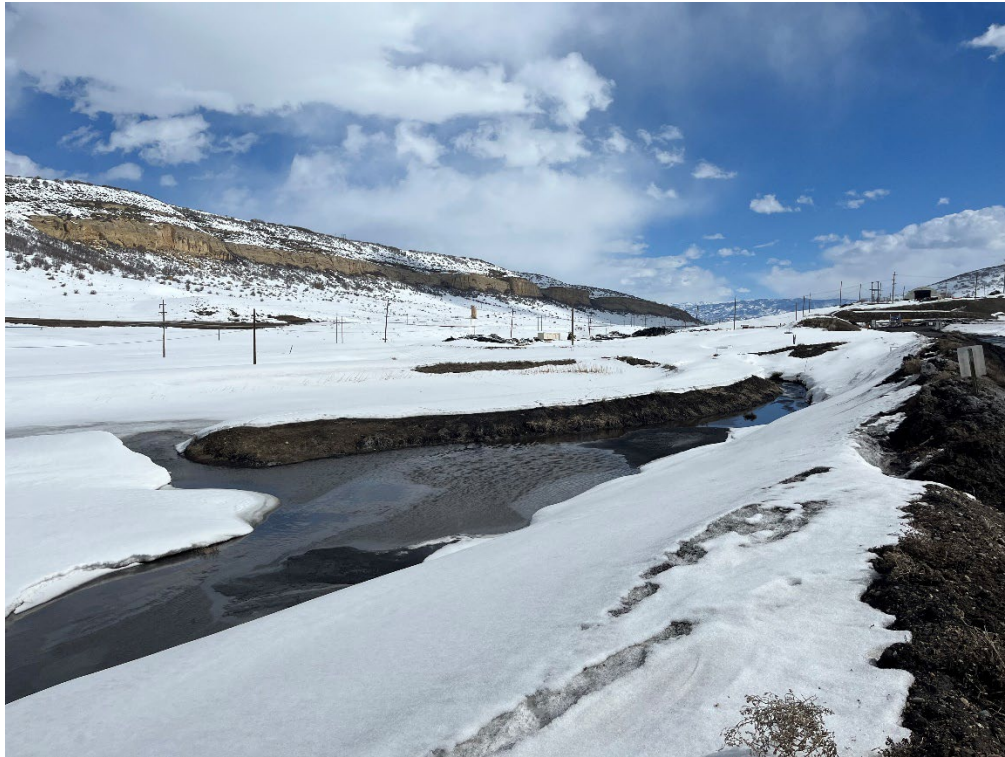
Photo 9: Pond E. Discharge from the stoker coal loadout facility reports here.

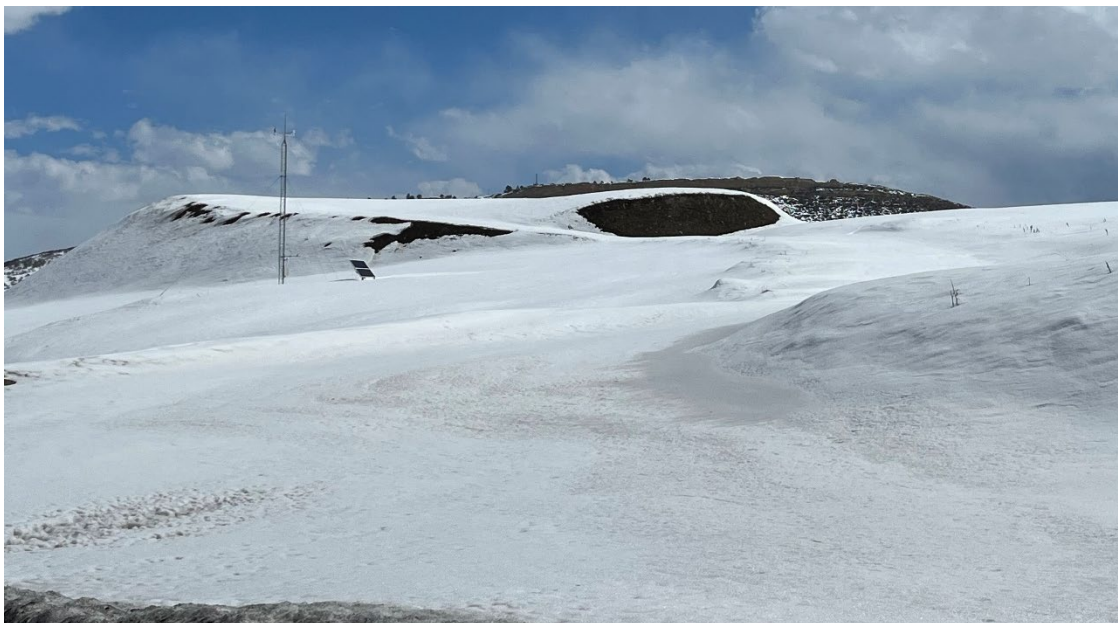
Topsoil piles were appropriately marked throughout the site and snow plowing was not interfering with topsoil piles near roads. Small tufts of vegetation were visible through the snow on some piles. TC representative noted that topsoil piles surrounding the refuse disposal area are to be reseeded in the spring (Photo 10).

Photo 10: Topsoil pile located near the refuse disposal area.

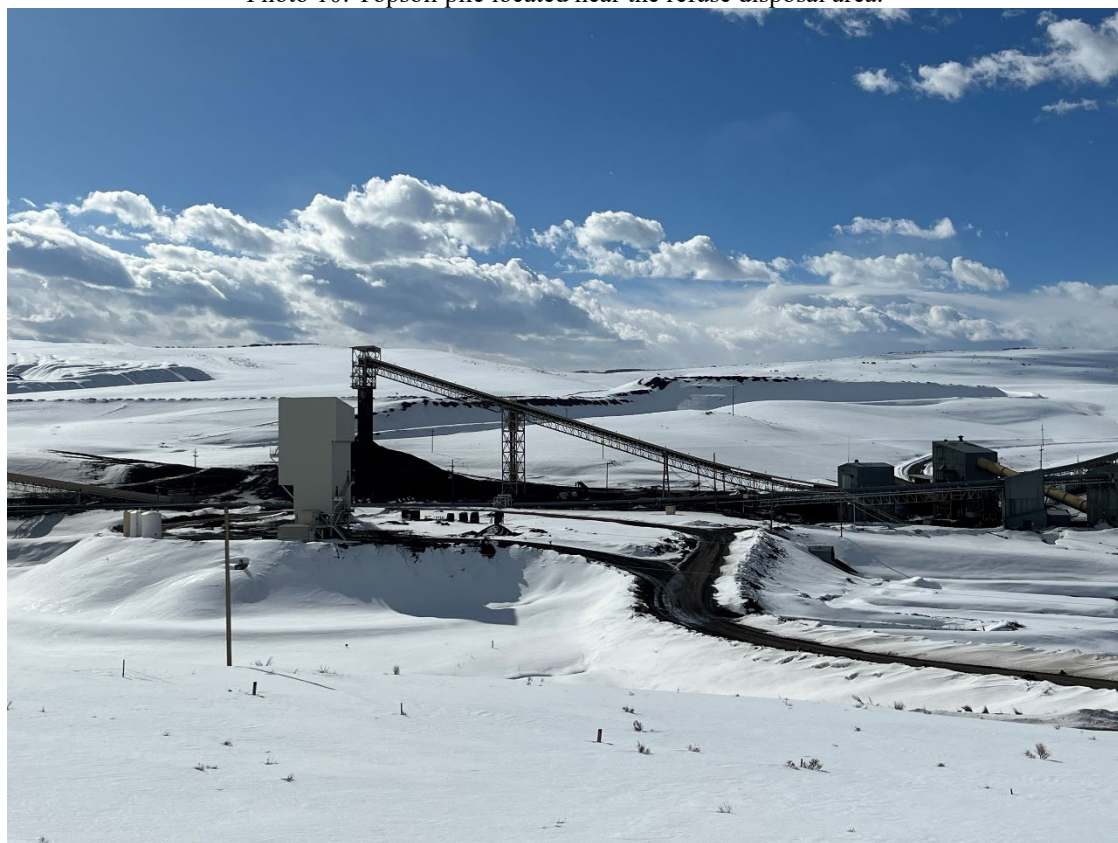
Placement; Drainage Control; Surface Stabilization: No standing water was present on the pile. Loads are placed in piles in Winter months when snow is present to avoid improper compaction when the snow melts. Piles will be leveled and compacted in 2' lifts during the Spring/Summer season (Photos 11 and 12). TR67 approved plans to expand the coal refuse disposal area from 3 Million cubic yard volume to a maximum of 20 Million cubic yards.

Photo 11: View to the south of the main facilities, BOB (belt out back) pile, stoker building, and snow covered refuse disposal area from Highway 27.

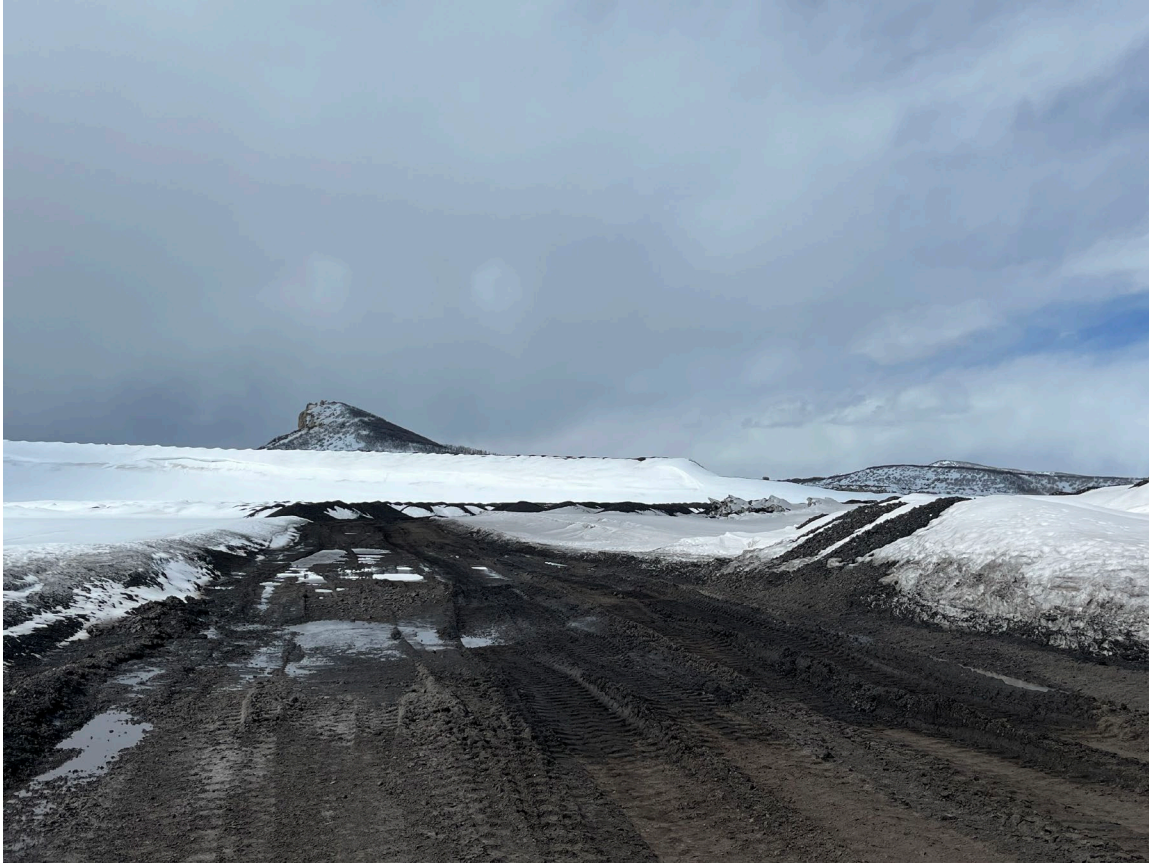
The expansion area would abut the current Refuse pile on the West and expand to the East onto a previously reclaimed surface mined slope. TC is currently operating in the original refuse disposal area and will continue work on Lift 4 in the spring/summer.

Photo 12: View north of the current refuse disposal area. Area was active at the time of inspection. TC representative noted that work will continue on lift four in the spring/summer months. Pile will eventually be constructed to match the currently existing ridge shown in this photo.
