MINERALS PROGRAM INSPECTION REPORT
PHONE: (303) 866-3567

MINE NAME: Otter Creek Pit	MINE/PROSPECTING ID#: M-2012-050	MINERAL: Gravel and sand	COUNTY: Mesa
INSPECTION TYPE: Monitoring	WEATHER: Cloudy	INSP. DATE: March 29, 2023	INSP. TIME: 12:00
OPERATOR: Oldcastle SW Group, Inc. dba United Companies of Mesa County	OPERATOR REPRESENTATIVE: Jason Burkey	TYPE OF OPERATION: 112c - Construction Regular Operation	
REASON FOR INSPECTION: Normal I&E Program	BOND CALCULATION TYPE: Complete Bond	BOND AMOUNT: \$125,282.00	
DATE OF COMPLAINT: NA	POST INSP. CONTACTS: None	JOINT INSP. AGENCY: None	
INSPECTOR(S): Amy Yeldell	INSPECTOR'S SIGNATURE:

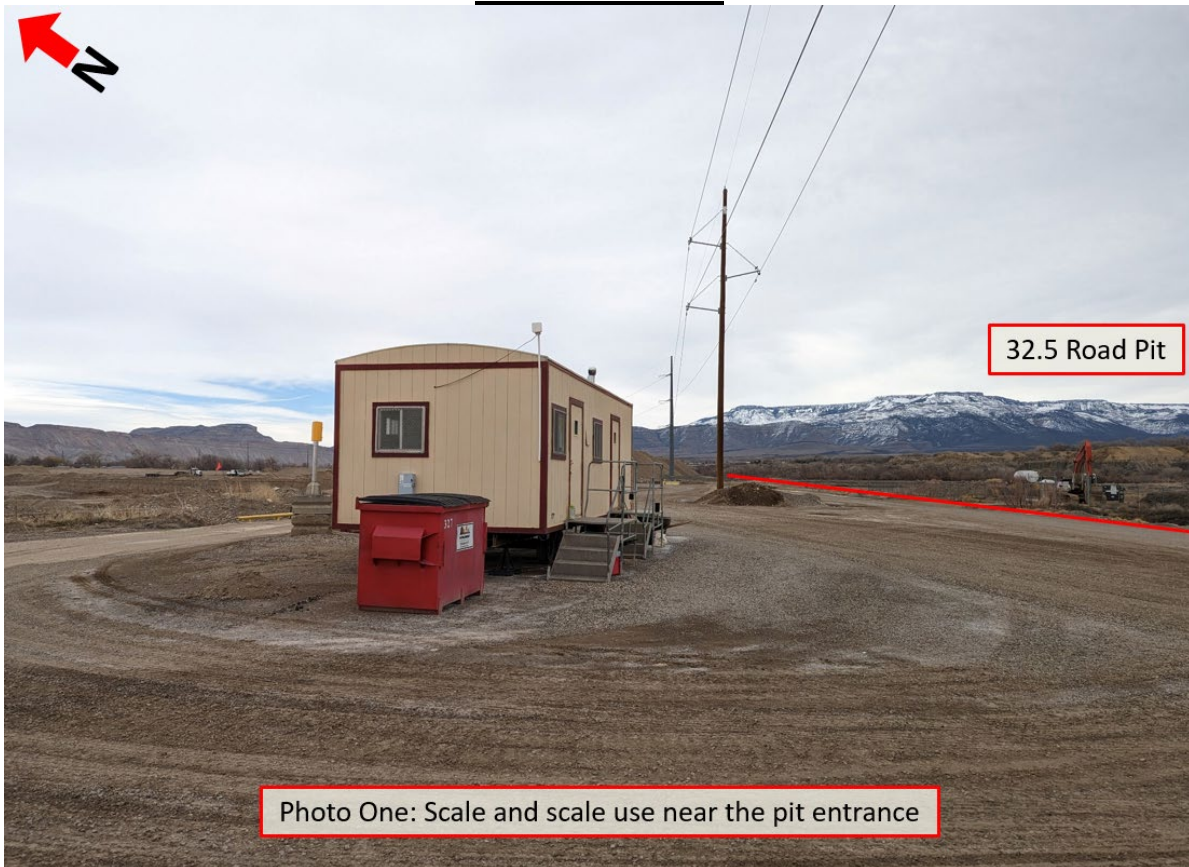
The mine identification sign and affected area boundary markers are in place and in compliance with Rule 3.1.12. A sign is posted at the permit boundary entrance. A locked gate has been installed near the access road to limit access to the pit as needed. Note that the 32.5 Road Pit (M-2009-035) Operated by M.A. Concrete Construction, Inc. shares an access road since the pits are adjoined. The permit boundary is delineated by fences. A scale and scale house were located near the pit entrance.

Photo One: Scale and scale use near the pit entrance

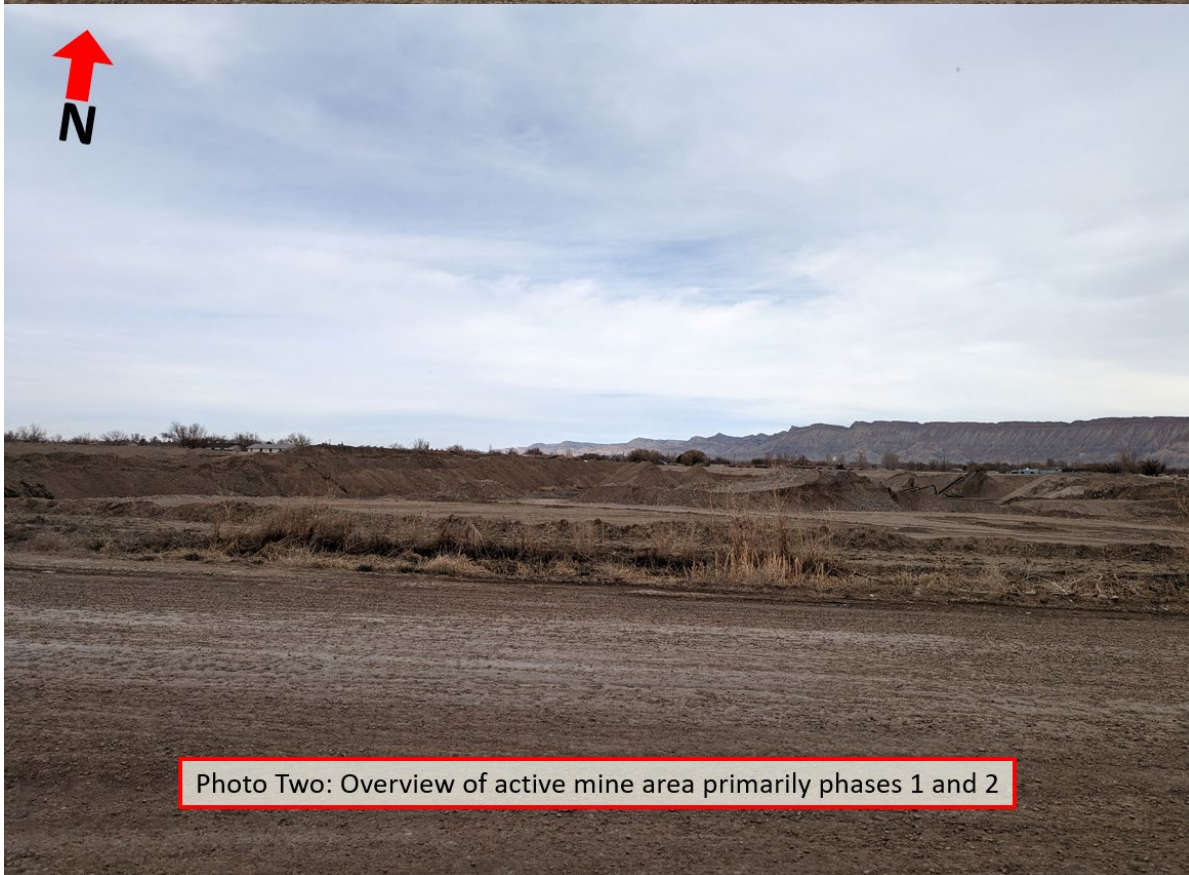
Photo Two: Overview of active mine area primarily phases 1 and 2

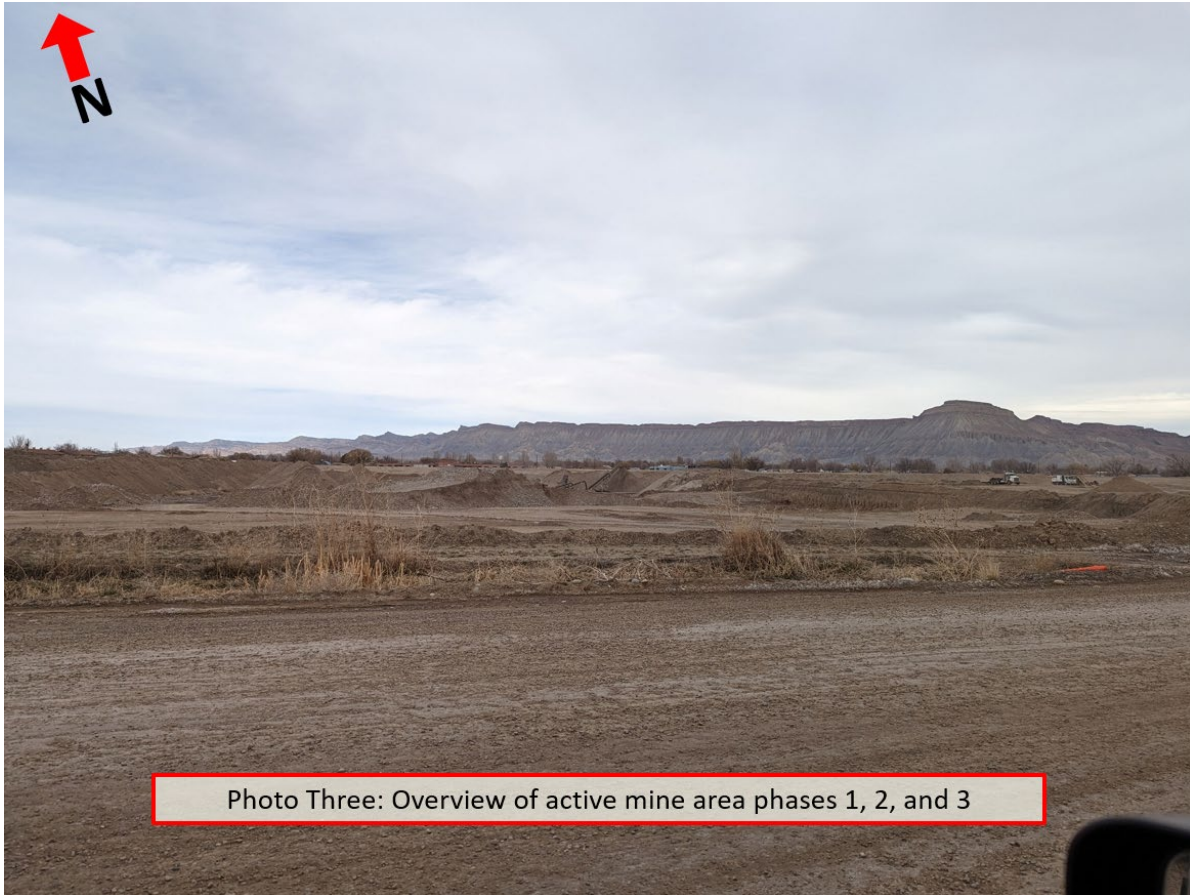
Photo Three: Overview of active mine area phases 1, 2, and 3

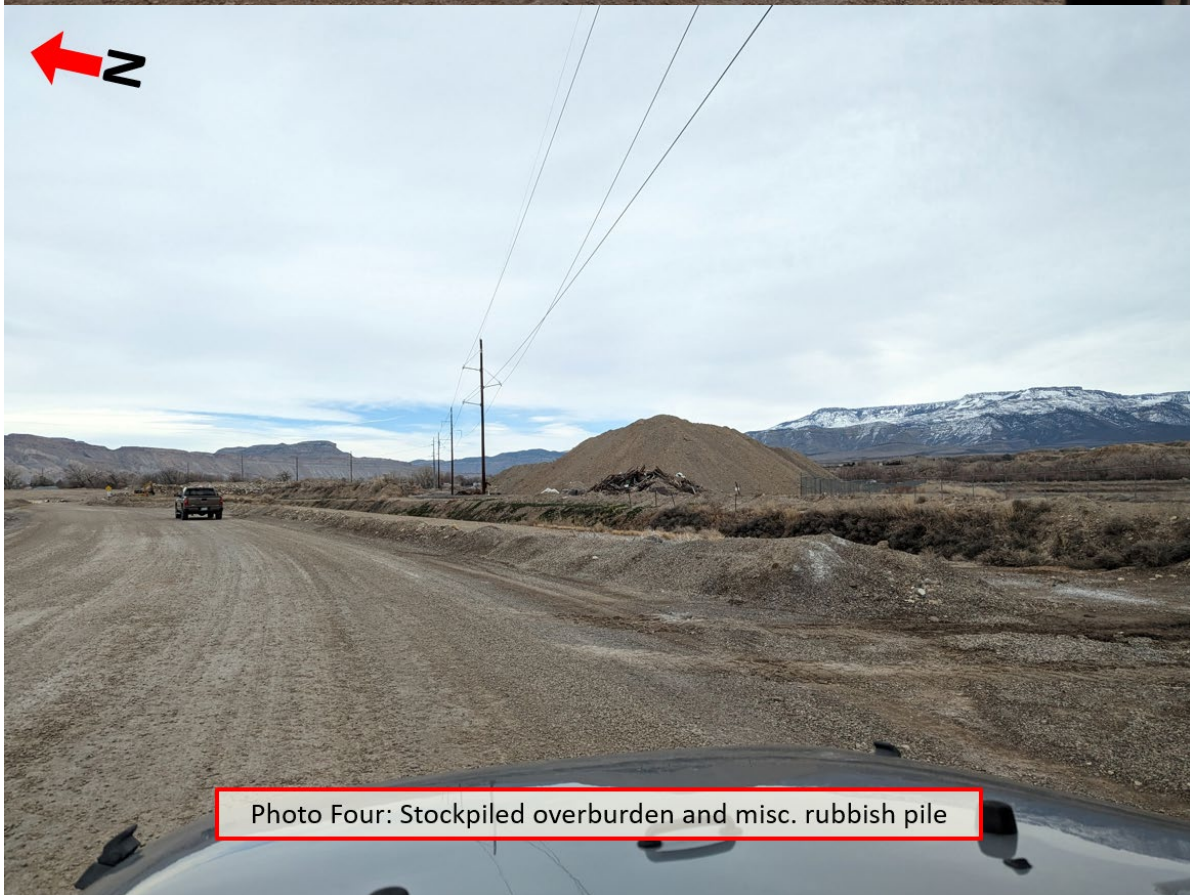
Excess overburden is stored in the southeast corner across the 33 Road Drain from the pit. This area has previously been mined and was backfilled prior to being used for staging and stockpiling activities. A small rubbish pile is located adjacent to the overburden stockpile area. The overall disturbance is approximately 6 ac.

Photo Four: Stockpiled overburden and misc. rubbish pile

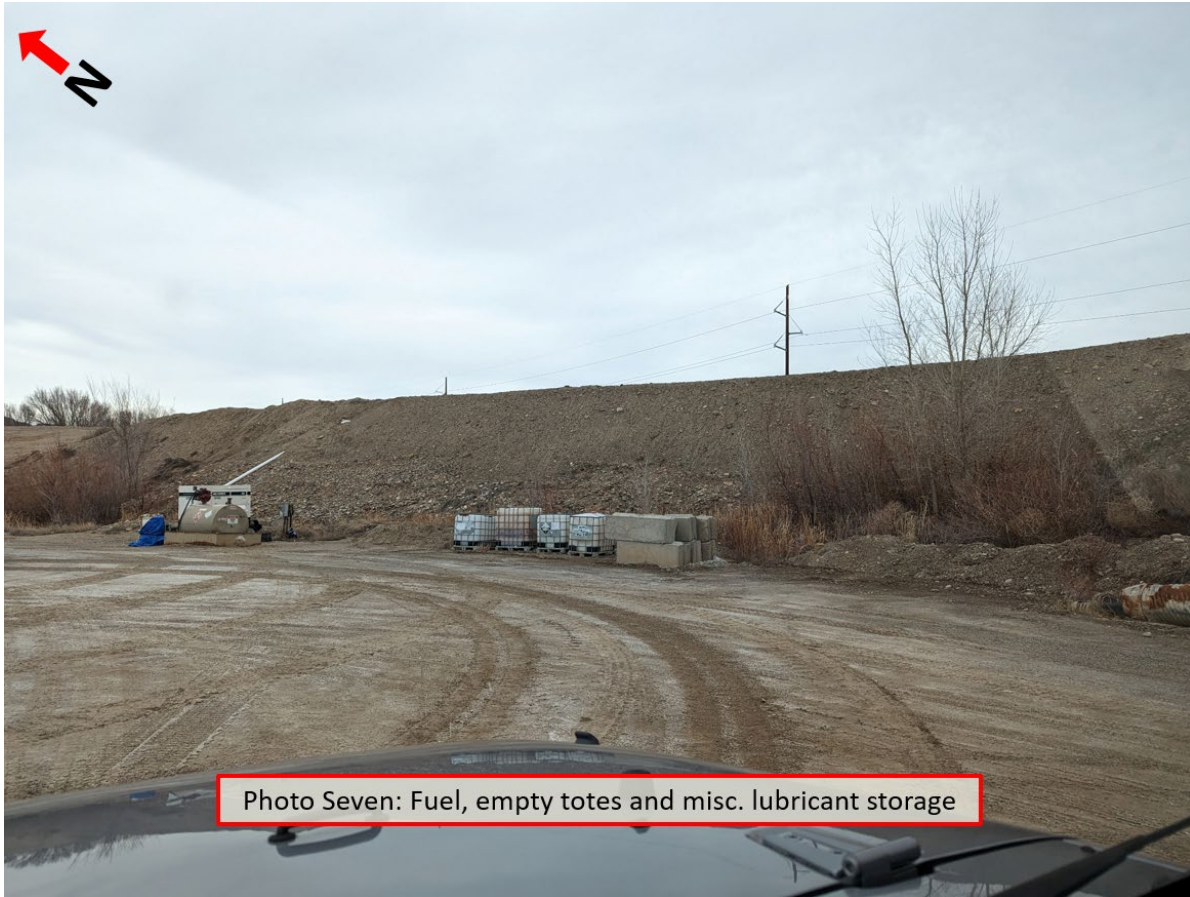
Excess equipment is being stored on the eastern side of phase 3 within the pit. A double walled fuel tank and generator are located on the pit floor. Several empty chemical totes on pallets are stored near the fueling area. These items should be removed from site if no longer necessary or be stored within a secondary containment structure.

Photo Seven: Fuel, empty totes and misc. lubricant storage

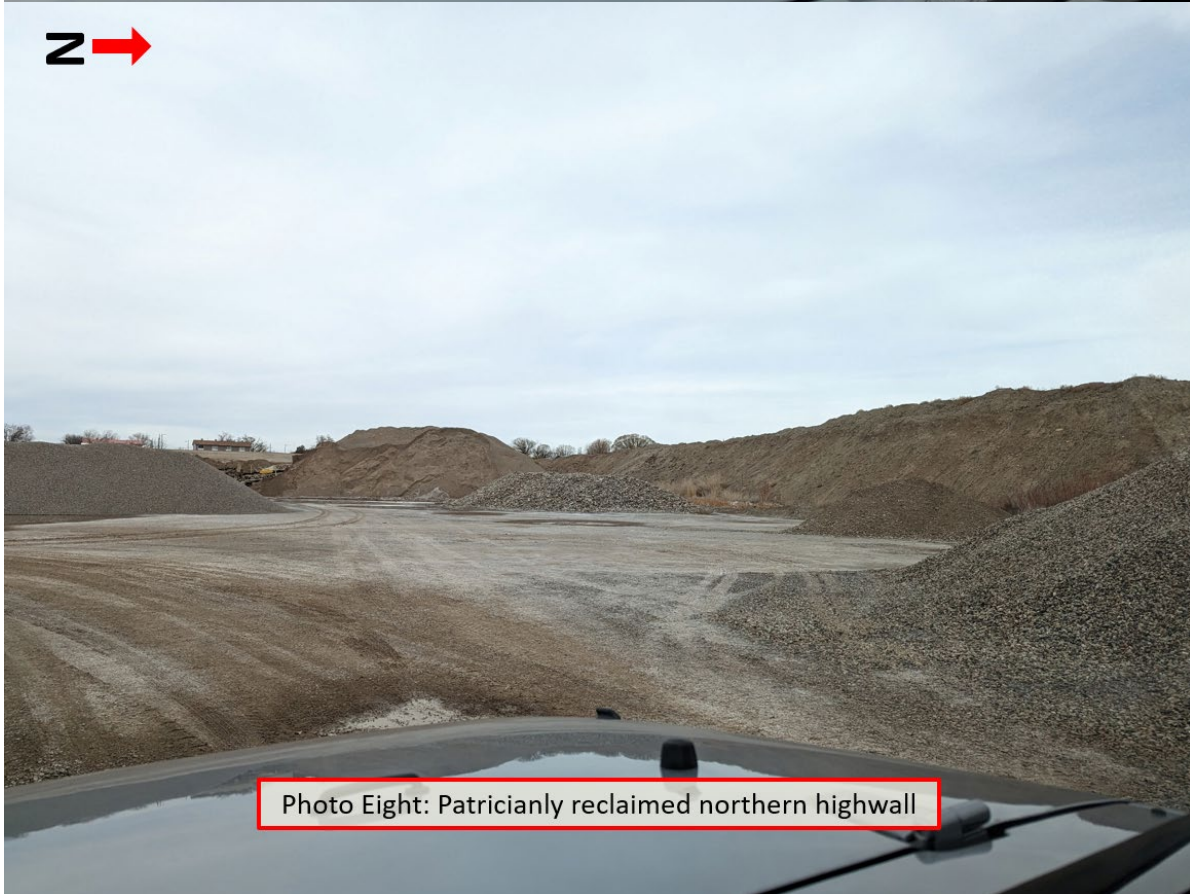
or less, however topsoil and seed has not yet been applied. The Northeast corner and eastern slope adjacent to phase 4 is completely sloped and seeded. This area was reclaimed prior to the approval of AM-1. Eventually this area will be mined back through. Then lastly 1000 LF of the southern highwall (interior pit slope) were observed and ranged from near vertical to 2H: V1. These internal slopes are the active mining highwalls as mining progresses to the south.

Photo Eight: Patricianly reclaimed northern highwall
