# **Horse Gulch Fill Quarterly Inspection Report**

**First Quarter 2023**

**Trapper Mining Inc.  
Trapper Mine  
Craig, Colorado**

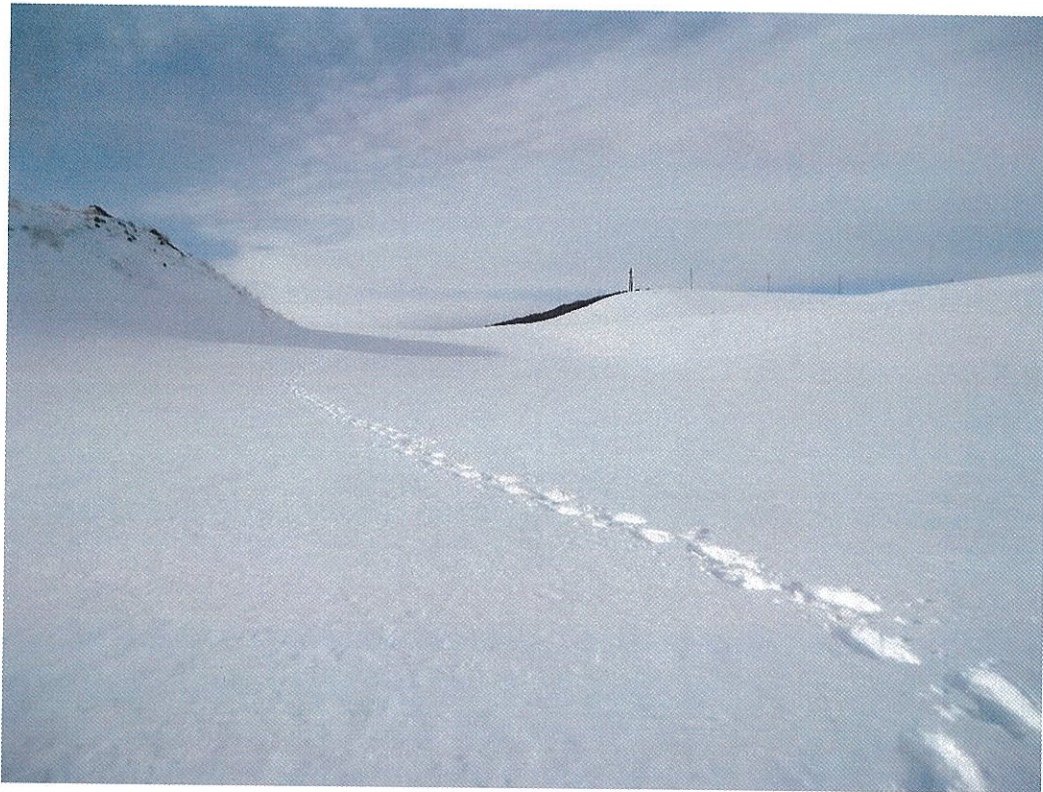
At the time of the inspection the area was heavily covered with several feet of snow. No appearances of instability, structural weakness, or other hazardous conditions were observed. Both the southeast side of the fill and the northeast side of the fill were inspected this quarter (Photographs 1 and 2). The area where cracks were detected on the top south portion of the dump during the first quarter of 2013 inspection was checked. There was no additional cracking found.

Photograph 1: North Side Looking South (3/29/2023)

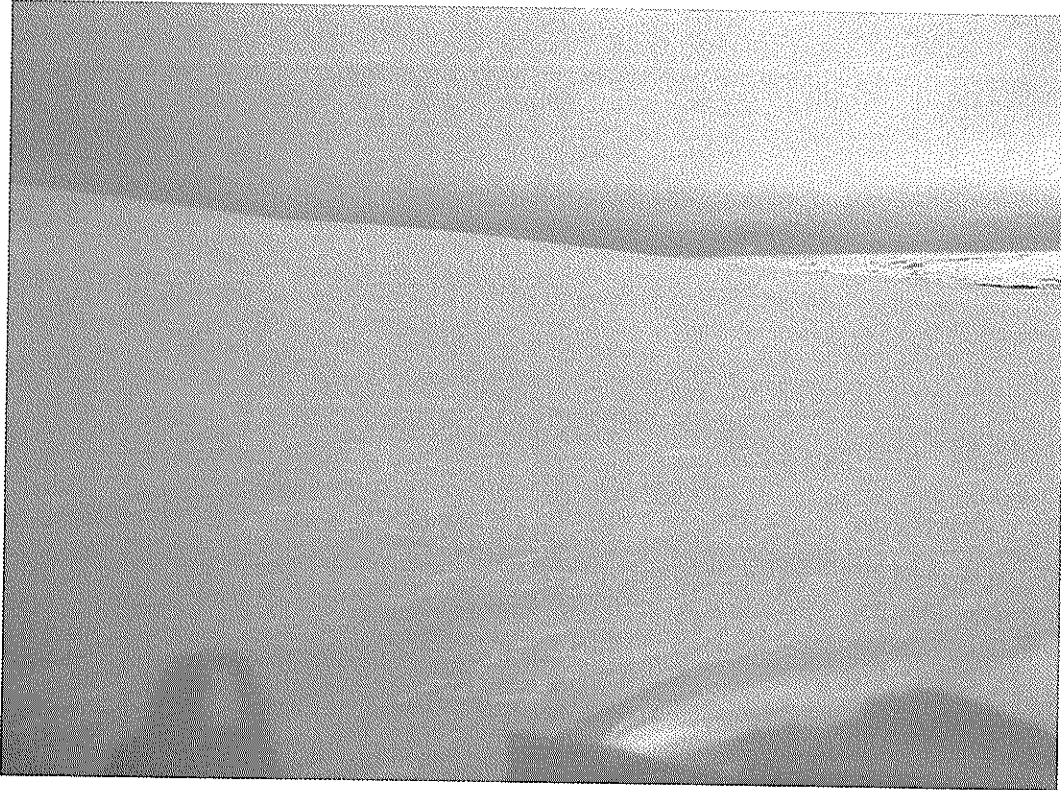
*Photograph 2: South Side Looking North (10/19/2022)*

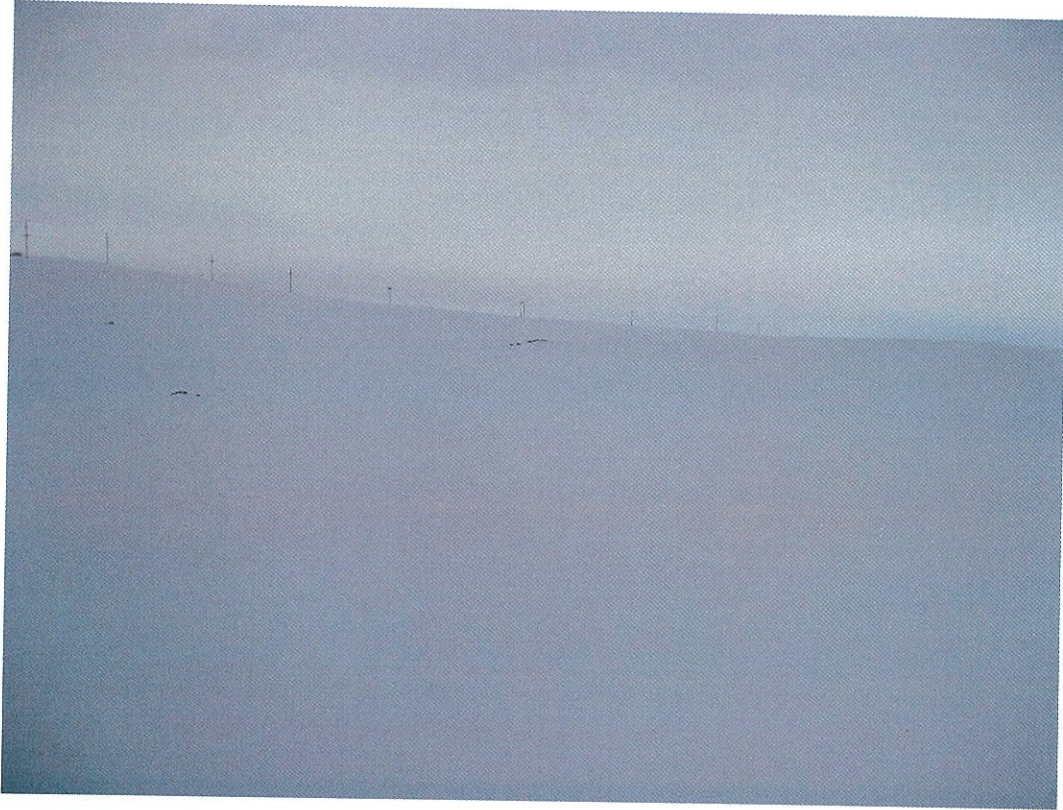
Photograph 3 depicts the east facing slope of the fill.

*Photograph 3: East Side of the Fill Looking North-west (3/29/2023)*
