**MINERALS PROGRAM INSPECTION REPORT**  
**PHONE: (303) 866-3567**

<b>MINE NAME:</b> Chavers Mining Resource	<b>MINE/PROSPECTING ID#:</b> M-2015-030	<b>MINERAL:</b> Sand and gravel	<b>COUNTY:</b> Weld
<b>INSPECTION TYPE:</b> Preoperation Inspection	<b>WEATHER:</b> Clear	<b>INSP. DATE:</b> April 5, 2023	<b>INSP. TIME:</b> 09:45
<b>OPERATOR:</b> Asphalt Specialties CO., Inc.	<b>OPERATOR REPRESENTATIVE:</b> Greg Geras, David King	<b>TYPE OF OPERATION:</b> 112c - Construction Regular Operation	
<b>REASON FOR INSPECTION:</b> Normal I&E Program	<b>BOND CALCULATION TYPE:</b> None	<b>BOND AMOUNT:</b> \$1,233,955.00	
<b>DATE OF COMPLAINT:</b> NA	<b>POST INSP. CONTACTS:</b> None	<b>JOINT INSP. AGENCY:</b> None	
<b>INSPECTOR(S):</b> Eric Scott	<b>INSPECTOR'S SIGNATURE:</b>

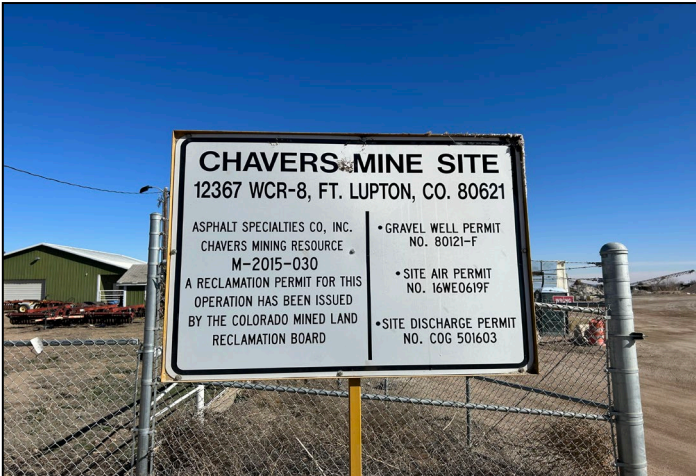
**Photo 1 – Site identification sign at site entrance.**

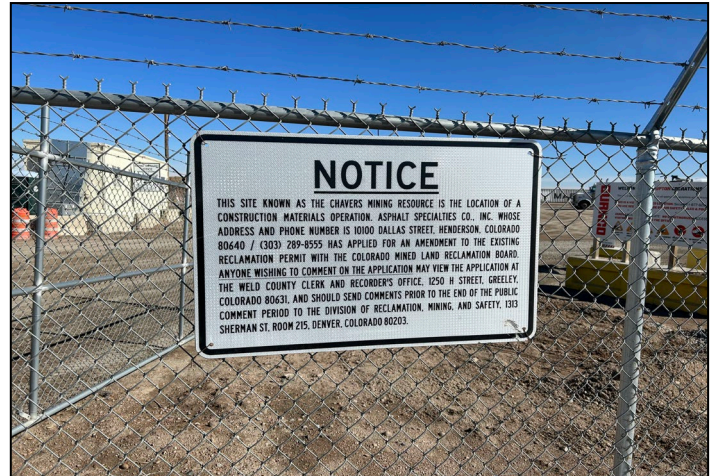
**Photo 2 – Notice of amendment applied for at site entrance.**

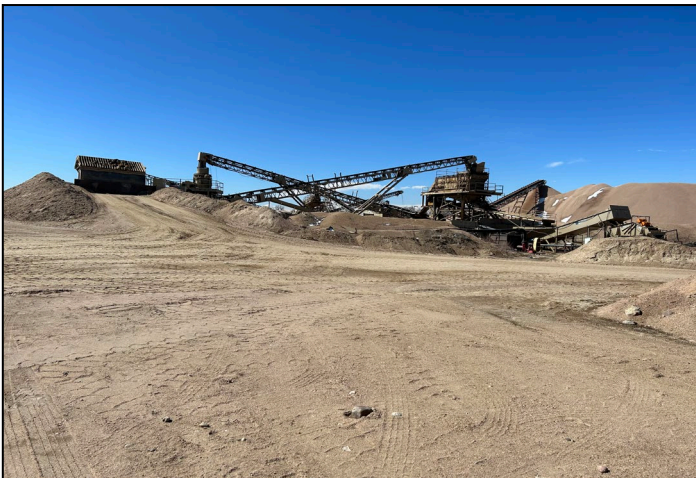
**Photo 3 – Mined material wash and sorting plant active near the center of site.**

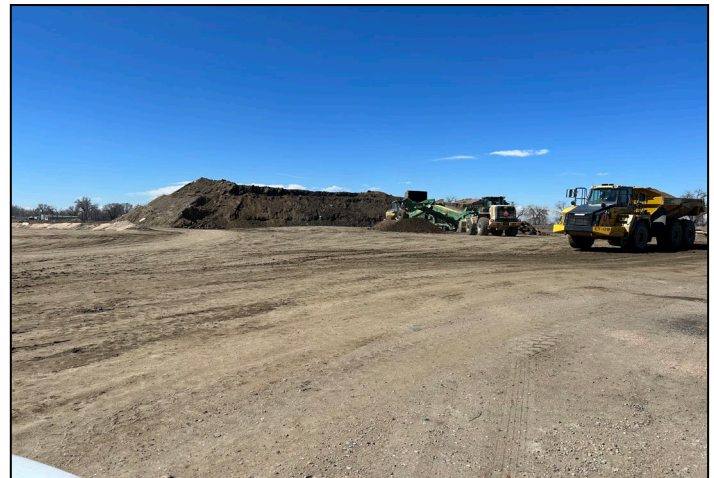
**Photo 4 – Sorting inert recycle materials near center of site.**

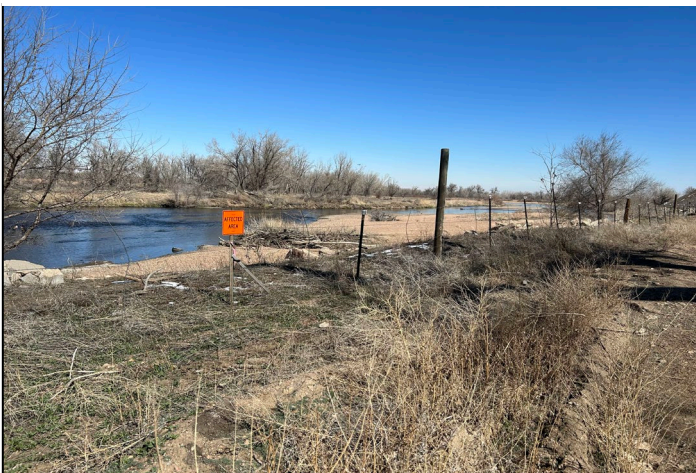
It should be noted that for this permit the affected area differs from the permit boundary. As required by rule, the affected area has been marked by steel posts with orange "mining limit" signs along with existing fencing (photo 5). Asphalt Specialties will need to maintain these markers and make it clear to all site workers that all mining related disturbances must be kept within the affected area boundary. The affected area and mining limit as marked will provide the required buffer from CDOT structures in the river and Highway 85, as well as prevent excessive encroachment along the east bank of the South Platte River.

**Photo 5 – Affected area sign placed on existing fencing near northwest area of site.**
