**MINERALS PROGRAM INSPECTION REPORT**  
**PHONE: (303) 866-3567**

<b>MINE NAME:</b> Morton Lakes	<b>MINE/PROSPECTING ID#:</b> M-2008-082	<b>MINERAL:</b> Sand and gravel	<b>COUNTY:</b> Weld
<b>INSPECTION TYPE:</b> Monitoring	<b>WEATHER:</b> Clear	<b>INSP. DATE:</b> April 5, 2023	<b>INSP. TIME:</b> 11:45
<b>OPERATOR:</b> Ready Mixed Concrete Company, LLC	<b>OPERATOR REPRESENTATIVE:</b> Joe Lamanna	<b>TYPE OF OPERATION:</b> 112c - Construction Regular Operation	
<b>REASON FOR INSPECTION:</b> Normal I&E Program	<b>BOND CALCULATION TYPE:</b> Complete Bond	<b>BOND AMOUNT:</b> \$6,634,000.00	
<b>DATE OF COMPLAINT:</b> NA	<b>POST INSP. CONTACTS:</b> None	<b>JOINT INSP. AGENCY:</b> State Engr. (Water Resources)	
<b>INSPECTOR(S):</b> Eric Scott	<b>INSPECTOR'S SIGNATURE:</b>

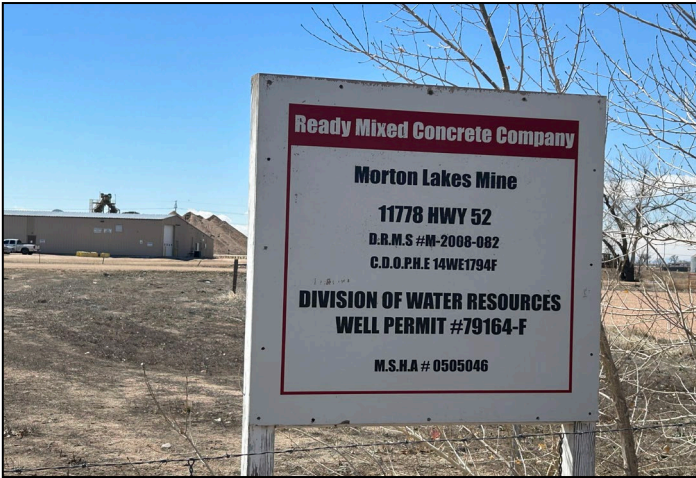
Photo 1 – Site identification sign at entrance to the site.

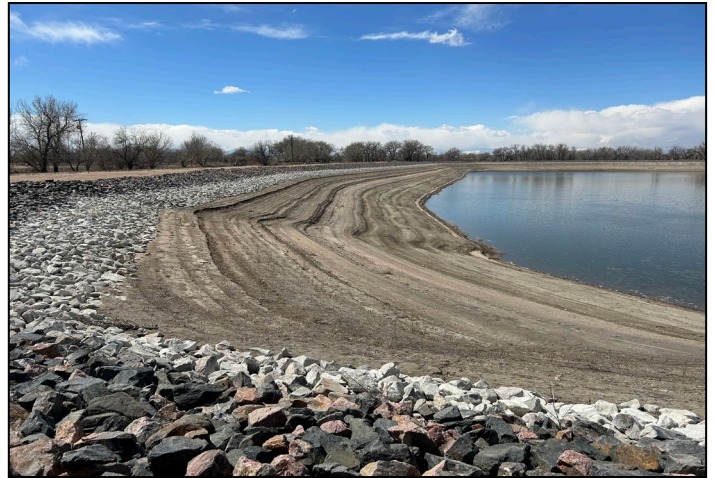
After this meeting with SEO, DRMS accompanied Mr. Lamanna on a tour of the site to inspect the current site conditions. Phase 4 of the site on the east side of the Platte River has been mined out and the slurry wall has been approved. Phase 4 has been almost entirely reclaimed (still needs final grading and seeding around the perimeter) and is being utilized by United Water (photo 2). Phase 3, located to the north of Phase 4, has been mined and backfilled and is currently being graded for final seeding and reclamation. Because the mining on the east side of the Platte River has been completed, the conveyor bridge is no longer being utilized by RMCC, however the current property owner has requested that it be left in place for their use in the future. This will require a simple revision to the approved reclamation plan.

Photo 2 – Completed lined water storage reservoir in Phase 4 on east side of South Platte River.

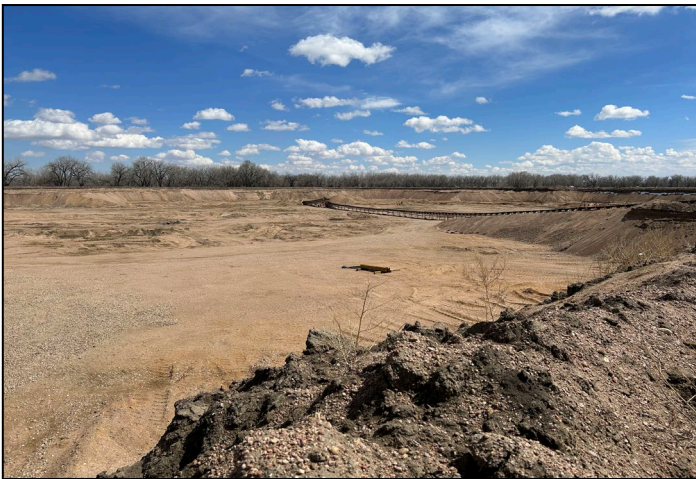
On the west side of the South Platte, Phase 6 has been almost fully mined and the slurry wall has been installed. Phase 5 located in the south center of the permit has also been fully lined, however, some mining in the southeast area of the cell remains to be completed (photo 3). The slurry walls for Phases 7A and 7B near the center of the site are currently being installed by Hall Irwin (photo 4), and these will be the next areas to be mined.

Photo 3 – SE area of lined Phase 5, some mining remaining in this area to be completed.

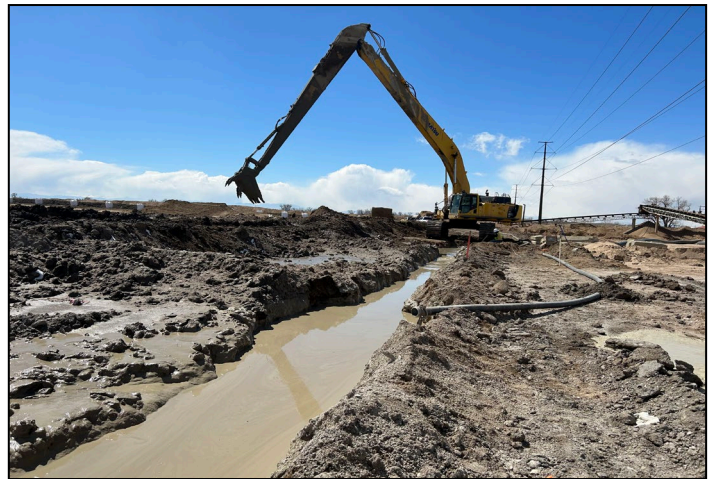
Photo 4 – Slurry wall being installed by Hall Irwin around Phase 7 near the center of the site.
