### PERMIT INFORMATION

<b>Permit Number:</b> C-1981-018 <b>Mine Name:</b> Deserado Mine <b>Operator:</b> Blue Mountain Energy, Inc. <b>Operator Address:</b> Mr. Kurtis Blunt 3607 County Road 65 Rangely, CO, 81648	<b>County:</b> Moffat, Rio Blanco <b>Operation Type:</b> Underground <b>Permit Status:</b> Active <b>Ownership:</b> Private
	<b>Operator Representative Present:</b>  Kurt Blunt
<b>Operator Representative Signature: (Field Issuance Only)</b>

<b>Inspection Start Date:</b> March 29, 2023 <b>Inspection Start Time:</b> 11:15 <b>Inspection End Date:</b> March 29, 2023 <b>Inspection End Time:</b> 14:45	<b>Inspection Type:</b> Coal Complete Inspection <b>Inspection Reason:</b> Normal I&E Program <b>Weather:</b> Cloudy	
<b>Joint Inspection Agency:</b>  None	<b>Joint Inspection Contacts:</b>  None	
<b>Post Inspection Agency:</b>  None	<b>Post Inspection Contacts:</b>  None	
<b>Inspector(s):</b>  Clayton Wein  Todd Jesse	<b>Inspector's Signature:</b>  <i>Clayton Wein</i>	<b>Signature Date:</b>  4/7/2023

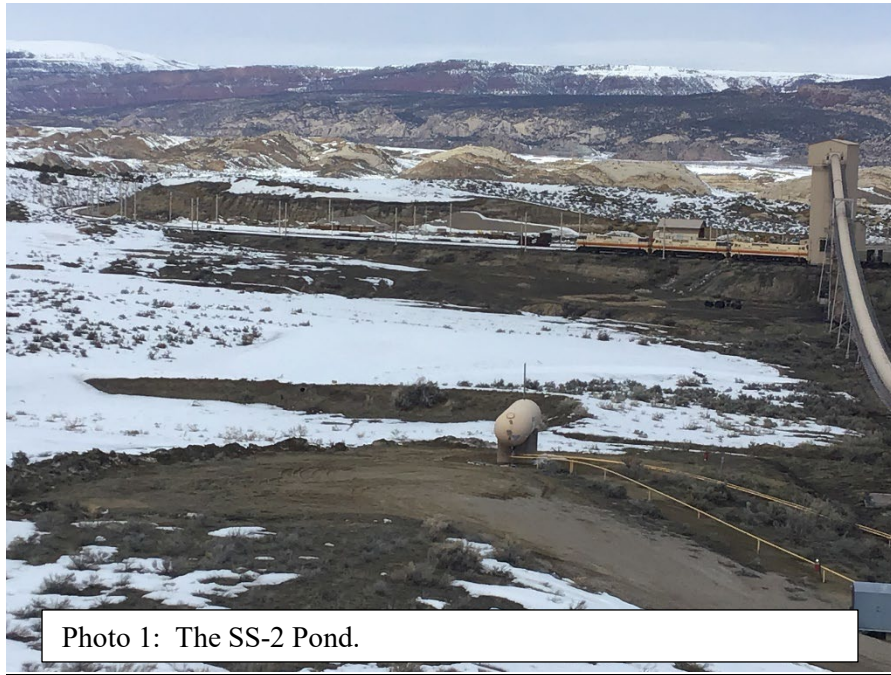
The SS-1 pond and the SS-2 pond are located to the north of the Slot Storage facility. The SS-1 pond was holding water during the inspection. No discharge was observed. The discharge outlet was clear of debris. Embankments for the pond were partly covered with snow. There were no erosional concerns or indications of erosion observed. The SS-2 pond was covered with snow (Photo 1). The embankment was stable with no erosional concerns identified.

Photo 1: The SS-2 Pond.

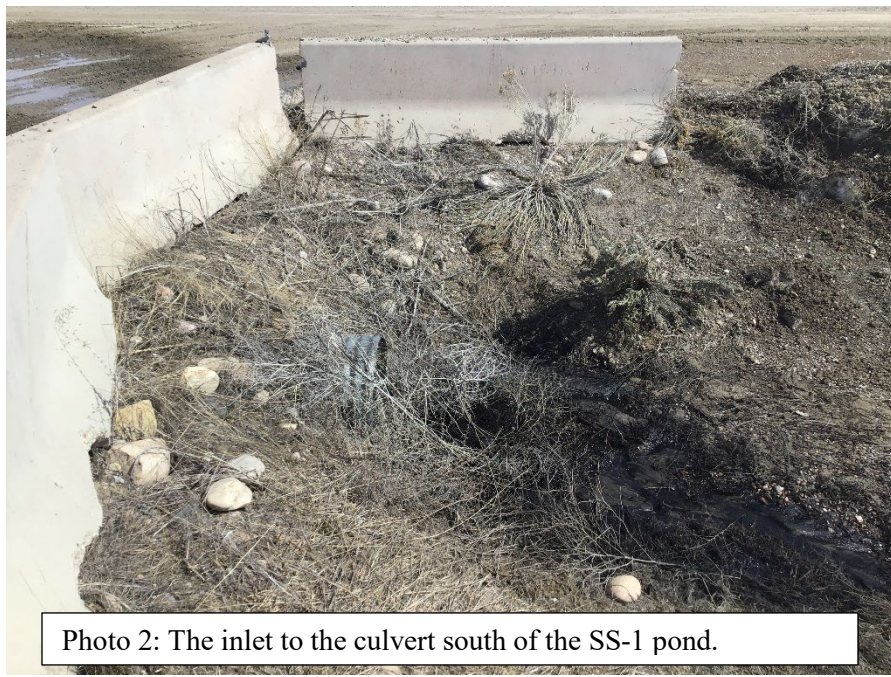
There are a couple of culverts below access roads adjacent to the SS-1 pond. Both culverts are south of the SS-1 pond. The culverts were observed to be partly filled with sediment (Photo 2). Runoff was observed being conveyed to the SS-1 pond properly even with the excess sediment in the culverts and ditches. **Please clean out the culverts and ditches of the excess sediment. The current ground conditions were too soft to complete these items. The operator has added the culverts to the list of items requiring maintenance when ground conditions allow.**

Photo 2: The inlet to the culvert south of the SS-1 pond.

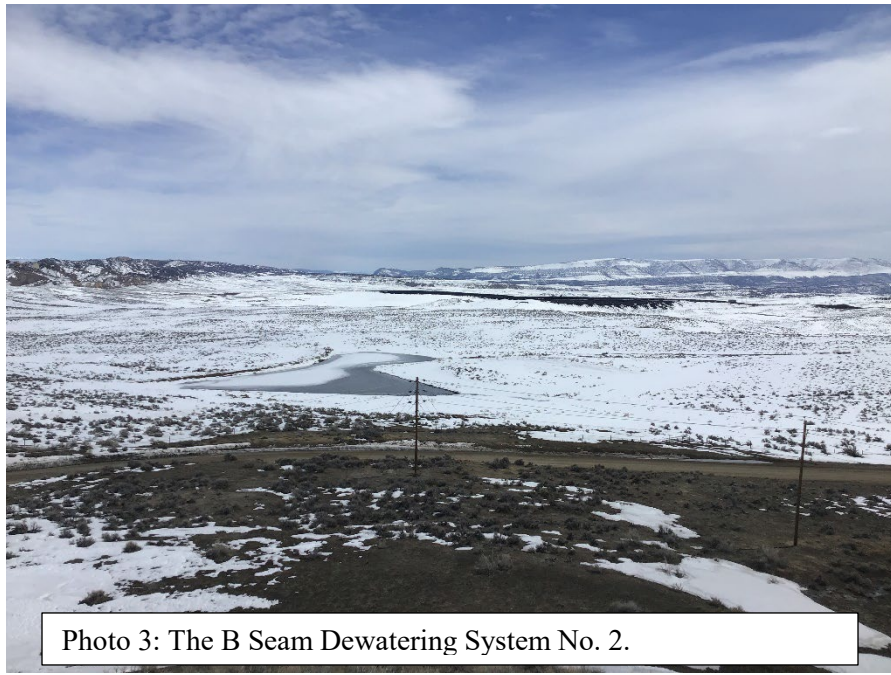
Water was observed to be impounded in the second cell of the B Seam Dewatering System No. 2 (Photo 3). The cell was frozen over and the embankments were covered with snow. The level of water and ice had not reached the primary discharge outlet. The embankment was stable and no erosional features were identified. The third cell of the system is not used. The cell was covered with snow and there was not any water observed to be impounded in the cell. The first cell was inaccessible during the inspection.

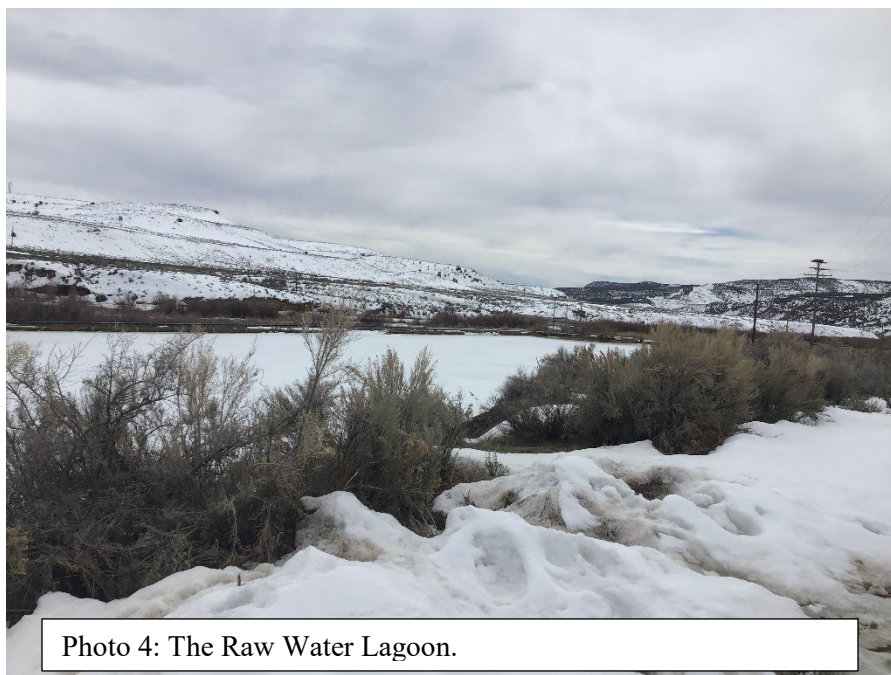
The Raw Water Lagoon is located in the southern portion of the permit area, north of the White River and adjacent to CR-65. The pond was holding water and frozen over during the inspection (Photo 4). The embankment was snow covered and stable. There were no erosional concerns identified.

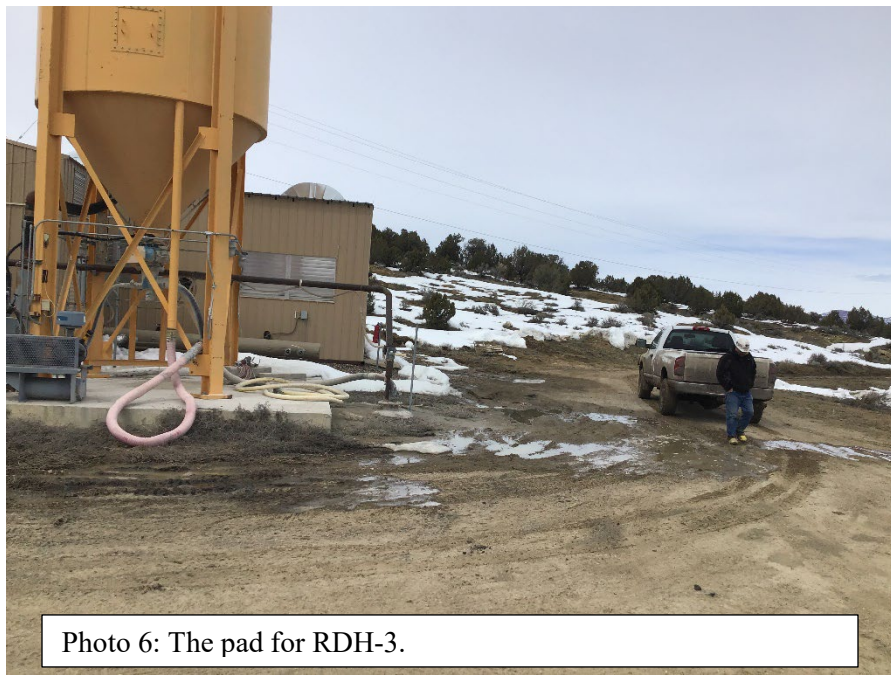
Support facilities that were able to be accessed included; the main facilities/portals area, B Vent Shaft no. 1, RDH-2, RDH-3 (Photo 6), RDH-4, the Nitrogen Plant No. 2, The conveyor corridor, the Slot Storage, The radio tower (Photo 7), the West Mains Vent Shaft, and the water storage tanks. **A couple of culverts near the Nitrogen Plant No. 2 were observed to be mostly plugged with sediment. The first culvert is a small pipe located on the north side of the Nitrogen plant No. 2 pad (Photo 8). Both the inlet and outlet of the culvert were almost completely buried. The second culvert is located at the entrance to the access road from the haul road directly southwest of the Nitrogen Plant No. 2 (Photo 9). Please clear out these culverts as soon as possible to help ensure snowmelt continues to flow through the designed ditches.**

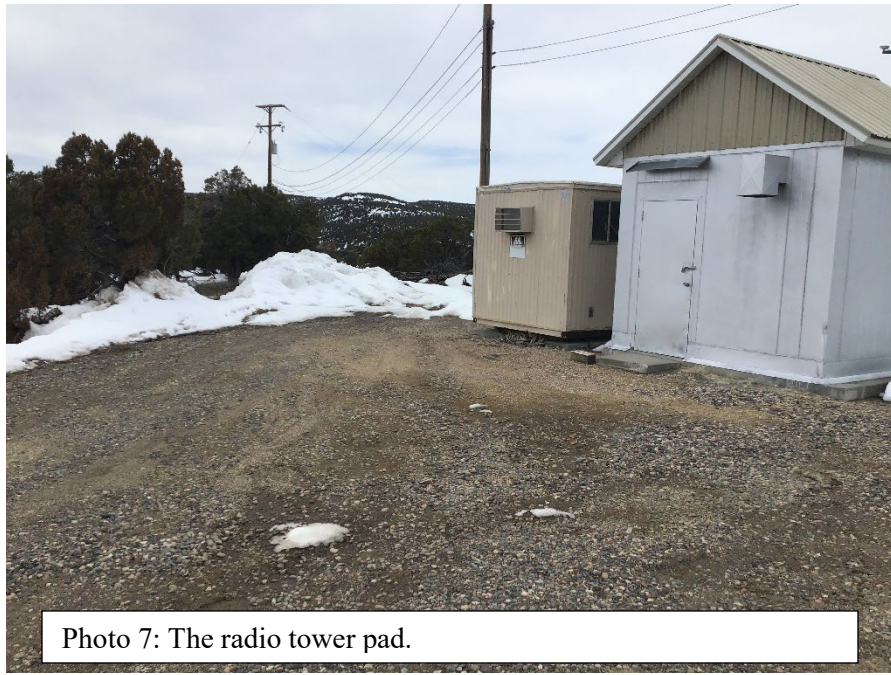
Photo 7: The radio tower pad.

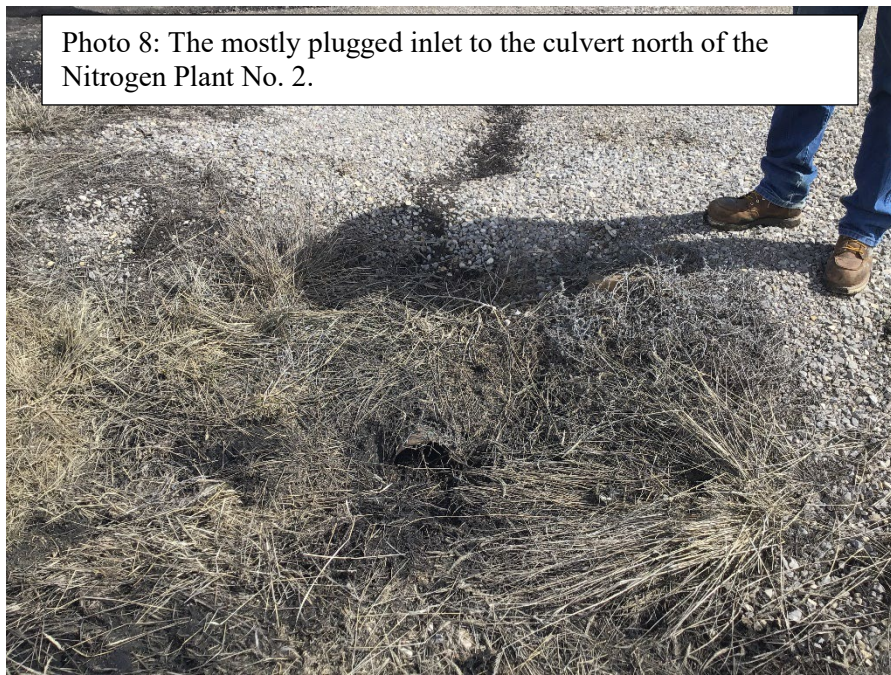
Photo 8: The mostly plugged inlet to the culvert north of the Nitrogen Plant No. 2.
