Re: GCC Energy, LLC, King II Mine CDRMS Permit # C-1981-035 Stoner Engineering: Quarterly Inspection: Water Quality Improvements 1st Quarter 2023

Re: King Coal I – Quarterly Water Quality Improvements Inspection

On March 31, 2023, Ryan Griglak, P.E. visited the GCC Energy, LLC King I Mine site to conduct the quarterly inspection of the water quality features installed to prevent contaminated storm water runoff from escaping the site in events smaller than the 100-year storm event.

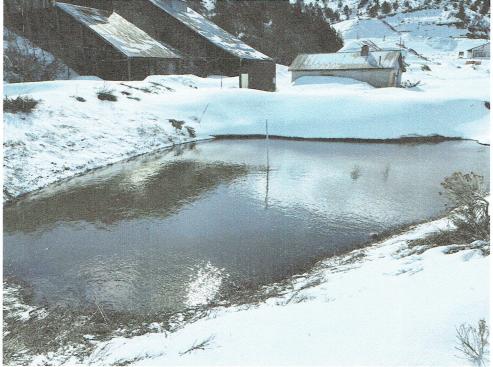
Both ponds held water at the time of the inspection due to recent runoff. The east pond water level was likely between 2-3 feet in depth at the time of the inspection (see Pic. 1). The west pond held less runoff however, there had been material placed/stockpiled within the existing pond area (see Pic. 2). The material placed within the west pond most likely results in the available storage capacity being less than required for storm water runoff. This excess material should be removed as soon as possible to ensure adequate pond capacity for runoff/storm events. The sedimentation traps at the entrance to the site are generally in good condition.

Pic. 1 – Water level, East pond.

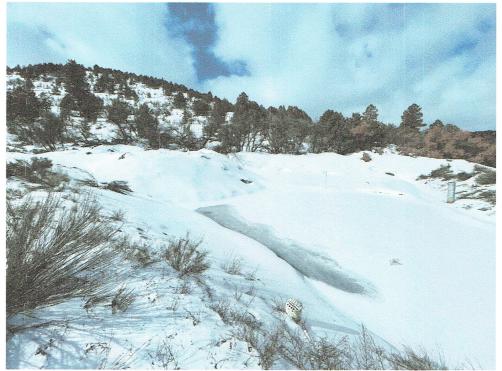
Pic. 2 – Waste material within boundary of West pond.

The clear water and the treated water ditches were not observable due to the current snow accumulation. There is no reason to believe that the drainage for the overall site is not functioning as designed however, the waste material placed within the west pond needs to be removed as soon as possible to ensure adequate storage capacity for the upcoming snow melt and spring storms (see Pic. 6).

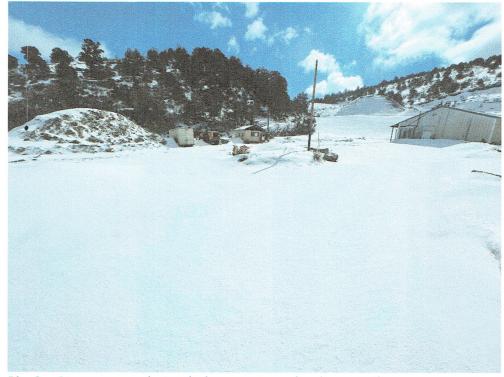
Recent and accumulated snow made inspecting the ditches and culverts impossible. While some areas were windblown and partially visible, most areas and ditches were drifted and completely covered at the time of the inspection (see Pic. 3 & Pic. 4). The culvert located at the north switchback of the haul road was crushed due to the soft conditions by maintenance equipment and will need to be replaced (see Pic. 5).

Pic. 3 – Snow accumulation below waste embankment piles.

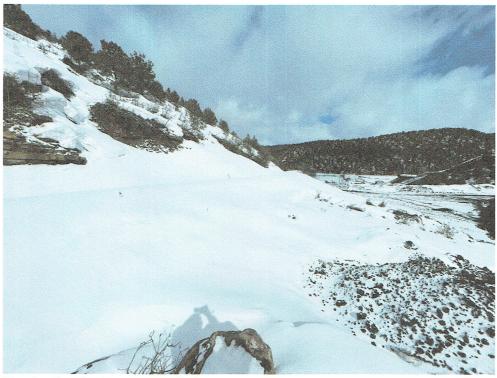
Pic. 4 - South clear water ditch.

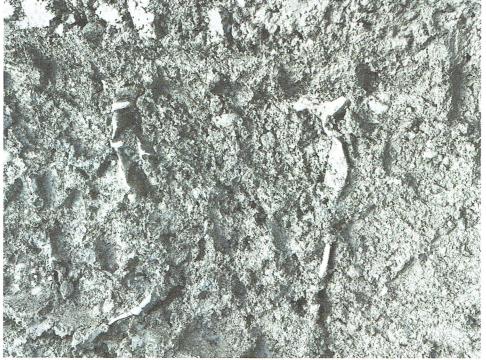
Pic. 5 – Top of culvert crushed at north switchback.

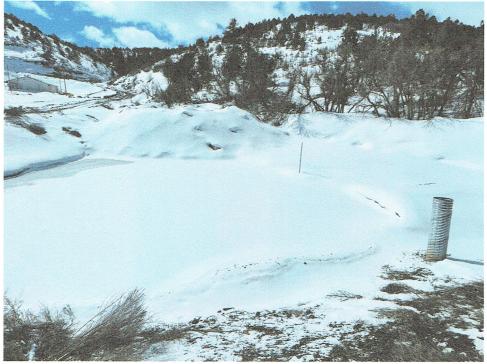
Pic. 6 - Waste material placed within West Pond.
