MINERALS PROGRAM INSPECTION REPORT
PHONE: (303) 866-3567

MINE NAME: River Road Pit	MINE/PROSPECTING ID#: M-1991-136	MINERAL: Sand and gravel	COUNTY: Mesa
INSPECTION TYPE: Monitoring	WEATHER: Cloudy	INSP. DATE: March 29, 2023	INSP. TIME: 13:30
OPERATOR: Oldcastle SW Group, Inc. dba United Companies of Mesa County	OPERATOR REPRESENTATIVE: Jason Burkey	TYPE OF OPERATION: 112c - Construction Regular Operation	
REASON FOR INSPECTION: Normal I&E Program	BOND CALCULATION TYPE: Complete Bond	BOND AMOUNT: \$16,351.00	
DATE OF COMPLAINT: NA	POST INSP. CONTACTS: None	JOINT INSP. AGENCY: None	
INSPECTOR(S): Amy Yeldell	INSPECTOR'S SIGNATURE:

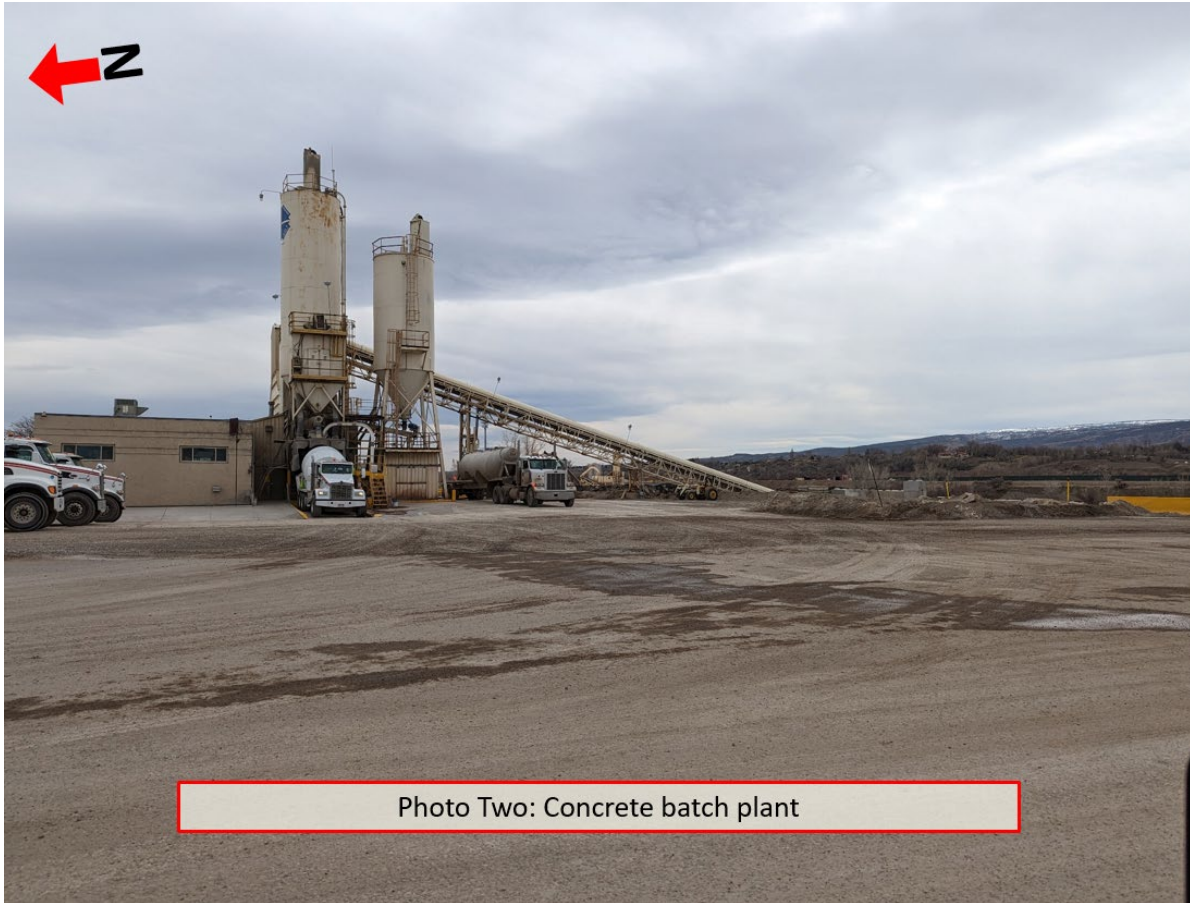
Photo Two: Concrete batch plant

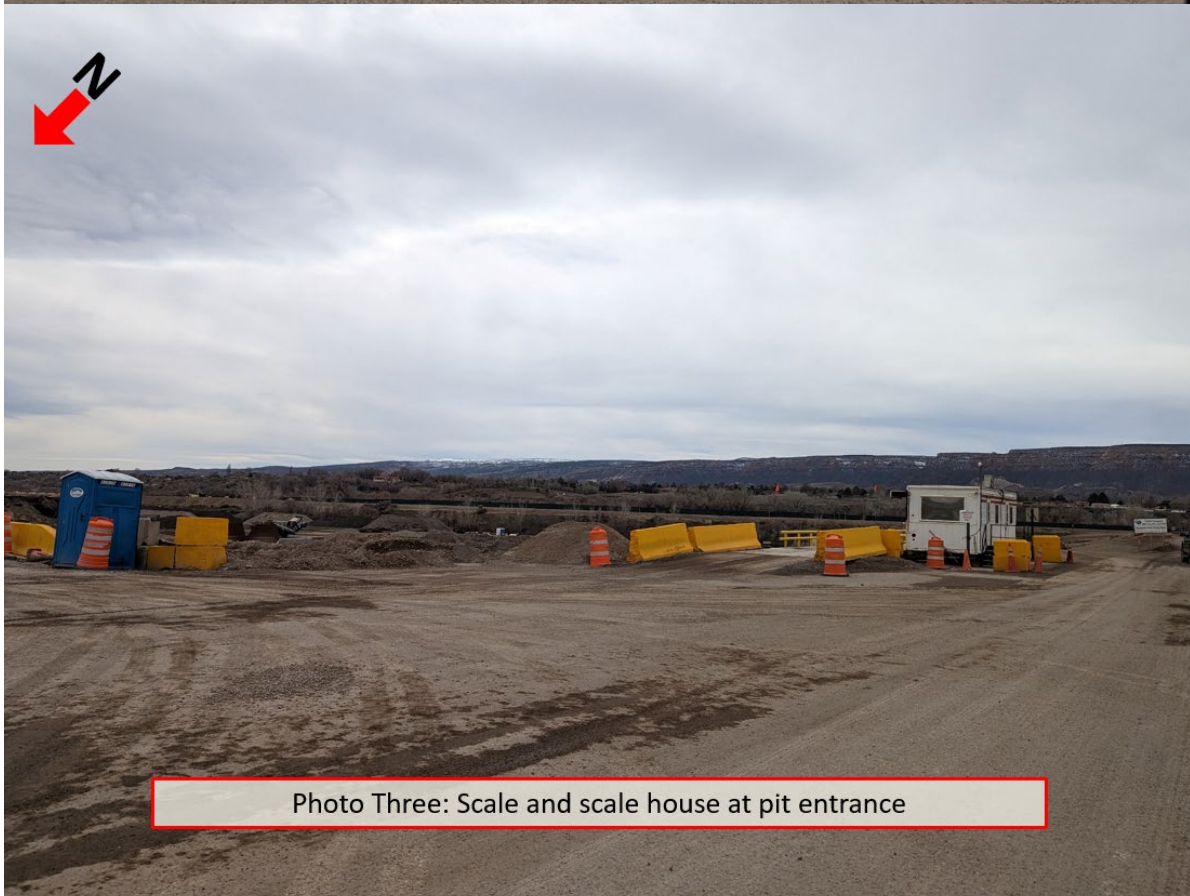
The mine identification sign and affected area boundary markers are in place and in compliance with Rule 3.1.12. A scale and scale house is located on the west side of pit entrance.

Photo Three: Scale and scale house at pit entrance
