**MINERALS PROGRAM INSPECTION REPORT**  
**PHONE: (303) 866-3567**

<b>MINE NAME:</b> Railhead Gravel Pit	<b>MINE/PROSPECTING ID#:</b> M-1995-036	<b>MINERAL:</b> Sand and gravel	<b>COUNTY:</b> Mesa
<b>INSPECTION TYPE:</b> Monitoring	<b>WEATHER:</b> Cloudy	<b>INSP. DATE:</b> March 29, 2023	<b>INSP. TIME:</b> 14:00
<b>OPERATOR:</b> Oldcastle SW Group, Inc. dba United Compas County	<b>OPERATOR REPRESENTATIVE:</b> Jason Burkey	<b>TYPE OF OPERATION:</b> 112c - Construction Regular Operation	
<b>REASON FOR INSPECTION:</b> Normal I&E Program	<b>BOND CALCULATION TYPE:</b> Complete Bond	<b>BOND AMOUNT:</b> \$127,950.00	
<b>DATE OF COMPLAINT:</b> NA	<b>POST INSP. CONTACTS:</b> None	<b>JOINT INSP. AGENCY:</b> None	
<b>INSPECTOR(S):</b> Amy Yeldell	<b>INSPECTOR'S SIGNATURE:</b>

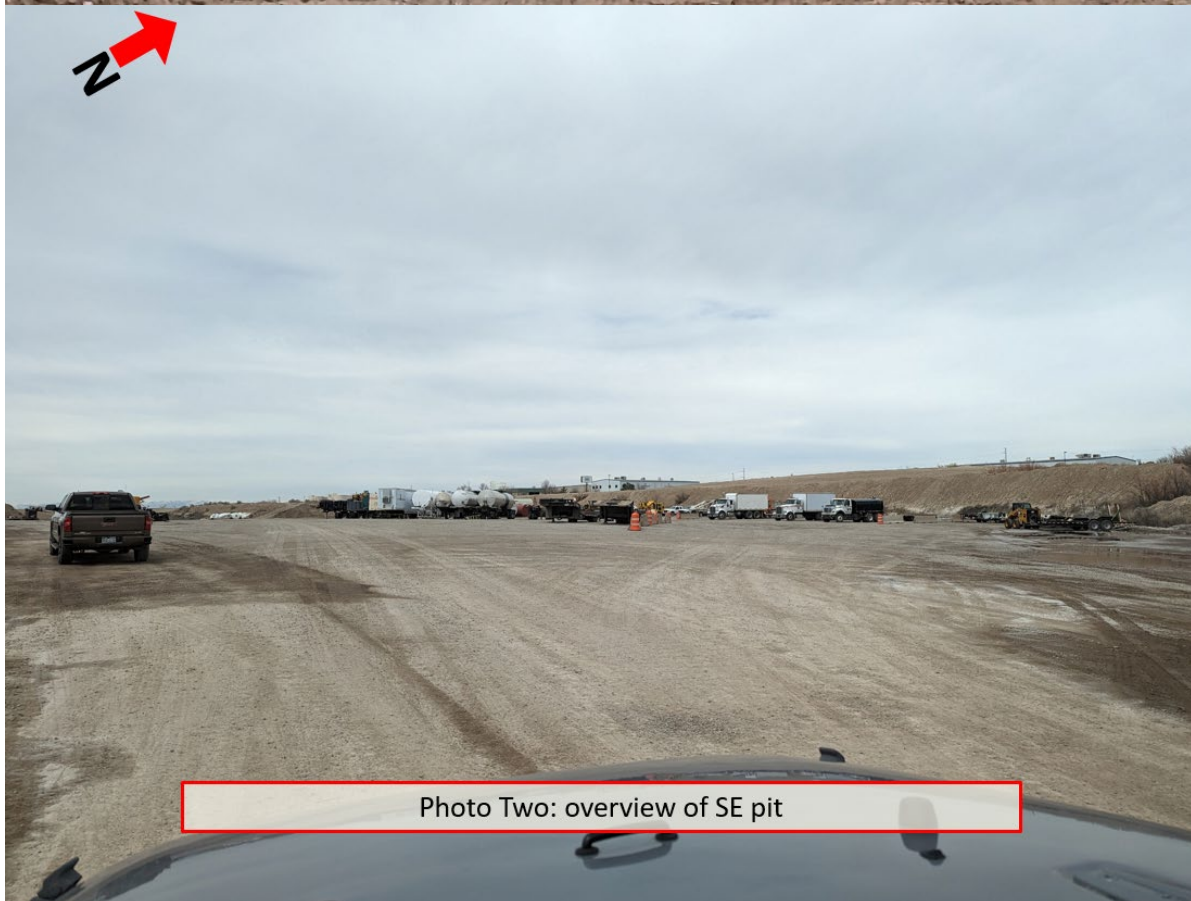
Photo Two: overview of SE pit

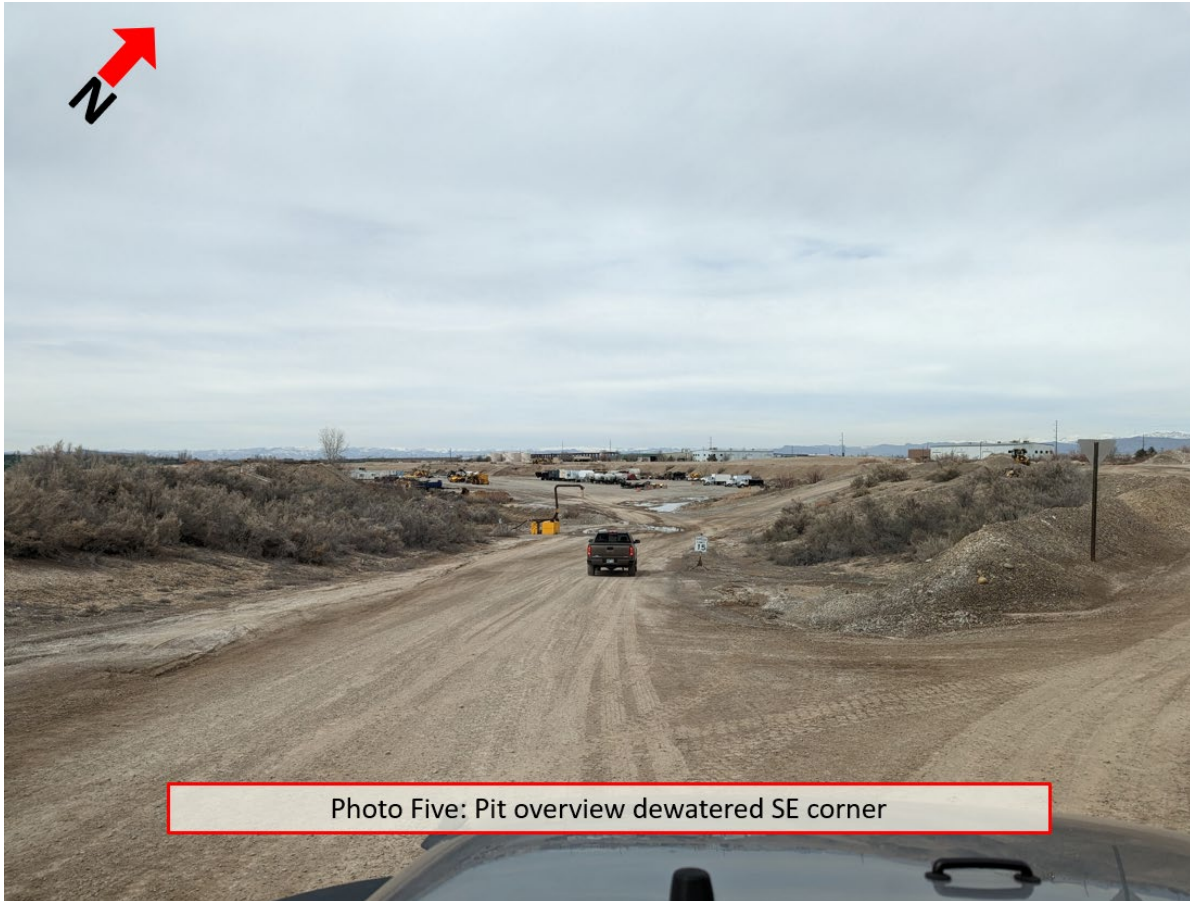
Photo Five: Pit overview dewatered SE corner

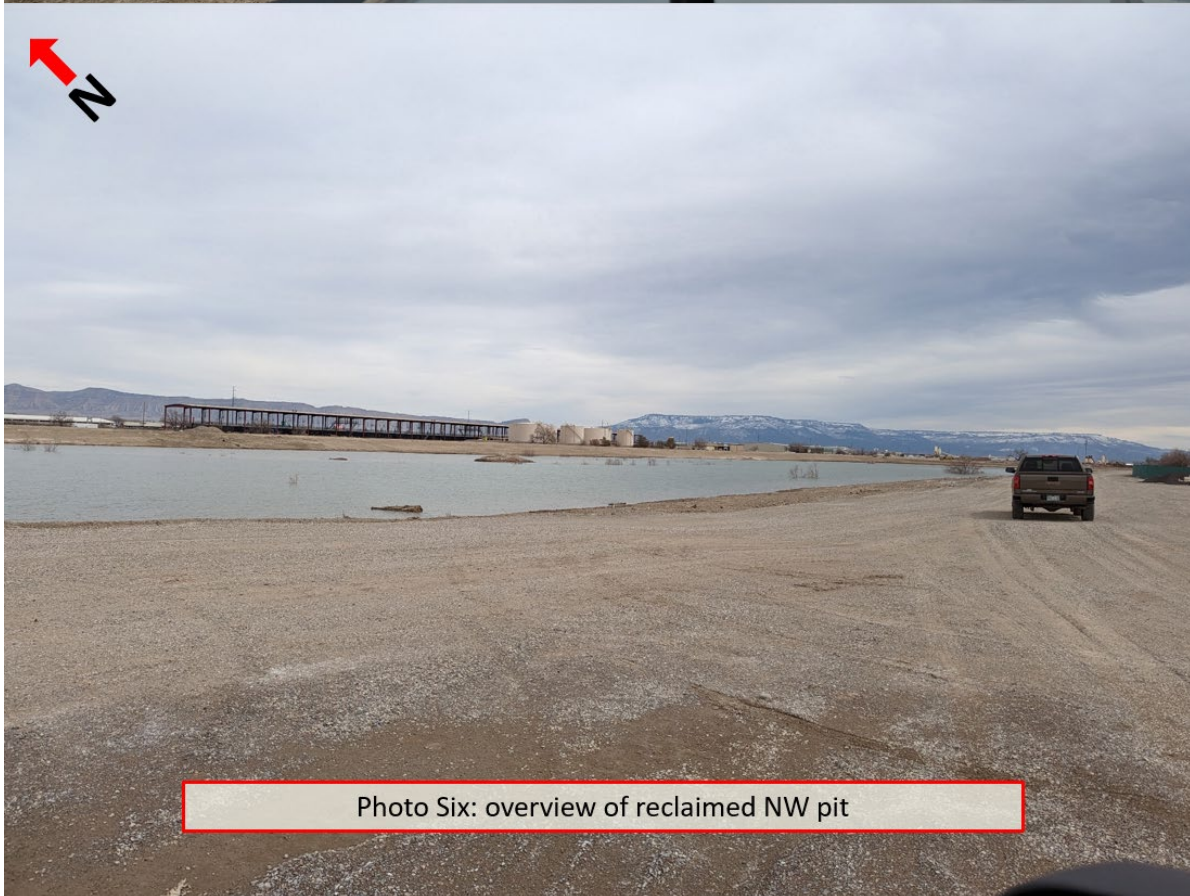
Photo Six: overview of reclaimed NW pit
