Camilletti Milner #2 Pit Inspection Request (M-2001-023)

MINERALS PROGRAM INSPECTION REPORT
PHONE: (303) 866-3567

MINE NAME: Camilletti Milner Pit #2	MINE/PROSPECTING ID#: M-2001-023	MINERAL: Sand and gravel	COUNTY: Routt
INSPECTION TYPE: Monitoring	WEATHER: Clear	INSP. DATE: March 29, 2023	INSP. TIME: 13:00
OPERATOR: Precision Excavating, Inc.	OPERATOR REPRESENTATIVE: David Zehner	TYPE OF OPERATION: 112c - Construction Regular Operation	
REASON FOR INSPECTION: Normal I&E Program	BOND CALCULATION TYPE: Partial	BOND AMOUNT: \$325,500.00	
DATE OF COMPLAINT: NA	POST INSP. CONTACTS: None	JOINT INSP. AGENCY: None	
INSPECTOR(S): Hunter Ridley Michael Cunningham	INSPECTOR'S SIGNATURE:

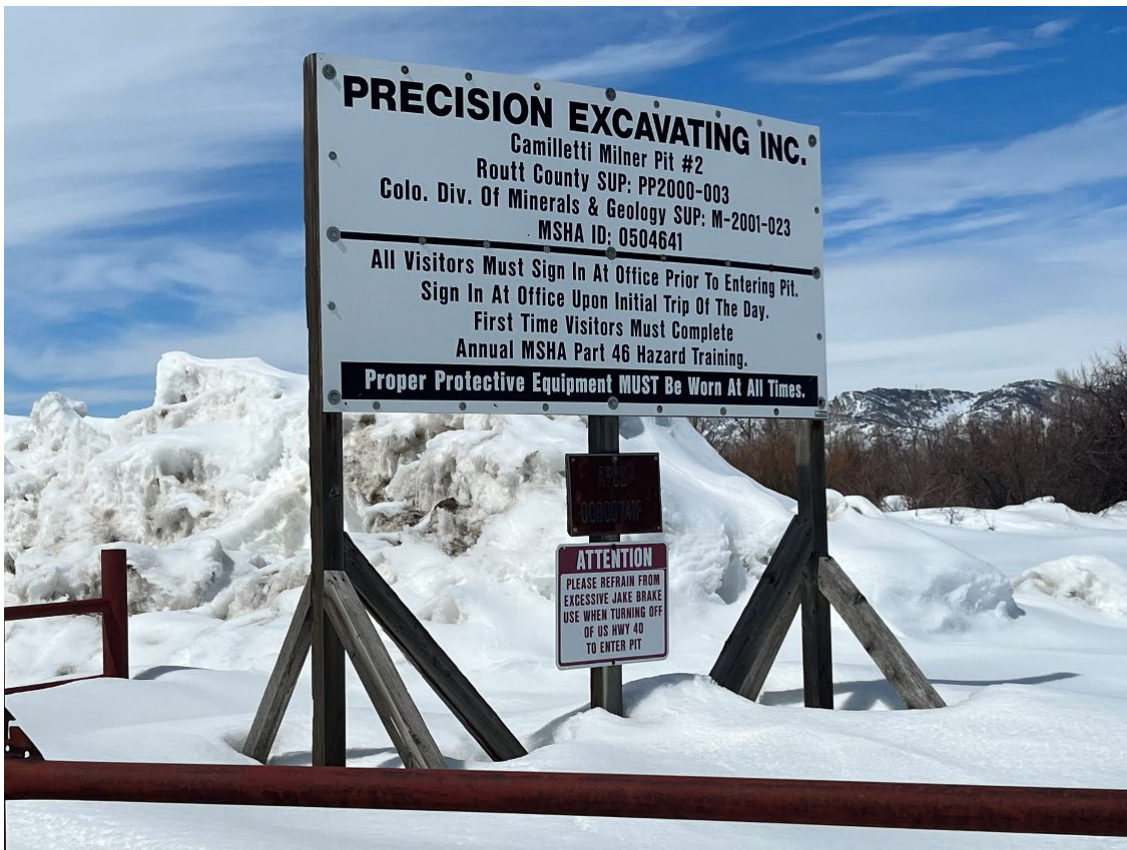
The mine identification sign and affected area boundary markers are in place and in compliance with Rule 3.1.12. The mine sign was located at the main entrance from CR 179 (Photo 1). The main pit boundary is delineated by a fence and the expansion area uses a combination of fencing and posts. A scale and scale house (Photo 2) are located at the pit entrance. All fuel and hazardous materials are located within a cement secondary containment (Photo 3).

Photo 1: Proper mine identification is posted at the entrance off CR 179.

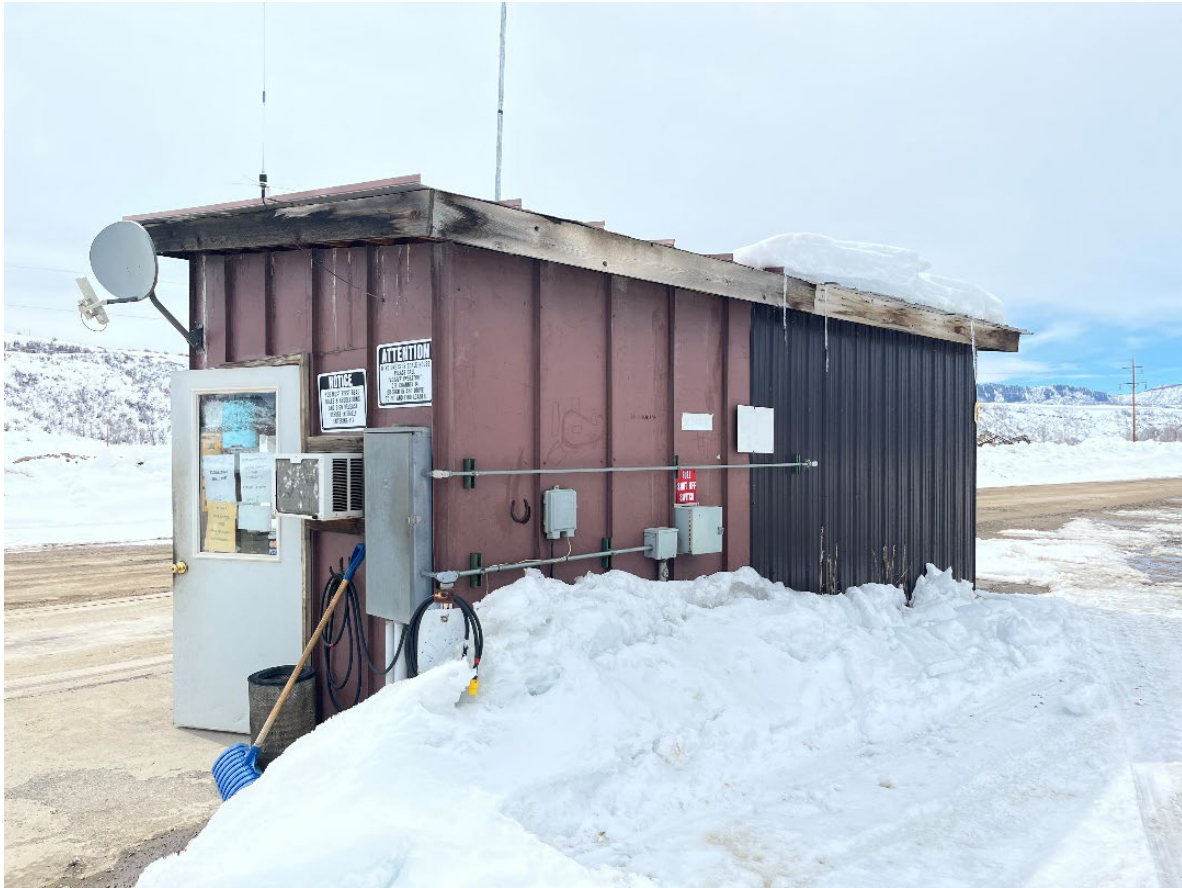
Photo 2: Scale and scale house on the main road

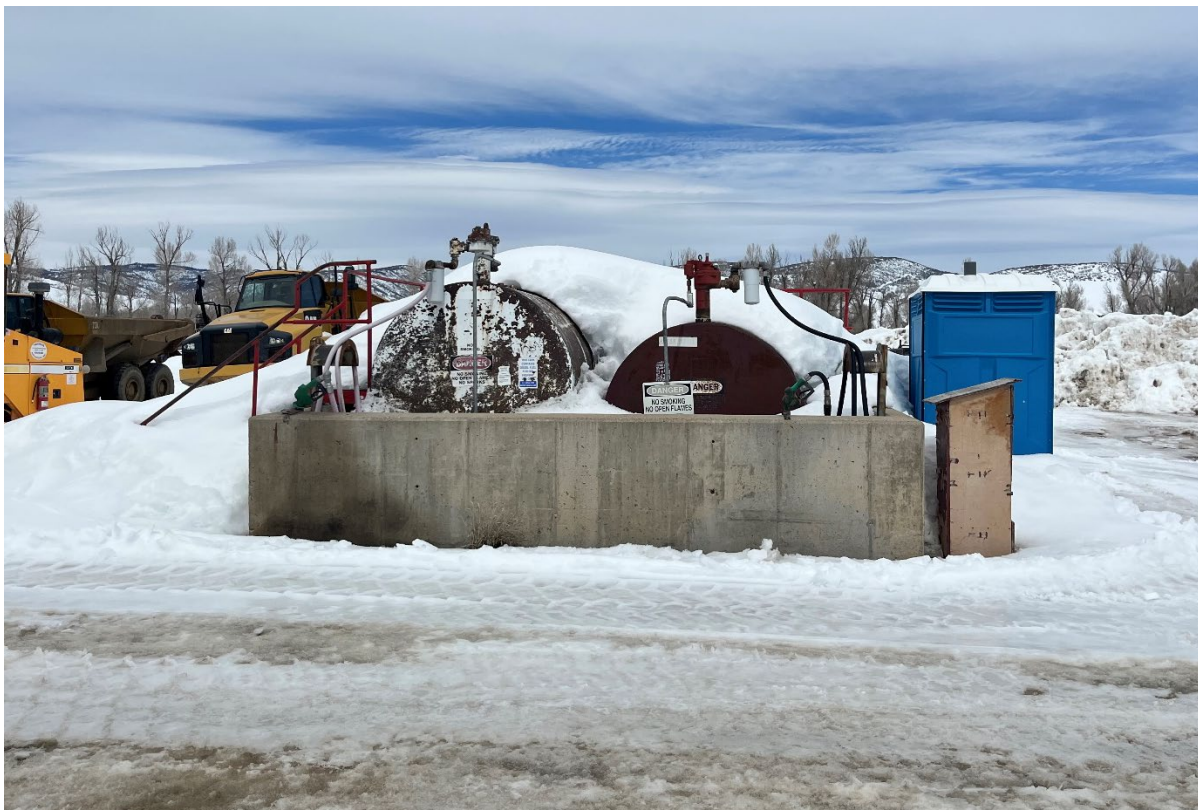
Photo 3: Fuel is stored in secondary containment.

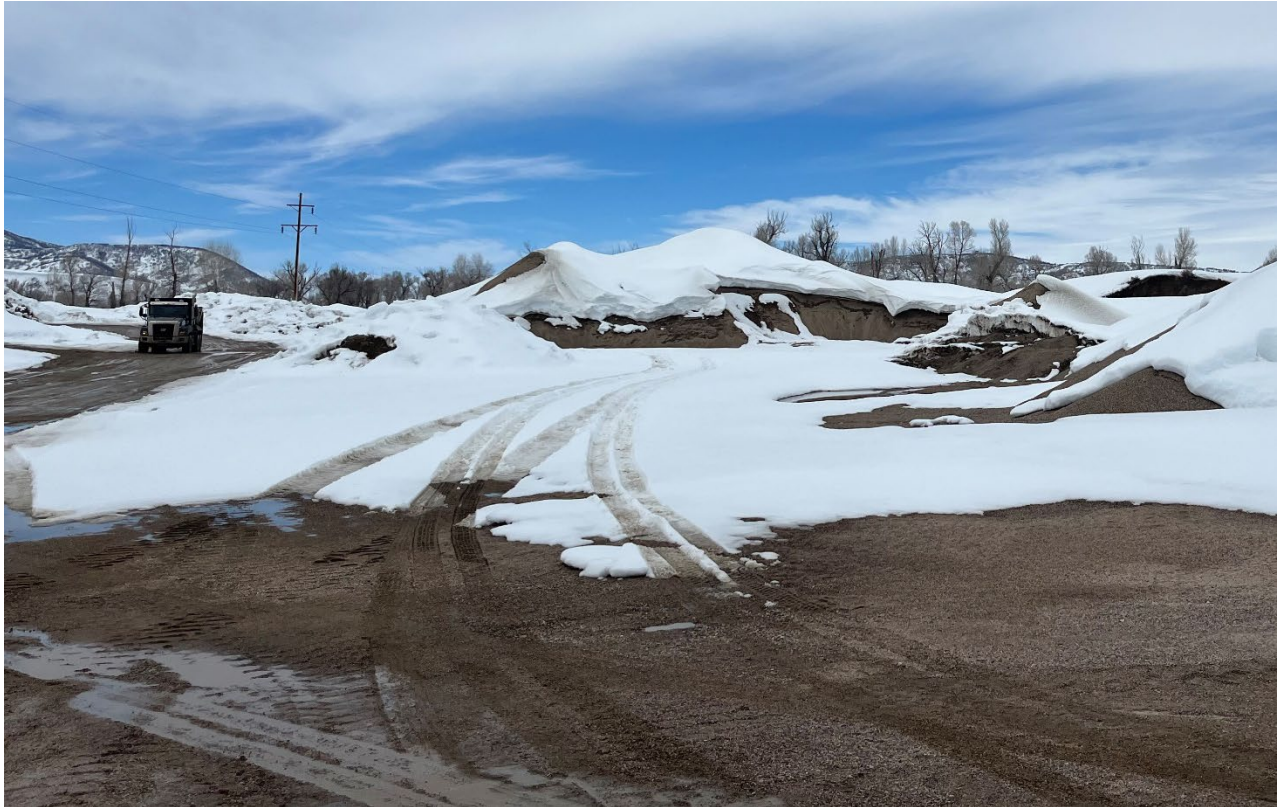
The site was active at the time of the inspection with trucks loading and hauling material offsite (Photo 4). There are several processing plants which include crushers and a wash plant. Any imported material is crushed then resold, no imported material will be used for reclamation as per the approved mine plan.

Photo 4: Site was actively loading and hauling material at the time of inspection.

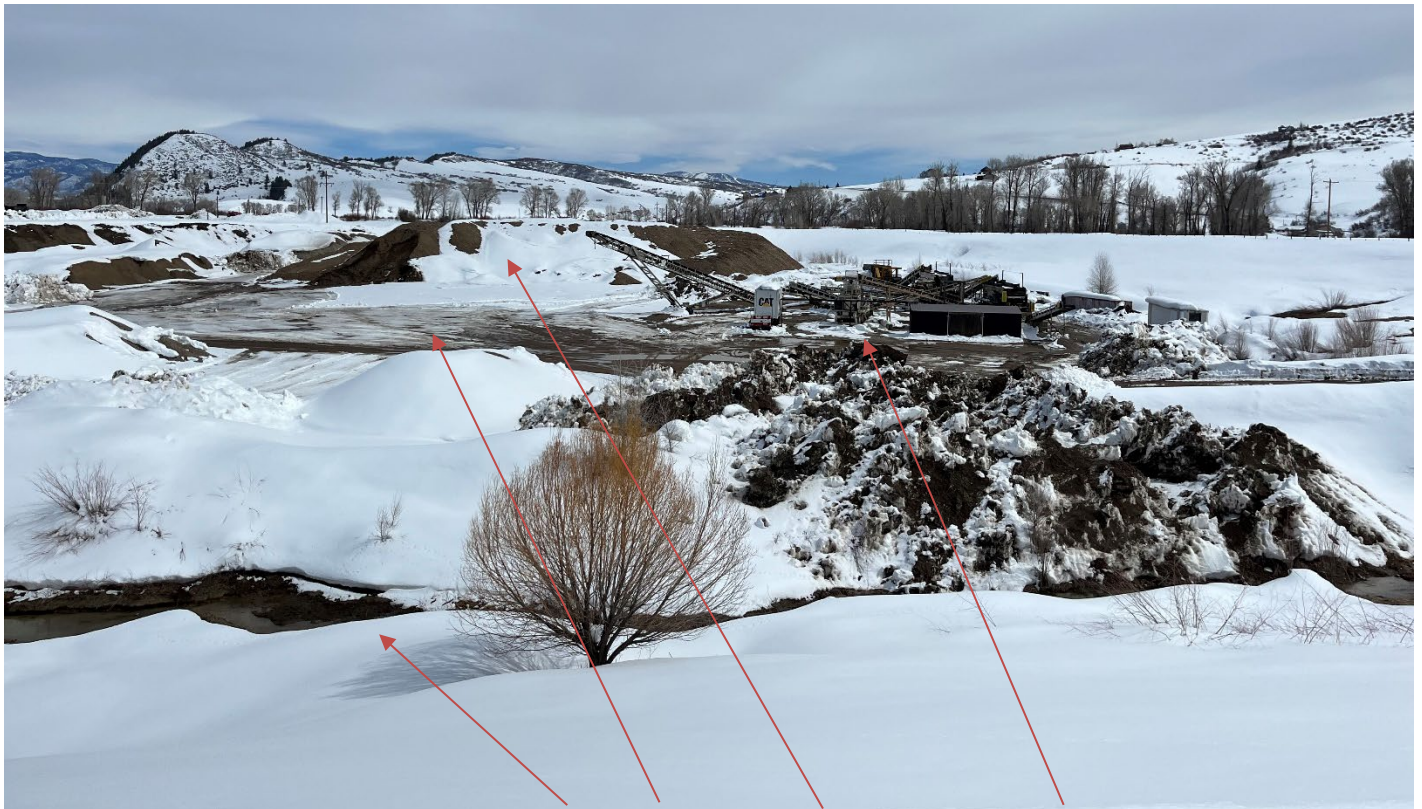
The main pit has several huge stockpiles on the pit floor and other smaller piles throughout the rest of the pit. All stockpiles are stable and neatly organized (Photo 5). Most slopes in the main pit have been graded and seeded. Only a small portion of highwall remains adjacent to the main pit floor and the access road down into the pit. Topsoil piles around the site show signs of vegetation through the snow (Photo 10). The south and east pit walls have been successfully reclaimed and are releasable. However, the operator wants to keep these within the permit to account for possible future use.

Photo 5: View to the east of the ditch, pit floor, product stockpiles, and processing equipment

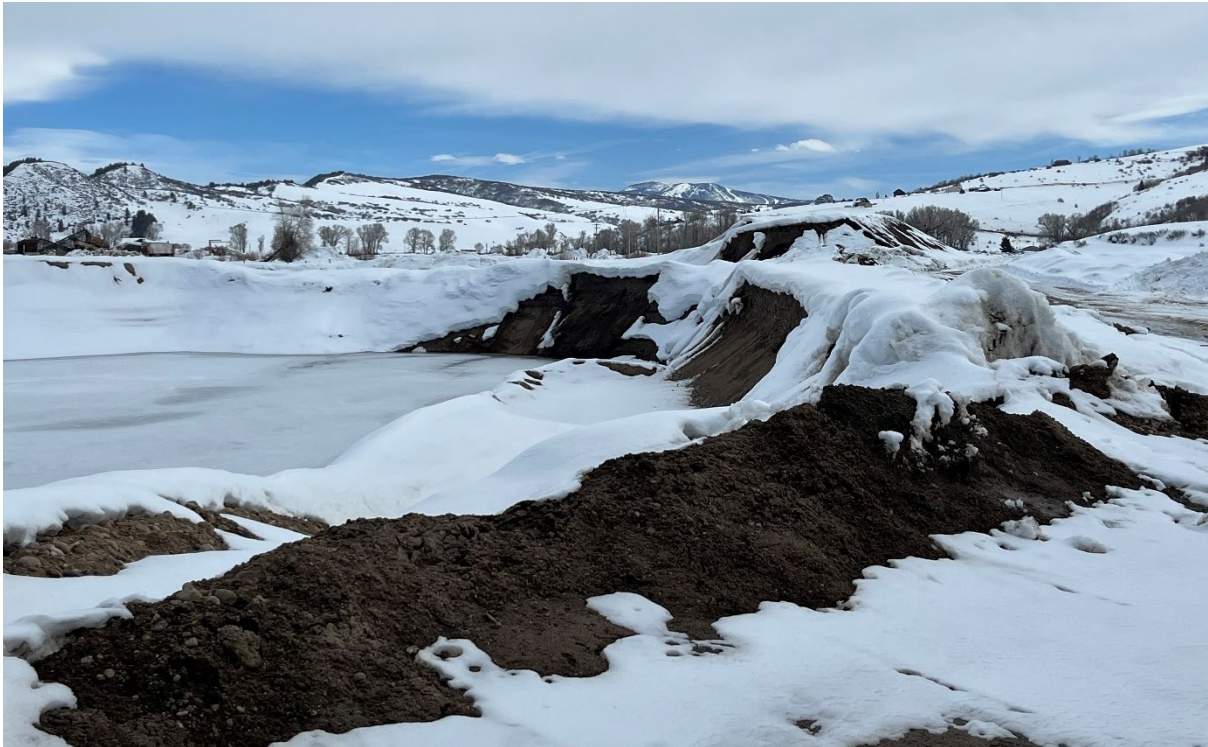
Photo 6: Unreclaimed highwall to the west of the expansion pit pond.

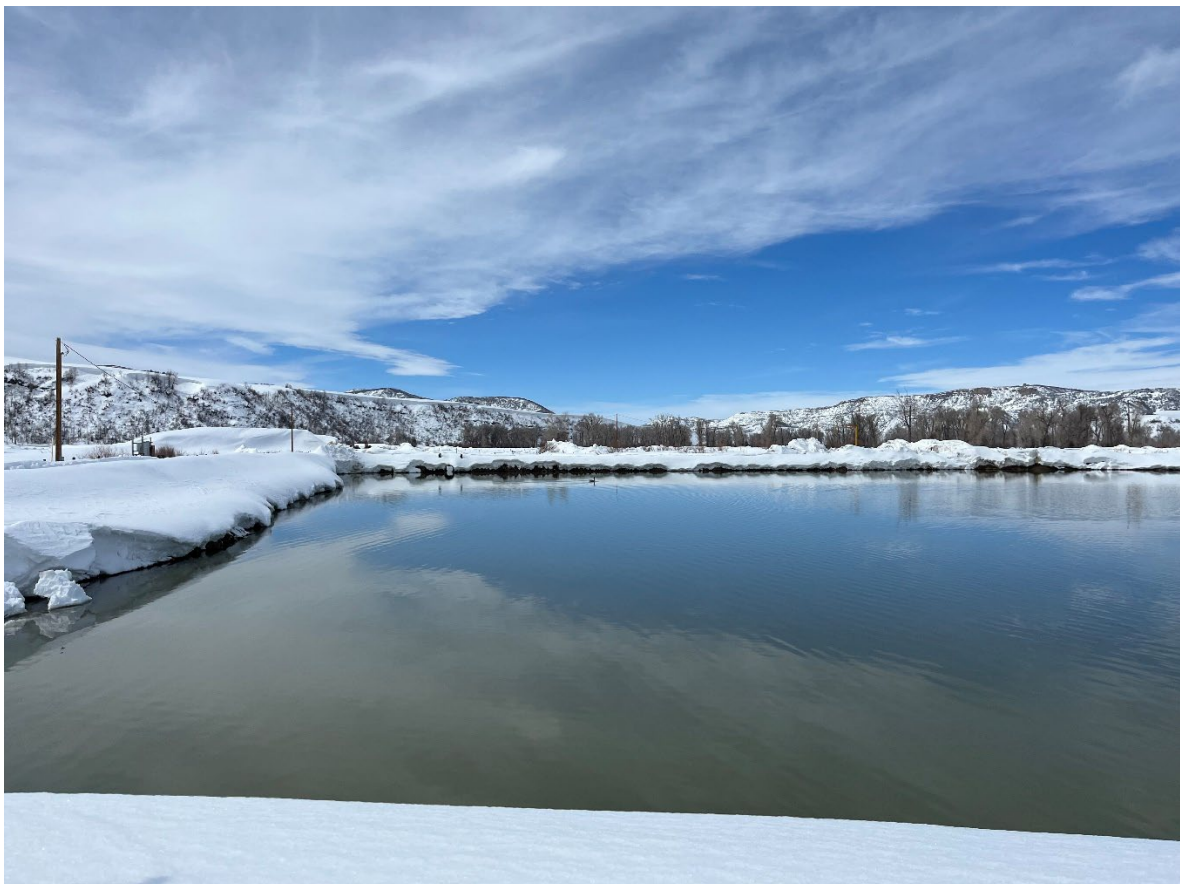
The bench to the north of the main pit floor is mainly used for additional stockpiling. The wash plant reports to two sediment/wash ponds which are approximately 30' deep (Photo 7). Waterfowl were seen using this area.

Photo 7: One of two sediment ponds located west of the main pit floor area.

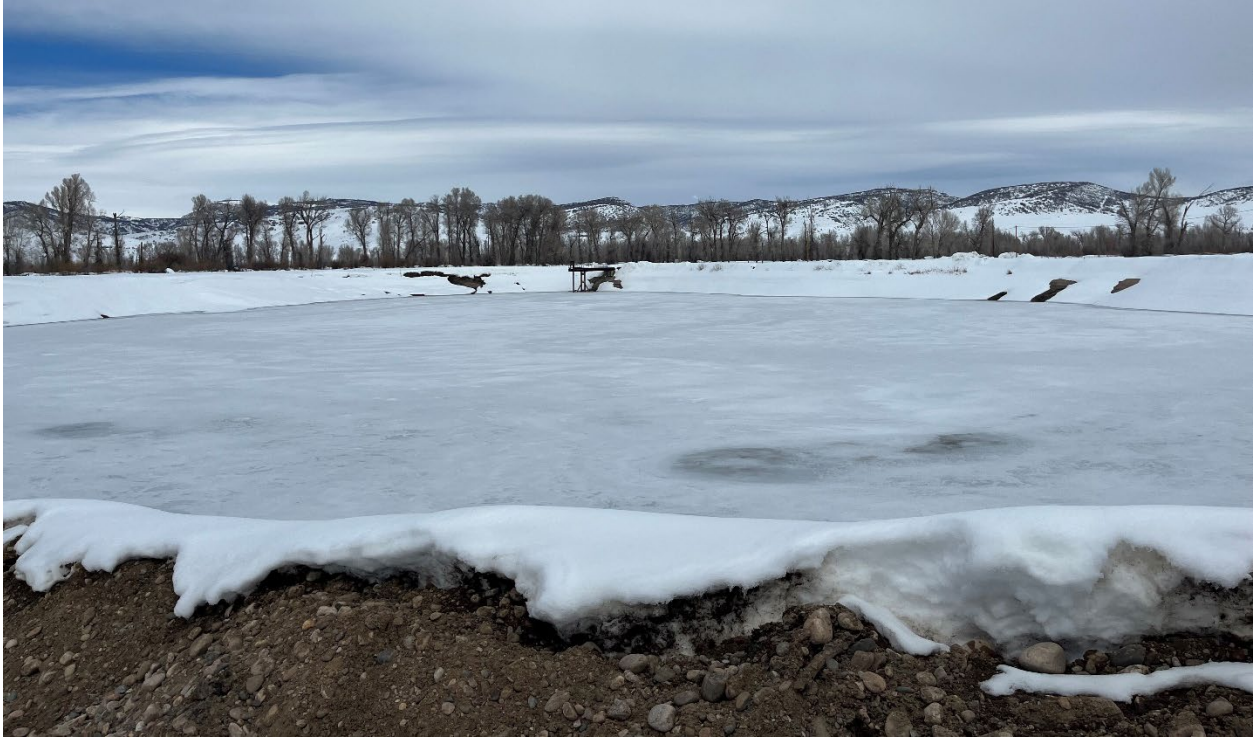
The western expansion area pit is full of water and has not been mined this year. The post mining land use for this site is developed water resources and will consist of two permanent ponds in this area. Only the larger of the two ponds is currently being constructed and holds anywhere from 12 to 24' of water, depending on the season (Photos 8 and 9). There is a permanent dewatering well installed in the north portion of the pond. A 6" pipe expands around the site which, during the summer months, diverts a portion of water from dewatering procedures to patches of cottonwoods which surround the site (background of photos 7, 8, and 9). This ensures that the operation does not negatively impact this patch of vegetation. The unreclaimed highwall is on the west side of the pond (Photo 6). All other slopes have been reclaimed to a 3:1 and are continually maintained after small slippage events (visible in Photo 8). Mining in the expansion area is working towards the south and west. No mining has occurred south of the fence line in this area.

Photo 8: View north of the expansion area pit pond. Current water level is around 12 feet.

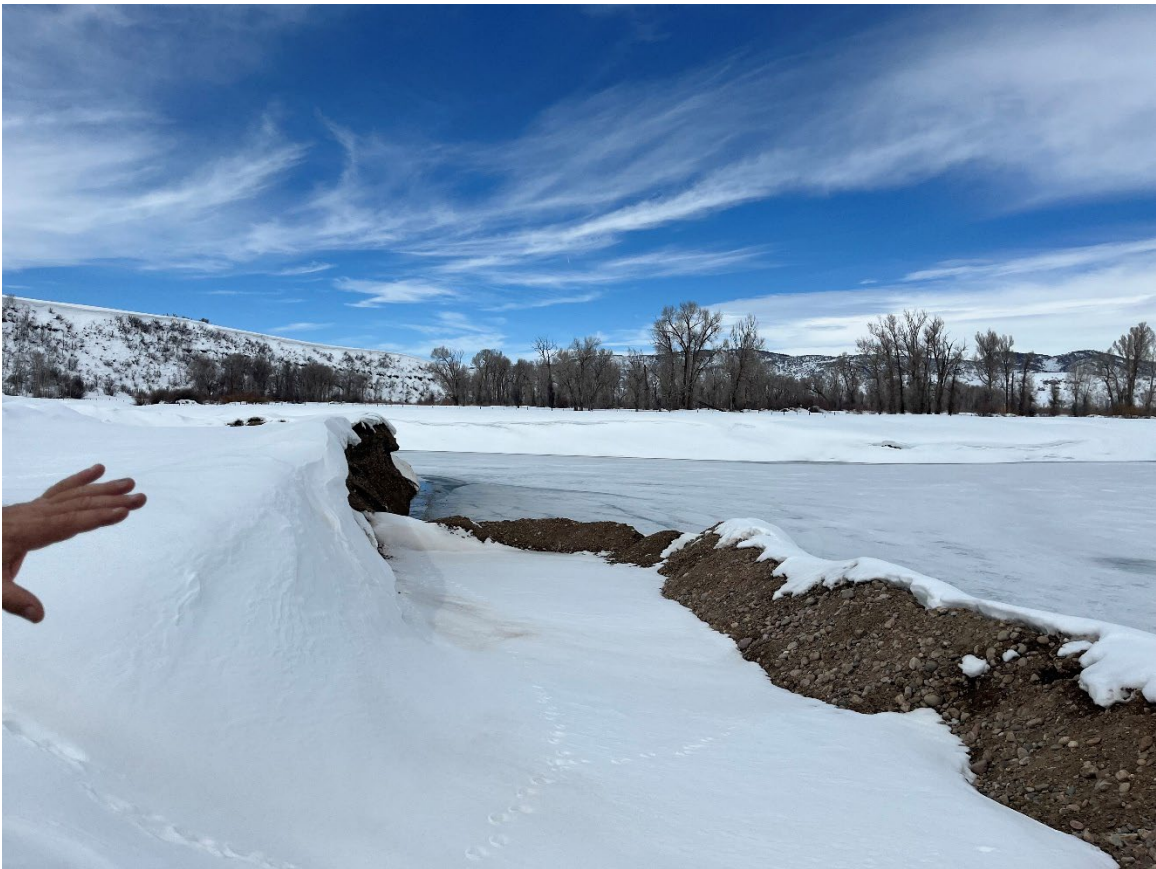
Photo 9: Western edge of the expansion area pit pond which will resume active mining in the Spring/Summer months.

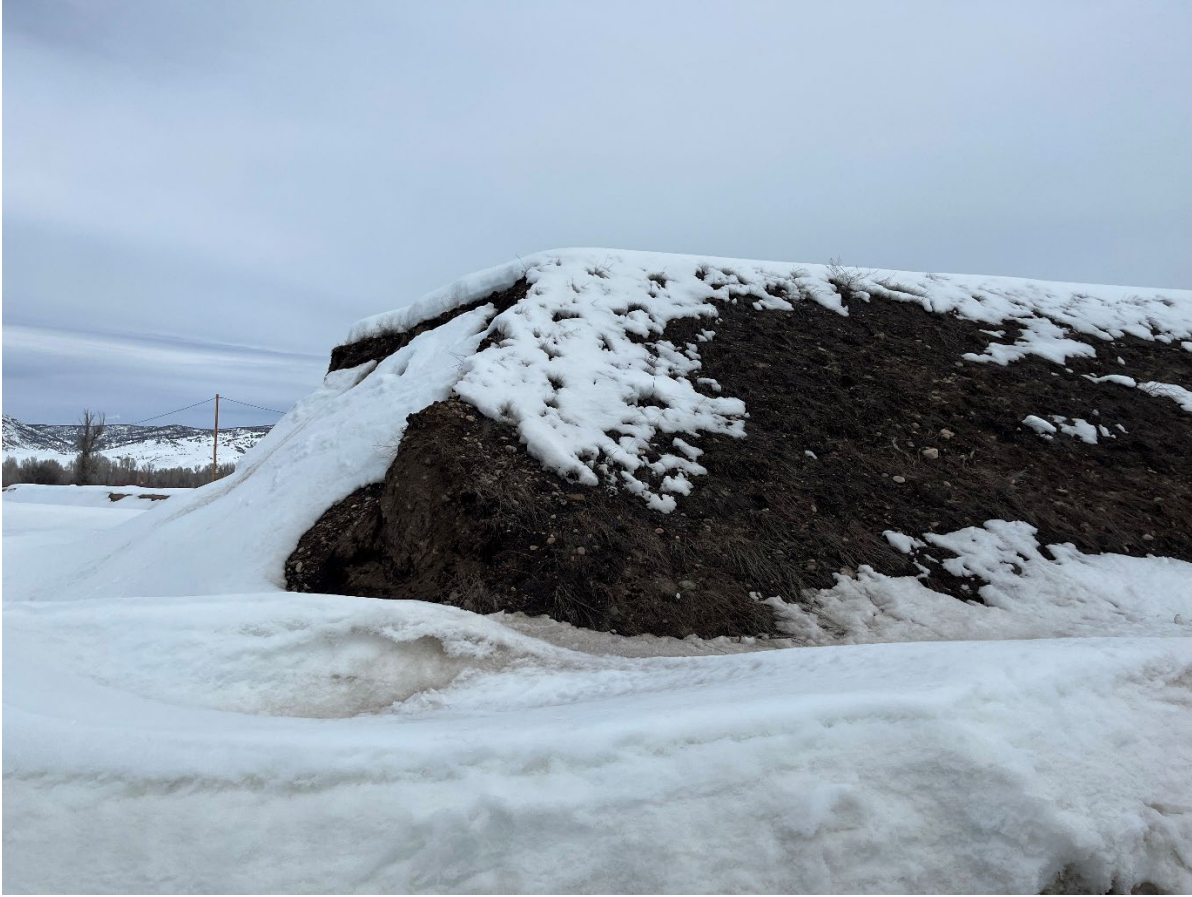
Photo 10: Topsoil piles which shows signs of vegetation in previous months.
