Alpine Aggregates inspection

MINERALS PROGRAM INSPECTION REPORT
PHONE: (303) 866-3567

MINE NAME: Steamboat Sand and Gravel Pit	MINE/PROSPECTING ID#: M-2001-090	MINERAL: Sand and gravel	COUNTY: Routt
INSPECTION TYPE: Monitoring	WEATHER: Cloudy	INSP. DATE: March 30, 2023	INSP. TIME: 14:00
OPERATOR: Alpine Aggregates, LLC	OPERATOR REPRESENTATIVE:	TYPE OF OPERATION: 112c - Construction Regular Operation

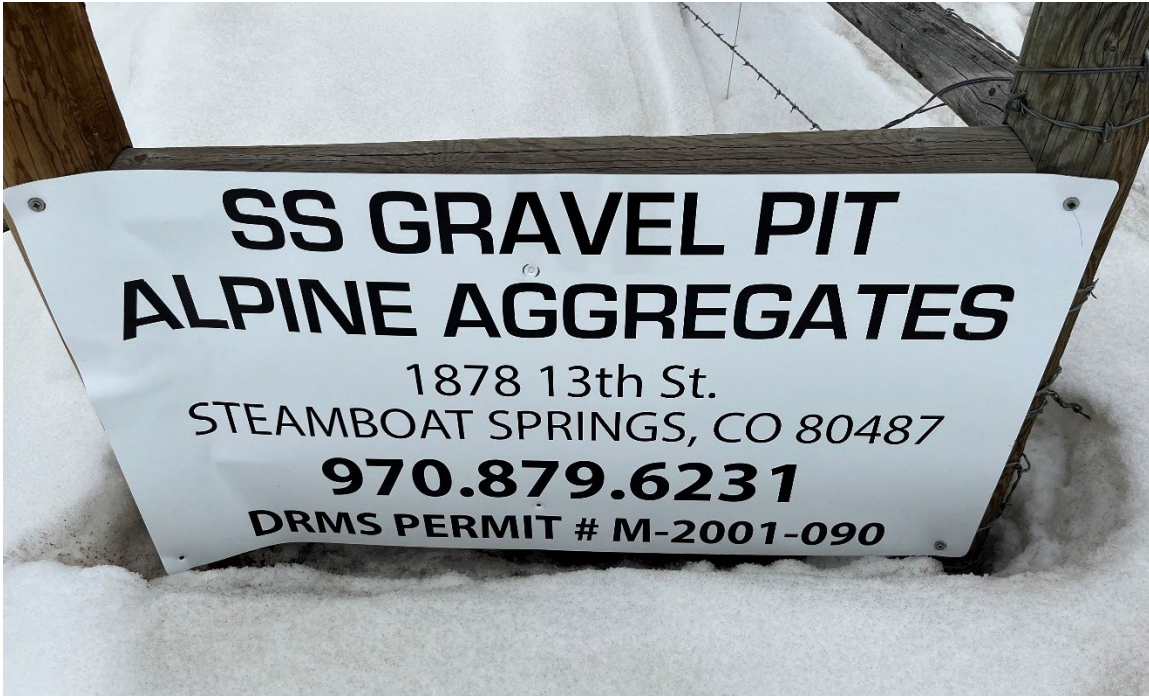
The mine identification sign (Photo 1) and affected area boundary markers are in place and in compliance with Rule 3.1.12. T -posts with 10 ft tall white PVC have been placed approximately every 100 ft to delineate permit boundaries and make it easy to follow the irregular shape. The current mining operation is in the southeast portion of the permit boundary in Phase 1A and to the north in Phase 2. The operator stated that Phase 3 is likely to begin this summer. Phase 1 to the southeast has been partially reclaimed to its final use as a pond (Photos 2 and 3). Tree planting in this phase is planned for the spring. There is slight loss of groundwater in this pond due to the nature of the sand and gravel substrate, so the pond is kept full by use of operator owned water rights from nearby Suttle Ditch (Photo 3).

Photo 1: A mine identification sign is located at the entrance gates to the operation.

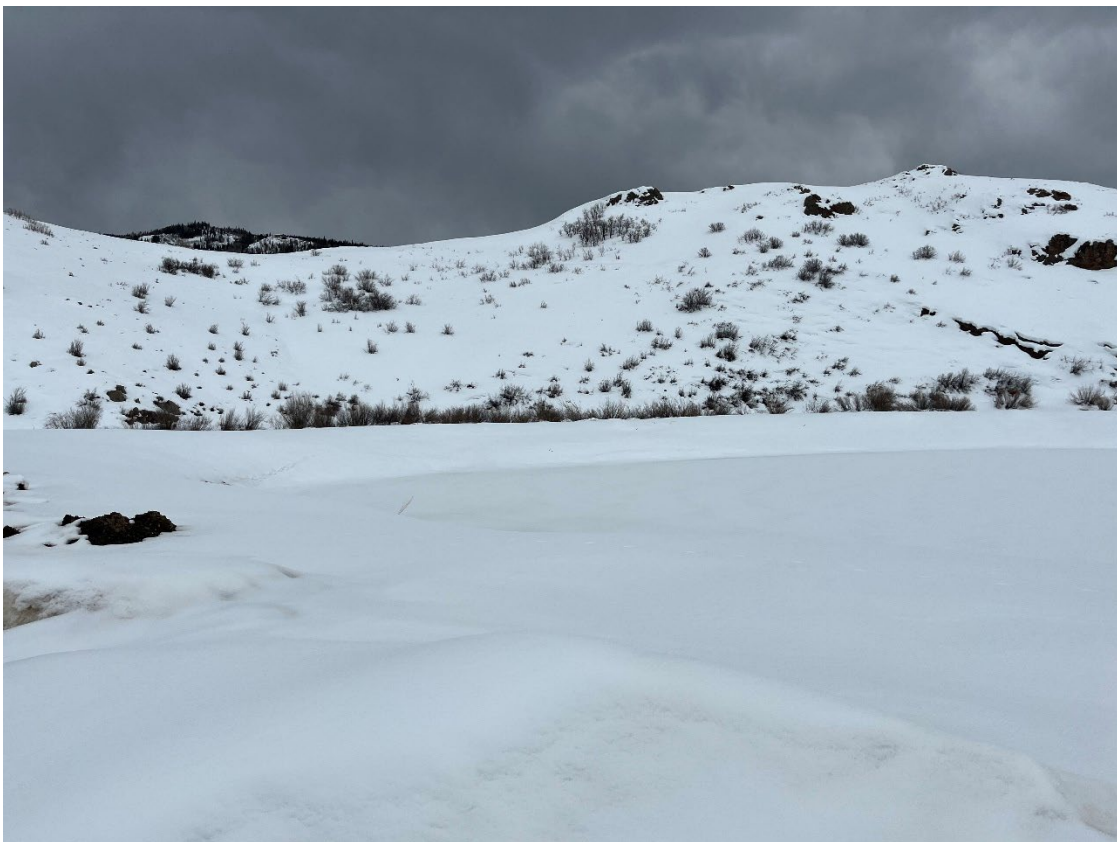
Photo 2: View east of the partially reclaimed Phase 1 area. Tree planting in this area is scheduled to begin in the spring.

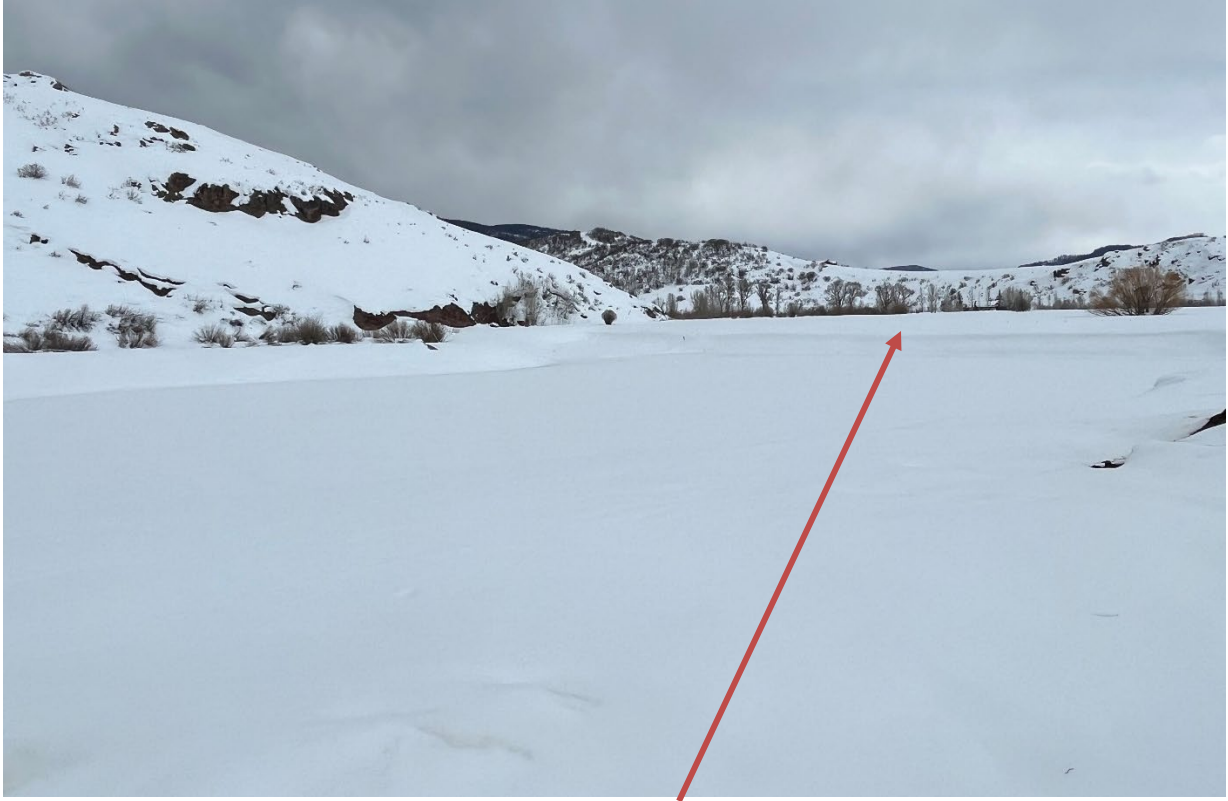
Photo 3: View south of the partially reclaimed Phase 1 pond area. The ditch which supports the water rights used to keep this pond full is located to the far south of the photo.

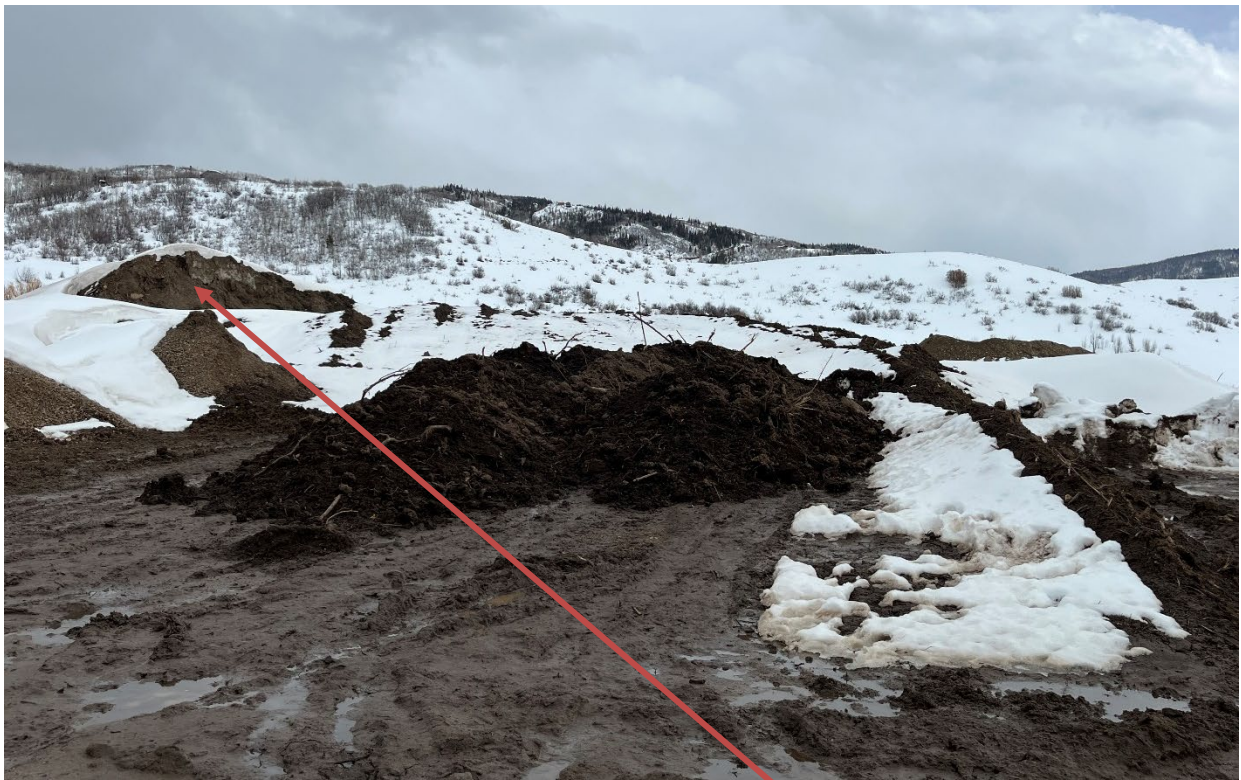
There are two main processing areas in the Phase 1A pit. A topsoil screen is located on the southeast portion and a crusher makes road base on the northwest portion of the pit. The site was active at the time of inspection. Several stockpiles are stored neatly according to size class. Additional piles of topsoil are brought in from various offsite jobs and sold to the public or hauled off for later use (Photo 4). Piles of asphalt and

Photo 4: View east of the gravel and backfill stockpile area. The back of the topsoil pile visible to the north is fully reclaimed. The main processing area is to the south.

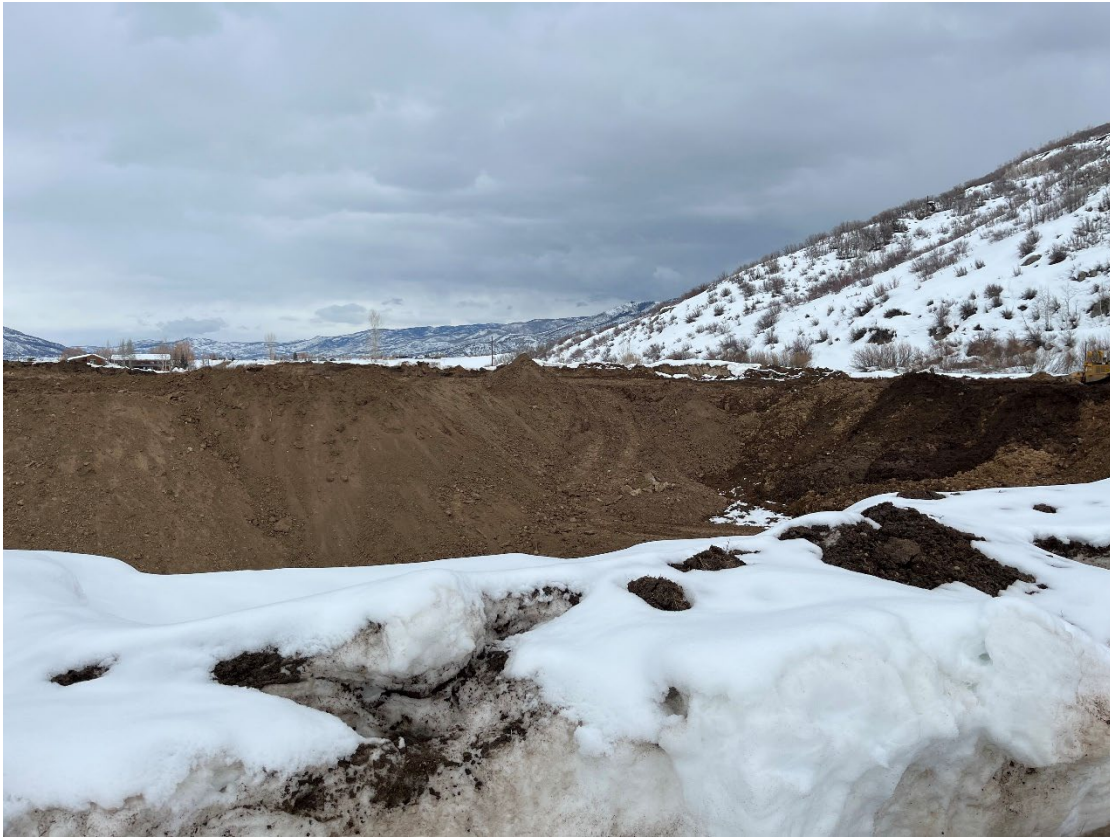
Work on Phase 2 to the north has begun since the last inspection (Photos 5 and 6). A pump works to actively dewater this pit (Photo 7). The operator stated that enough backfill is entering the site so as to potentially provide enough material to completely fill in Phase 2. Therefore, the operator stated that this pit will either be completely filled in or partially filled in, creating a smaller pond than is approved with the current reclamation plan. Pursuant to C.R.S. 34-32.5-116 (1), the Division is citing a problem for failure to follow the approved reclamation plan. Corrective action will require submittal of a Technical Revision and the required fee to the Division by the corrective action due date of 7/05/23. This problem was discussed with the operator at the time of inspection.

Photo 5: View north of the recently excavated Phase 2 area.

CORRECTIVE ACTIONS: The operator shall submit a Technical Revision, with the required \$216 revision fee, to update and clarify the current approved reclamation plan to reflect existing and proposed activities by the corrective action date.

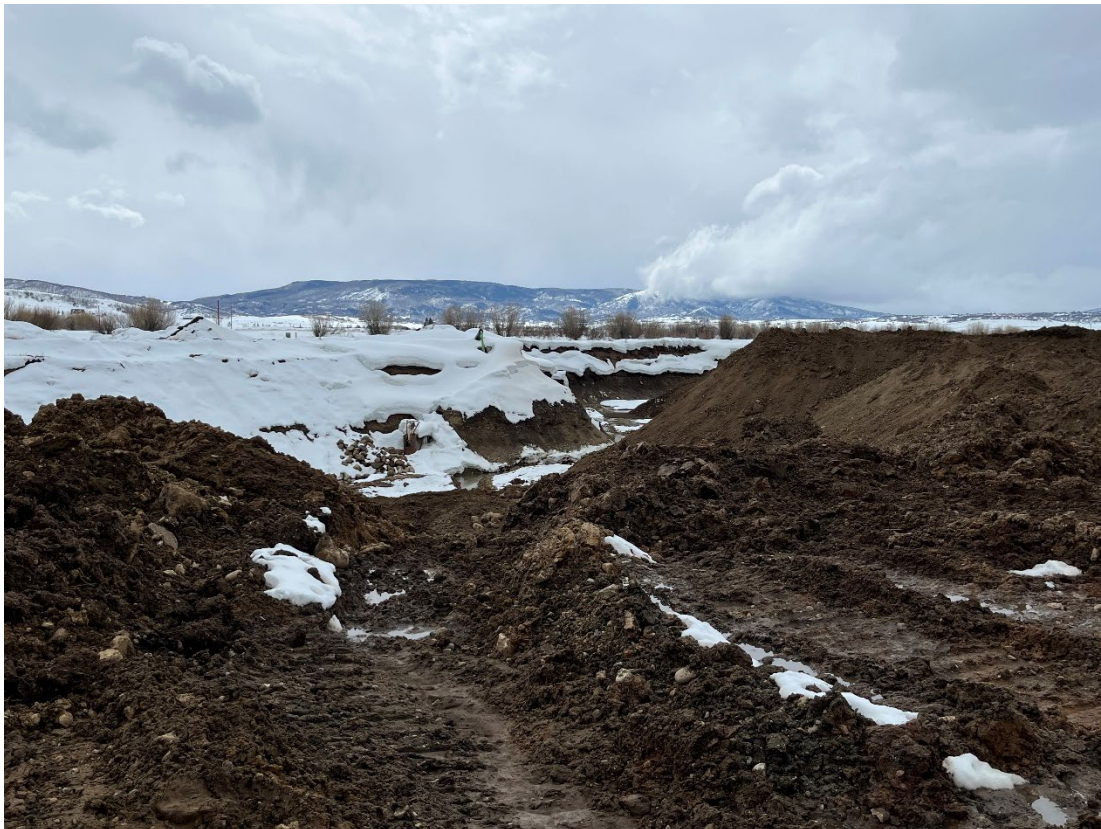
Photo 6: View southwest, looking into the Phase 2 pit.

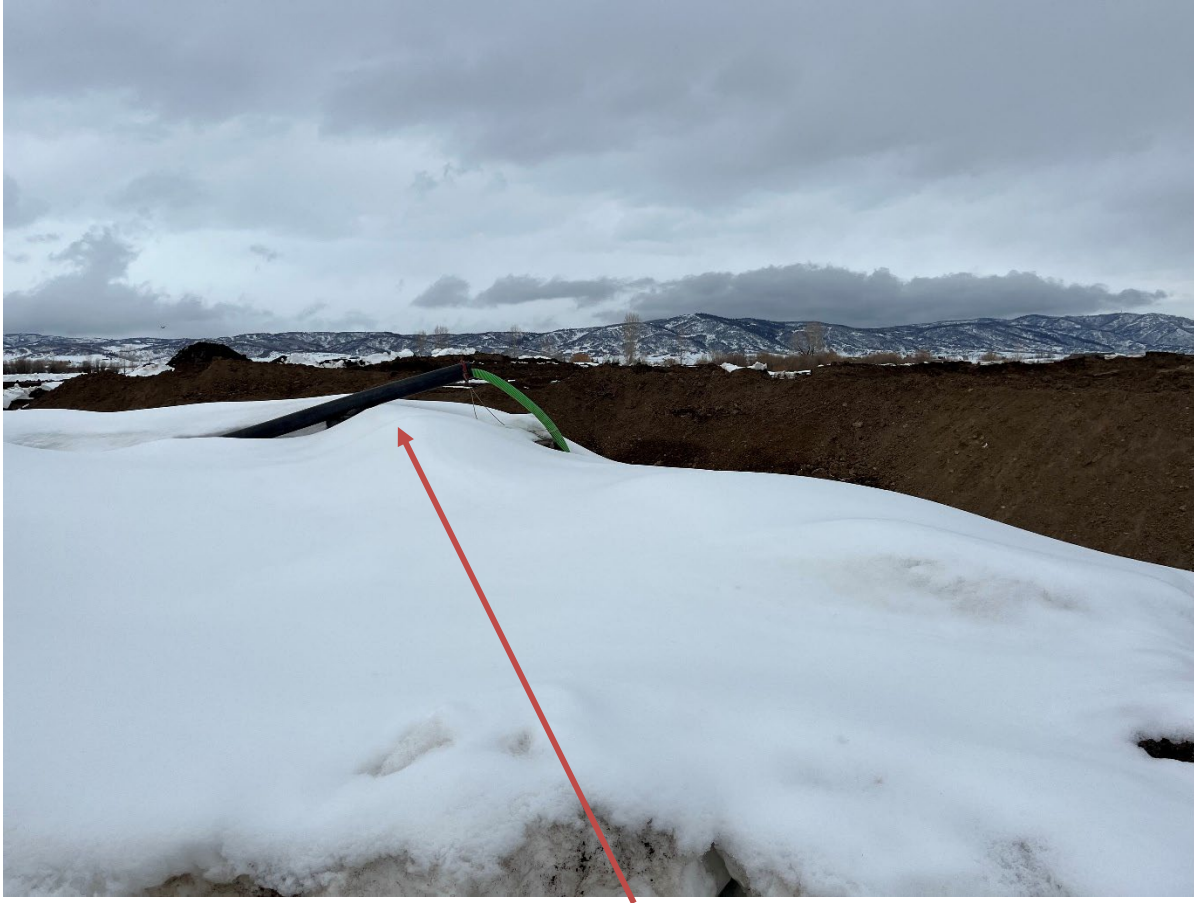
Photo 7: View west of Phase 2 area, shows pump which is actively dewatering this pit.
