Gardner Gravel Pit Inspection Request

MINERALS PROGRAM INSPECTION REPORT
PHONE: (303) 866-3567

MINE NAME: Gardner Gravel Pit	MINE/PROSPECTING ID#: M-1979-034	MINERAL: Sand and gravel	COUNTY: Routt
INSPECTION TYPE: Monitoring	WEATHER: Snowing	INSP. DATE: March 31, 2023	INSP. TIME: 09:00
OPERATOR: General Operating Company	OPERATOR REPRESENTATIVE: Zach Gomez	TYPE OF OPERATION: 112c - Construction Regular Operation	
REASON FOR INSPECTION: Normal I&E Program	BOND CALCULATION TYPE: Partial	BOND AMOUNT: \$130,932.00	
DATE OF COMPLAINT: NA	POST INSP. CONTACTS: None	JOINT INSP. AGENCY: None	
INSPECTOR(S): Hunter Ridley Michael Cunningham	INSPECTOR'S SIGNATURE:

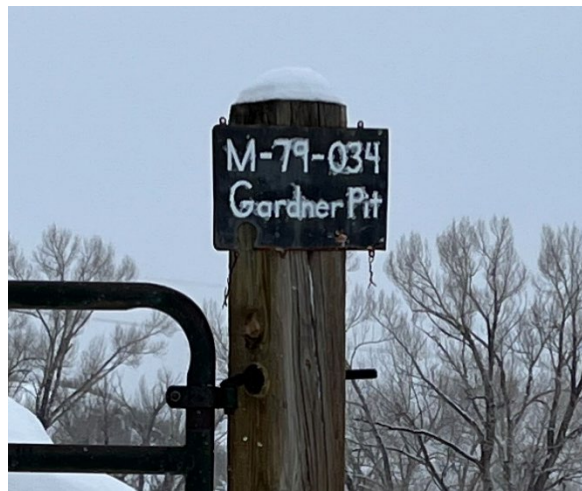
PROBLEM/POSSIBLE VIOLATION: Problem: The mine identification sign posted at the entrance of the mine site was inadequate. This is a problem for failure to post an adequate mine identification sign as required by Section 3.1.12(1) of the rule. The Operator shall, at the entrance of the mine site post a sign, which shall be clearly visible from the access road, with a minimum size equaling one hundred and eighty-seven (187) square inches, such as eleven (11) inches in height and seventeen (17) inches in width, with appropriate font size, with the following: the name of the Operator, a statement that a reclamation permit for the operation has been issued by the Colorado Mined Land Reclamation Board; and the permit number.

There is a mine identification sign posted at the bottom of the access road to the pit (Photo 1). This sign is not currently in compliance with our regulations under Rule 3.1.12. Therefore, the Division is citing a problem for failure to fully comply with the requirements under Rule 3.1.12. Corrective action will require submitting evidence to the Division that an appropriately amended sign has been posted.

Photo 1: Mine sign at the entrance to the site.

CORRECTIVE ACTIONS: The operator shall, at the entrance of the mine site, post a sign which shall be clearly visible from the access road with the following: the name of the operator, a statement that a reclamation permit for the operation has been issued by the Colorado Mined Land Reclamation Board; and the permit number. The operator shall submit photo documentation that a proper sign has been posted by the corrective action date.

CORRECTIVE ACTION DUE DATE: 6/10/23

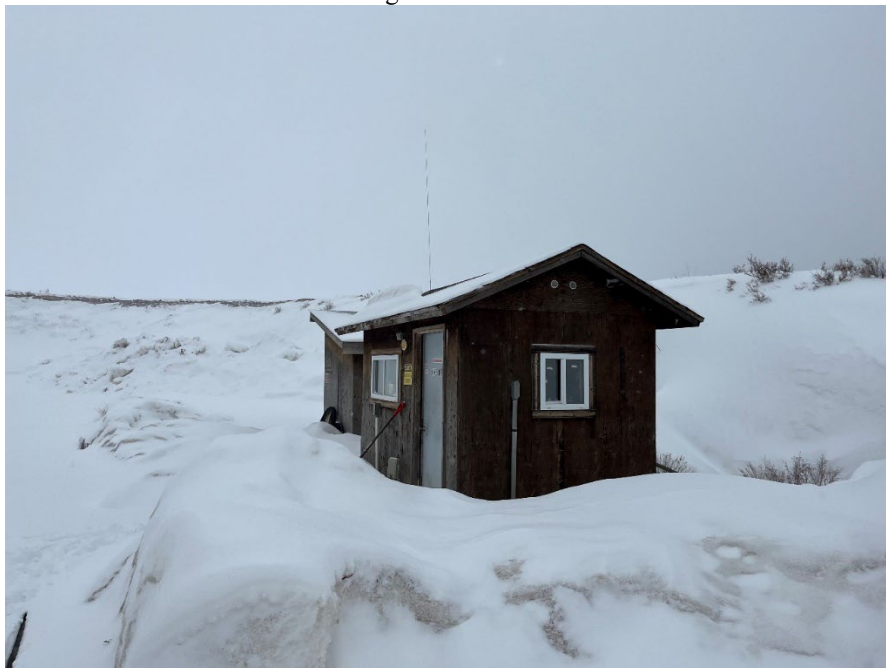
A wire fence delineates the permit boundary. At the entrance of the pit there is a small office/ shop and load scale (Photo 2). Two fuel tanks are stored in a secondary containment (Photo 3). The operator representative stated they are required to dig out this secondary containment feature during the snowy months.

Photo 2: Scale and scale house located on the entry road to the site.

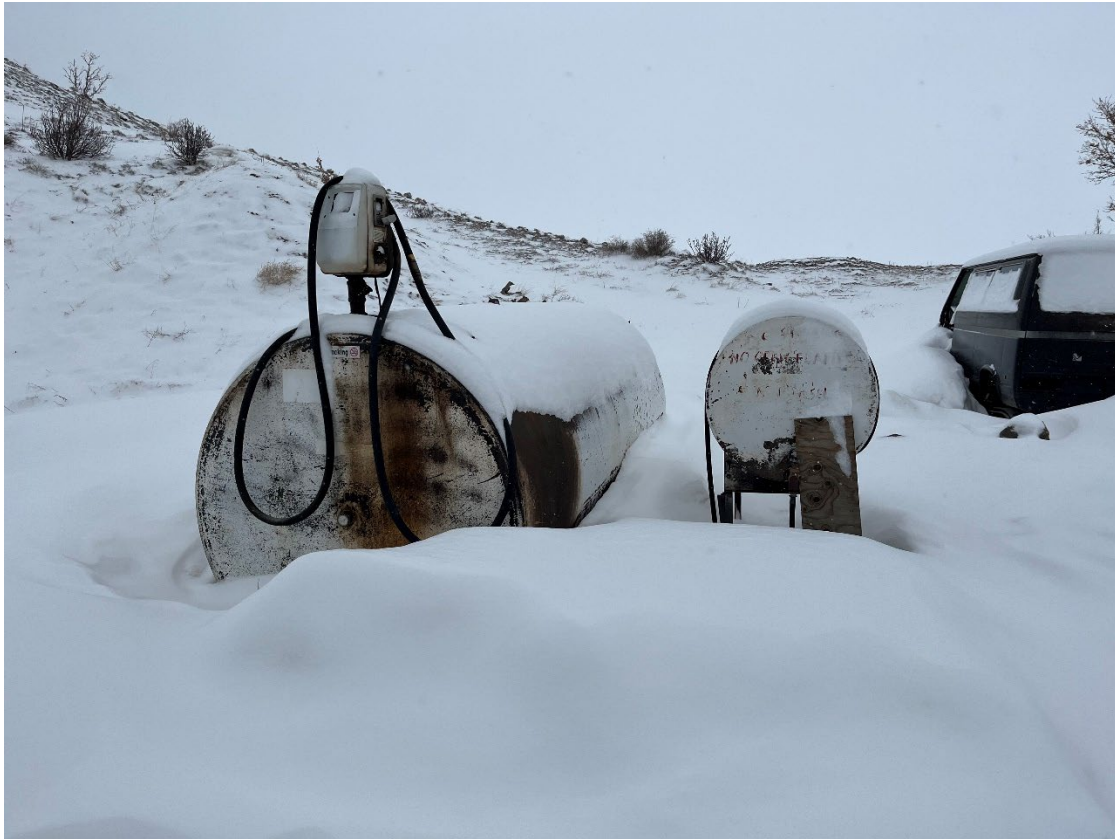
Photo 3: Fuel is stored in secondary containment.

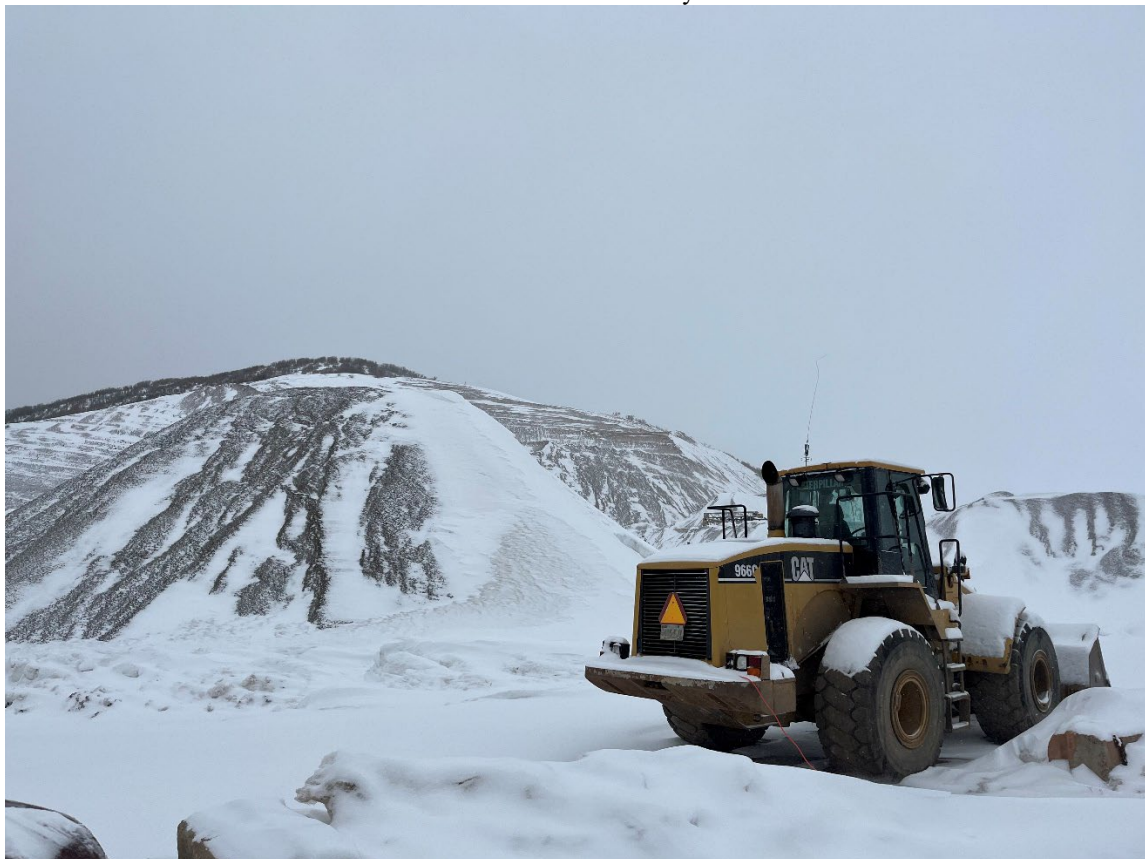
northwest along the toe of the hillside (Photo 6 and 7). A shaker plant is on site to process material. All stockpiles are stable (Photo 4). No new material was being processed while the inspector was on site.

Photo 4: View North of the operation. The excavated hillside is visible from behind the foreground stockpile.

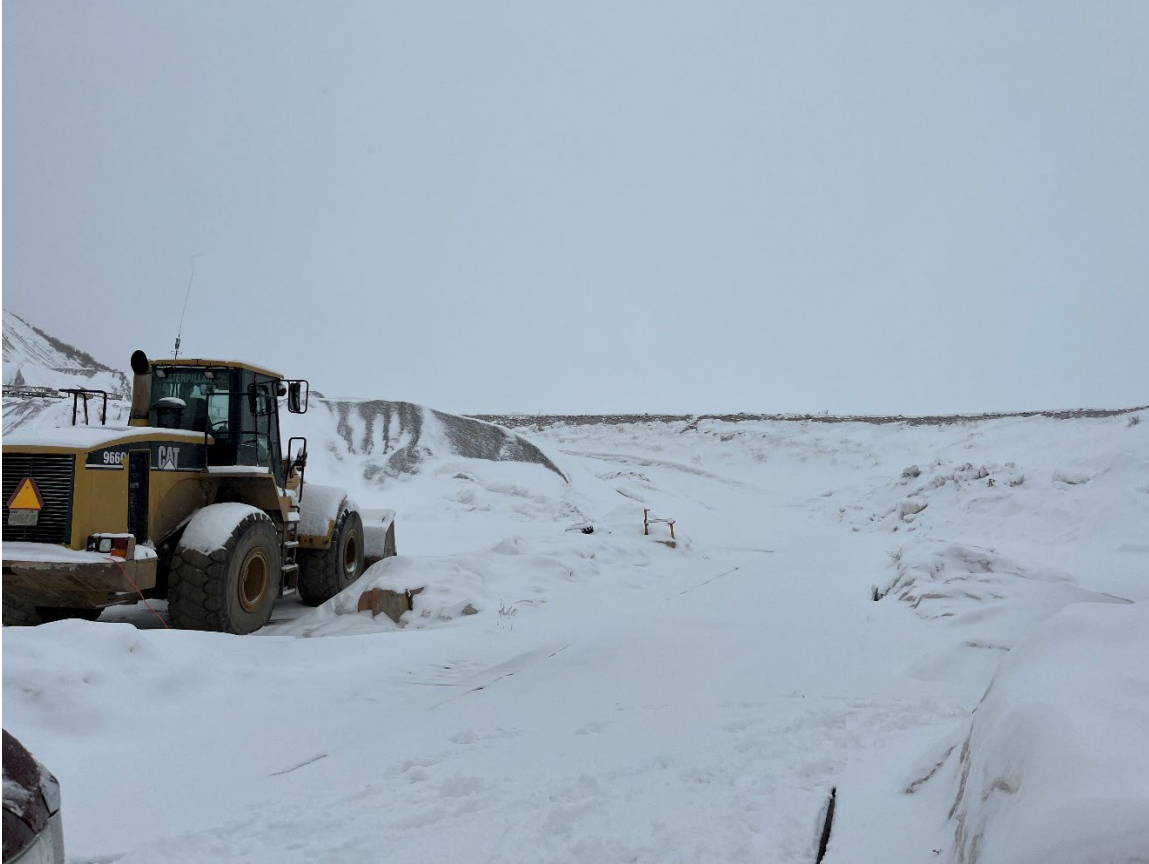
Currently the pit is in 3 sections. Two flat levels for processing and storing material (Photo 5), then the excavated hillside to the north. Material is pushed off of the hillside and collected below via a road running

Photo 5: View northeast of the road leading to the processing area of the operation.

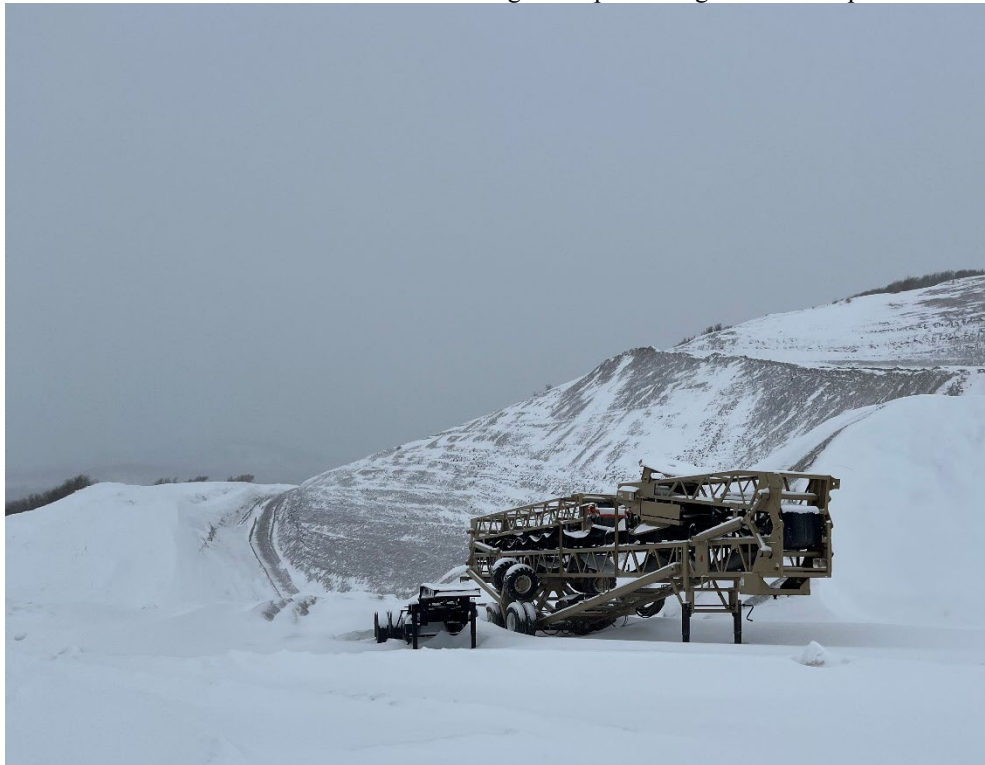
Photo 6: View north of the excavated hillside and haul road from the upper processing portion of the pit.

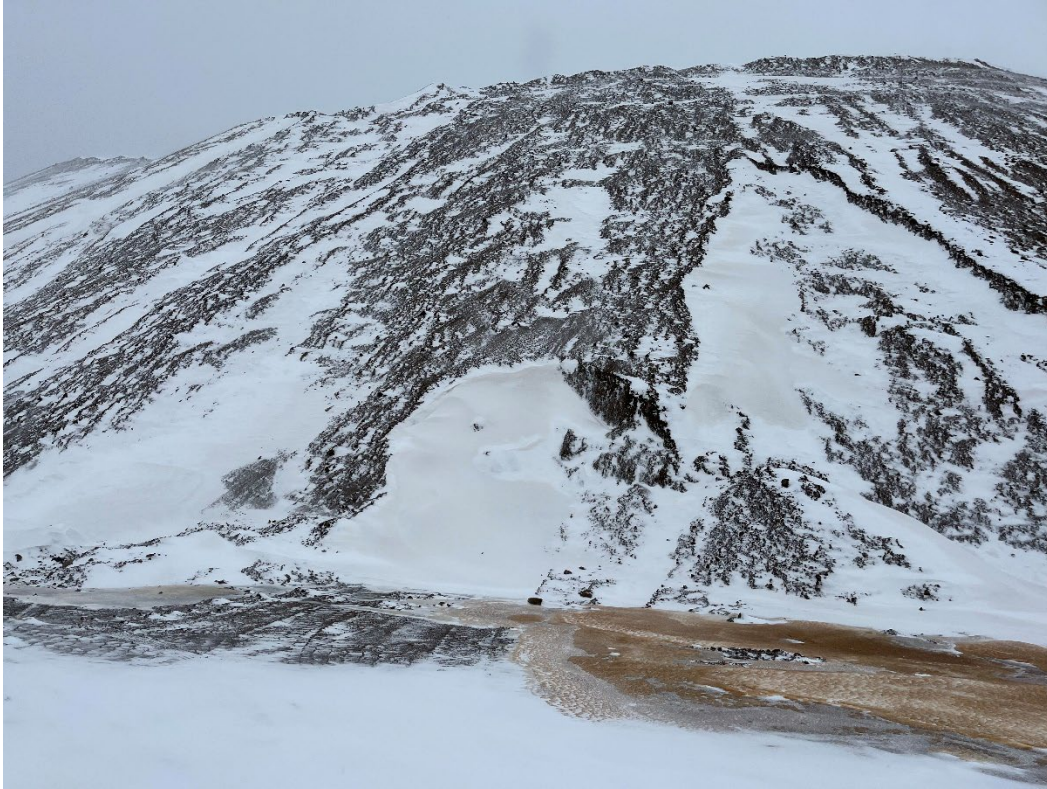
Photo 7: View north of the excavated hillside from the upper processing portion of the pit.
