**PERMIT INFORMATION**

<b>Permit Number:</b> C-1981-008 <b>Mine Name:</b> New Horizon Mine <b>Operator:</b> Elk Ridge Mining and Reclamation, LLC <b>Operator Address:</b> Mr Tony Tennyson P.O. Box 628 27646 West 5th Avenue Nucla, CO 81424	<b>County:</b> Montrose <b>Operation Type:</b> Surface <b>Permit Status:</b> Active <b>Ownership:</b> Private
	<b>Operator Representative Present:</b>  Tony Tennyson
<b>Operator Representative Signature: (Field Issuance Only)</b>

**INSPECTION INFORMATION**

<b>Inspection Start Date:</b> April 4, 2023 <b>Inspection Start Time:</b> 09:40 <b>Inspection End Date:</b> <b>Inspection End Time:</b>	<b>Inspection Type:</b> Coal Partial Inspection <b>Inspection Reason:</b> Normal I&E Program <b>Weather:</b> Snowing	
<b>Joint Inspection Agency:</b>  None	<b>Joint Inspection Contacts:</b>	
<b>Post Inspection Agency:</b>  None	<b>Post Inspection Contacts:</b>	
<b>Inspector(s):</b>  Lucas West	<b>Inspector's Signature:</b>

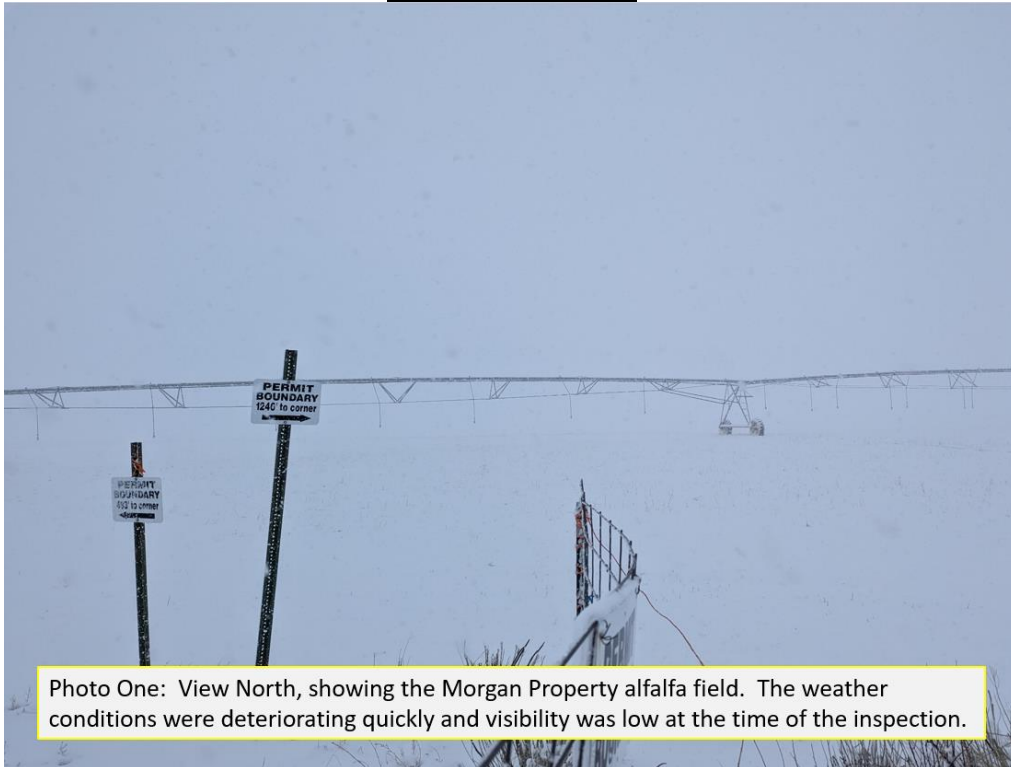
The Morgan Property alfalfa fields were observed and no signs of settling or slumping was observed. The fields were covered in snow, with very low visibility but the fields appeared to be in good condition at the time of the inspection. Photo One shows an example of the fields as well as the conditions.

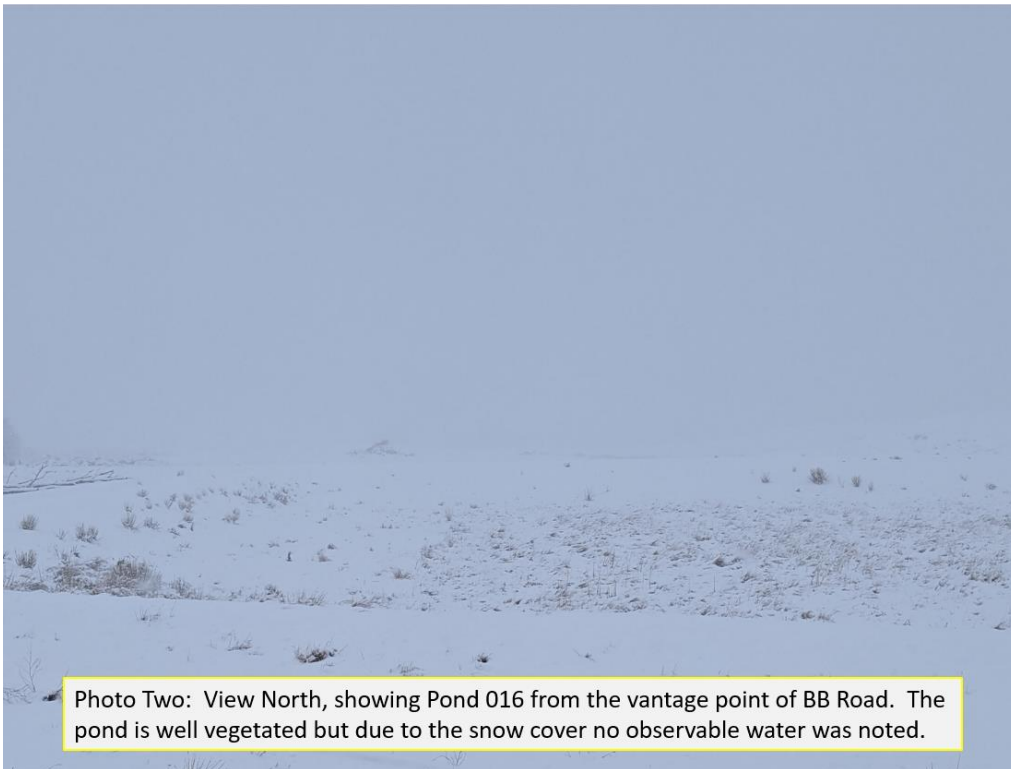
Due to the conditions of the site and the weather only Pond 016 was observed as well as the surface water control structures in the immediate vicinity. Pond 016 was snow covered with no observable water within it. The ditches leading to the pond were also snow covered, however appeared to be free from any obstructions or debris and able to function as designed. Pond 016 can be seen in Photo Two.

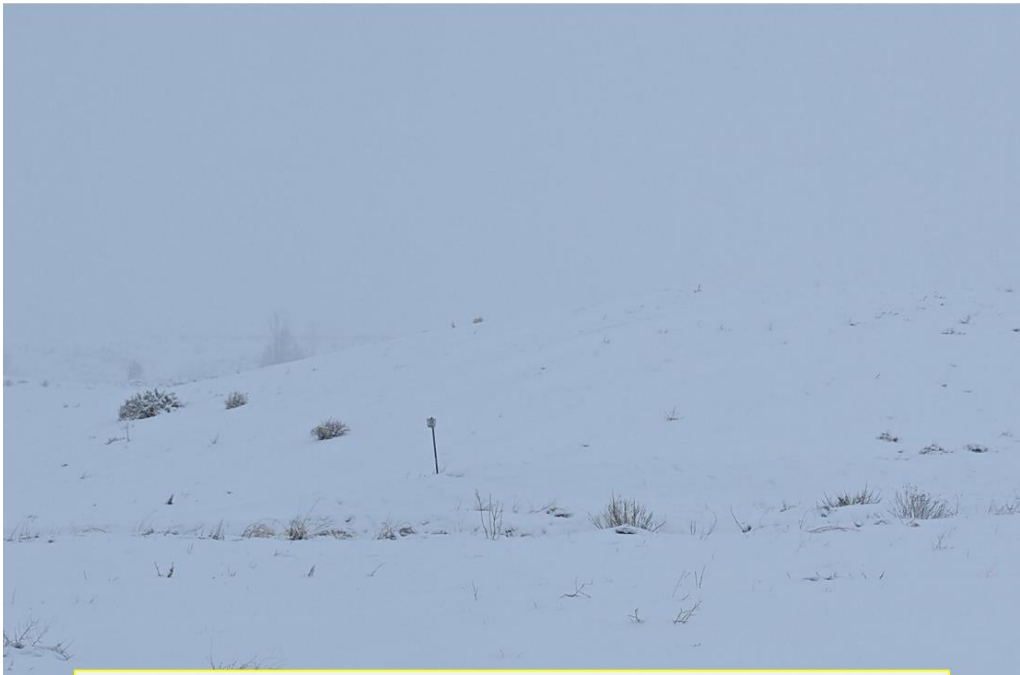
The only visible topsoil stockpiles were located at the Johnson Property Storage Area. Of the stockpiles observed, no evidence of erosion or material transport was noted and the stockpiles appeared to be in good condition. All ring berms appeared to be functioning as designed. An example of the stockpiles and conditions can be seen in Photo Three.

Photo Three: View Northwest, showing an example of the topsoil stockpiles located at the Johnson Property Storage Area.
