**PERMIT INFORMATION**

<b>Permit Number:</b> C-1981-015 <b>Mine Name:</b> Fruita No 1 & 2 <b>Operator:</b> Dorchester Coal Company <b>Operator Address:</b> Greg Lewicki 9054 South Forrest Drive Highlands Ranch, CO 80126	<b>County:</b> Mesa <b>Operation Type:</b> Underground <b>Permit Status:</b> Revoked <b>Ownership:</b> Private
	<b>Operator Representative Present:</b>  NA
<b>Operator Representative Signature: (Field Issuance Only)</b>

<b>Inspection Start Date:</b> March 30, 2023 <b>Inspection Start Time:</b> 11:20 <b>Inspection End Date:</b> March 30, 2023 <b>Inspection End Time:</b> 12:15		<b>Inspection Type:</b> Coal Complete Inspection <b>Inspection Reason:</b> Normal I&E Program <b>Weather:</b> Cloudy	
<b>Joint Inspection Agency:</b>  None		<b>Joint Inspection Contacts:</b>  None	
<b>Post Inspection Agency:</b>  None		<b>Post Inspection Contacts:</b>  None	
<b>Inspector(s):</b>  Clayton Wein	<b>Inspector's Signature:</b>  <i>Clayton Wein</i>		<b>Signature Date:</b>  4/12/2023

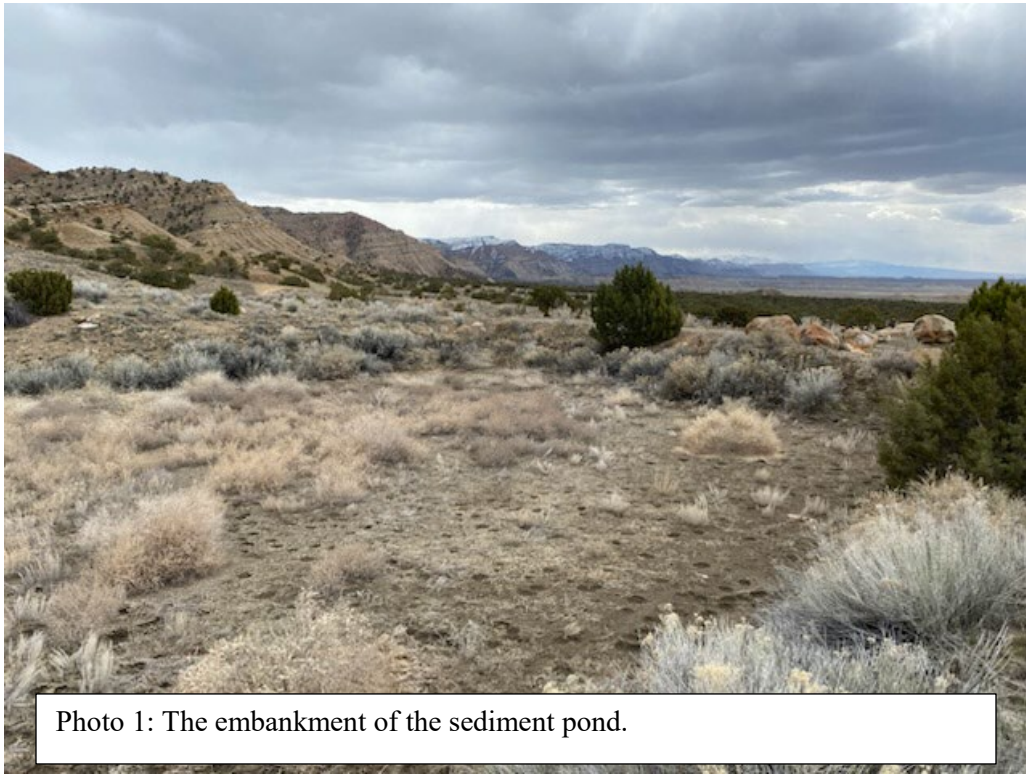
There is on sediment pond located at the southern portion of the permit boundary. The pond is going to remain as a permanent feature. During the inspection the pond was dry and stable. The embankments had vegetative cover with no erosional features identified (Photo 1). The outlet for the pond is a riprap lined channel. The riprap was in good condition and the outfall was stable.

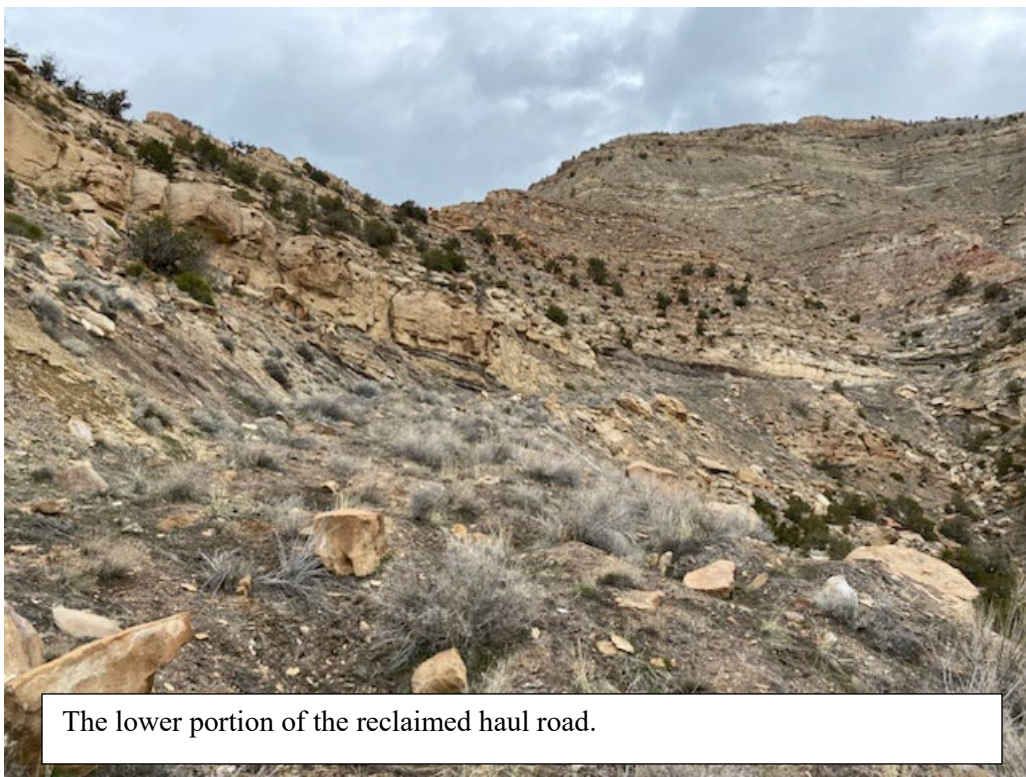
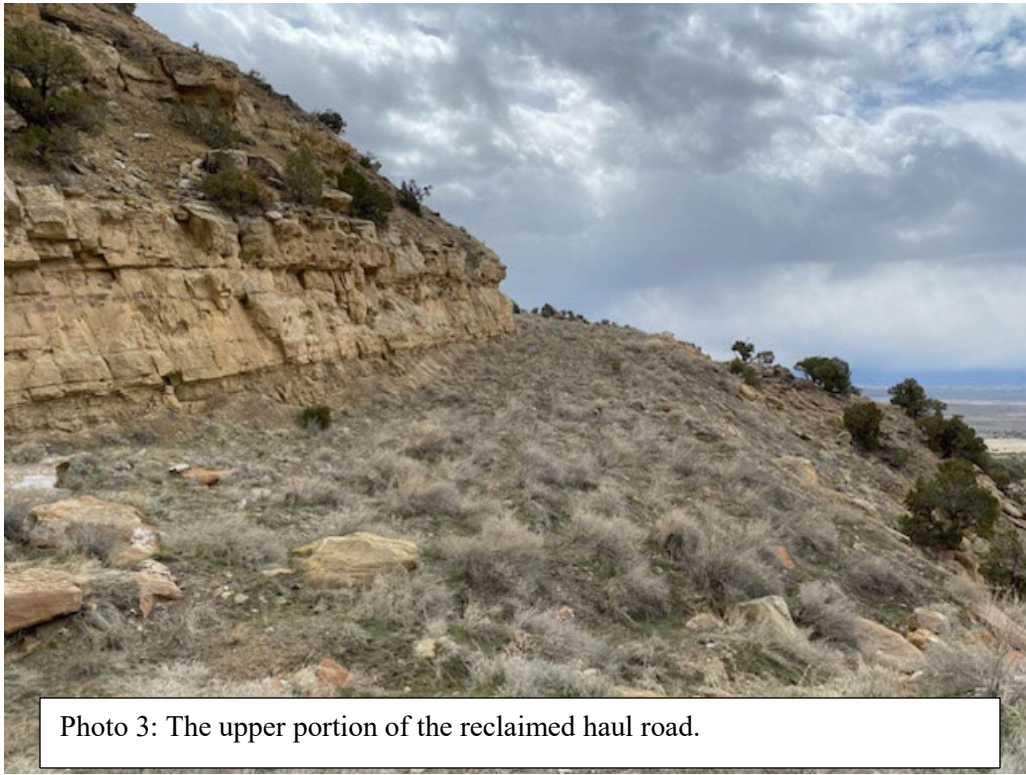
The reclaimed haul road extends from the base of the hill to the reclaimed portals bench. The haul road is located on a south-facing slope of the Book Cliffs. The haul road was stable with vegetative cover (Photos 2 and 3). There were no new erosional features observed. Previous Division inspection reports have documented a large rill on the lower portion of the reclaimed haul road. The rill has become stabilized and had not enlarged since the previous inspection. Any runoff transported through this rill will flow to the bottom of the hill and into the sediment pond. No off-site impacts were observed. Vegetation on the upper portion of the reclaimed haul road was denser than the lower portion. The upper reclaimed haul road was stable with sufficient vegetative cover. There were no erosional concerns identified.

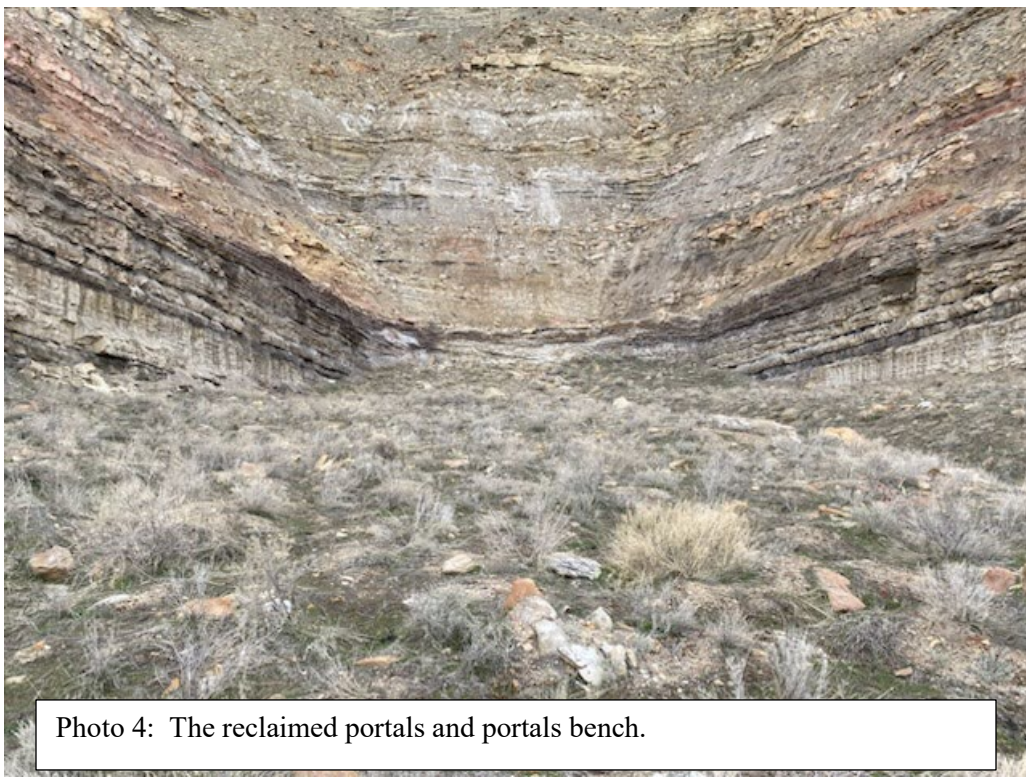
The portals bench was vegetated and stable (Photo 4). There were no new erosional features observed. There was a small gully on top of the reclaimed bench, as noted in previous Division inspection reports. The gully has stabilized and had not enlarged from previous inspections. Water that would be transported in the gully will flow to the riprap lined channel on the south end of the reclaimed portals bench. The backfilled portals were stable with

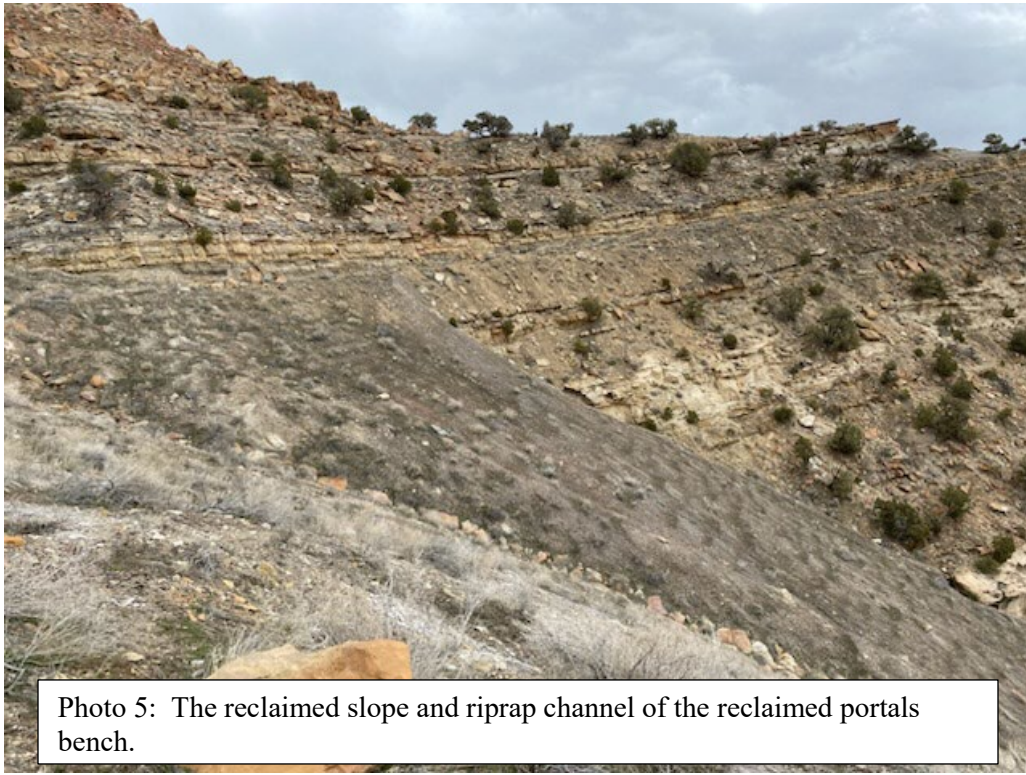
vegetative cover. There were no indications of sloughing or erosion. The reclaimed slop of the portals bench is south-facing and has minimal vegetative cover (Photo 5). These conditions on the reclaimed slope have not changed from observations made during previous inspections. The slope was stable with only minor localized erosion (rills) identified. The riprap lined channel was stable with no erosional concerns identified.

Photo 5: The reclaimed slope and riprap channel of the reclaimed portals bench.
