MINERALS PROGRAM INSPECTION REPORT
PHONE: (303) 866-3567

MINE NAME: Riverbend Operation	MINE/PROSPECTING ID#: M-2000-016	MINERAL: Sand and gravel	COUNTY: Weld
INSPECTION TYPE: Monitoring	WEATHER: Clear	INSP. DATE: April 3, 2023	INSP. TIME: 10:00
OPERATOR: Martin Marietta Materials, Inc.	OPERATOR REPRESENTATIVE: Julie Mikulas	TYPE OF OPERATION: 112c - Construction Regular Operation	
REASON FOR INSPECTION: Citizen Complaint	BOND CALCULATION TYPE: Partial Bond	BOND AMOUNT: \$3,150,000.00	
DATE OF COMPLAINT: March 27, 2023	POST INSP. CONTACTS: None	JOINT INSP. AGENCY: None	
INSPECTOR(S): Peter Hays	INSPECTOR'S SIGNATURE:

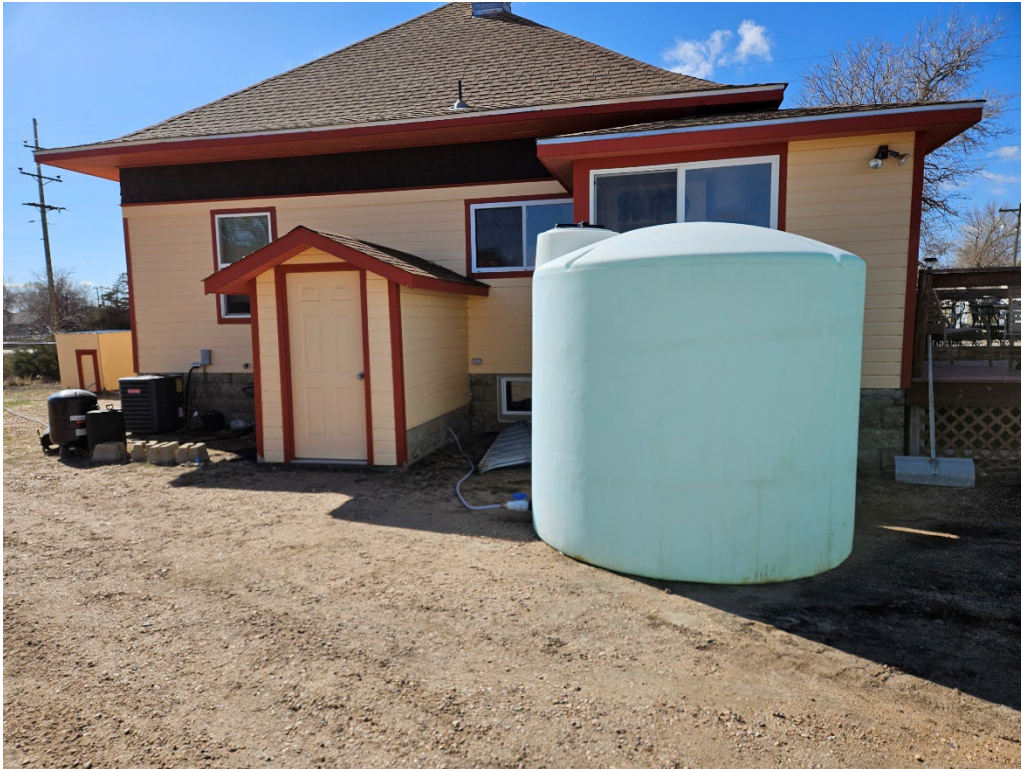
The Division observed two (2) plastic cisterns during the inspection. The black cistern was empty and not being used because the tank contained mud. The second clear cistern contained water and was plumbed into the water well pump for the residence. The cisterns were placed on the ground north of the Stieber home. Mr. Stieber stated the cistern system was working properly and the residence had adequate water. Mr. Stieber and the Operator were arranging the water delivery frequency based on the actual water usage for the home.

View of the north side of the Stieber residence and the cistern

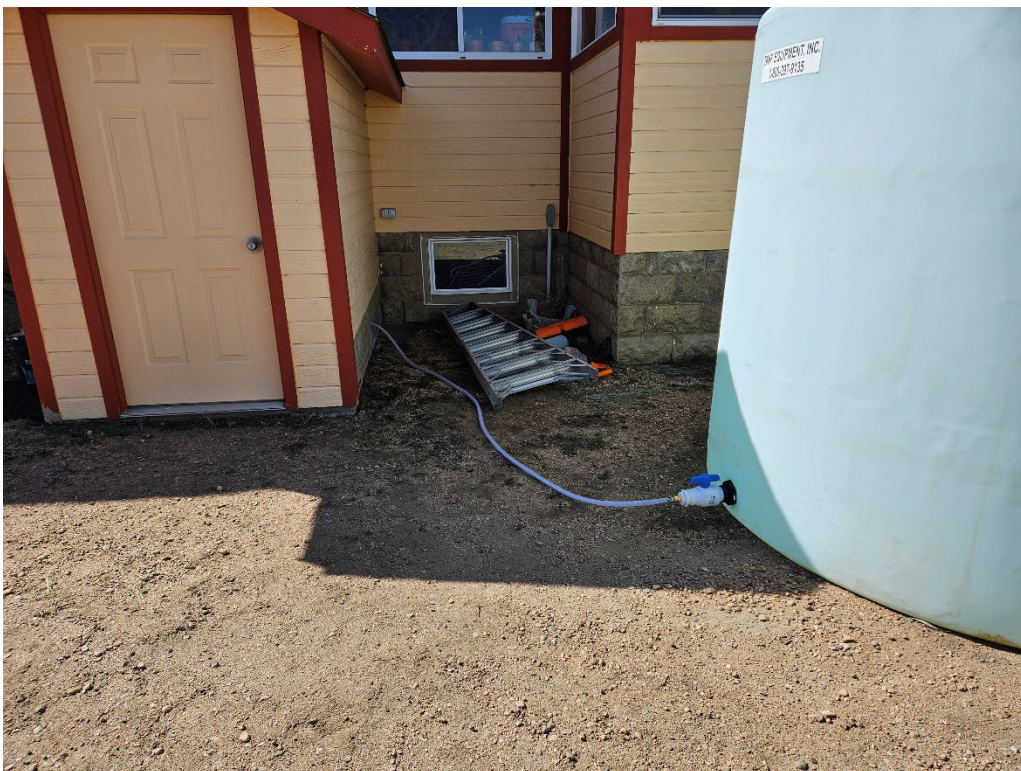
View of the exterior connection of the cistern to the well pump

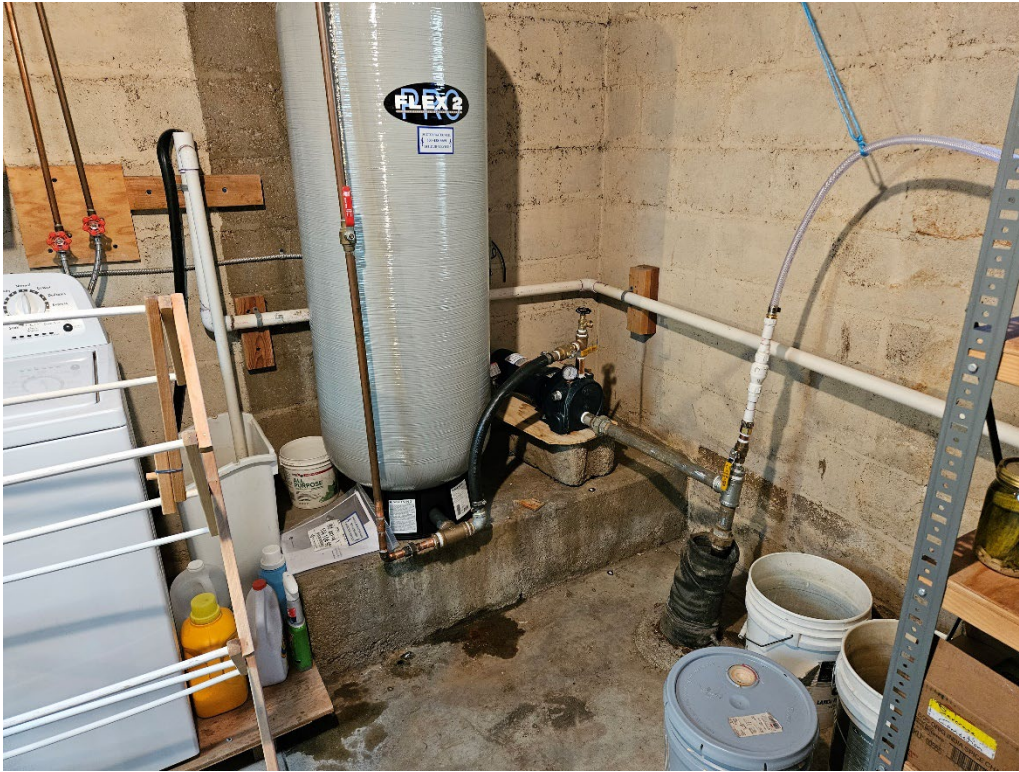
The well in Mr. Stieber's residence, the house located north of and closest to WCR 6 on the property, was measured during the inspection. The well is located in the northwest corner of the basement. The Division estimated the distance from the ground elevation to the basement floor elevation at five (5) feet. The well depth and depth to water were measured by the Division with a water meter. The depth to water was measured at 5'-4" below the basement floor (10'-4" from the exterior ground elevation). The total well depth was measured at 6'-0" below the basement floor (11'-0" from the exterior ground elevation). Mr. Stieber stated the well has supplied water to the residence for 100 years.

View of the Stieber well located in the basement of the residence
