**MINERALS PROGRAM INSPECTION REPORT**  
**PHONE: (303) 866-3567**

<b>MINE NAME:</b> Schoen Farm	<b>MINE/PROSPECTING ID#:</b> M-2020-062	<b>MINERAL:</b> Stone	<b>COUNTY:</b> Rio Grande
<b>INSPECTION TYPE:</b> Monitoring	<b>WEATHER:</b> Clear	<b>INSP. DATE:</b> April 12, 2023	<b>INSP. TIME:</b> 09:30
<b>OPERATOR:</b> O'Rourke Excavating, Inc.	<b>OPERATOR REPRESENTATIVE:</b> Tom O'Rourke	<b>TYPE OF OPERATION:</b> 110c - Construction Limited Impact	
<b>REASON FOR INSPECTION:</b> Normal I&E Program	<b>BOND CALCULATION TYPE:</b> None	<b>BOND AMOUNT:</b> \$11,429.00	
<b>DATE OF COMPLAINT:</b> NA	<b>POST INSP. CONTACTS:</b> None	<b>JOINT INSP. AGENCY:</b> None	
<b>INSPECTOR(S):</b> Todd Jesse	<b>INSPECTOR'S SIGNATURE:</b>

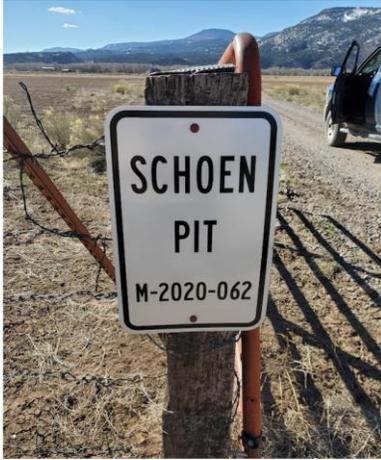
The mine identification sign and the affected area boundary markers are in place and in compliance with rule 3.1.12. The sign was posted at the entrance to the site which can be seen in Photo 1. The corners of the permit boundary were clearly marked and identified as seen in Photo 2.

Photo 1: View to the southeast showing the proper Mine ID signage posted at the entrance to the site

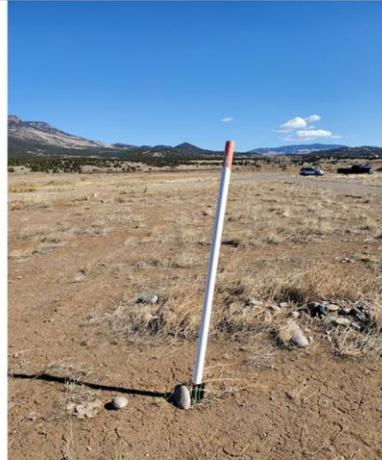
Photo 2: View to the northeast showing the boundary markers around the permit limits.

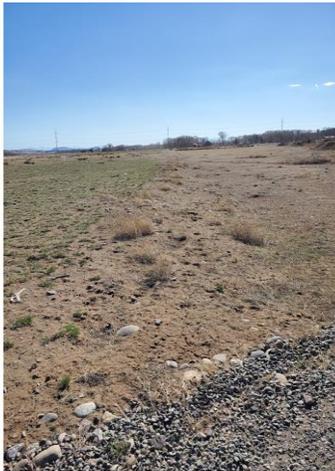
A buried powerline transverses the permit area. While there is a small berm on top of the powerline (Photo 3), Division staff suggested that the operator better define where the powerline is located to protect it from potential damage.

Photo 3: View to the east showing the small berm over the powerline transecting the permit area.

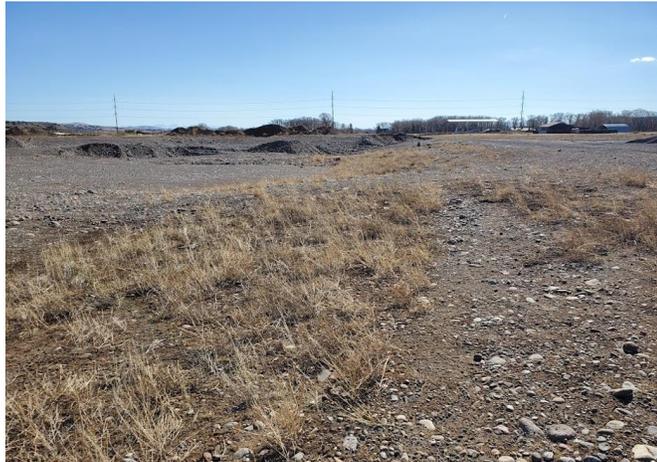
Pit slopes have been mined at approximately 3H:1V and small materials stockpiles remain on the pit floor. Native vegetation is becoming established over the southern slope of the pit (Photo 4). In addition to material stockpiles on the pit floor there are also material stockpiles to the south of the pit (Photo 5). Vegetation is beginning to establish on topsoil stockpiles as shown in Photo 6. There was no evidence of state listed noxious weeds on stockpiles or anywhere else within the affected area. No mining equipment or hydrocarbons were present on the site at the time of the inspection.

Photo 4: View to the east showing the vegetation that is establishing on the slopes of the pit and the stockpiles on the pit floor.

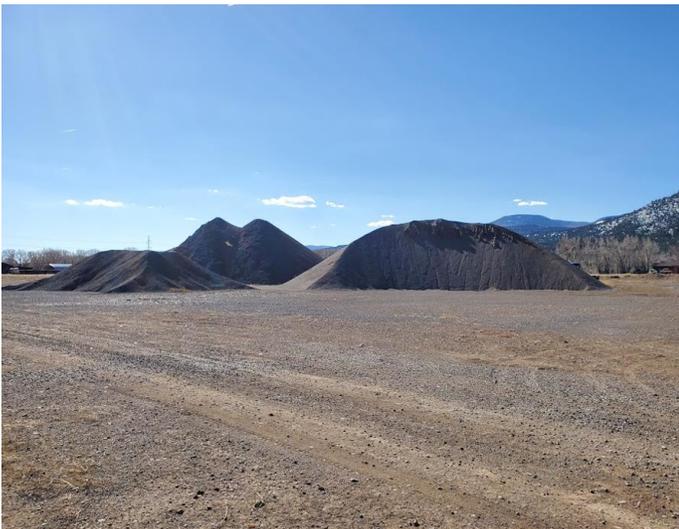
Photo 5: View to the southeast showing the material stockpiles on site.

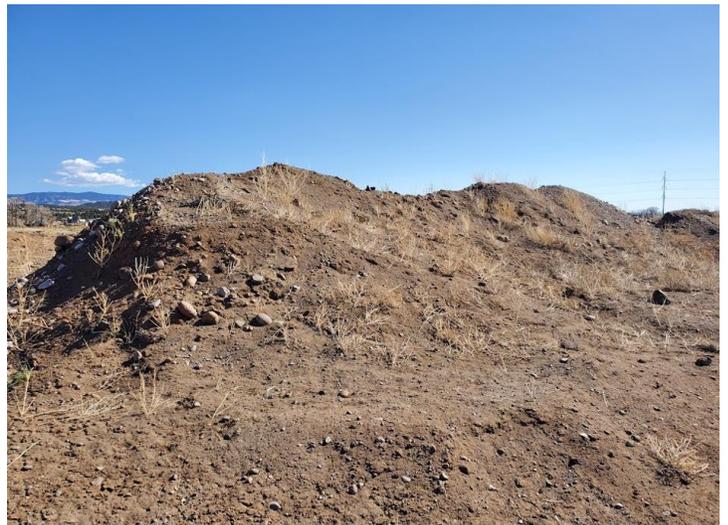
Photo 6: View to the northeast showing vegetation establishing on topsoil stockpiles on site.
