MINERALS PROGRAM INSPECTION REPORT
PHONE: (303) 866-3567

MINE NAME: Riverbend Operation	MINE/PROSPECTING ID#: M-2000-016	MINERAL: Sand and gravel	COUNTY: Weld
INSPECTION TYPE: Monitoring	WEATHER: Clear	INSP. DATE: April 3, 2023	INSP. TIME: 11:00
OPERATOR: Martin Marietta Materials, Inc.	OPERATOR REPRESENTATIVE: Julie Mikulas	TYPE OF OPERATION: 112c - Construction Regular Operation

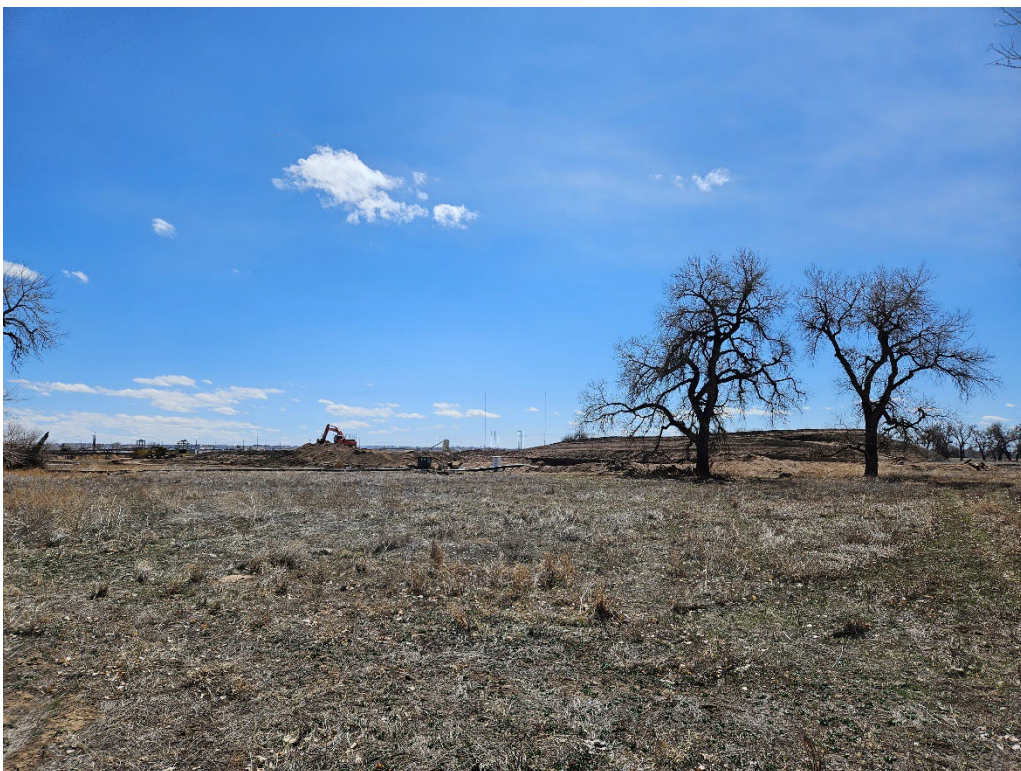
The overhead powerline dividing the cell from west to east was relocated along the south and east boundaries of the cell. The remaining material was mined from the powerline easement to complete the cell. Mining excavation was close to completion. The cell was being dewatered and prepared for the installation of a clay liner. The mining activities have extended into Cell 1 / Phase 2.

The overburden and topsoil from the cell were stockpiled to the west of the oil and gas facility located within the cell. The stockpiles appeared stable and no erosion was observed during the inspection. The Operator does not intend to vegetate the stockpiles since the materials will be used for concurrent reclamation in less than 180 days. Material from the overburden stockpile was being transported to the pit floor by a scraper during the inspection.

View of Cell 1 from the west side looking east

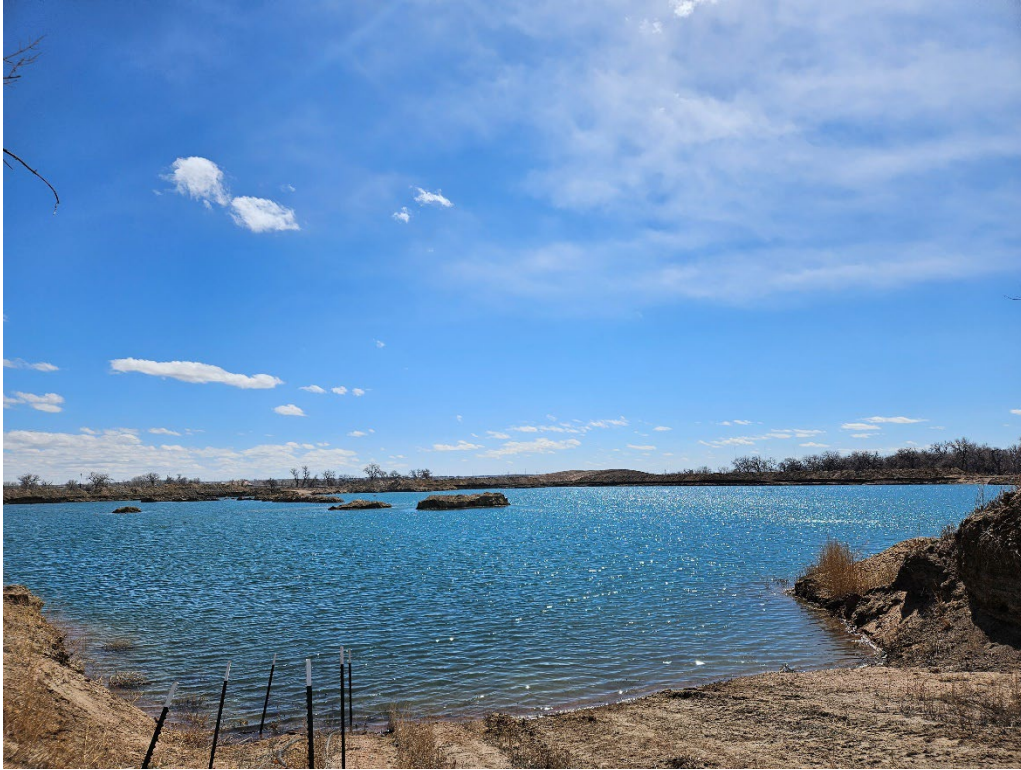
The mining activity in the cell was paused because of the amount of clay present in the material. The dewatering pumping was stopped and the cell was full of water at the time of the inspection.

View of Cell 1 / Phase 2 from the northwest corner looking southeast

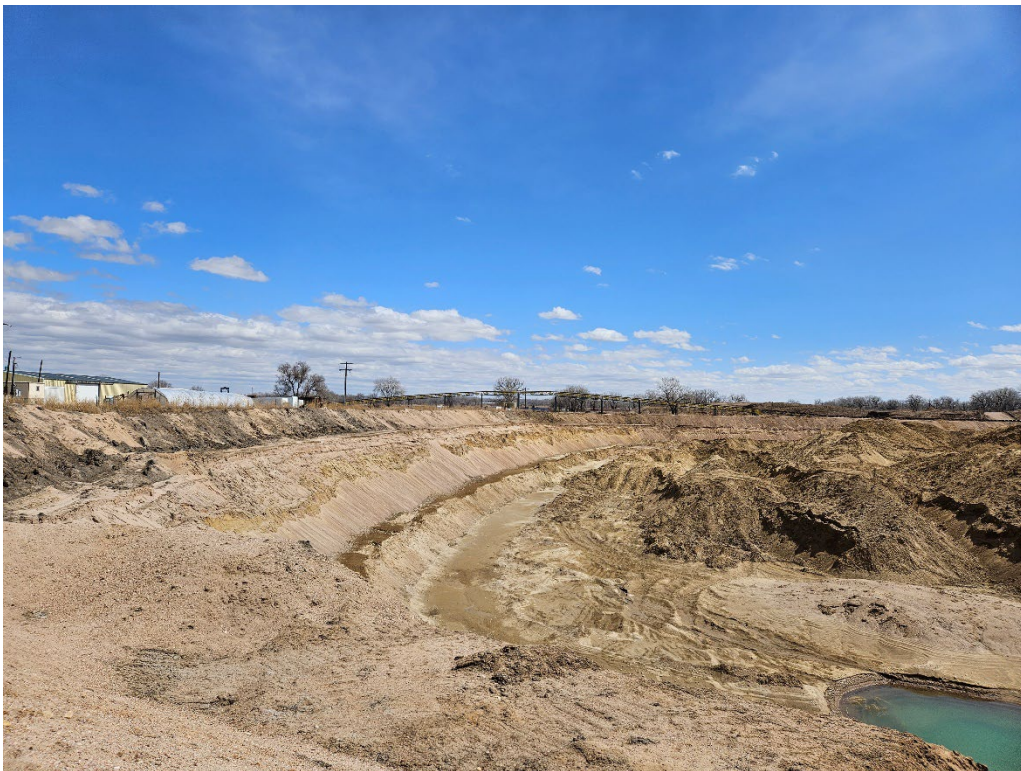
The cell is being mined by the Operator. The overburden and topsoil were stripped and stockpiled around the perimeter of the cell. A slurry wall was installed around the cell and the cell was dewatered to allow mining activity.

View of Cell 3 / Phase 5 from the north side looking east

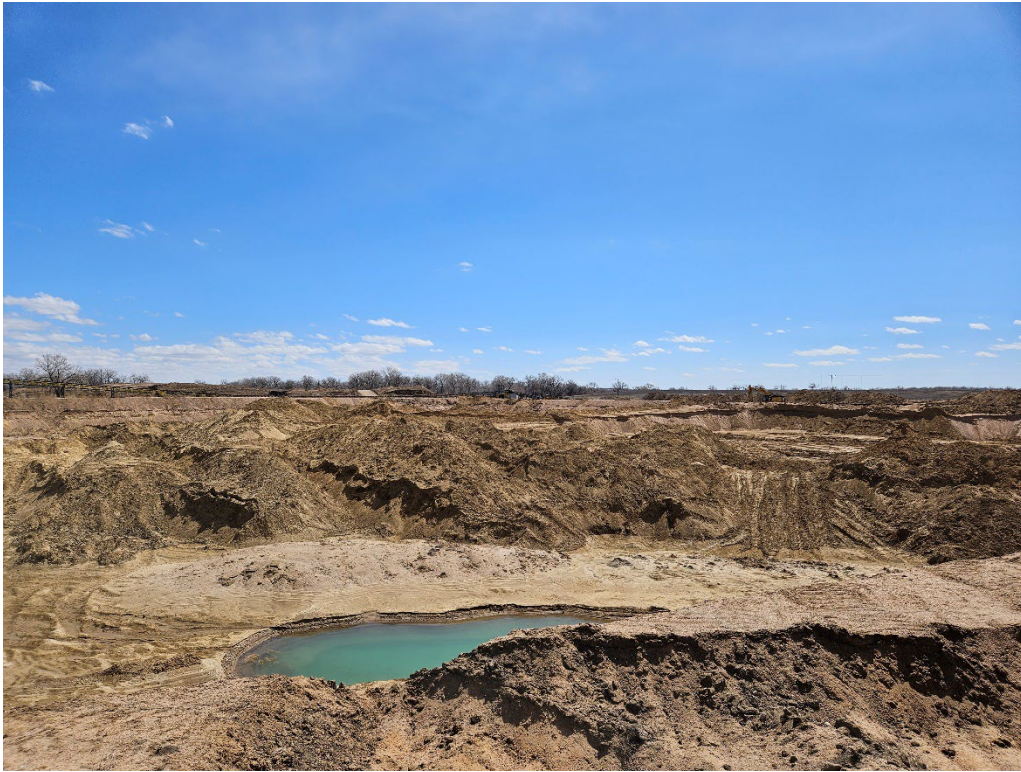
View of Cell 3 / Phase 5 from the north side looking southeast

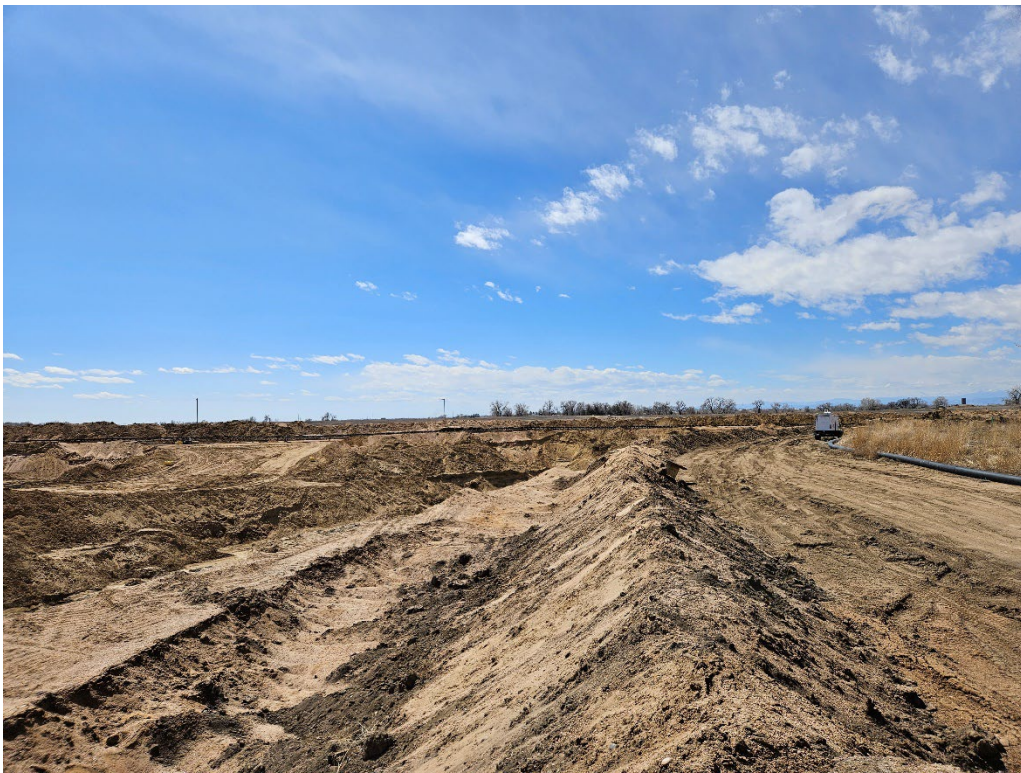
View of Cell 3 / Phase 5 from the north side looking southwest

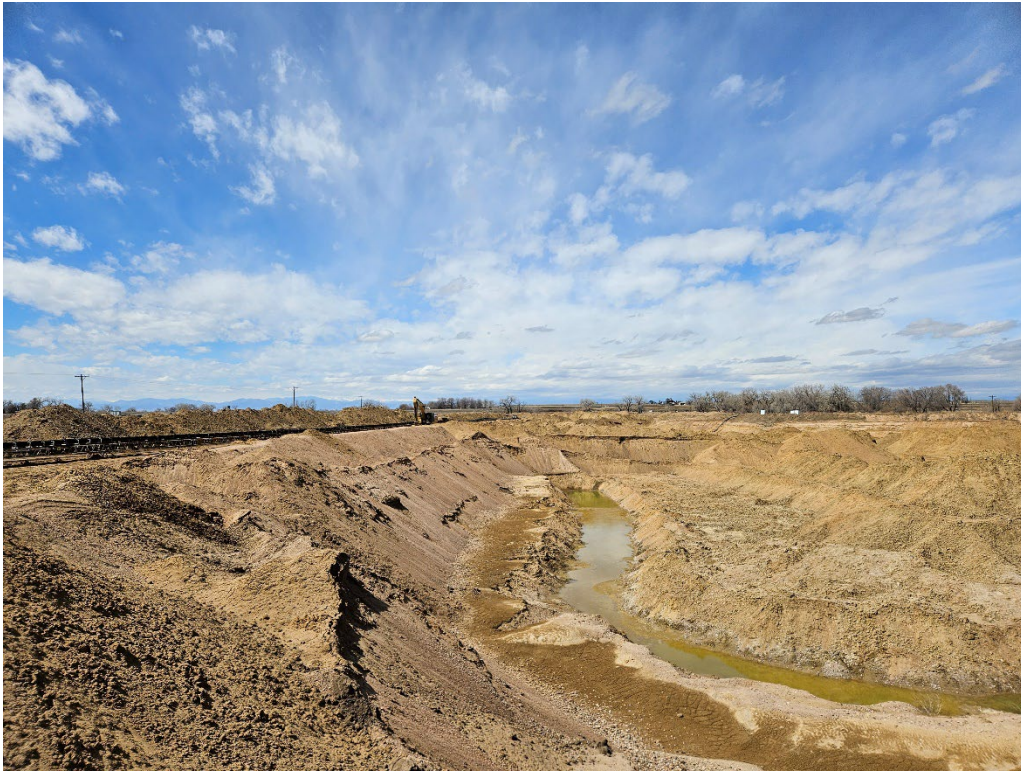
View of Cell 3 / Phase 5 from the southeast corner looking west

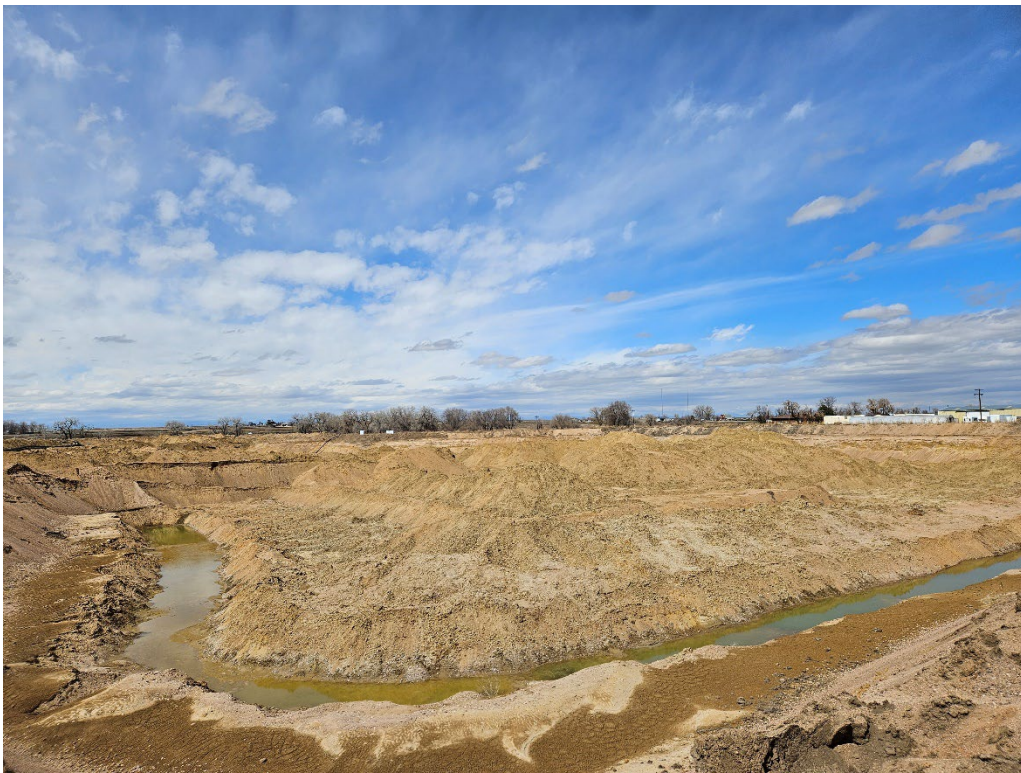
View of Cell 3 / Phase 5 from the southeast corner looking northwest

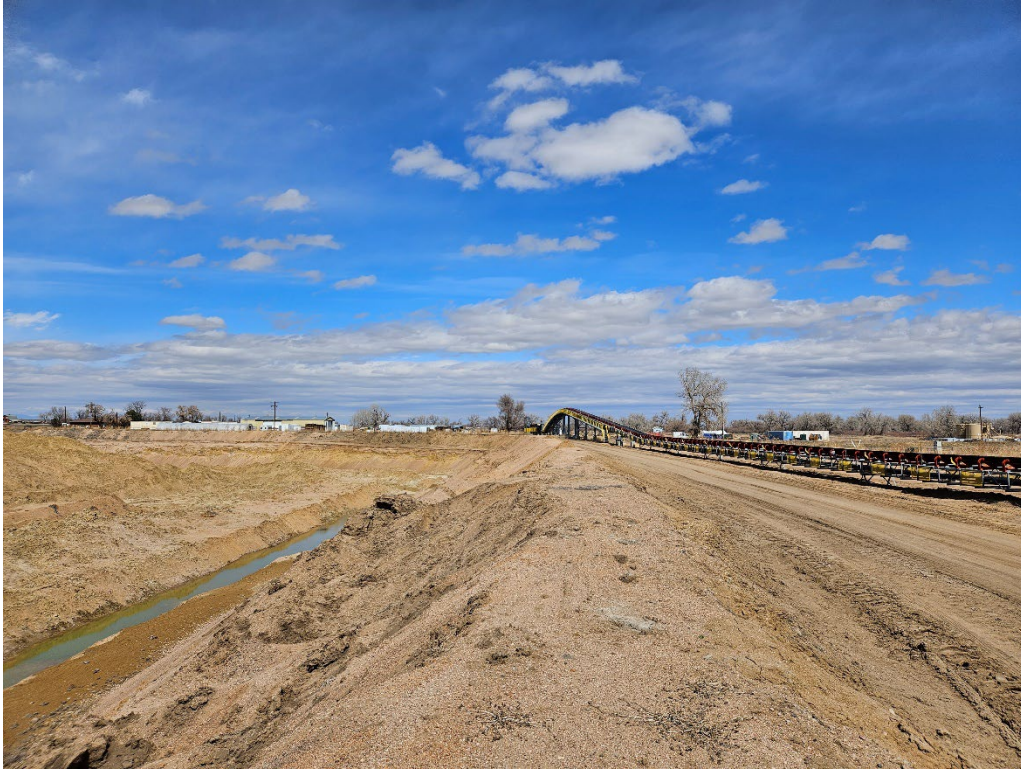
View of Cell 3 / Phase 5 from the southeast corner looking north
