**MINERALS PROGRAM INSPECTION REPORT**  
**PHONE: (303) 866-3567**

| <b>MINE NAME:</b><br>Nahcolite Project | <b>MINE/PROSPECTING ID#:</b><br>M-1983-194 | <b>MINERAL:</b><br>Carbonates | <b>COUNTY:</b><br>Rio Blanco |
| <b>INSPECTION TYPE:</b><br>Monitoring | <b>WEATHER:</b> Clear | <b>INSP. DATE:</b><br>April 3, 2023 | <b>INSP. TIME:</b><br>09:00 |

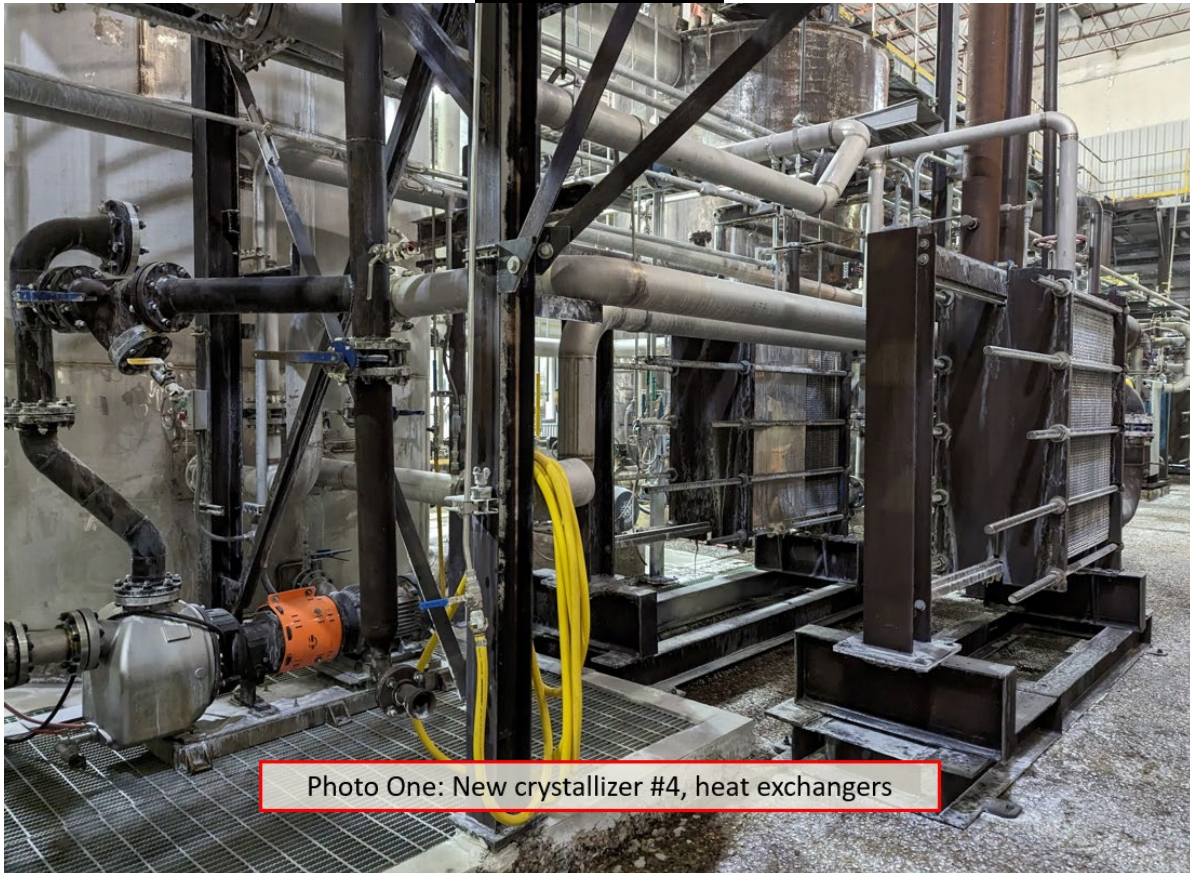
Last summer the original #4 crystallizer in Train #1 was replaced with a new stainless steel crystallizer (Photo One). Eventually the other three crystallizers in Train 1 will be replaced with stainless steel ones. The concrete curbing around the sump of Crystallizer #4 had also recently been repaired (Photo Two). In general the pregnant

Photo One: New crystallizer #4, heat exchangers

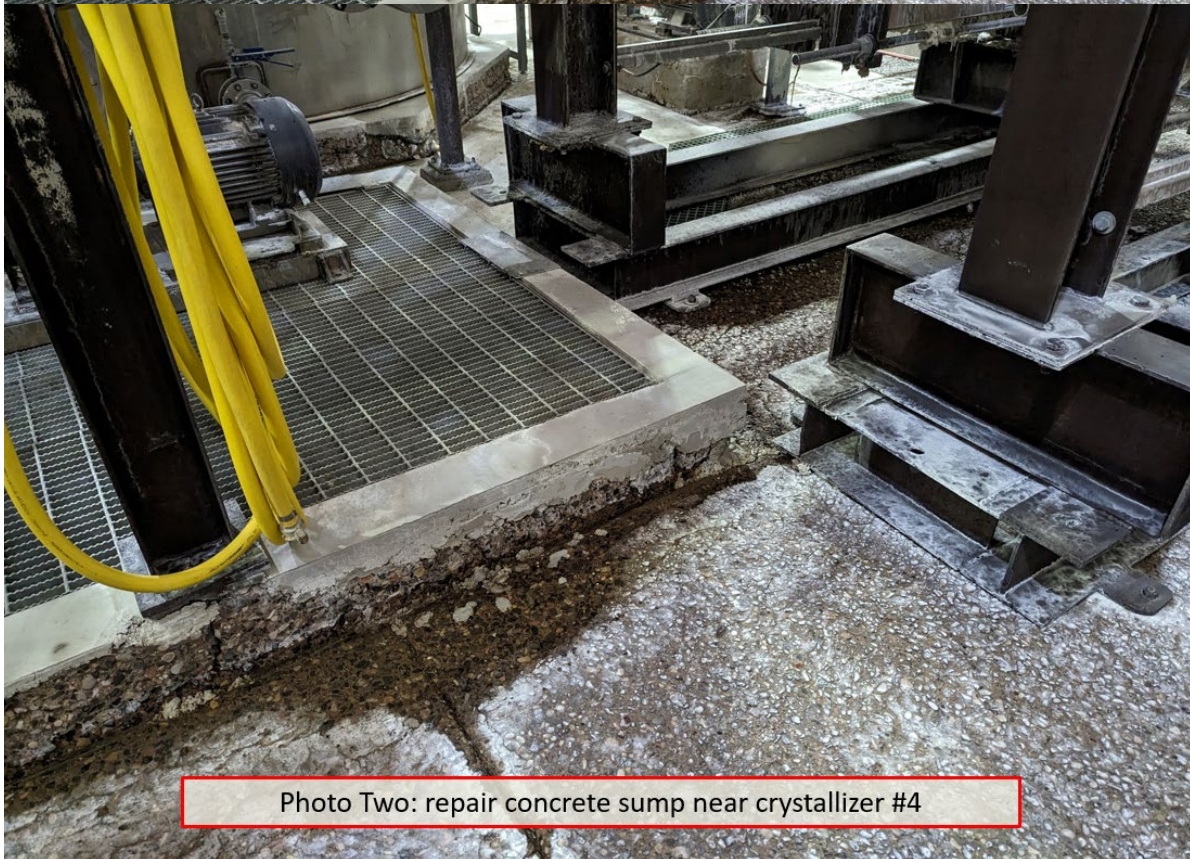
liquor is mildly corrosive to concrete. NSI has applied epoxy to one area so far and plans to eventually coat all concrete in epoxy to prevent it from eroding.

Photo Two: repair concrete sump near crystallizer #4

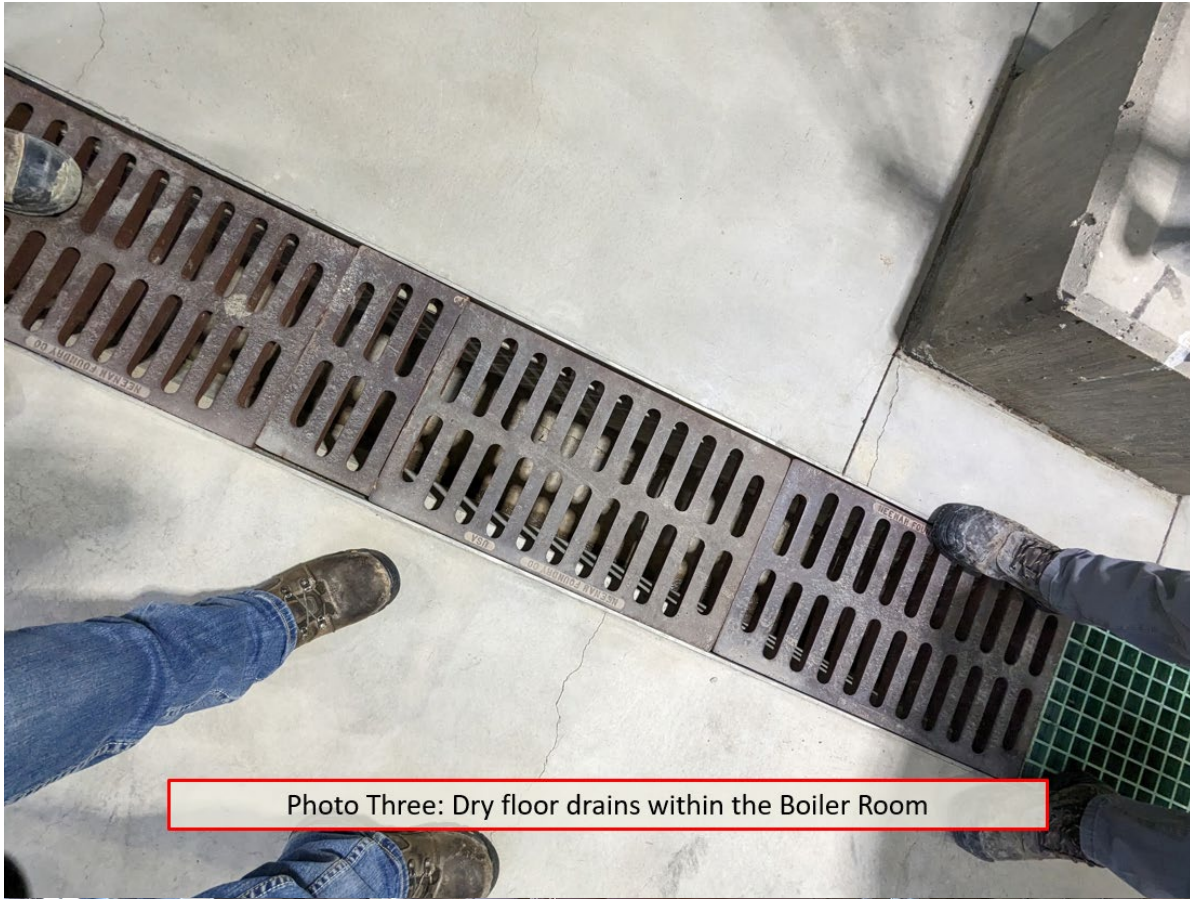
Next the boiler area was inspected. Barren liquor is reheated prior to reinjection for mining. At the time of the inspection both boilers were online. The boilers are fueled by natural gas. Routine boil outs (descale/clean out inside of boiler) are conducted as necessary for optimal performance of equipment. The flushed material reports to process pond #2 since it does not meet food grade standards. All other sumps report back to the barren liquid lines. At the time of the inspection all floor sumps within the boiler room appeared to be dry and in good working order (Photo Three).

Photo Three: Dry floor drains within the Boiler Room

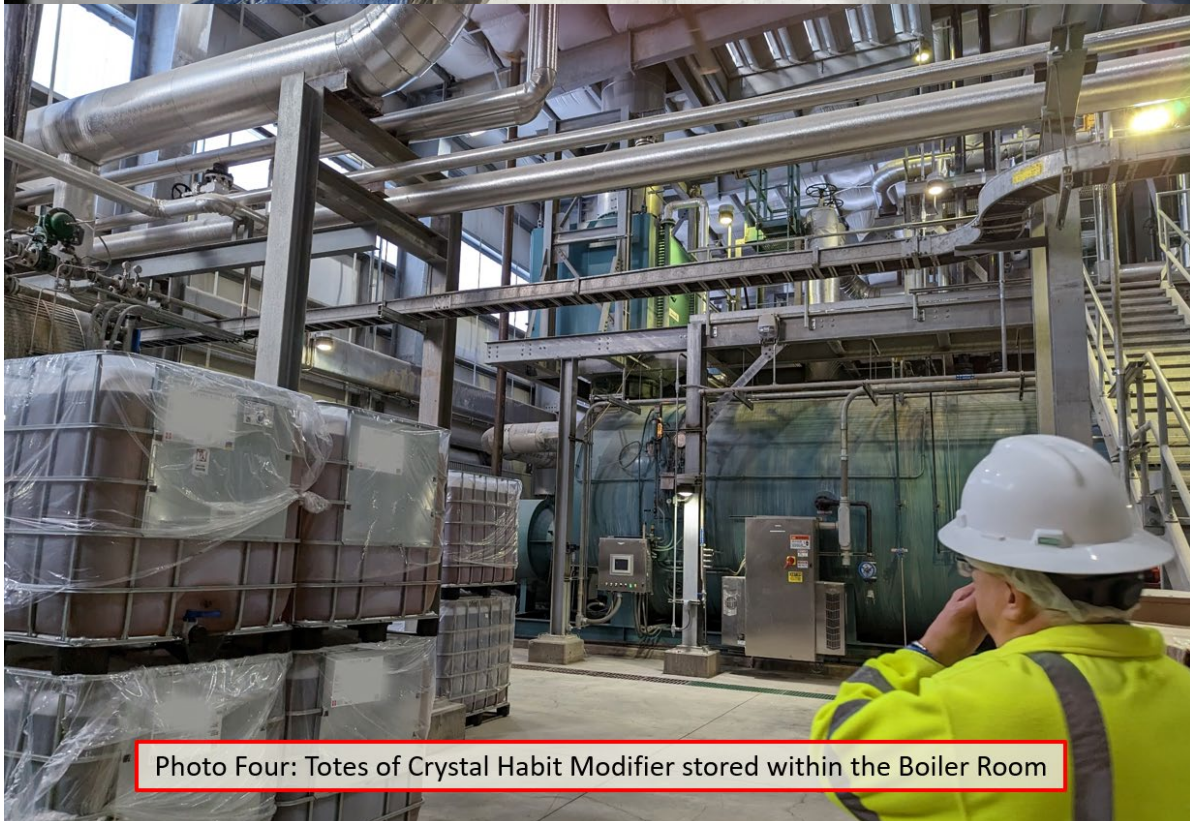
A food grade additive, crystal habit modifier (seed crystal), is stored within the boiler room (Photo Four). This product is added in low concentrations (less than 20 ppm). This additive helps keep particles flat and maintain shape throughout processing. The additive also helps give the sodium bicarbonates something to initially bind to rather than scaling up the process equipment.

Two additives (crystal habit modifier and defoamer) and a corrosion inhibitor (oxygen scavenger chemical) are being utilized on site. While these materials are being stored within the secondary containment of the process facility, the Division does not have sufficient information on these products. This is cited as an inspection problem. Please provide the Division with Safety Data Sheets for each of the materials mentioned above by the corrective action due date (June 16, 2023).

Photo Four: Totes of Crystal Habit Modifier stored within the Boiler Room

**CORRECTIVE ACTIONS:** Please provide the Division with Safety Data Sheets for each of the materials mentioned above by the corrective action due date.

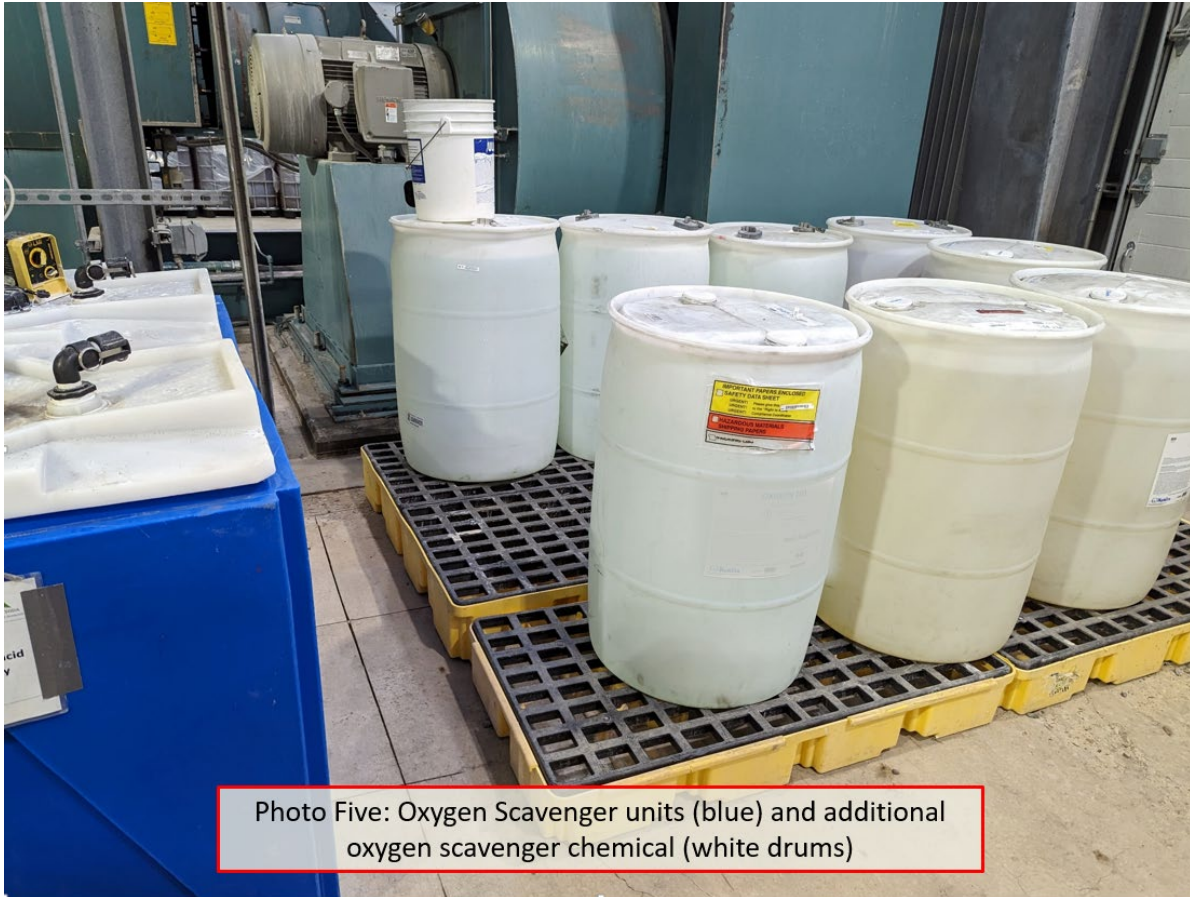
Also stored within the boiler room are four oxygen scavenger units which deaerate or remove dissolved oxygen from the boiler feed water and boiler by the use of a chemical additive. This process is essential because dissolved oxygen within the boiler is very corrosive at higher temperatures and pressure. Without treatment it could lead to pitting, leaks or equipment failure. Extra barrels of the liquid oxygen scavenger chemical are on site and the extra corrosion inhibitor chemical is stored on spill pallets (Photo Five). In the event of a spill the material would be contained within the floor sump system.

Photo Five: Oxygen Scavenger units (blue) and additional oxygen scavenger chemical (white drums)

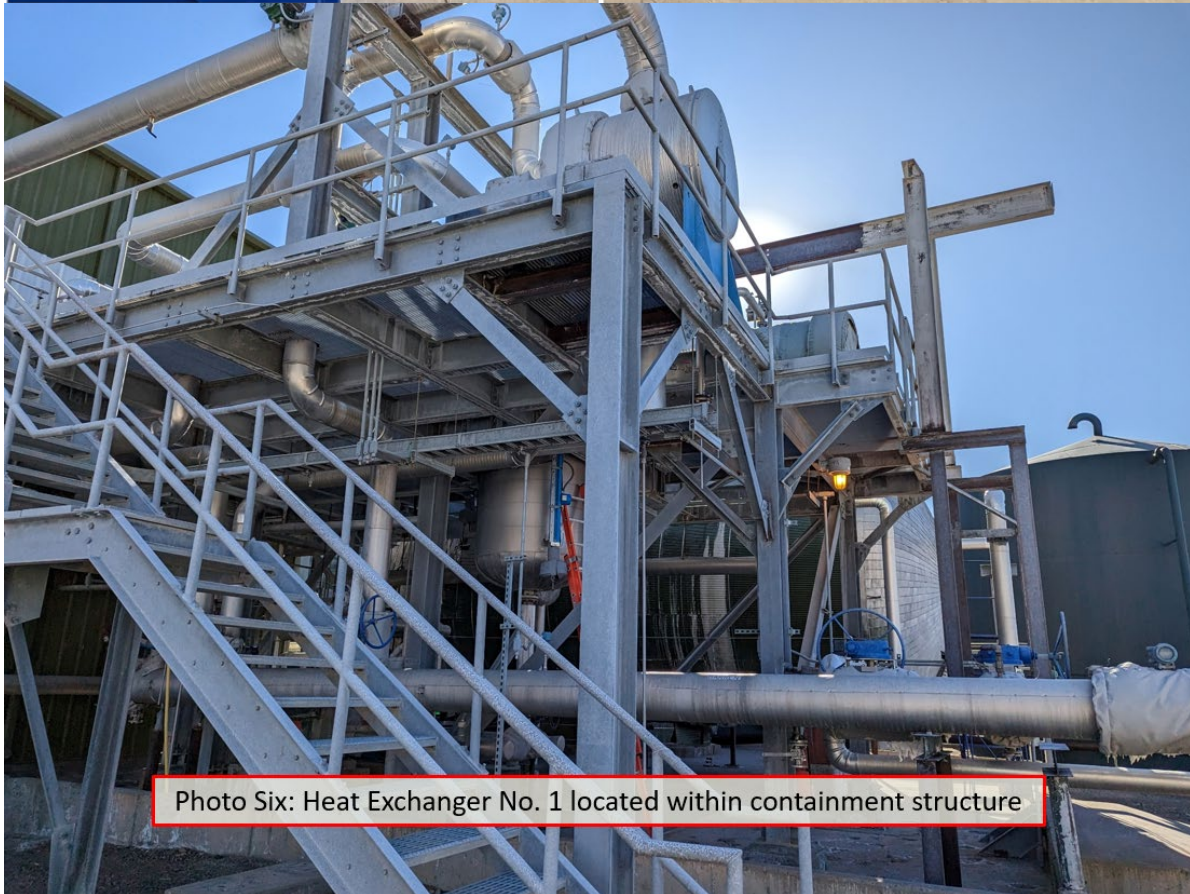
Outside of the boiler room contained within the process building to the south is the Heat Exchanger No. 1. This is the final heating point of the hot barren liquor prior to it going back into the well field for reinjection. The heat exchanger is located within the containment area which reports to the 3ac process pond via a 6-inch sump line (Photo Six).

Photo Six: Heat Exchanger No. 1 located within containment structure

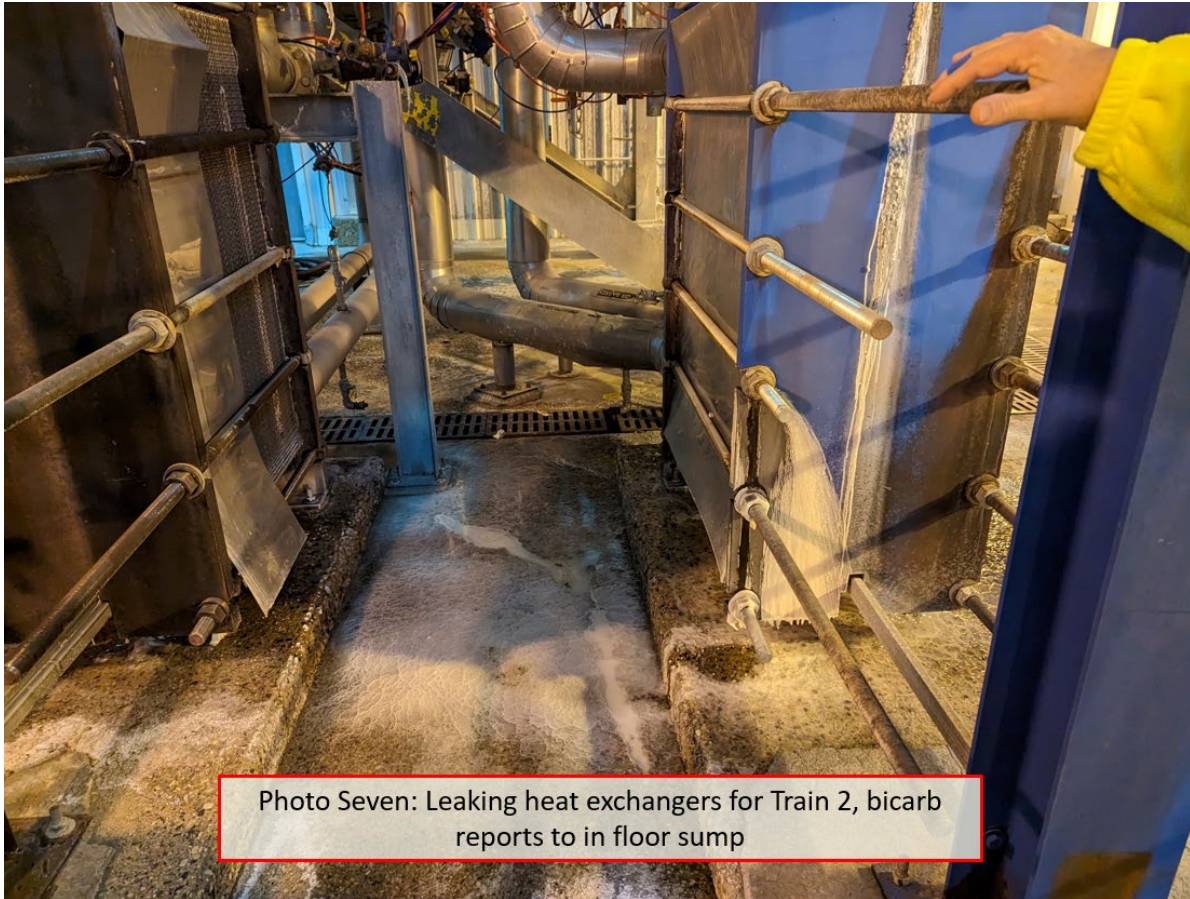
The Division then inspected the Train 2 crystallizers which are cone shaped on the bottom rather than flat bottomed like Train 1. During the inspection it was noted that several of the heat exchanger plates of Train 2 were leaking (Photo Seven). This was described as typical because the bicarb solution is corrosive. Internal plates are replaced as needed. All leaking bicarb solution within the process building reports to in floor containment sumps, which then pumps the material back into the barren liquor tank for reinjection. If the sump overflows a 6-inch overflow pipe gravity feeds material into the 3 acre process pond.

Photo Seven: Leaking heat exchangers for Train 2, bicarb reports to in floor sump

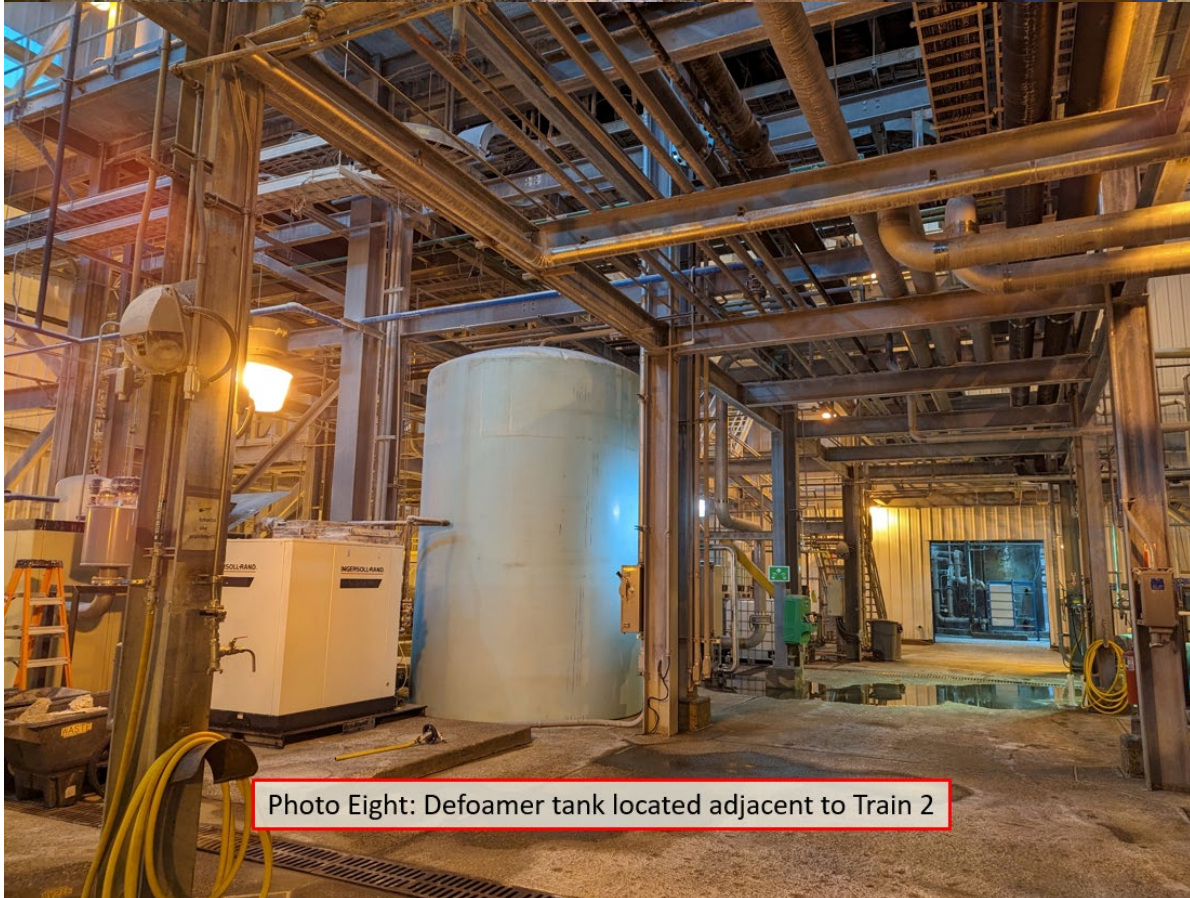
Adjacent to the Train 2 crystallizers is the defoamer tank (Photo Eight). This anti-foamant is utilized within the barren liquor streams.

Photo Eight: Defoamer tank located adjacent to Train 2

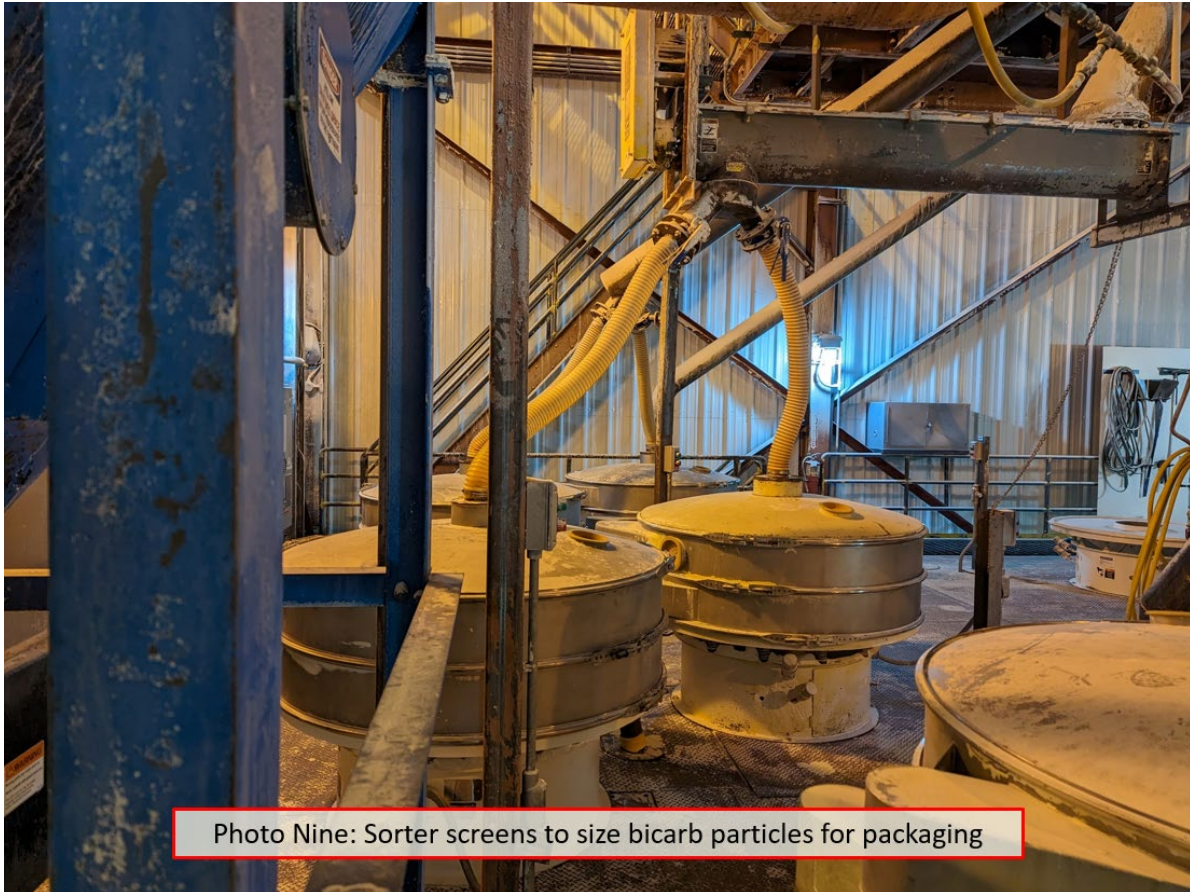
to the bag house. At the end of the drying system materials contain approximately 3% moisture. Particles are then sorted based on crystal size and packaged accordingly (Photo Nine).

Photo Nine: Sorter screens to size bicarb particles for packaging

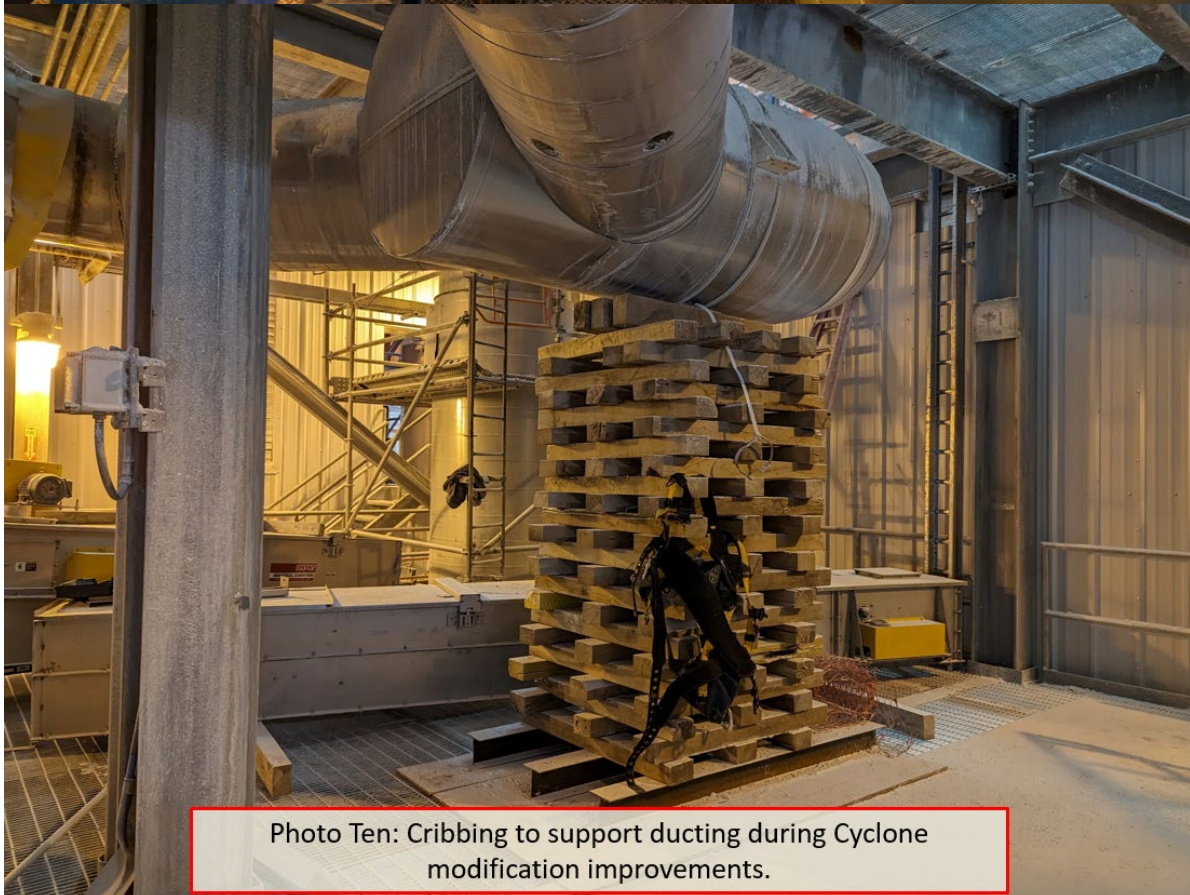
Currently modifications are being made to replace the existing cyclone with a new one. During the inspection, new ducting was observed on cribbing (Photo Ten). The existing beam needed to be removed and replaced with a larger sized one, to account for the new conveyor. The replacement dry cyclone will recover 92% of solids. The existing cyclone has a 90° angle for material to enter into the bag house decreasing its efficiency (Photo Eleven). The new cyclone will use conveyors to feed material straight through the cyclone then into the bag house. It is anticipated that Train 2 will be shut down for approximately five days to swap out equipment.

Photo Ten: Cribbing to support ducting during Cyclone modification improvements.

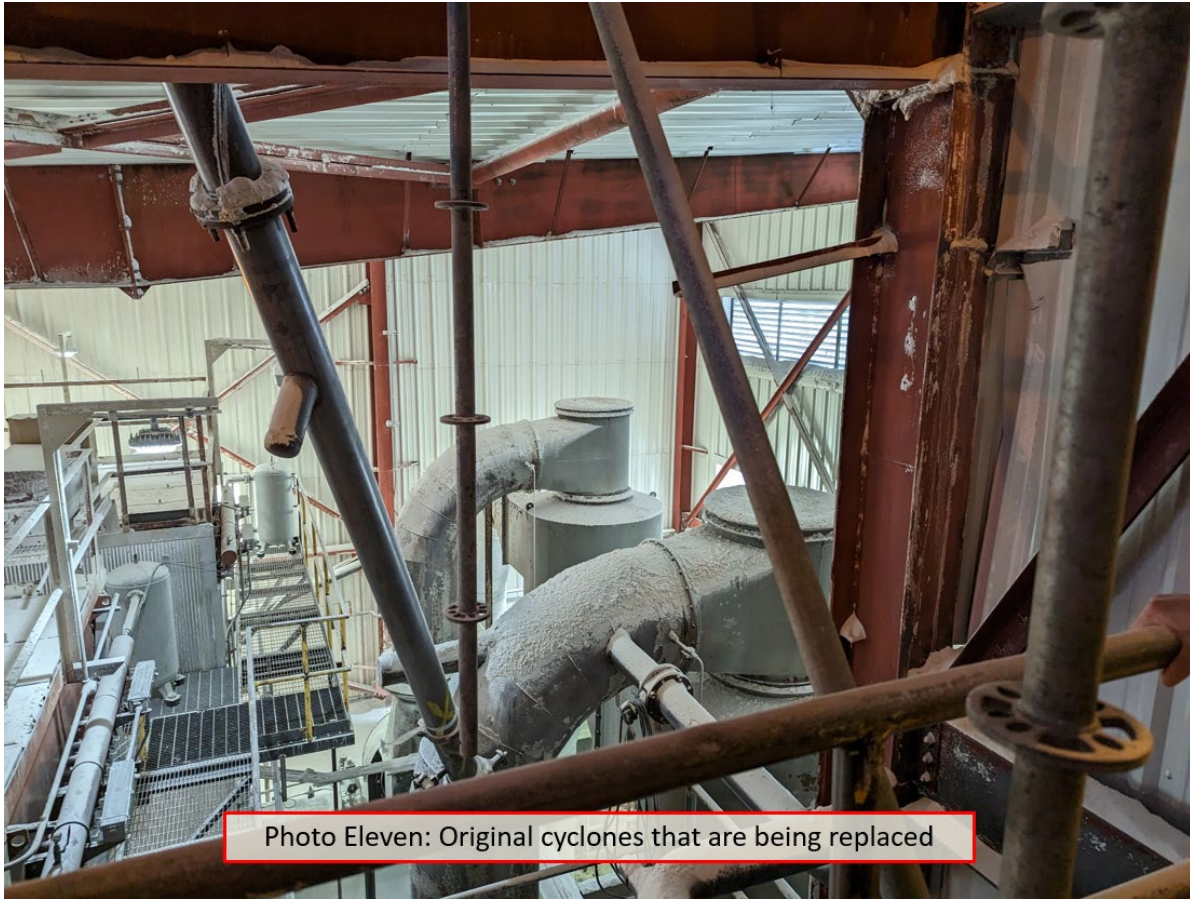
Photo Eleven: Original cyclones that are being replaced
