MINERALS PROGRAM INSPECTION REPORT
PHONE: (303) 866-3567

MINE NAME: Vasquez Quarry No 2	MINE/PROSPECTING ID#: M-1994-121	MINERAL: Sandstone	COUNTY: Boulder
INSPECTION TYPE: Monitoring	WEATHER: Clear	INSP. DATE: March 14, 2023	INSP. TIME: 10:00
OPERATOR: O & A Stone LLC	OPERATOR REPRESENTATIVE: Arthur Vasquez	TYPE OF OPERATION: 110c - Construction Limited Impact	
REASON FOR INSPECTION: Normal I&E Program	BOND CALCULATION TYPE: Complete Bond	BOND AMOUNT: \$7,670.00	
DATE OF COMPLAINT: NA	POST INSP. CONTACTS: None	JOINT INSP. AGENCY: None	
INSPECTOR(S): Patrick Lennberg	INSPECTOR'S SIGNATURE:

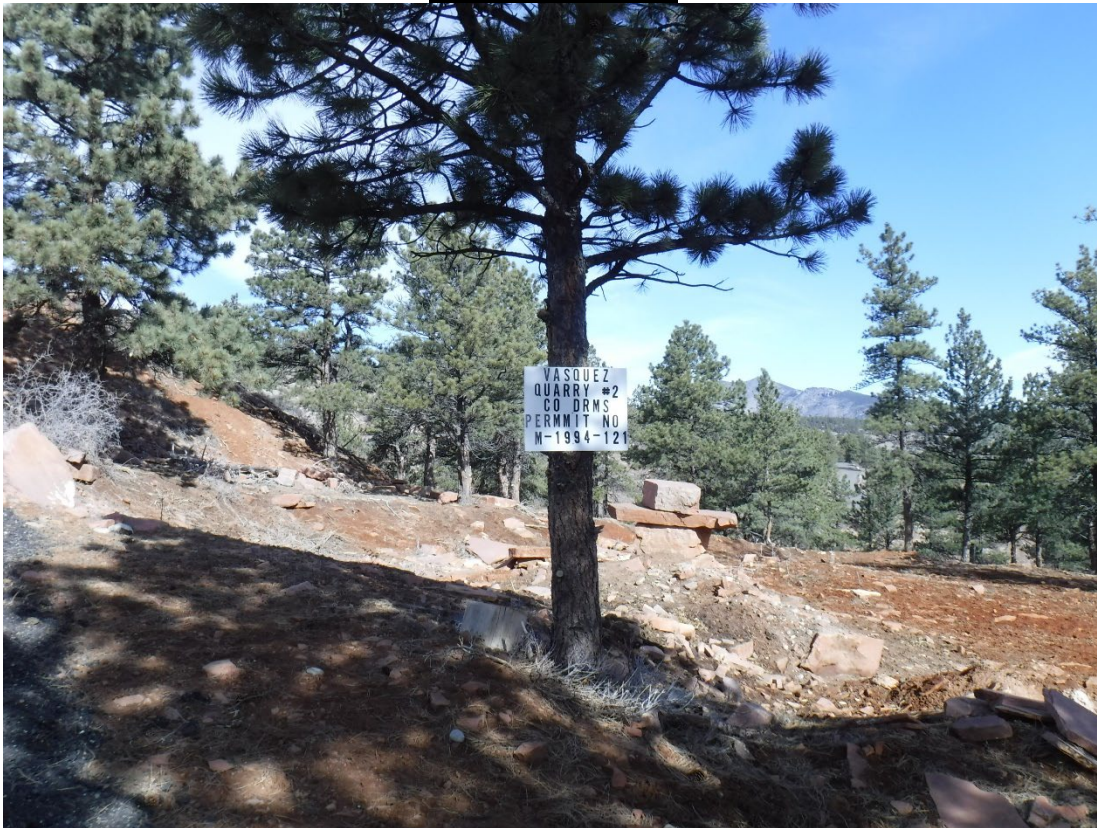
This is a 110c operation permitted for 7.4 acres. The permit is for the mining of dimensional sandstone for building materials and decorative use. The mine is located on property owned by Art Vasquez Family Trust. The mine is located in Boulder County. The site entrance is located approximately 4 miles north of Lyons, CO via 3587 Stone Canyon Road. The approved post-mining land use is industrial/commercial. A mine sign was posted at the mine entrance pursuant to Rule 3.1.12.

Photo 1: Mine sign at entrance

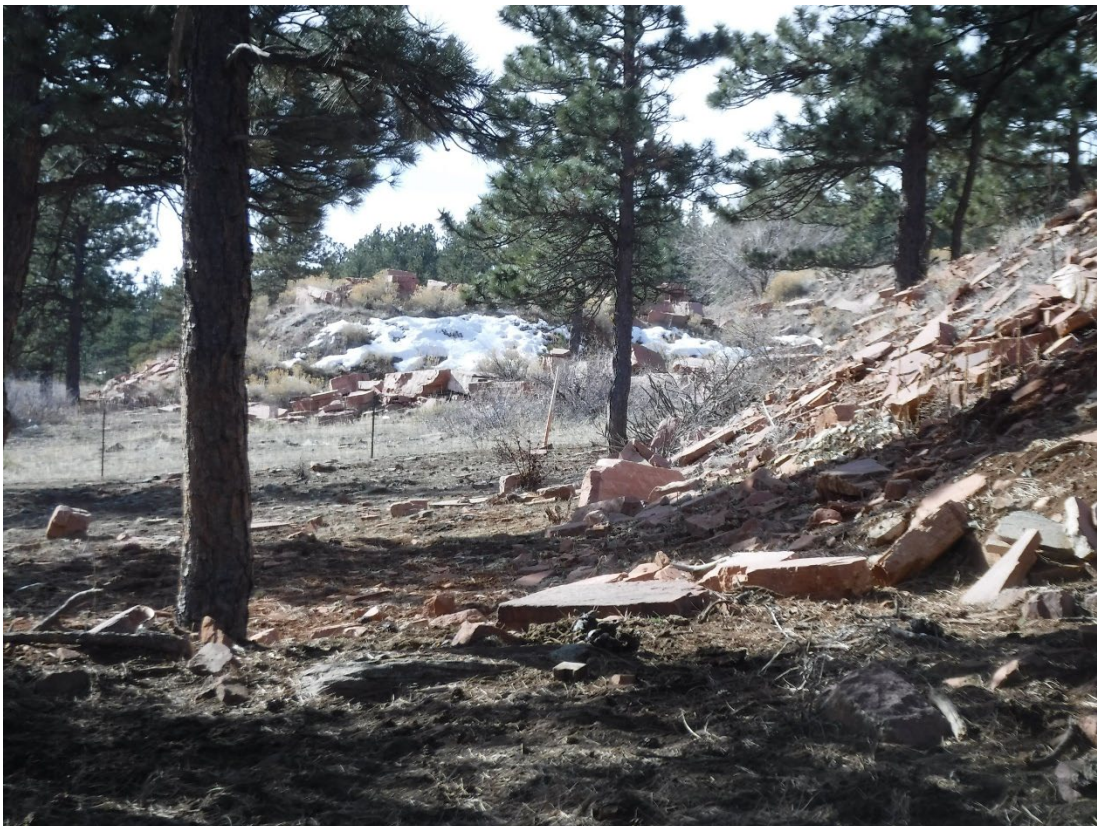
At the time of the inspection, it was clear and sunny, and the ground was dry. The site was not active during the inspection. However, Mr. Vasquez indicated the site is active every year, which is in compliance with its intermittent status. The permit boundary was delineated with posts. The Division estimates the operation has disturbed a total of 6 acres including internal haul roads, a topsoil stockpile at the eastern edge of the site, a large overburden/waste rock stockpile at the western edge of the site, a stone and equipment storage area in the southeastern portion of the site, and a highwall along the southern edge of the site that is approximately 460 feet in length and up to 30 feet in height. The portion of the access road that enters the permitted area was constructed on existing overburden/waste rock stockpiles created before the site was permitted. The disturbance area is on or very close to the northern, eastern, and western permit boundaries. The current highwall is within 25-100 feet of the southern permit boundary.

Photo 2: SE Permit boundary marker

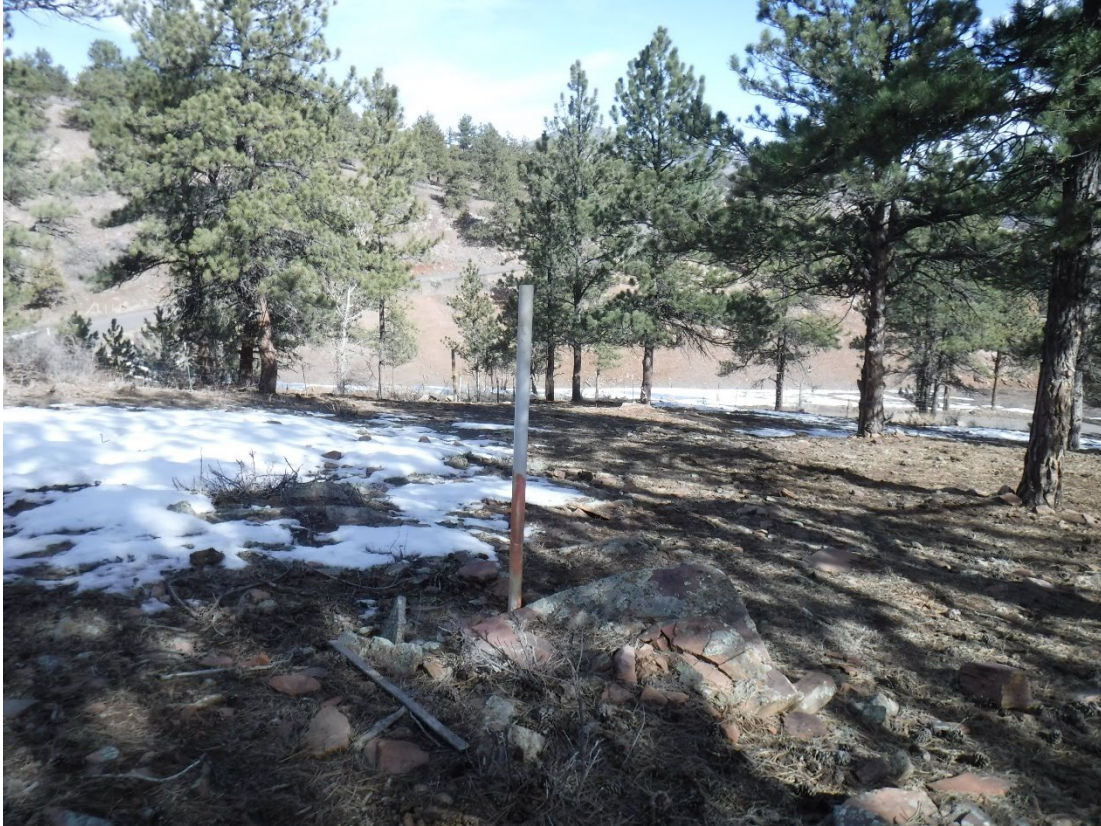
Photo 3: NE Permit boundary marker

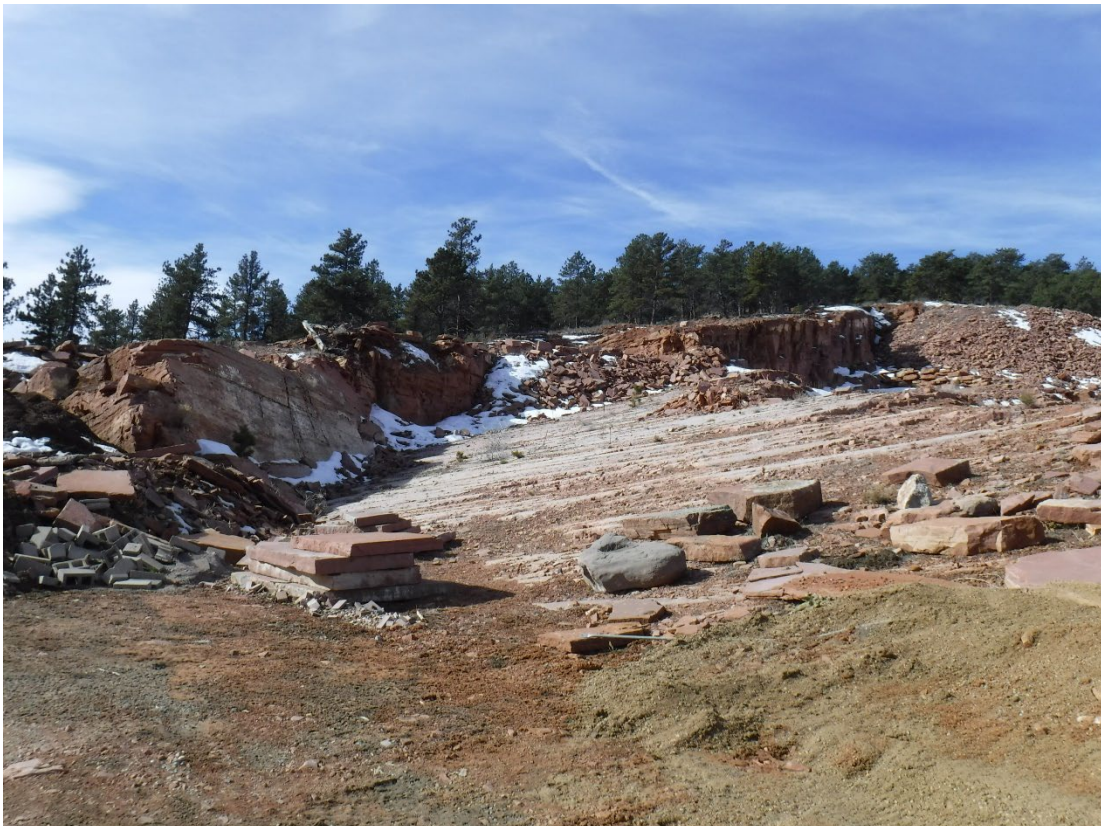
Photo 4: Eastern pit area

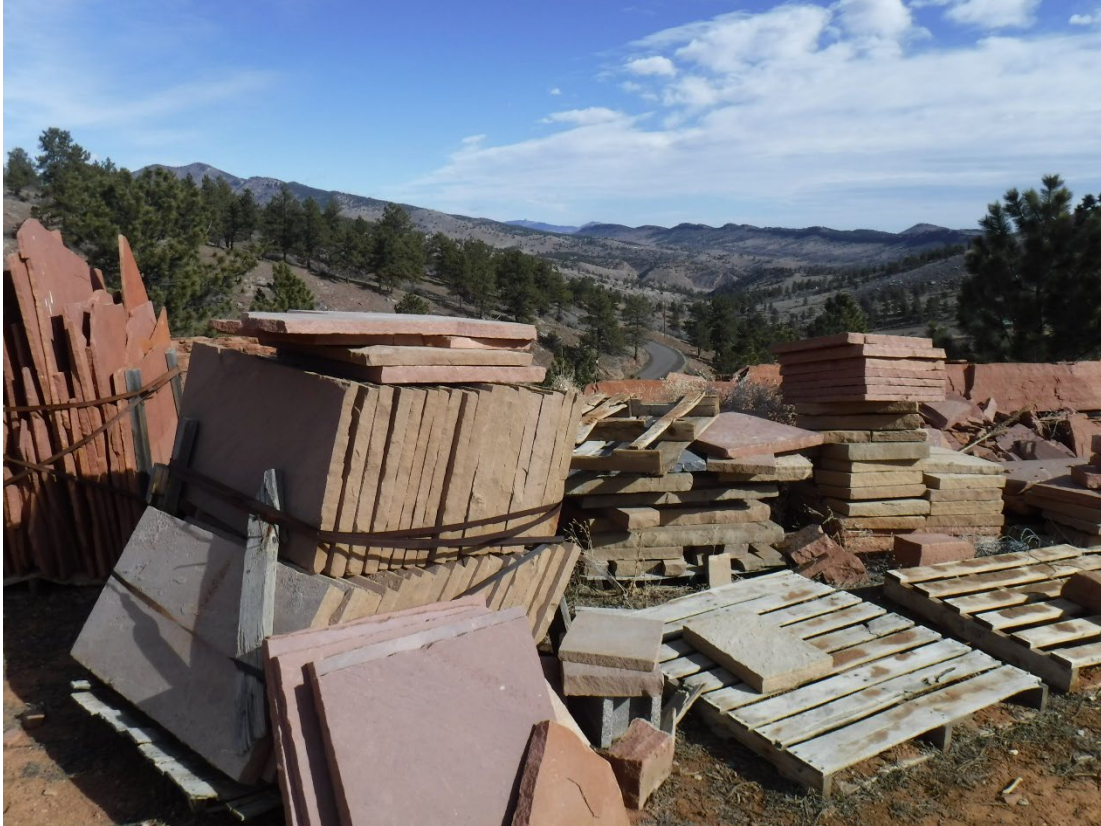
Photo 5: Marketable material stockpiled onsite

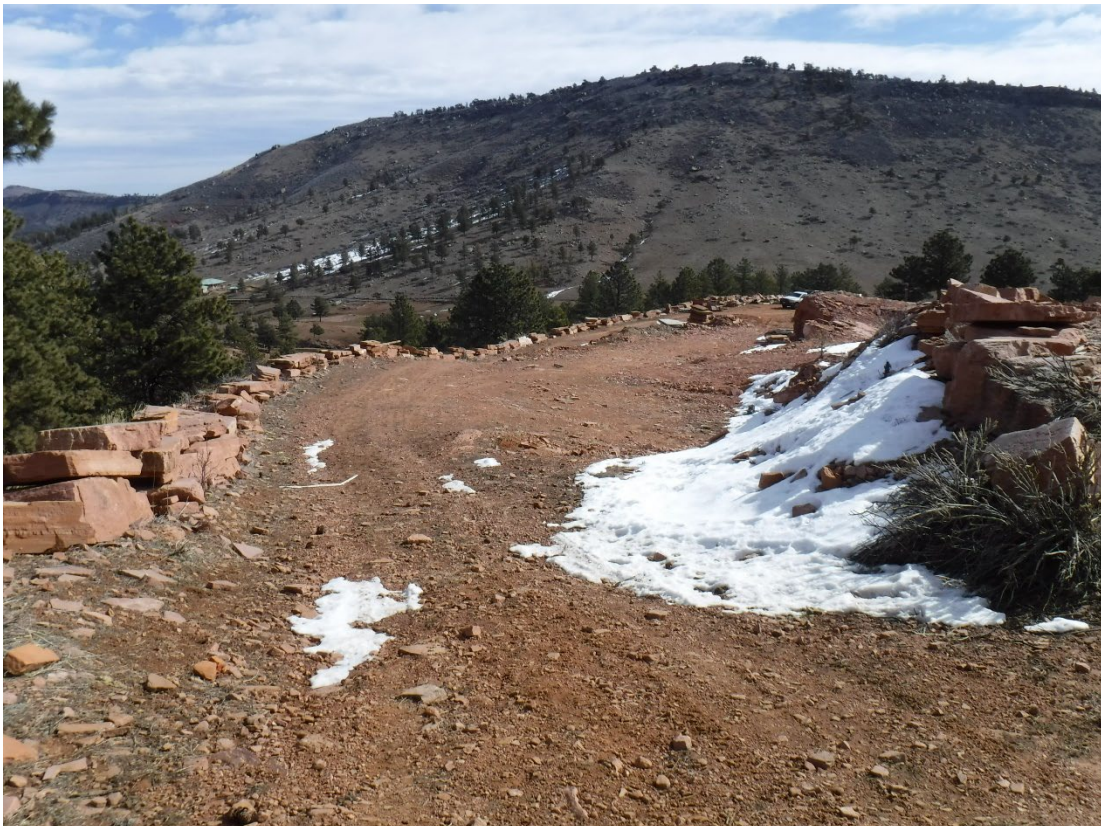
Photo 6: Looking east along the access road along the northern portion of the site

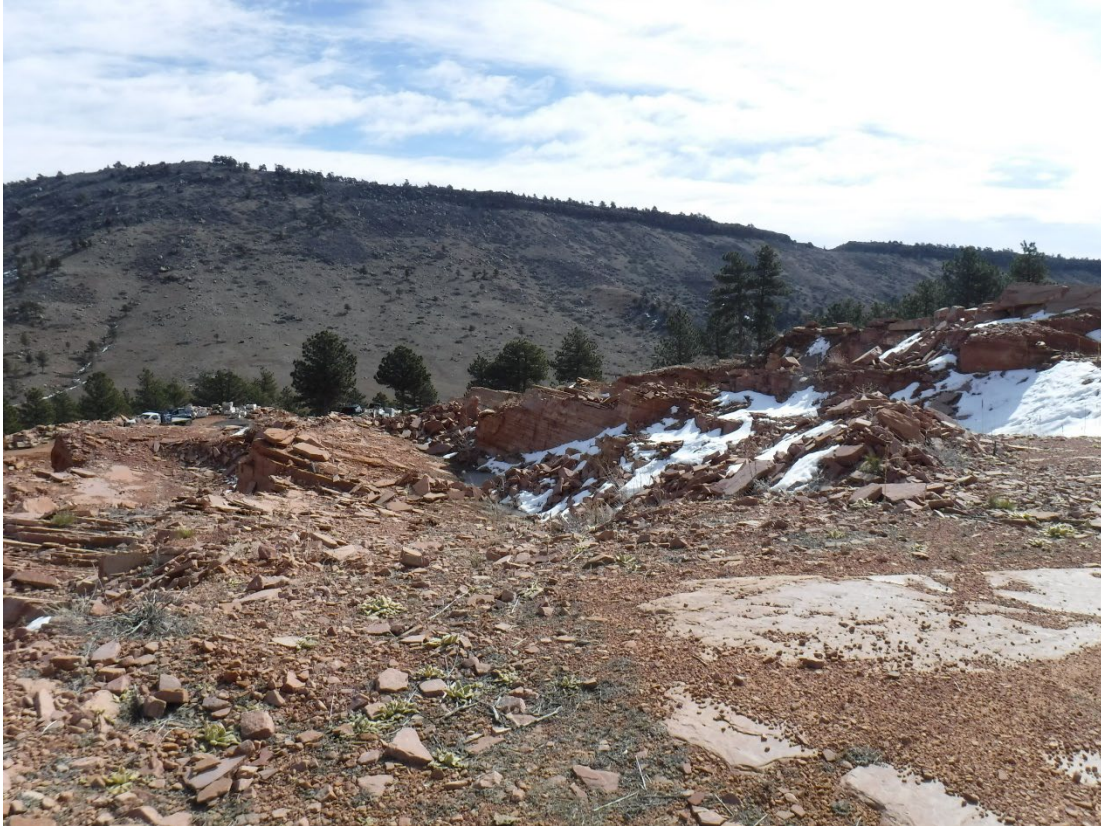
Photo 7: Western Pit areas

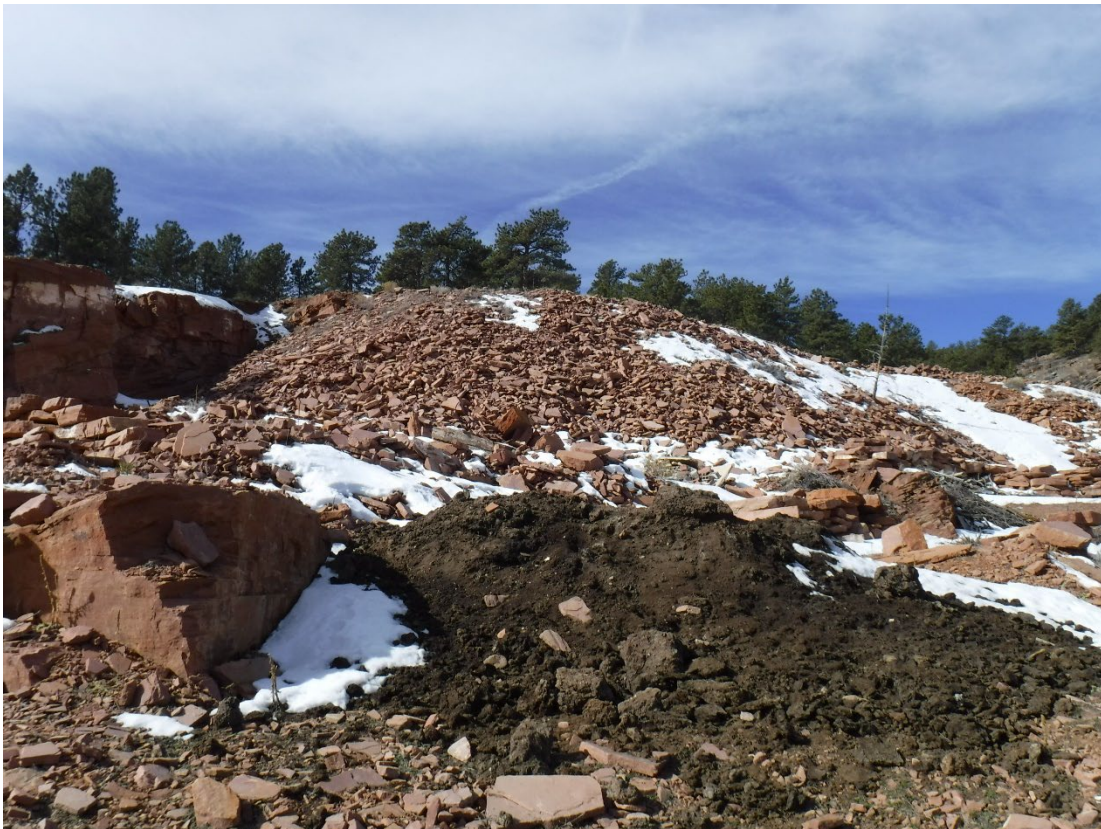
Photo 8: Overburden stockpile material

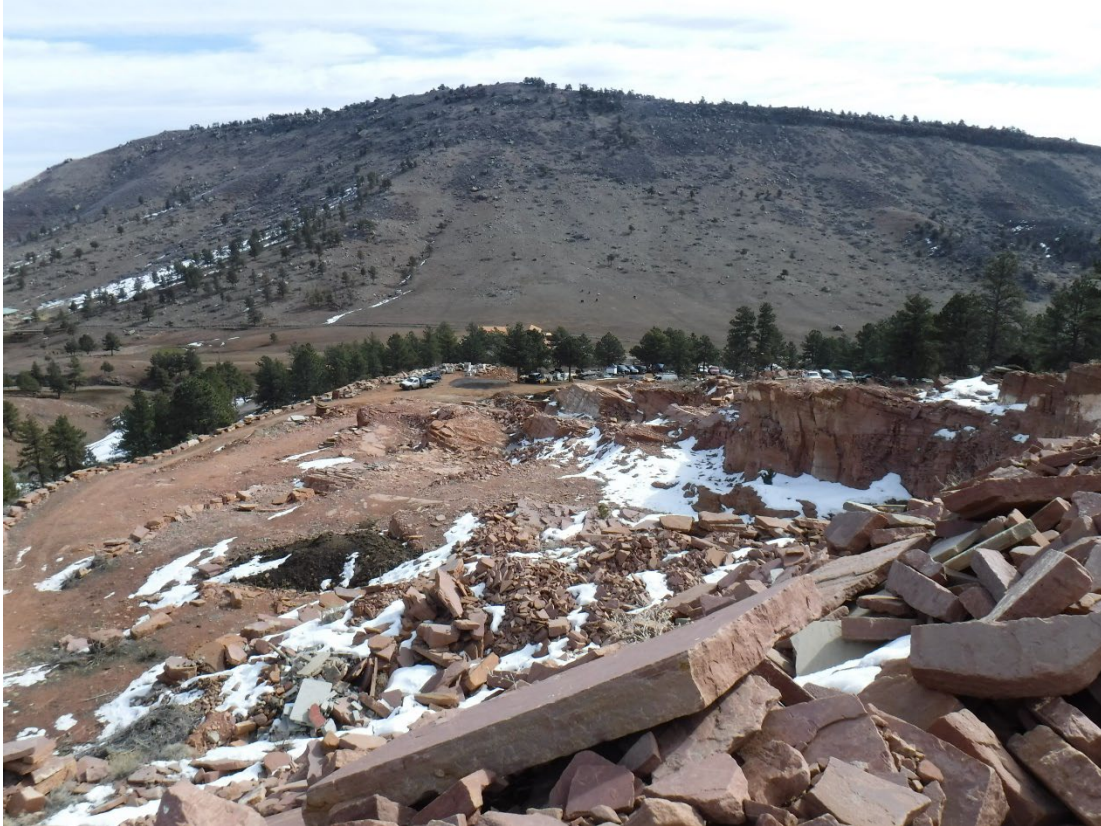
Photo 9: Looking east across the permit area from the western portion of the site

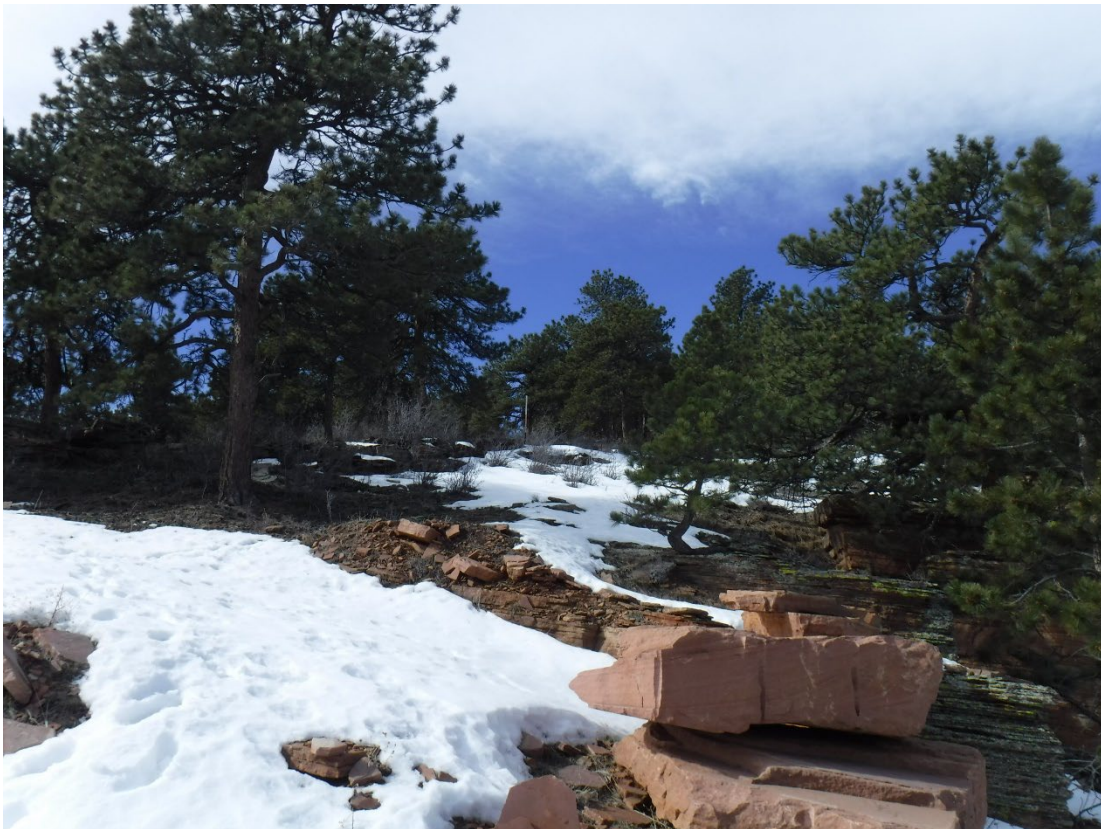
Photo 10: SE permit boundary marker
