MINERALS PROGRAM INSPECTION REPORT
PHONE: (303) 866-3567

MINE NAME: O'Rourke South Fork Pit	MINE/PROSPECTING ID#: M-2014-005	MINERAL: Gravel and sand	COUNTY: Rio Grande
INSPECTION TYPE: Monitoring	WEATHER: Clear	INSP. DATE: April 12, 2023	INSP. TIME: 09:00
OPERATOR: O'Rourke Excavating, Inc.	OPERATOR REPRESENTATIVE: Thomas O'Rourke	TYPE OF OPERATION: 110c - Construction Limited Impact	
REASON FOR INSPECTION: Normal I&E Program	BOND CALCULATION TYPE: Partial Bond	BOND AMOUNT: \$10,406.92	
DATE OF COMPLAINT: NA	POST INSP. CONTACTS: None	JOINT INSP. AGENCY: None	
INSPECTOR(S): Todd Jesse	INSPECTOR'S SIGNATURE:

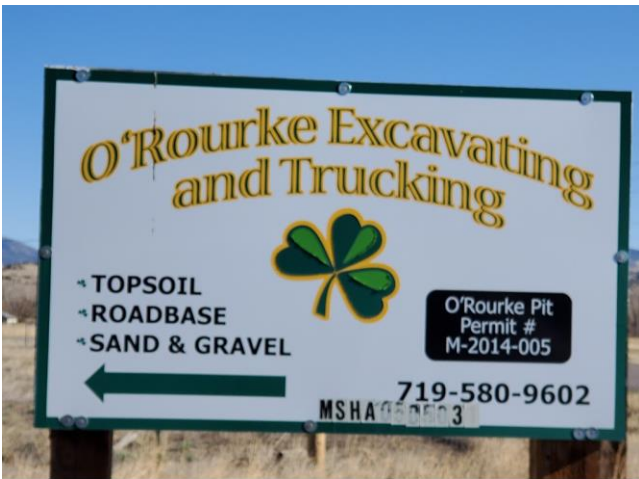
The mine identification sign and the affected area boundary markers are in place and in compliance with rule 3.1.12. The sign posted near the gate off the county road. The permit boundaries are comprised of fence lines that are easily identifiable. An office is the only on-site support facility. There were no hydrocarbons or designated chemicals stored at this support facility at the time of the inspection.

View to the northwest showing the proper Mine ID signage posted at the entrance to the site

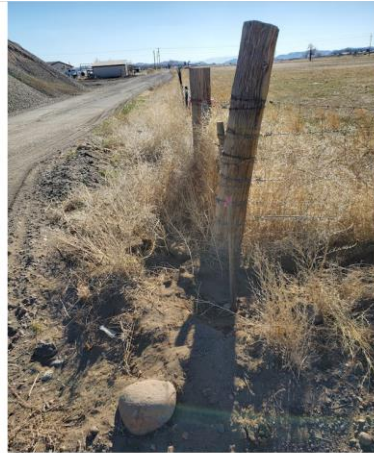
View to the east showing the fence and one of the survey markers that mark the permit limits

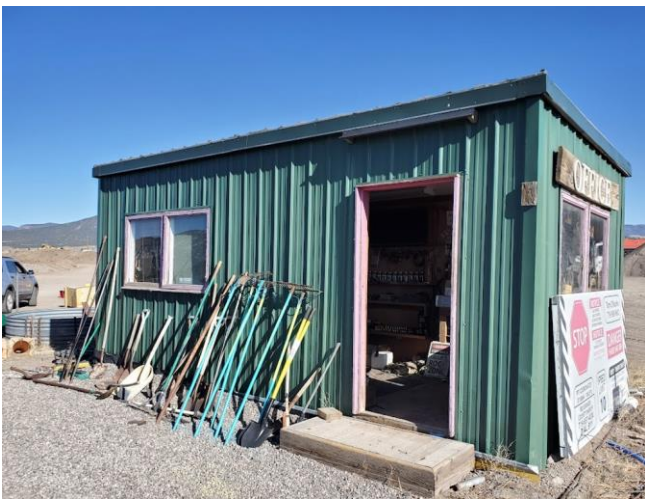
View to the northwest of on-site support facility. No hydrocarbons were present.

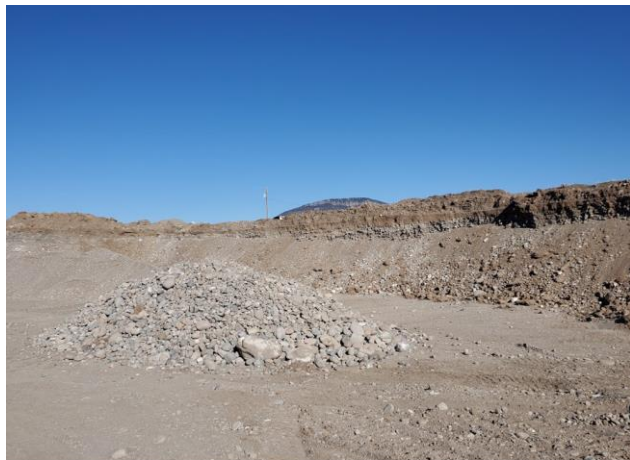
View to the northwest showing the highwall and material stockpiles on the floor of the pit.

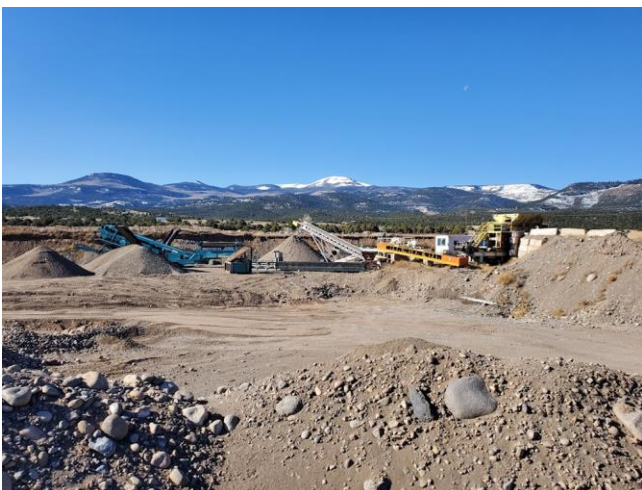
View to the south showing material stockpiles and screening system on the pit floor.

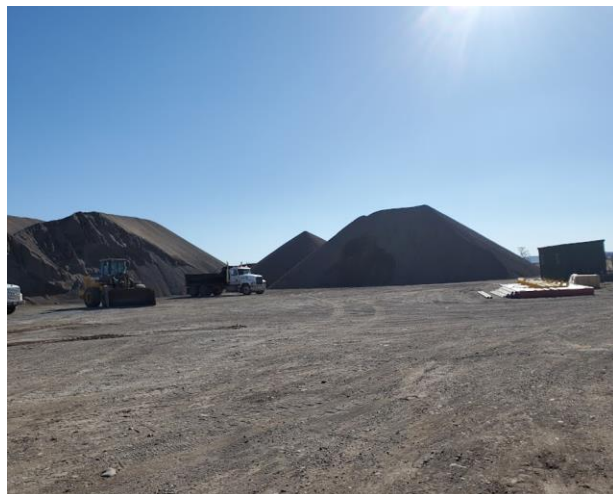
View to the east of product stockpiles and loading/hauling equipment.

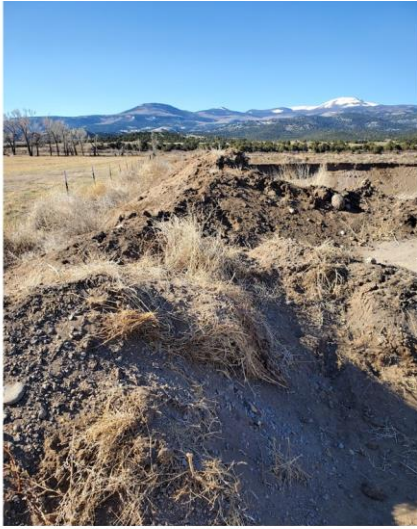
View to the south of topsoil stockpile along the edge of the pit.

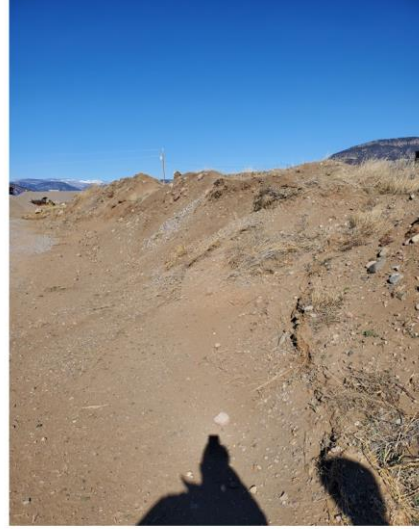
View to the west of topsoil stockpile along the north edge of the pit.
