RE: Angie Pit, Permit No. M-2000-049, Technical Revision (TR-05) Adequacy Review (01)

MINERALS PROGRAM INSPECTION REPORT
PHONE: (303) 866-3567

MINE NAME: Angie Pit	MINE/PROSPECTING ID#: M-2000-049	MINERAL: Gravel	COUNTY: Montrose
INSPECTION TYPE: Monitoring	INSPECTOR(S): Dustin Czapla	INSP. DATE: June 23, 2022	INSP. TIME: 13:45
OPERATOR: Louisiana Land and Gravel Company, LLC	OPERATOR REPRESENTATIVE: None	TYPE OF OPERATION: 112c - Construction Regular Operation

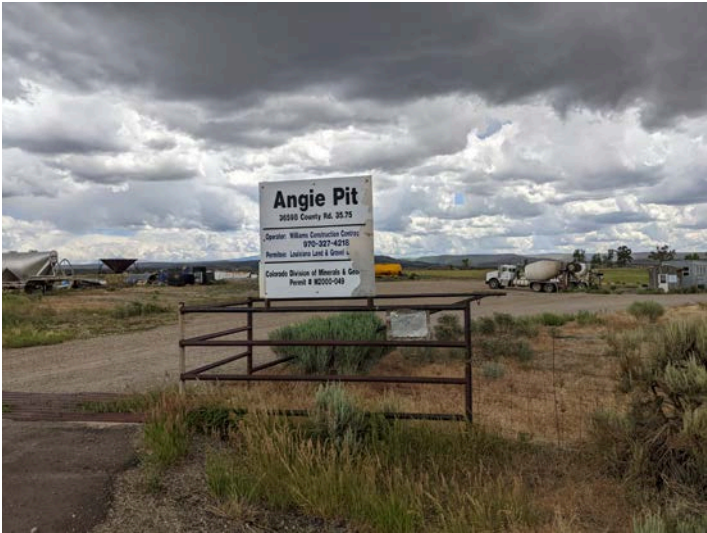
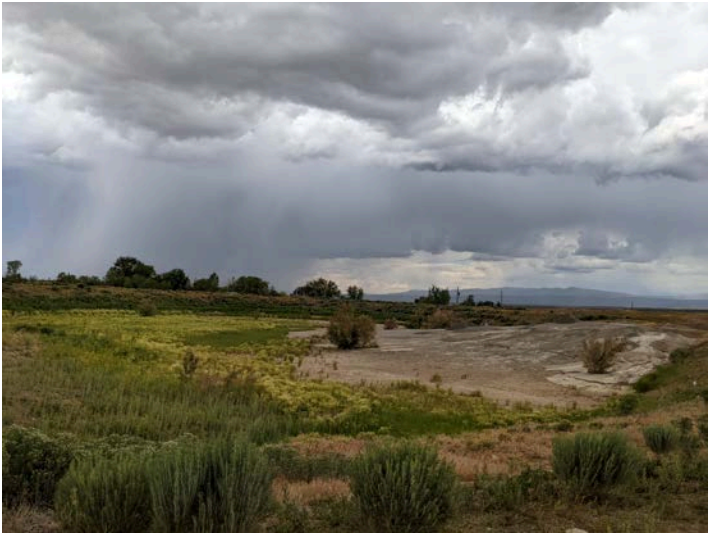
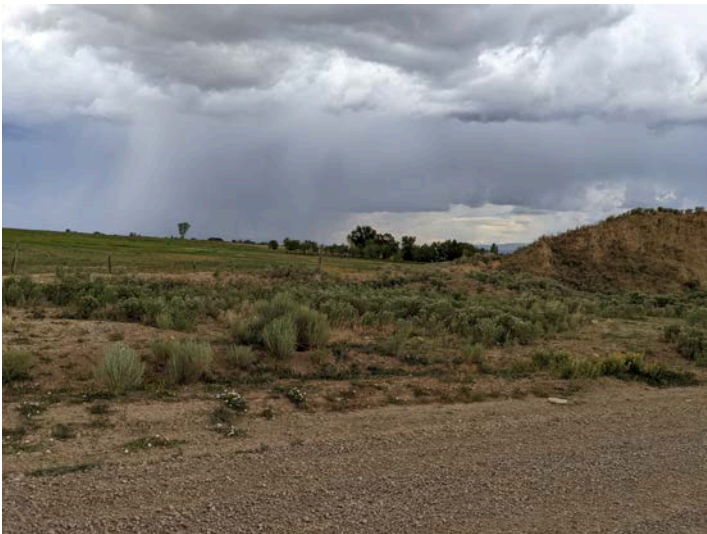
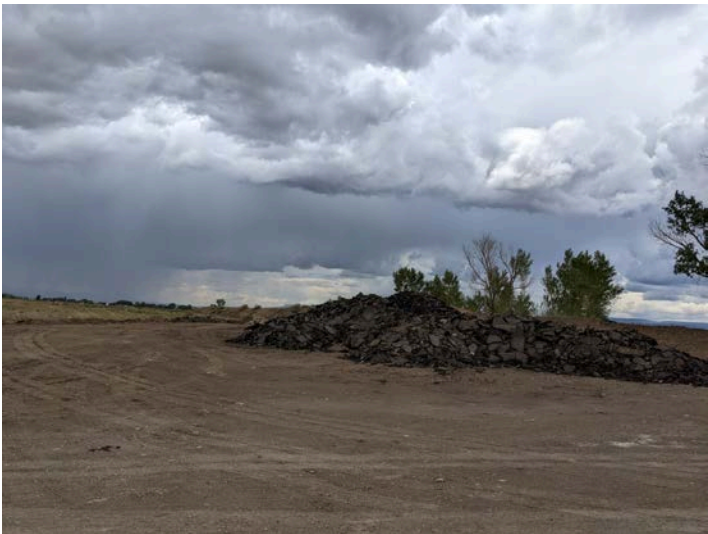
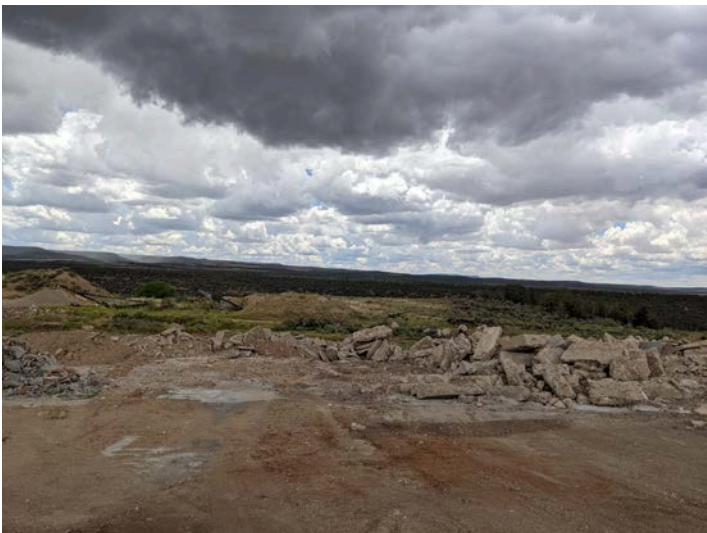
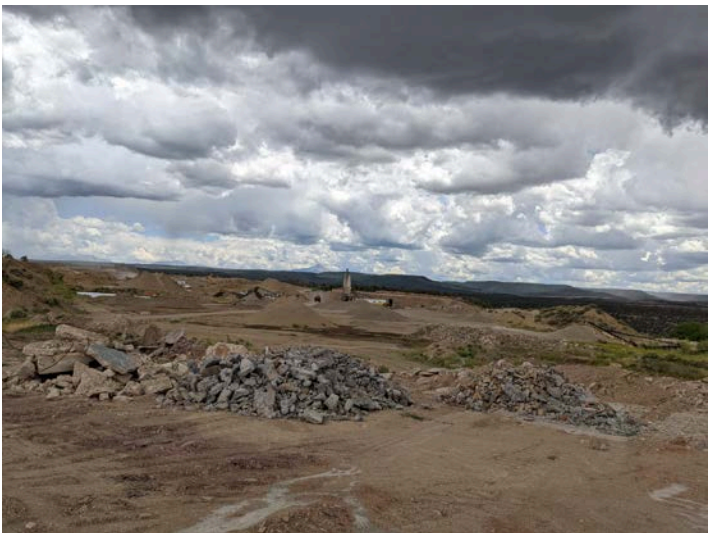
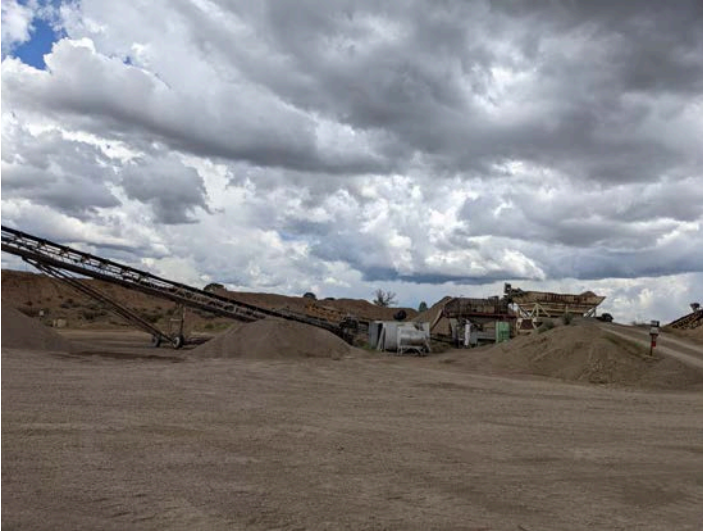
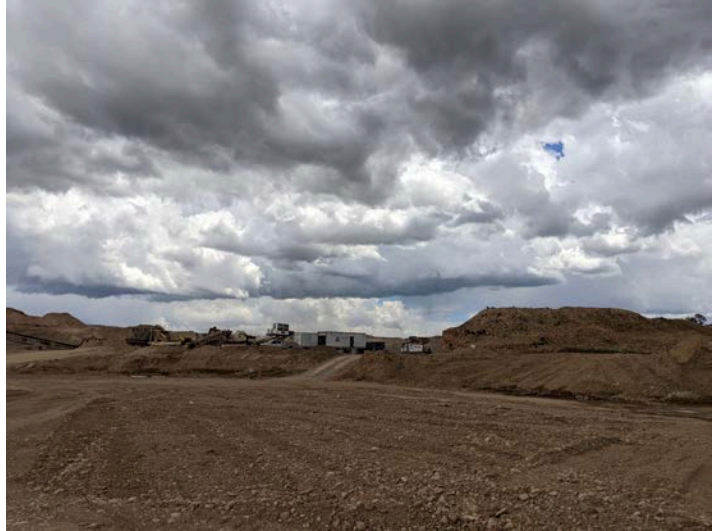
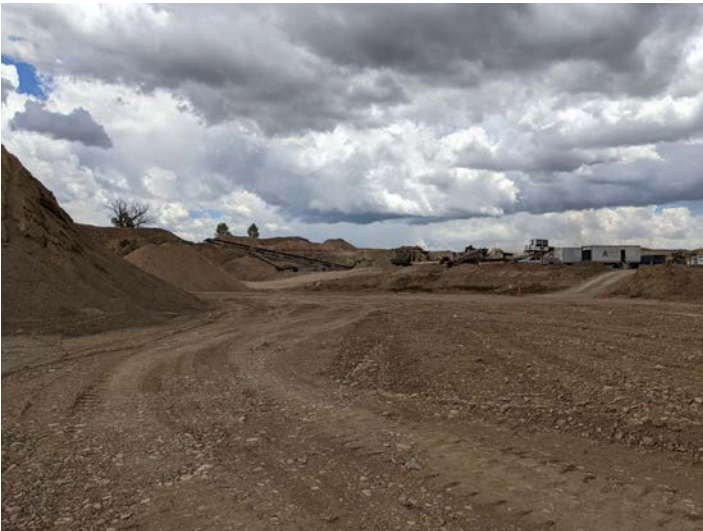
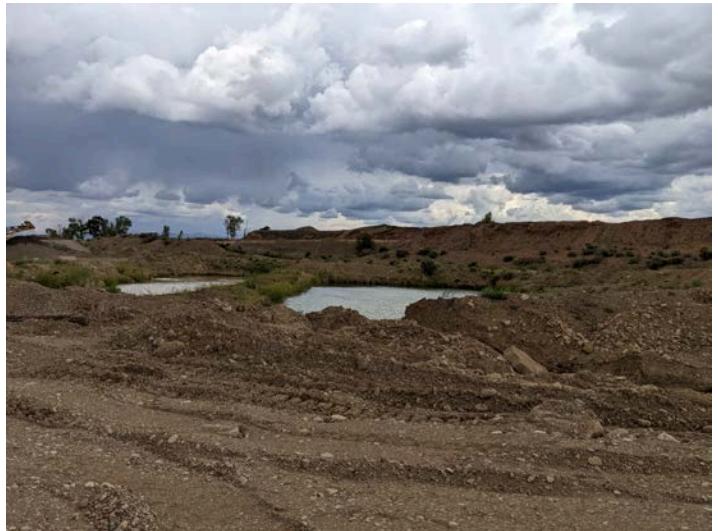
PROBLEM/POSSIBLE VIOLATION: Problem: Mining is not occurring in accordance with the approved Mine Plan. The operation has mined through the south permit boundary daylighting the pit to the adjacent Allen Pit (M-2002-094).

A scalehouse, washout area and stored equipment are located in the north part of the permit area near the site entrance. The area is maintained and orderly. **Small patches of knapweed were observed around this area that will need to be treated.**

Mining is currently taking place in the Phase 1 area in the south part of the permit area. A wash pond, batch plant, crusher and conveyors are located in the Phase 1 area. Materials stockpiles are located throughout the pit floor. During the Division's May 2019 inspection the operator stated that they were pursuing an agreement with the adjacent landowner that would allow the highwall separating the south end of the Angie Pit from the north end of the adjacent Allen Pit (M-2002-094) to be mined out in order to combine the two pits, both of which are operated by the same Operator. The currently approved Reclamation Plan requires that the highwall be backfilled to 2.5H:1V. **The Operator will need to submit a Technical Revision for the permit in order to address this change to the Mine Plan and associated change to the Reclamation Plan. This has been noted as a problem.**

CORRECTIVE ACTIONS: Submit a Technical Revision to the permit to address the change to the Mine Plan and to update the final Reclamation Plan for the site.
