April 14, 2023
Project No.: 19125

Holcim
1687 Cole Boulevard, Suite 300
Golden, CO 80401

Regarding: Daniels Sand Pit 2, Permit No. M-1973-007-SG
Slope Stability Monthly Monitoring Report

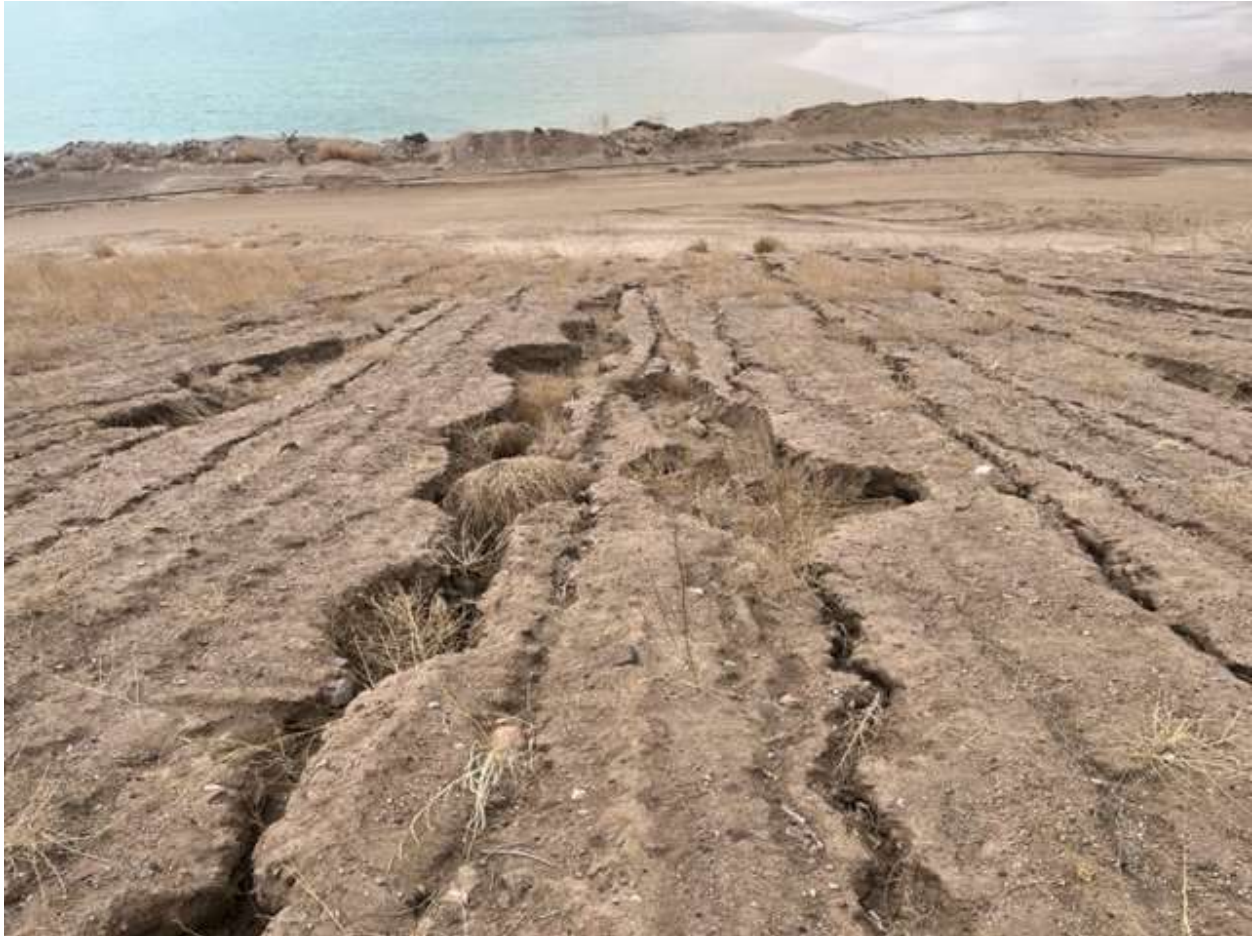
Photo 1. From the top of the buttress, looking down the slope, approximate 4 ft wide erosion gullies in central area of buttress are present.

In previous reports Lithos has addressed the eroding slope and suggested some low-cost repairs, aka gullies be backfilled with compacted soil within and that the areas be seeded per the reclamation plan. Because those recommendations haven't been implemented for the entire buttress there has been significant and rapid degradation of portions slope resulting in deep and steep gullies. As such some of the gully areas may require a more elaborate repair method, e.g. Stripping down to the depth of erosion and benching the slope back into the underlying materials. Neglecting the gullies will likely result in propagation of gullies upwards towards the Fountain Mutual Ditch.

The recommendation is to address the erosion of the slope immediately. Below is a graph of the monthly rainfall for the project area, it shows increasing amount of rainfalls for the next four and a half months. This will expedite the erosion process.

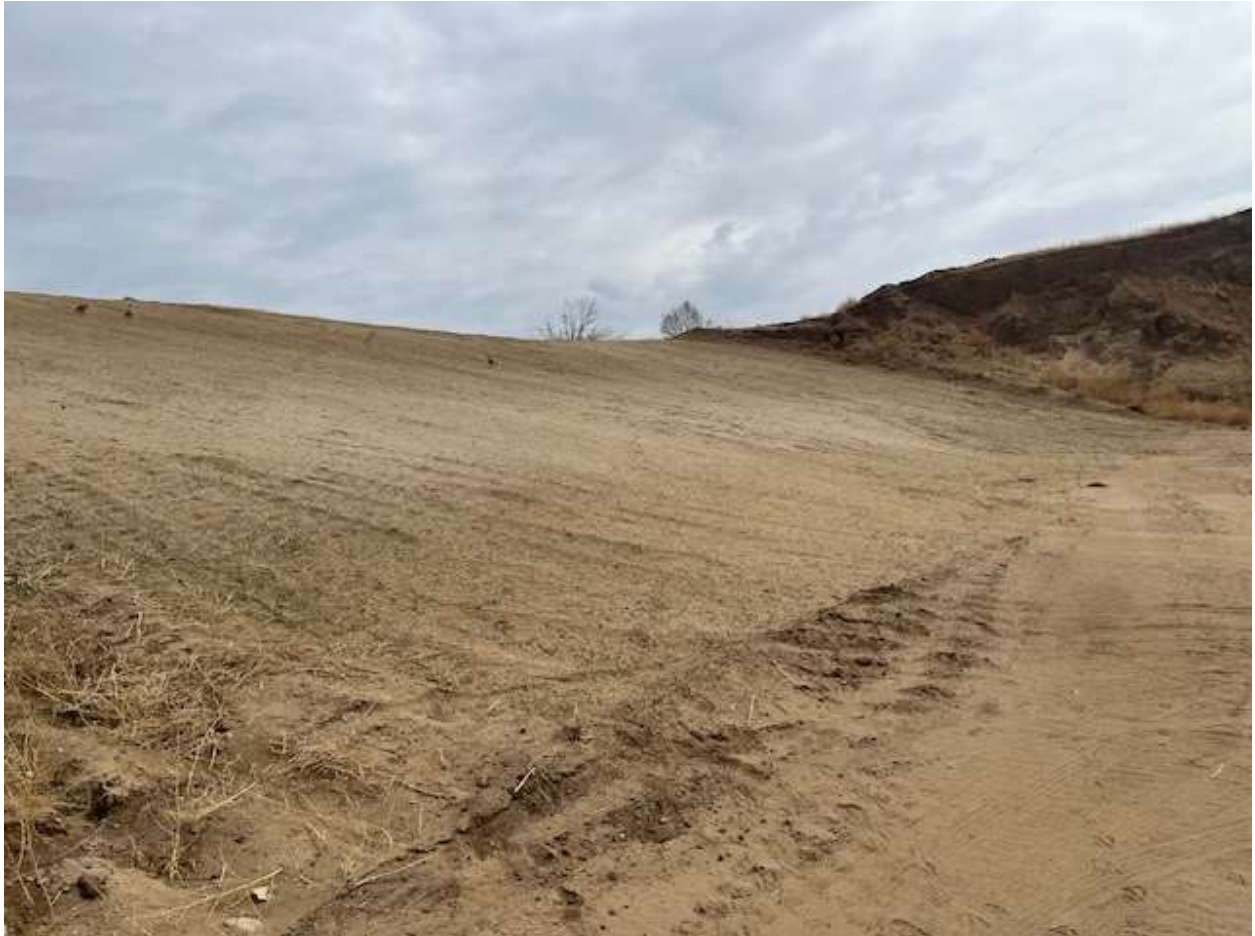
Photo 2. Looking NE from central area showing recently graded buttress slope on east.

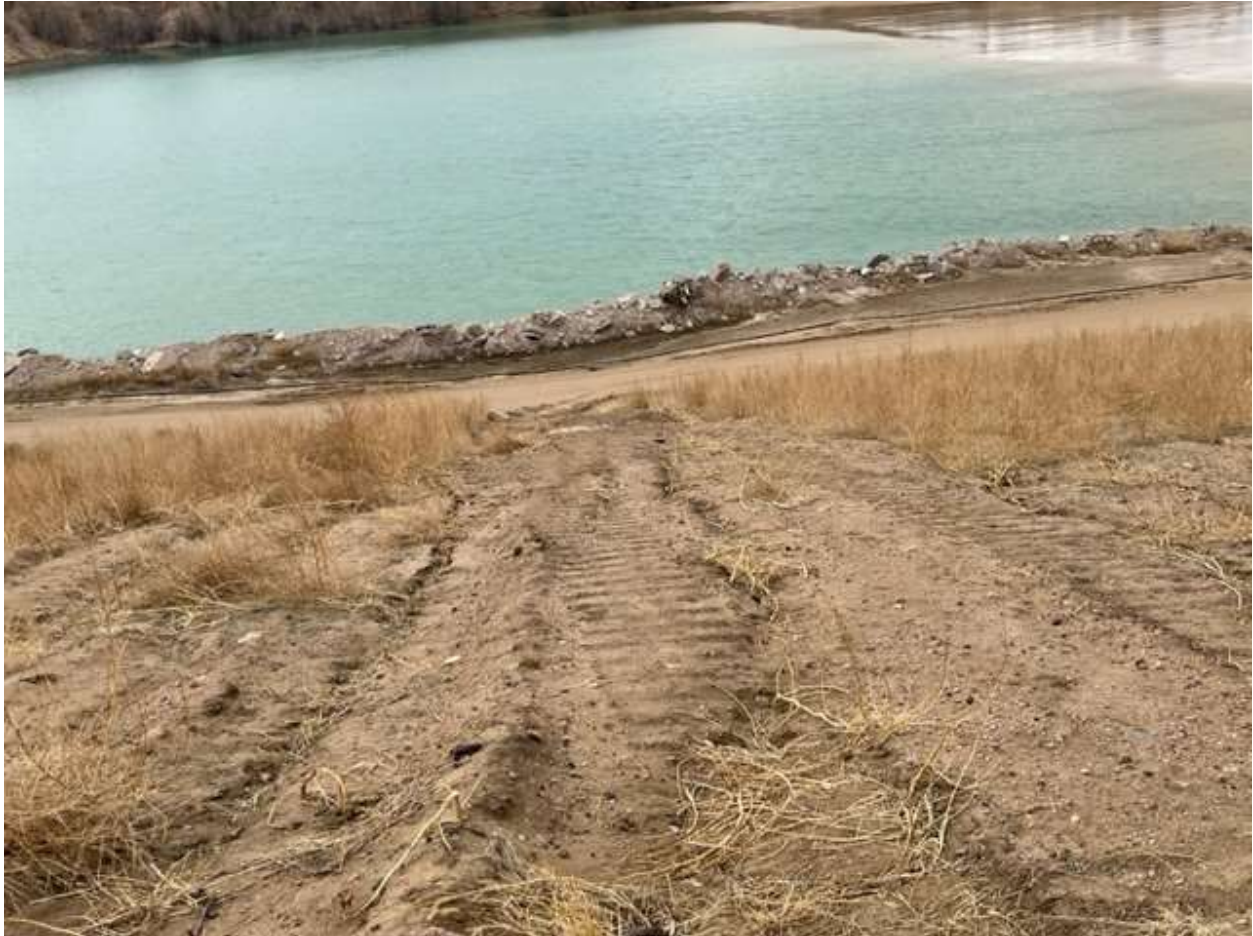
Photo 3. Heavy equipment path going up the slope

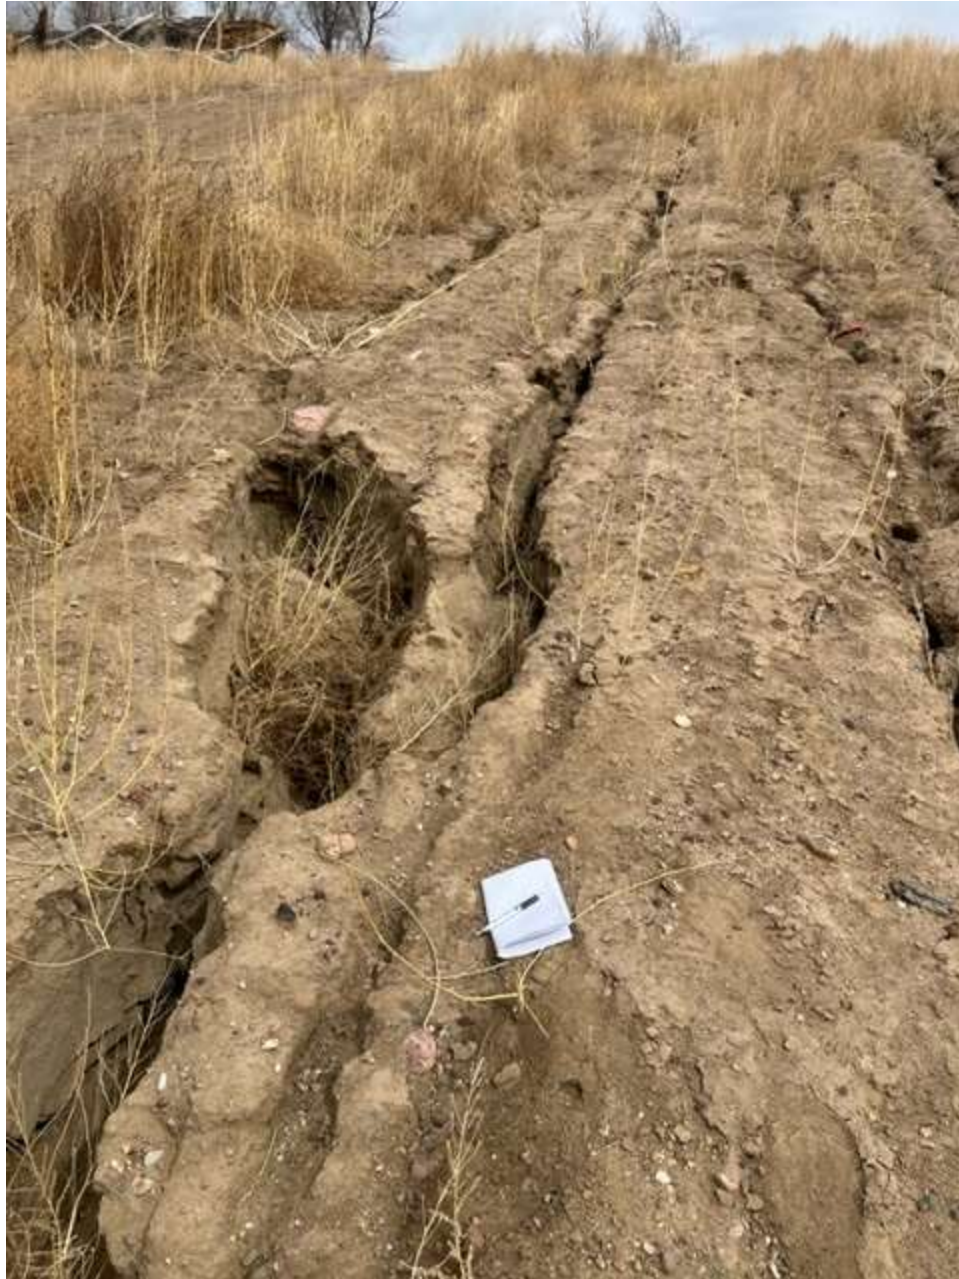
Photo 4. Representative image of erosion gullies near west end of buttress
