### PITCH RECLAMATION PROJECT COLORADO MINED LAND RECLAMATION BOARD 2022 ANNUAL RECLAMATION REPORT

**RECLAMATION PERMIT NUMBER M-1977-004**

April 2023

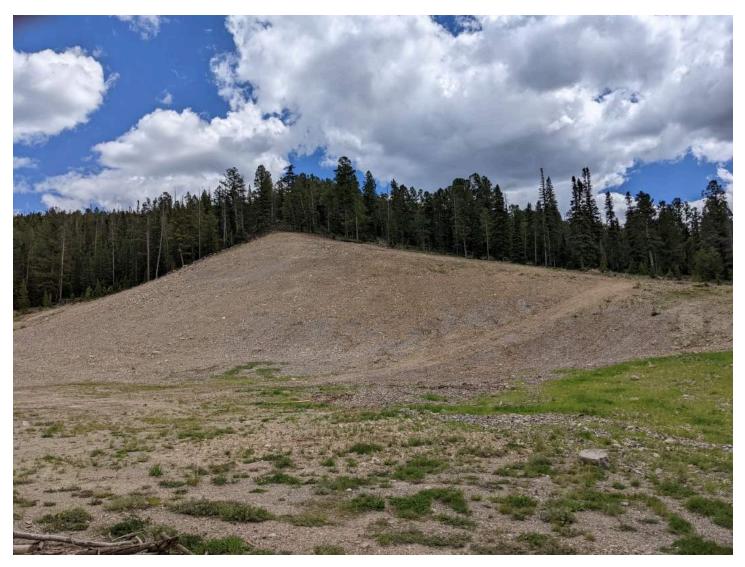
<u>Limestone Quarry</u>: Reclamation grading at the quarry area is complete. The area has been seeded and vegetation is becoming established. The work observed appears to be in accordance with the approved reclamation plan. No problems were noted.

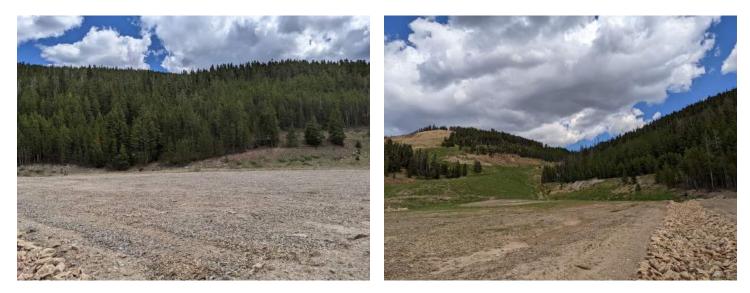
<u>Tie Camp area</u>: The laydown area in the Tie Camp area has been regraded and seeded. Vegetation is becoming established. Drainage structures have been constructed. No problems were noted in this area.

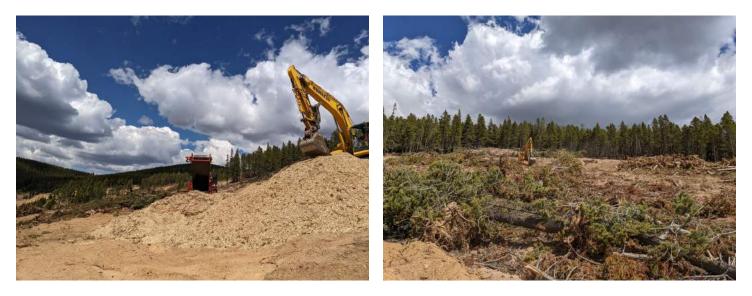
<u>North Pit</u>: Logging is underway to clear-cut the landslide crest area above the North Pit. Trees are to be removed so tension cracks can be filled in to prevent infiltration.

The channel at the 10,500-foot level has been reconstructed to reduce infiltration into the slope and to divert water from the upper Indian drainage around the North Pit Lake. The channel is lined with a geosynthetic clay liner and armored with riprap.

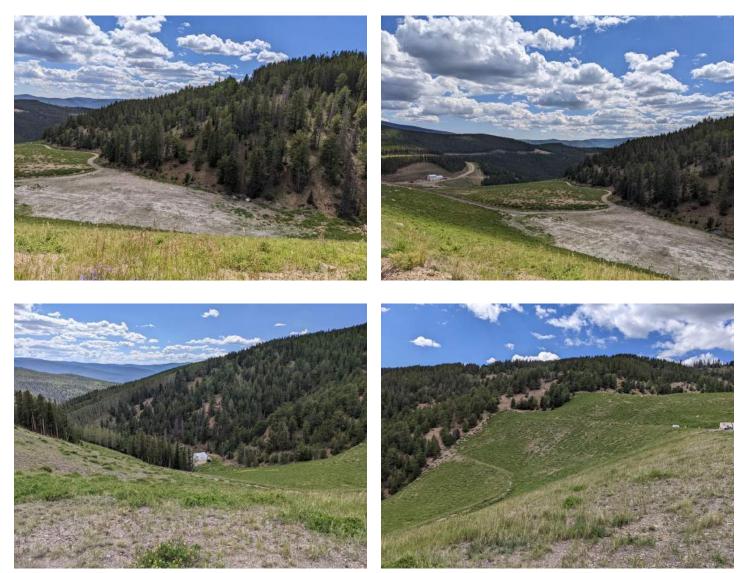
<u>Indian Rock Dump</u>: No problems were noted in the Indian Rock Dump area. Maintenance/improvements have been ongoing to improve drainage of the area. Slopes appeared stable. No erosional issues were noted.

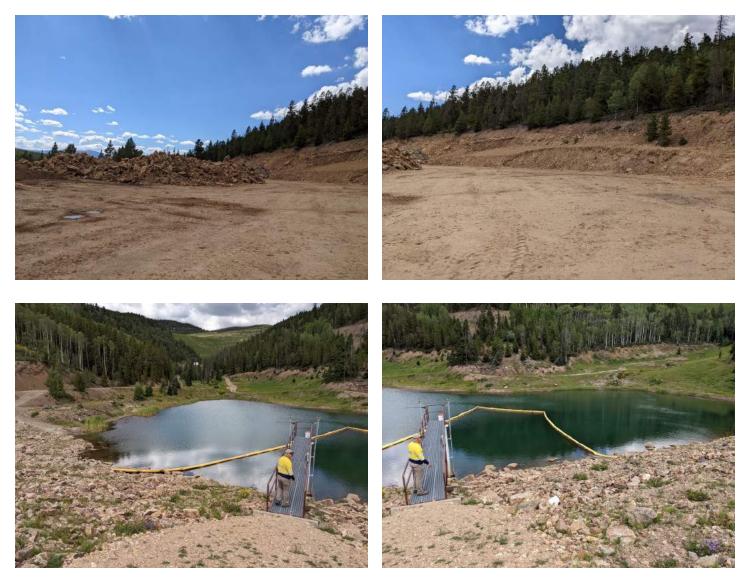
The sandstone quarry is still in use. No problems were noted around the sediment pond area.
