PERMIT INFORMATION

Permit Number: C-1996-083 Mine Name: Bowie No. 2 Mine Operator: Bowie Resources, LLC Operator Address: Mr. Basil Bear P.O. Box 1488 Paonia, CO 81428	County: Delta Operation Type: Underground Permit Status: Active Ownership: Private
	Operator Representative Present: Basil Bear
Operator Representative Signature: (Field Issuance Only)

Inspection Start Date: April 11, 2023 Inspection Start Time: 14:20 Inspection End Date: April 12, 2023 Inspection End Time: 11:10	Inspection Type: Coal Partial Inspection Inspection Reason: Normal I&E Program Weather: Clear
Joint Inspection Agency: None	Joint Inspection Contacts:
Post Inspection Agency: None	Post Inspection Contacts:
Inspector(s): Robert Zuber, P.E.	Inspector's Signature: <i>Robert D. Zuber</i> Signature Date: 4/18/2023

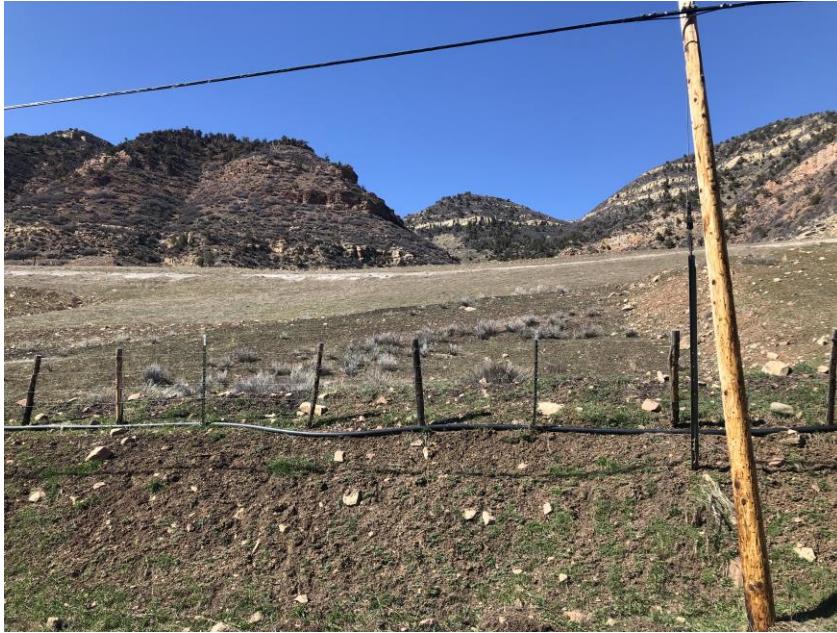
Rings of mineral deposits were seen on Gob Piles 2 and 4, suggesting that water is leaching through the pile. This issue should be alleviated somewhat on Gob Pile 2 when the upper portion is reclaimed and there is less infiltration through the gob.

Lower portion of Gob Pile 2 (note “ring” of mineral deposits from seep)

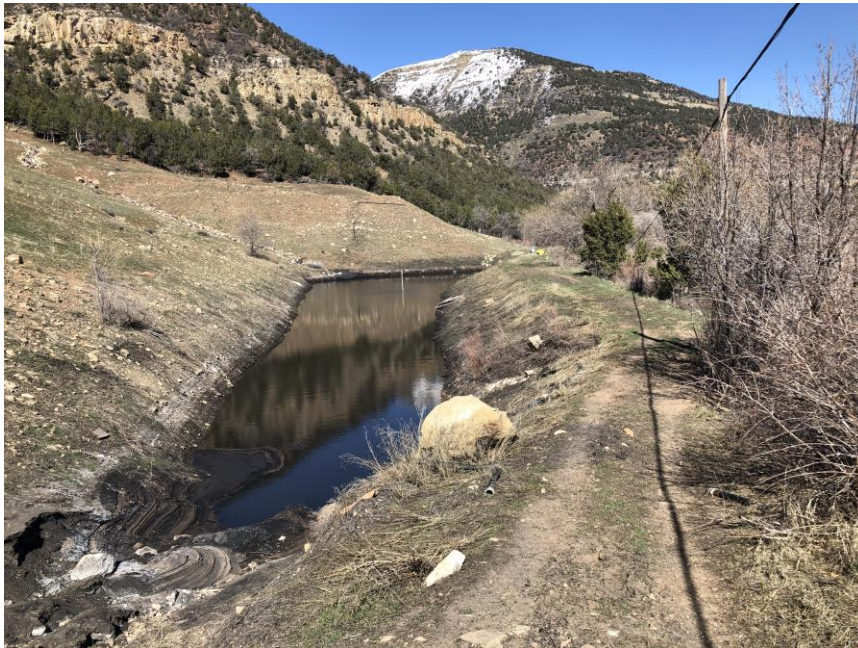
Pond F

Seven sediment ponds were inspected: B, C, D, F, J, and K. None of the ponds were discharging. Most of the ponds contained water, but it was well below spillways. No significant problems were identified with embankments, spillways, inlet channels, or other features of the ponds.

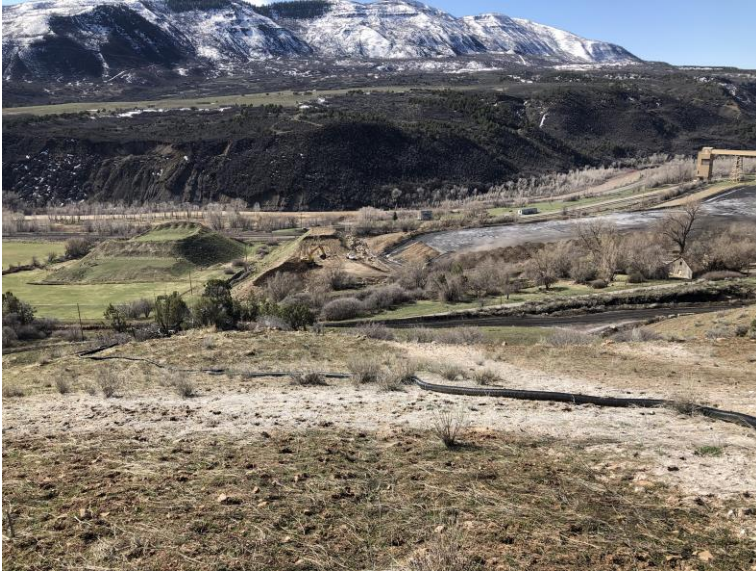
Soil piles east of Gob Pile 3

BRL staff were moving subsoil to the northwest corner of Gob Pile 3 from the stockpile east of that pile.

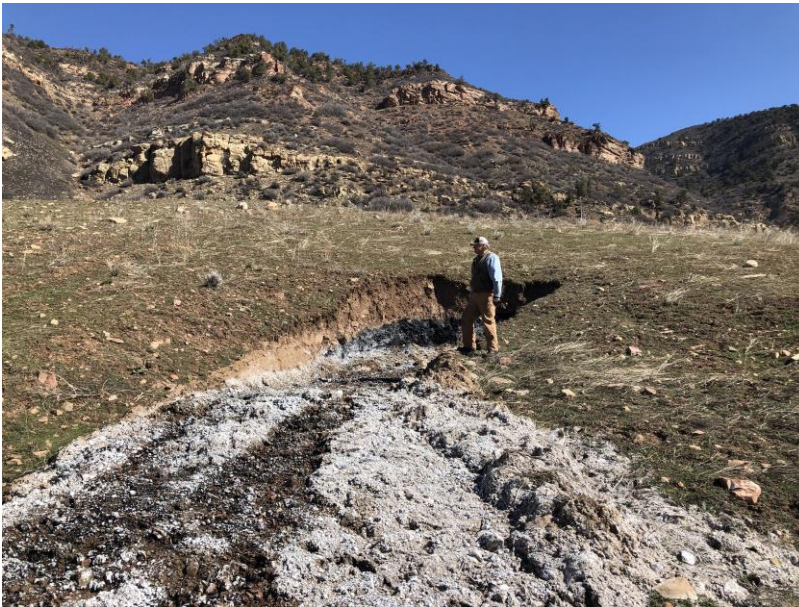
A blowout was seen at Gob Pile 4. This had been reported by BRL via email, and was inspected with Basil Bear. More detail is provided in the Slides and Other Damage section of this report.

The blowout on Gob Pile 4 is about ten feet wide, and the height of the resulting face is approximately seven feet. Several drain pipes were scattered around the area, and apparently had been placed to drain a seep at the area of the blowout. Basil Bear noted that he never saw flow out of the pipe. The area above the blowout was inspected, and no low spots for water ponding was seen. However, the diversion ditch above this area needs to be cleaned.

Blowout on Gob Pile 4

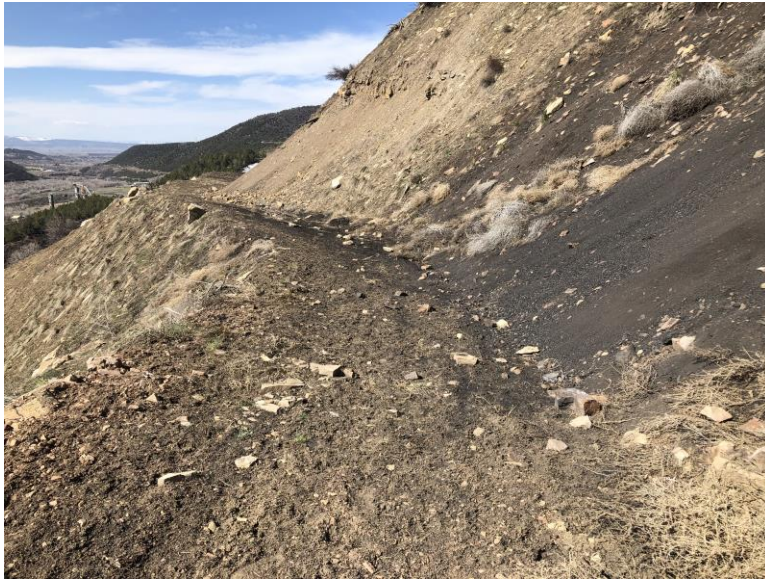
West Diversion Ditch above the blowout on Gob Pile 4

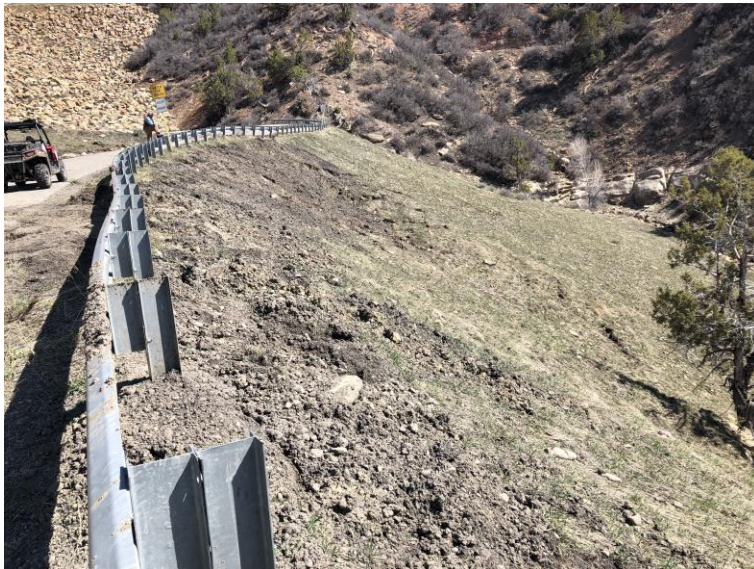
- A slide has appeared above Curve 6.
- The slide on the west side of the B Portal bench is significantly worse and covers a bigger area than in the past.
- A small slide was seen at Curve 10.

Slide above Curve 6 (Curve 8 in background)

These slides need to be monitored closely, and ditches and culverts along the road to the portals must be continually inspected to make sure they are functioning. Also, on the road surface itself, any cracks that appear need to be sealed to prevent water from saturating the soil below the road. .

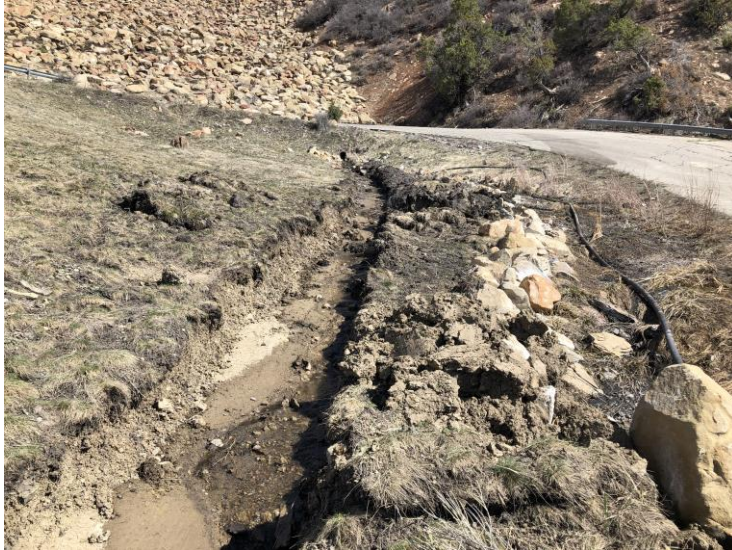
The ditch below Curve 8 on the road to the portals (Ditch B10) has been temporarily repaired. Permanent repairs (e.g., riprap) are required. No other problems with ditches or culverts were seen.

Temporary repair of Ditch B10 (Curve 8 in background)

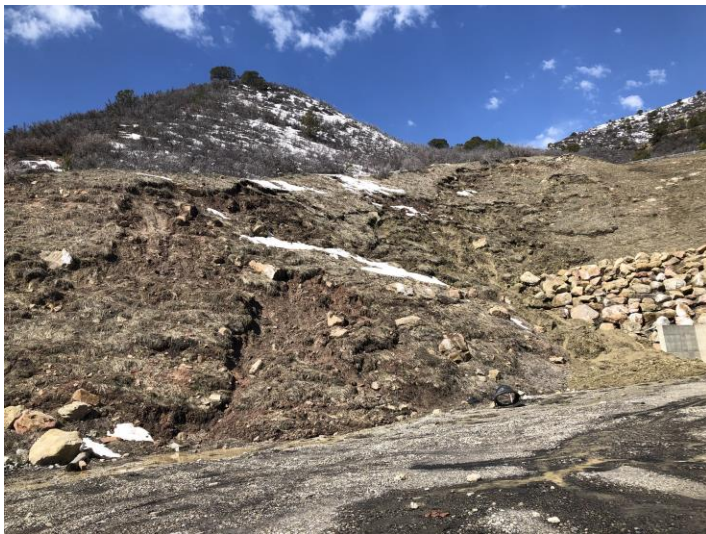
Slides above the B Portal bench
