MINERALS PROGRAM INSPECTION REPORT
PHONE: (303) 866-3567

MINE NAME: Pikeview Quarry	MINE/PROSPECTING ID#: M-1977-211	MINERAL: Limestone (general), granite, granite gneiss and dolomite	COUNTY: El Paso
INSPECTION TYPE: Monitoring	WEATHER: Cloudy	INSP. DATE: April 13, 2023	INSP. TIME: 10:00
OPERATOR: Continental Materials Corporation	OPERATOR REPRESENTATIVE: Jerry Schnabel	TYPE OF OPERATION: 112c - Construction Regular Operation	
REASON FOR INSPECTION: Priority	BOND CALCULATION TYPE: None	BOND AMOUNT: \$13,389,784.00	
DATE OF COMPLAINT: NA	POST INSP. CONTACTS: None	JOINT INSP. AGENCY: None	
INSPECTOR(S): Timothy Cazier, P.E.	INSPECTOR'S SIGNATURE:

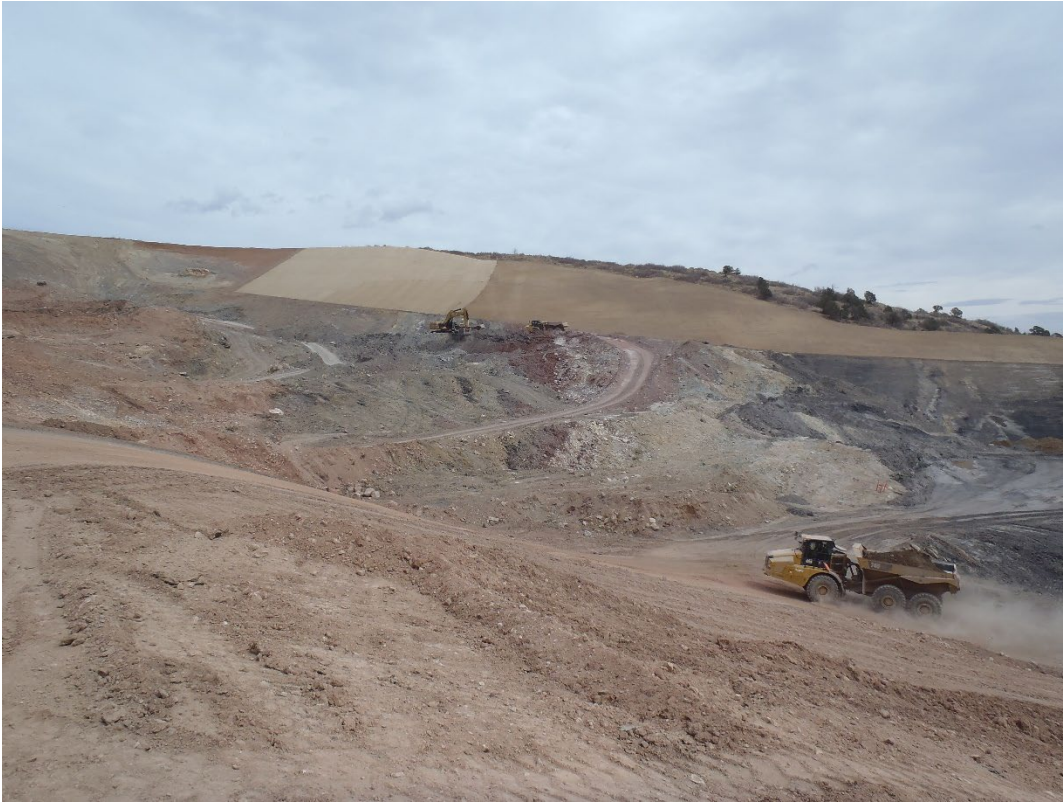
Backfill/Grading: Backfill was being actively excavated from both the north (**Photo 1**) and south borrow areas (**Photo 2**). Site representatives stated 70 percent of the compacted backfill had been placed as of this inspection (**Photos 3 and 4**). Site representatives stated the goal is to reach 100 percent of the backfill placed by the end of August, 2023.

Photo 1. Active excavation of north borrow area (looking NE from top of backfill).

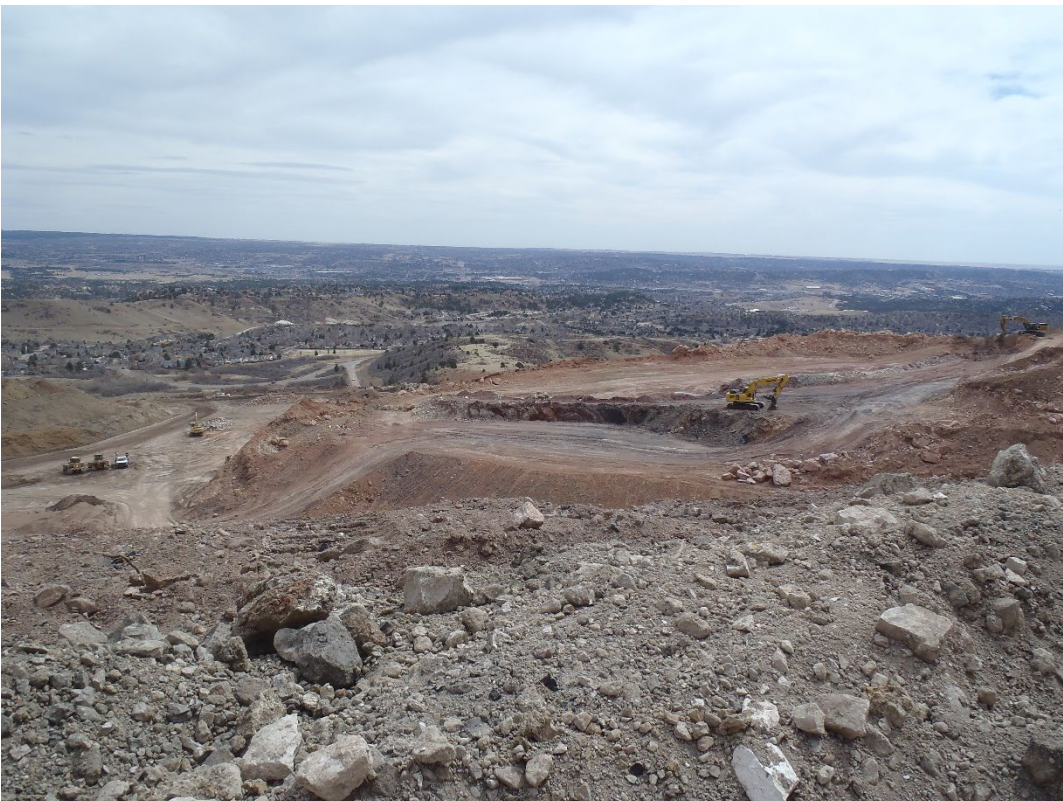
Photo 2. Active excavation of south borrow area (looking SE from top of backfill).

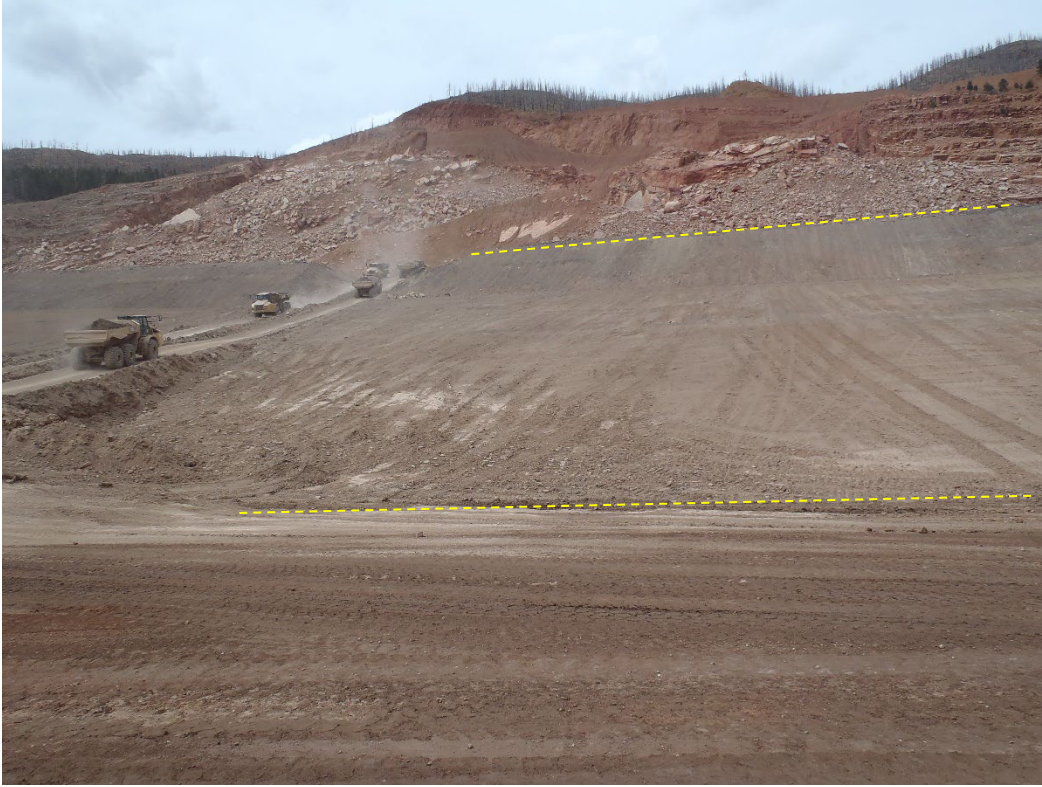
Photo 3. Full height of backfill placed (between dotted lines) to date (looking west from toe area).

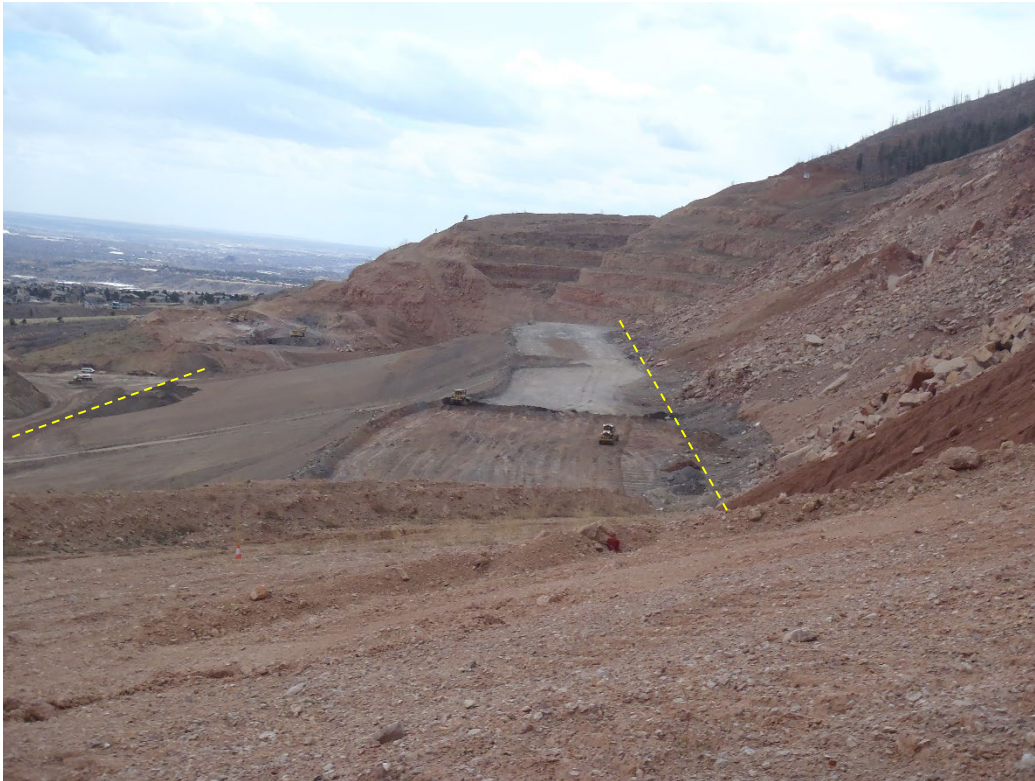
Photo 4. Placed backfill (between dotted lines, looking south) .

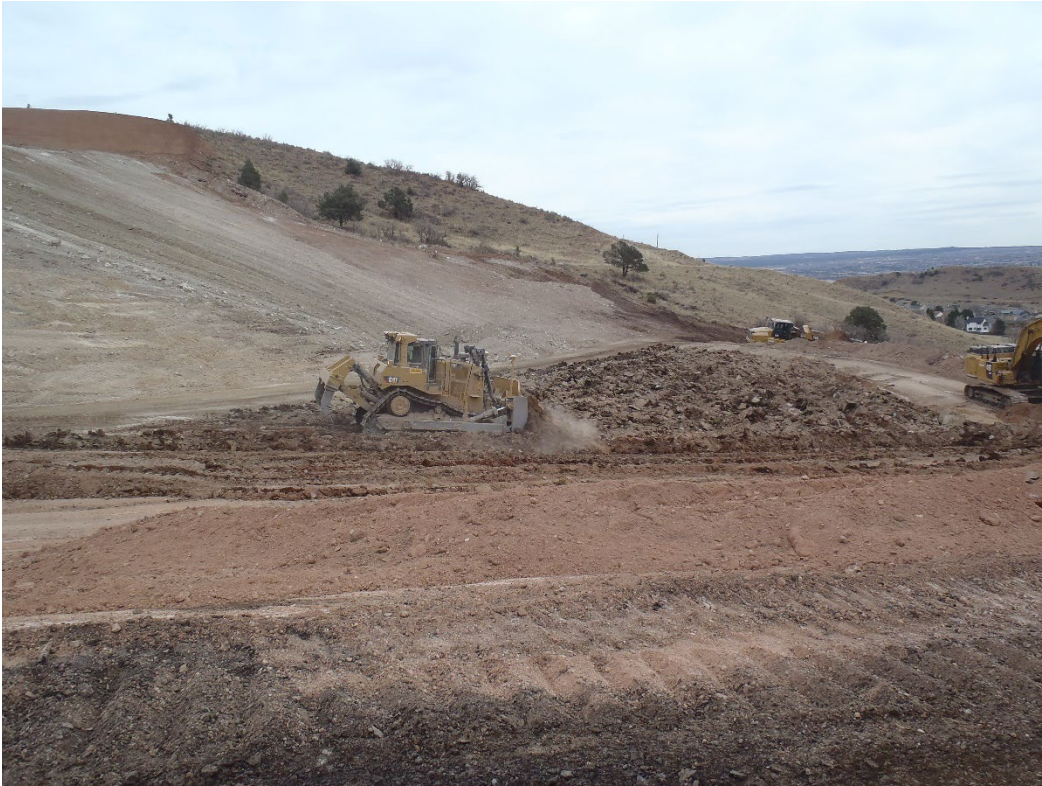
A dozer was observed beginning shaping of the lower (east) end of the main stormwater channel (**Photo 5**). Riprap for the stormwater channels was being screened (**Photo 6**) and stockpiled near the south borrow area.

Photo 5. Full height of backfill placed (between dotted lines) to date (looking west from toe area).

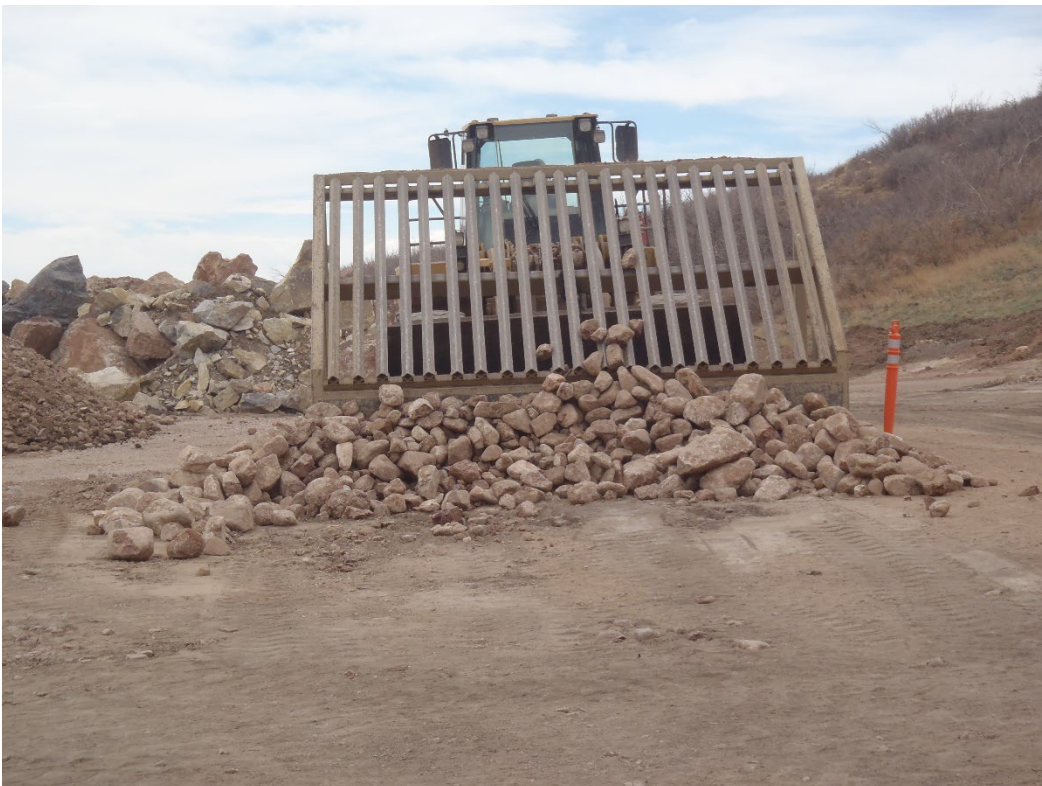
Photo 6. Riprap (grizzly) screen (south of backfill area).

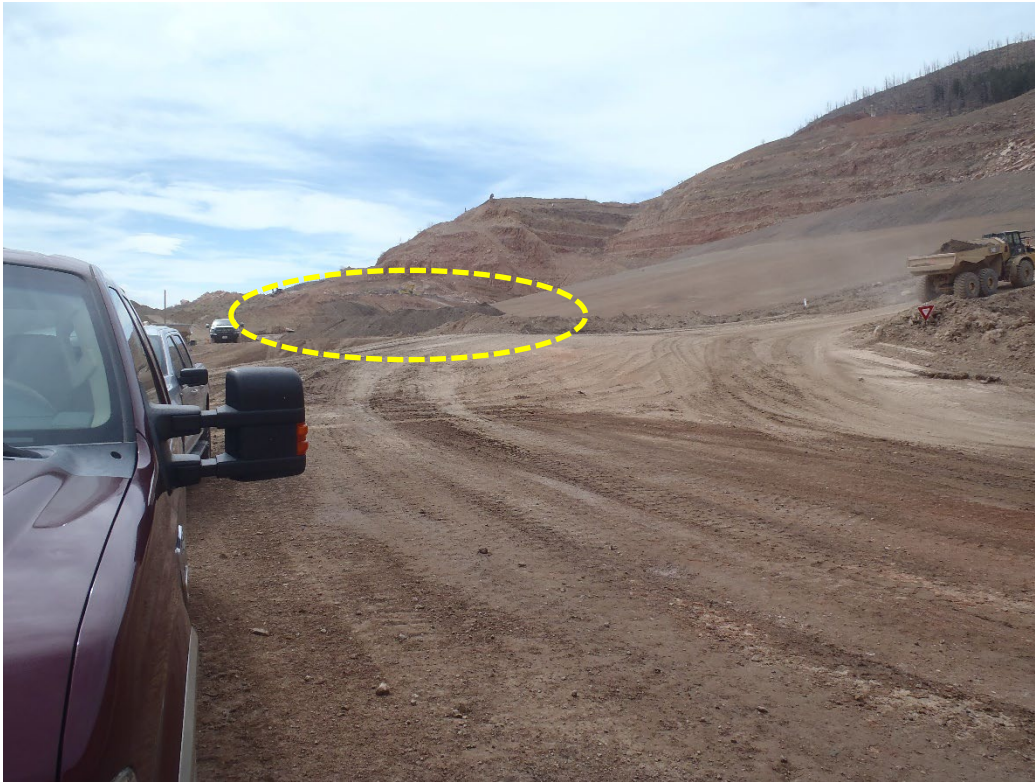
Topsoil: Topsoil was observed stockpiled at the toe of the south end of the backfill (**7**) and in the former shop area (**Photo 8**) for spreading prior to seeding an additional 30 acres planned for May 2023.

Photo 7. Topsoil ready for spreading on lower tier of backfill (looking south from backfill toe).

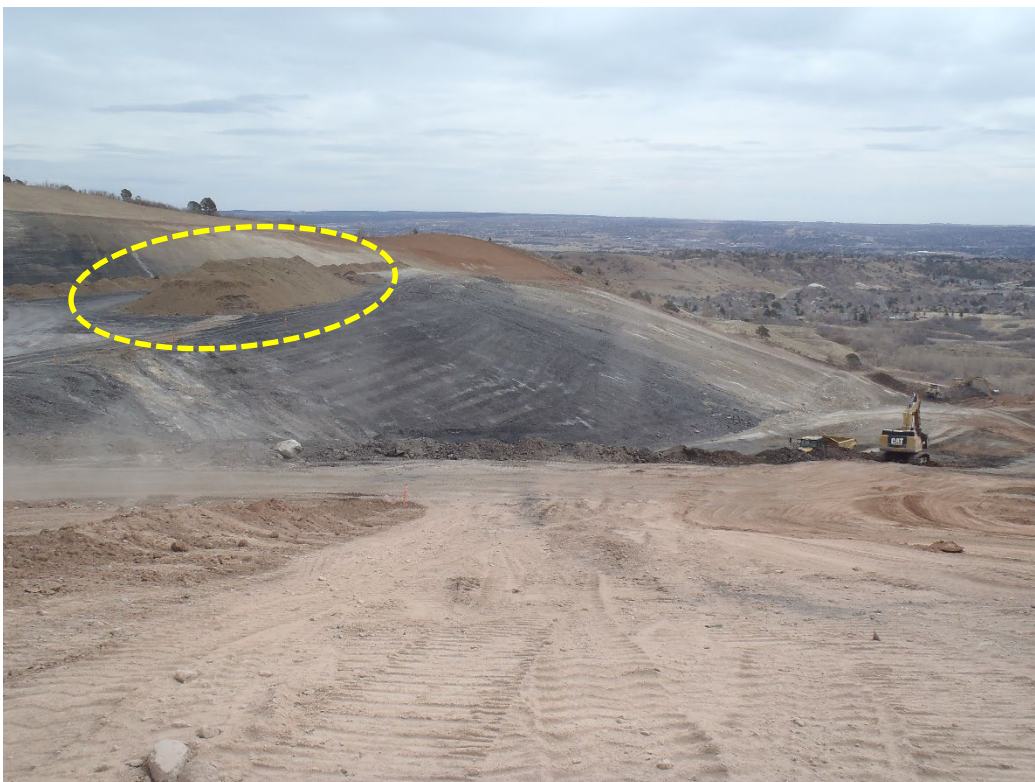
Photo 8. Topsoil ready for spreading on north shop area (looking NE from top of backfill).
