MINERALS PROGRAM INSPECTION REPORT
PHONE: (303) 866-3567

MINE NAME: Guenzi S & G Pit	MINE/PROSPECTING ID#: M-1987-159	MINERAL: Sand and gravel	COUNTY: Logan
INSPECTION TYPE: Monitoring	WEATHER: Clear, cool	INSP. DATE: March 14, 2023	INSP. TIME: 11:00
OPERATOR: Logan County	OPERATOR REPRESENTATIVE: Jeff Reeves	TYPE OF OPERATION: 112c - Construction Regular Operation	
REASON FOR INSPECTION: Normal I&E Program	BOND CALCULATION TYPE: None	BOND AMOUNT: N/A	
DATE OF COMPLAINT: NA	POST INSP. CONTACTS: None	JOINT INSP. AGENCY: None	
INSPECTOR(S): Nikie Gagnon	INSPECTOR'S SIGNATURE:

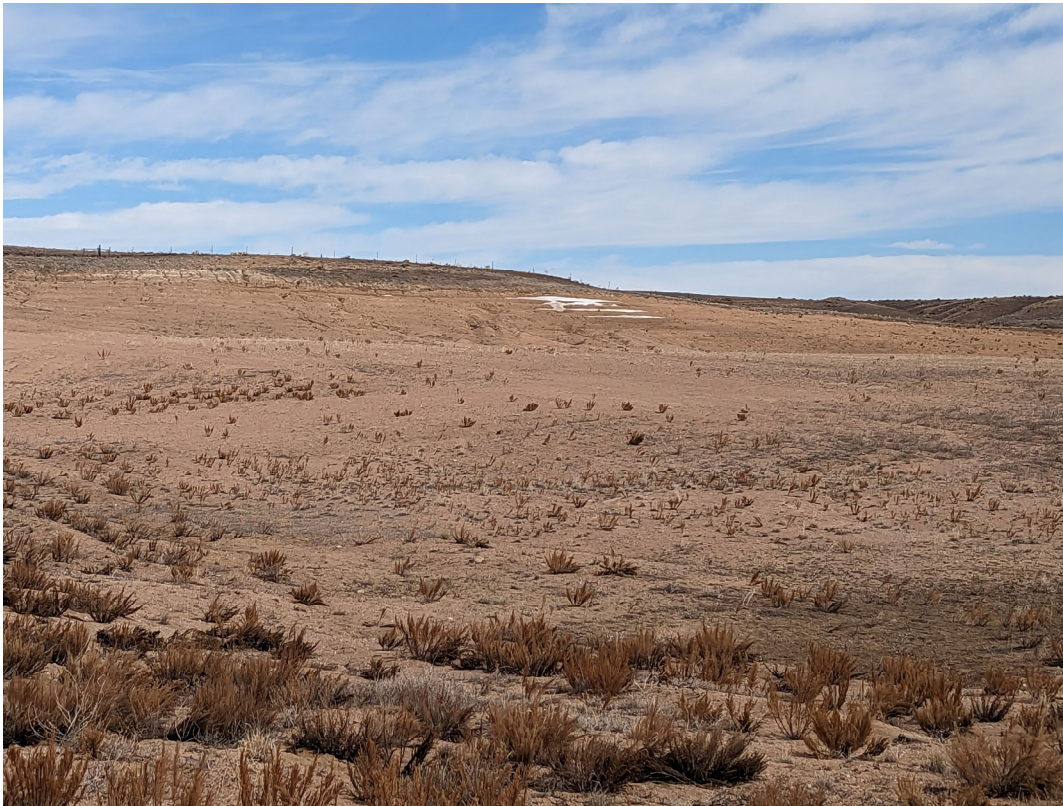
The slopes around the pit have been graded to 3H:1V or flatter. The Division observed some water erosion rills developing on the northern slope and recommends repairing the slopes prior to spreading topsoil and seeding.

Photo 1. Looking north across the former pit area. Erosion rills noted on slope.

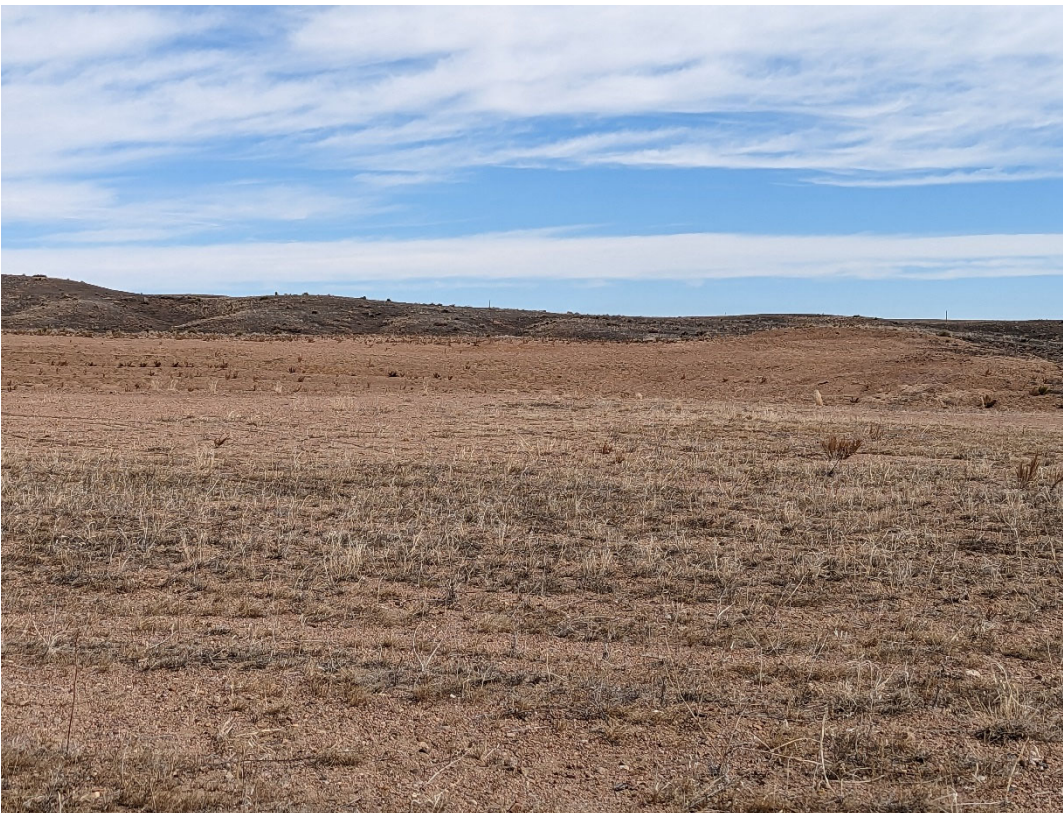
Photo 2. Looking northeast across the former pit area.

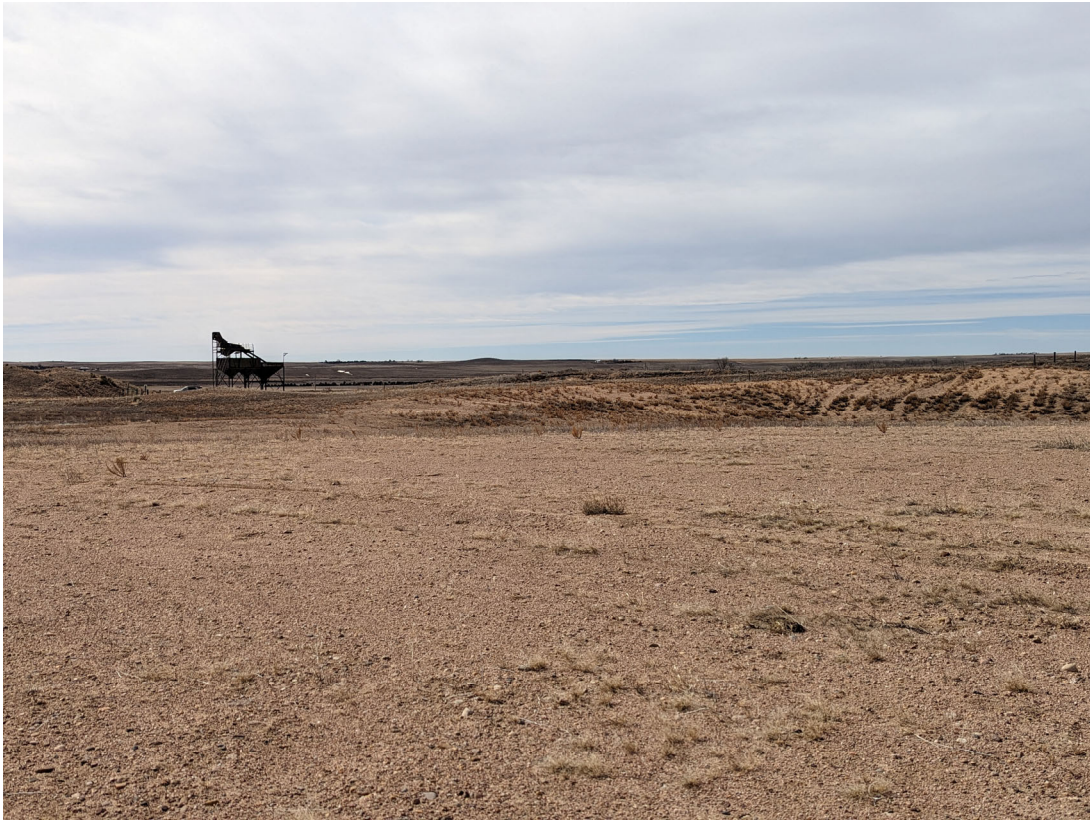
During the last inspection on February 12, 2019, the Operator indicated grading, topsoiling and seeding would occur in the spring of 2019. During this inspection, graded slopes were observed, however, topsoiling and seeding has not yet occurred. Very little vegetation has sprouted on the former pit and slopes and a few weeds are starting to encroach. According to the Mr. Reeves, grading of the pit slopes occurred in 2020 and topsoil needs to be brought in to complete reclamation. The approved reclamation plan states topsoil will be spread uniformly over the disturbed area to a packed depth of 6 inches. The disturbed area will be drill seeded using the approved seed mix and straw mulch will be spread and crimped into the soil at a rate of 4,000 pounds per acre to control wind and water erosion until grass becomes established.

Photo 3. Looking south across former pit area. Little vegetation has reestablished.

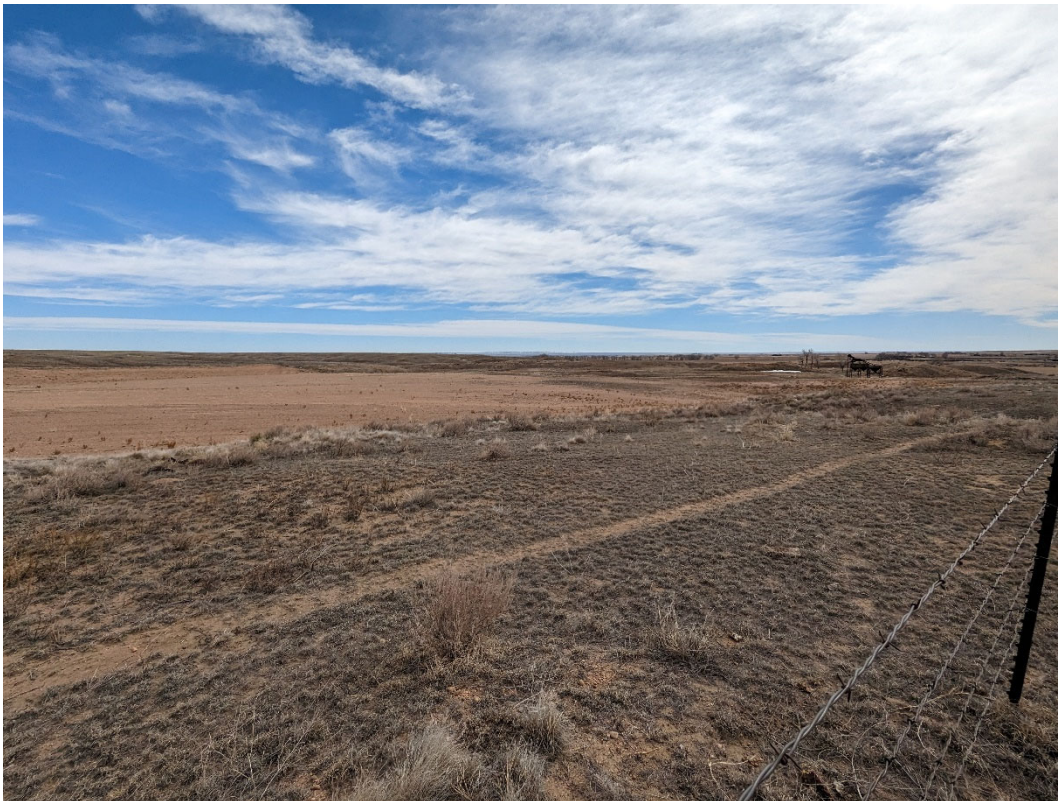
Photo 4. Looking southeast across former pit from the fence that runs along the county road.

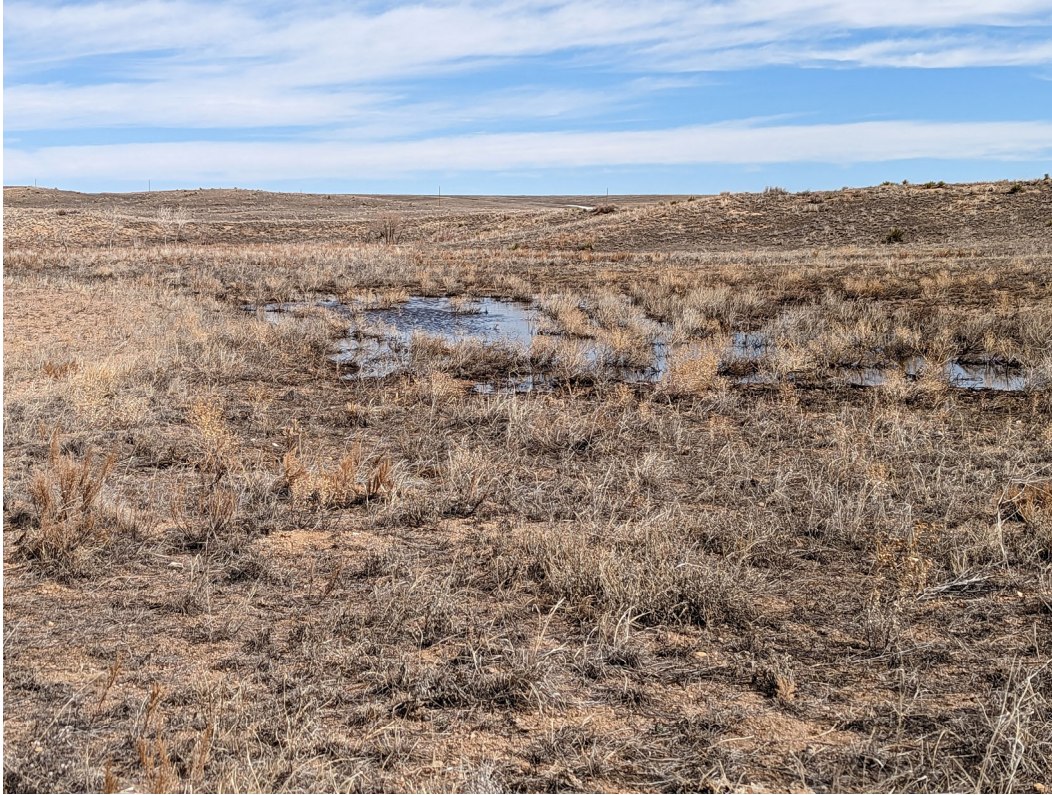
A shallow pool of water was observed within the southern area of the permit, within the original 9.96 acre permit boundary. This is likely snow melt from recent storms. The Division reminds the operator to monitor this area and avoid improper impounding of stormwater beyond 72 hours.

Photo 5. Looking east from the southern end of the pit. Shallow pool of water from snowmelt.

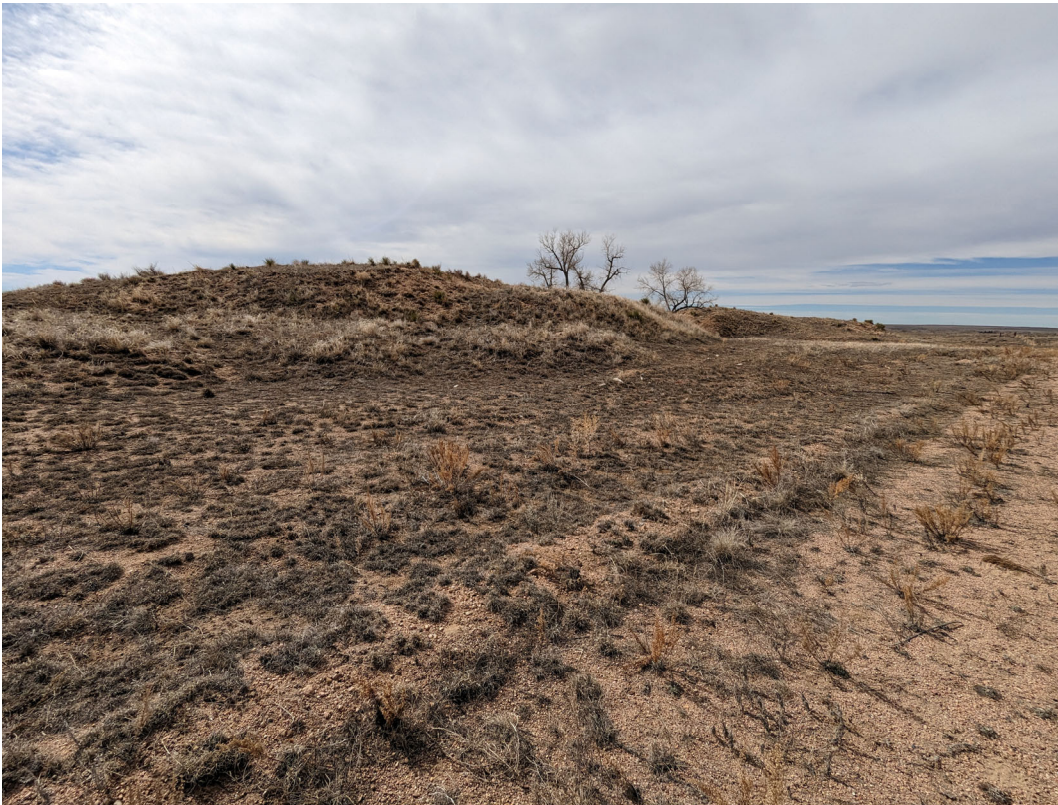
Photo 6. Berm along the southern edge of the permit area.

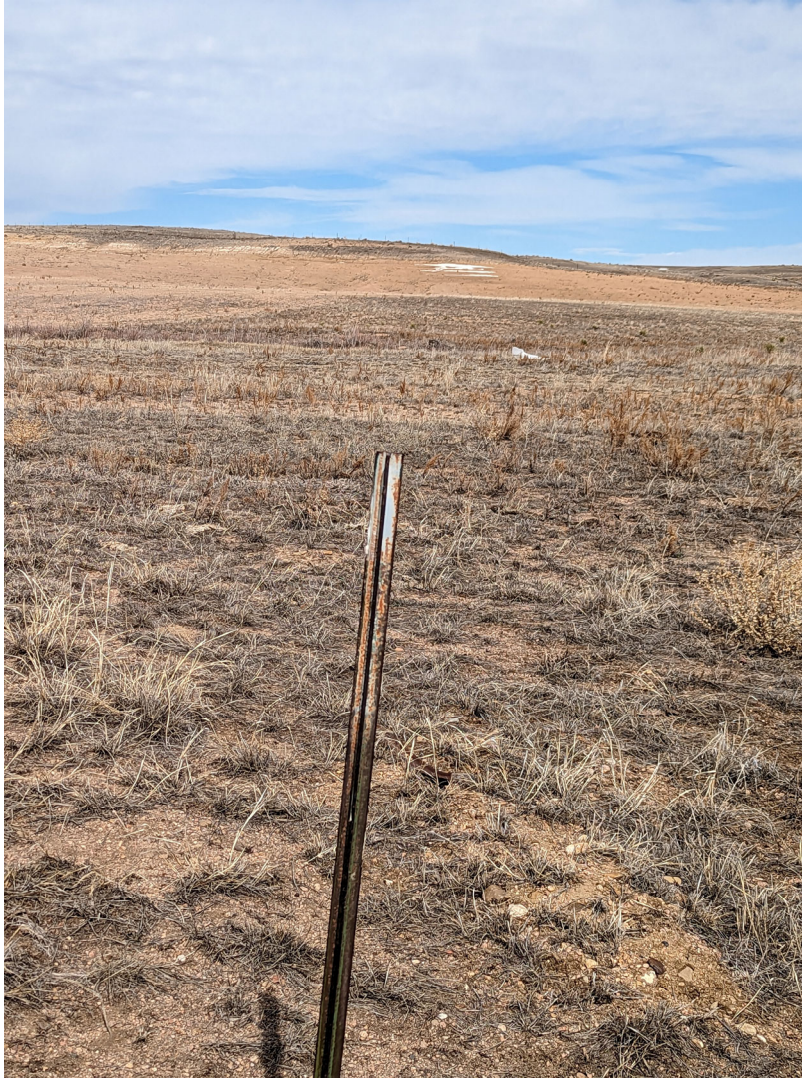
Photo 7. Looking north from southeast boundary marker

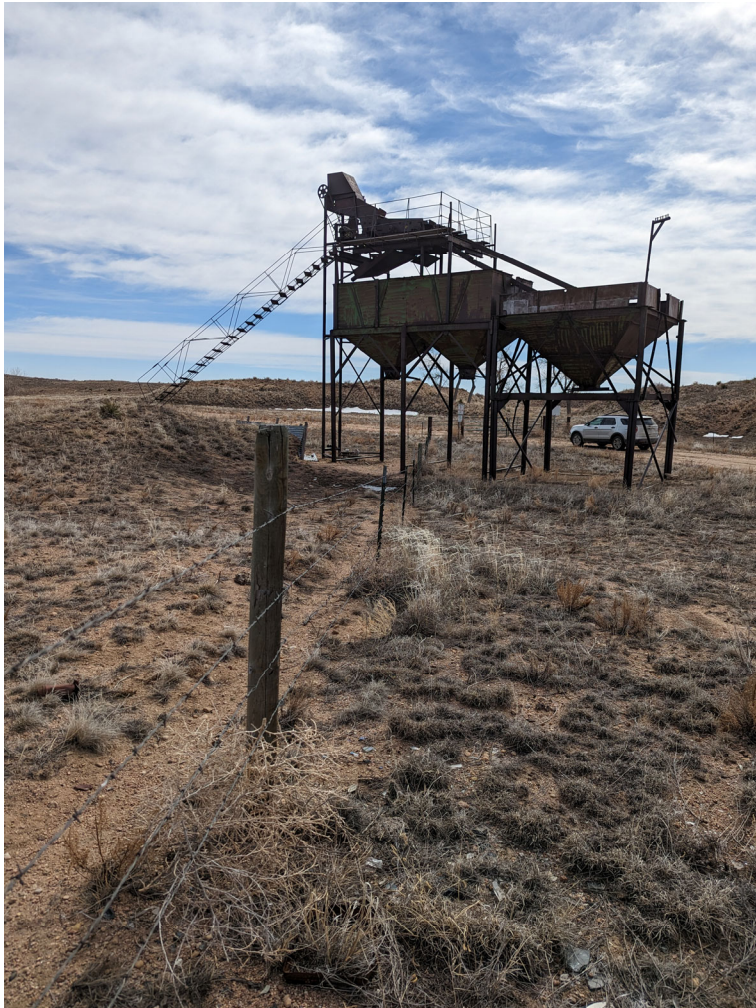
No evidence of recent mining was noted at the time of the inspection. A large hopper/load out bin remains on site near the entrance. Per the approved reclamation plan, the hopper will need to be removed since the plan states no structures will remain after reclamation.

Photo 7. Hopper/load out bin remains on site near the entrance
