MINERALS PROGRAM INSPECTION REPORT
PHONE: (303) 866-3567

MINE NAME: Two Rivers	MINE/PROSPECTING ID#: M-1998-038	MINERAL: Gravel	COUNTY: Pueblo
INSPECTION TYPE: Monitoring	WEATHER: Clear	INSP. DATE: March 28, 2023	INSP. TIME: 09:15
OPERATOR: Kirkland Construction, R.L.L.P.	OPERATOR REPRESENTATIVE: Mike Ausmus	TYPE OF OPERATION: 112c - Construction Regular Operation

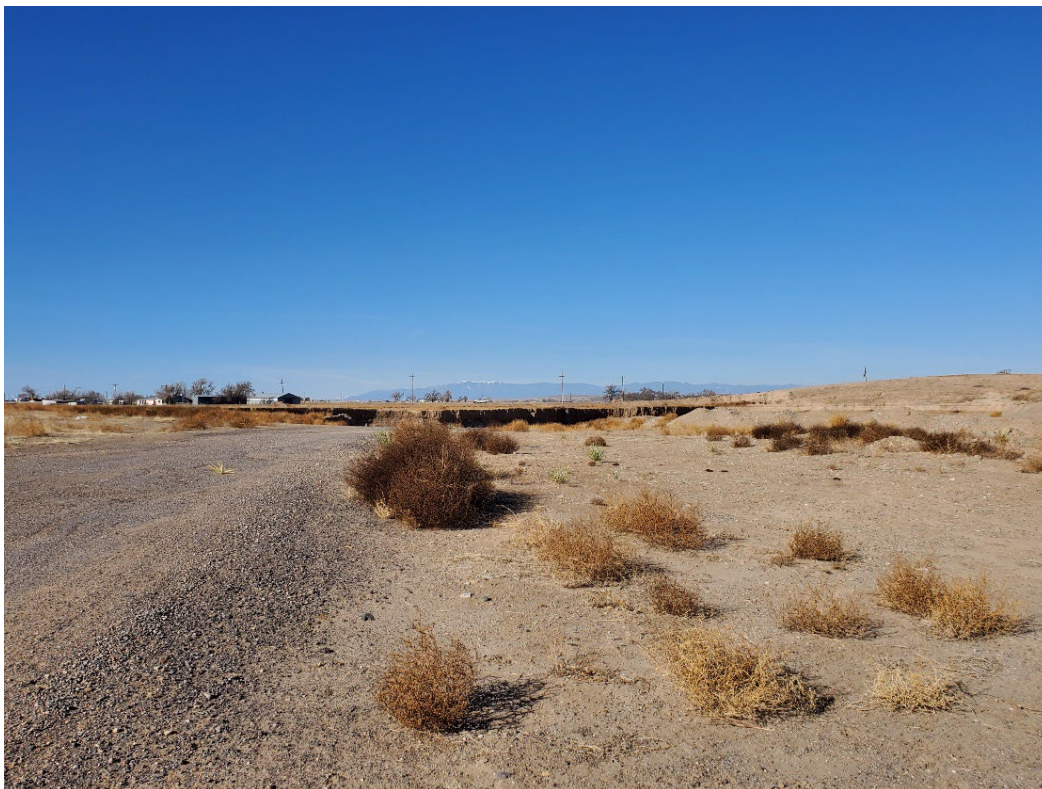
Photo 7: Looking north-west at the highwall in Phase 3.

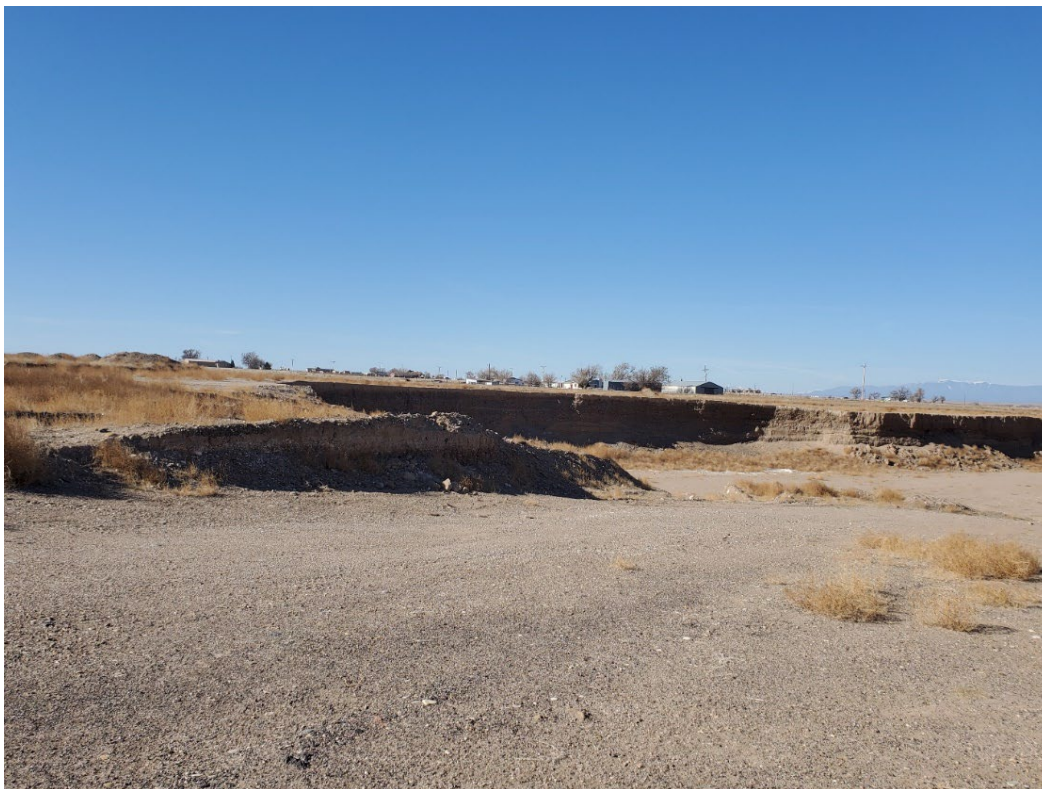
Photo 9: Looking west across the western boundary of Phase 3 at the highwall.

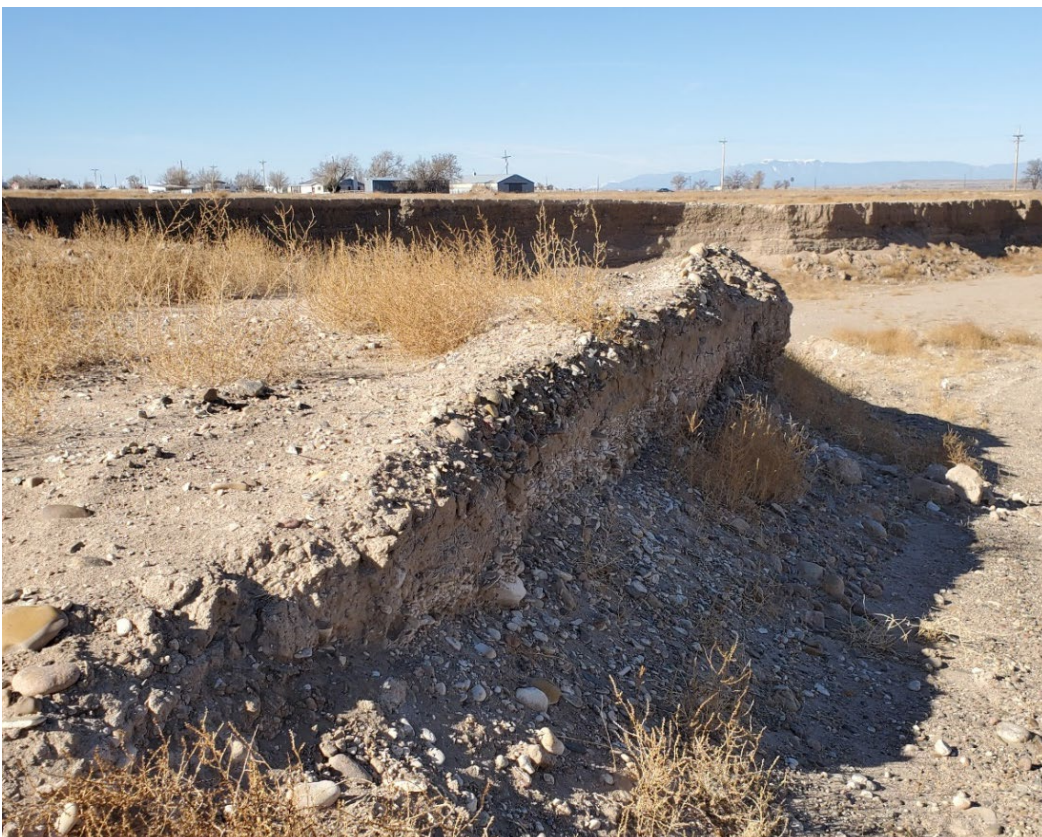
Photo 10: Looking north-west at western boundary of the Phase 3 highwall from pit entrance.

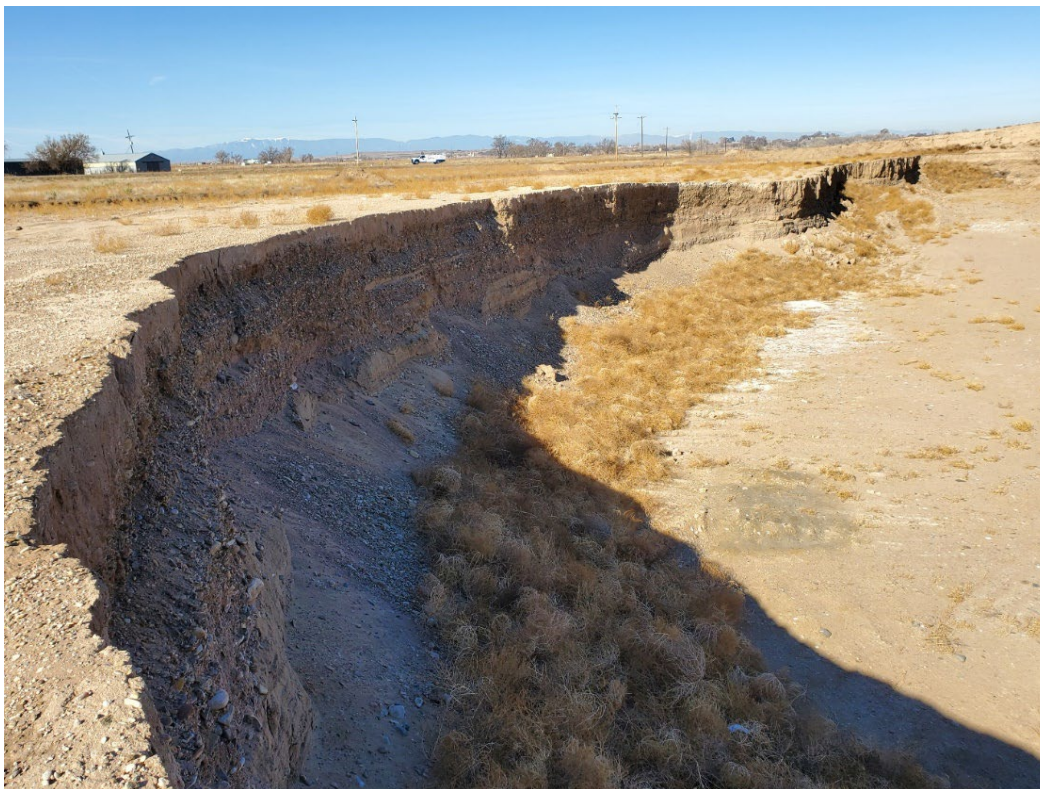
Photo 11: Looking north-west along western highwall in the Phase 3 area.

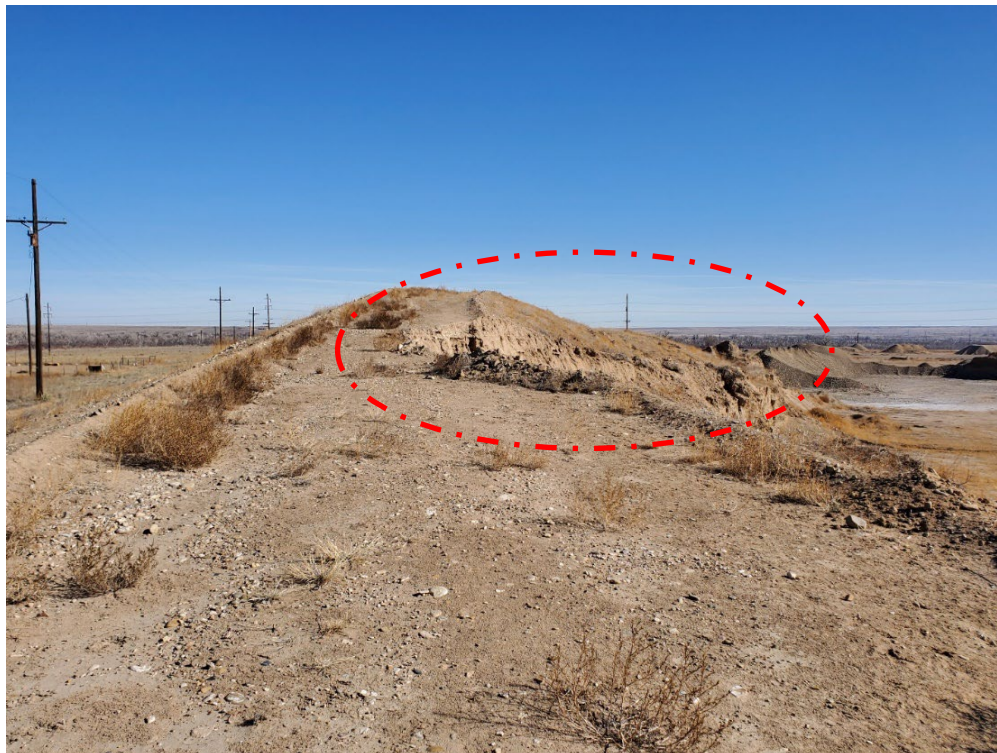
PROBLEM: The topsoil pile is located in an area not approved to be affected by mining. Additionally, the topsoil stockpile does not have established vegetation on it and is therefore susceptible to erosion and appears to have been affected by the mining operation. This is a problem for failure to protect the topsoil stockpile from erosion in accordance with Rule 3.1.9(1). Also, this is a problem for failure to minimize disturbance to the stockpiled topsoil from the mining operation in accordance with Rule 3.1.9(3)

A problem was cited above due to improper topsoil placement, stabilization, and damage. The topsoil pile was identified along the western edge of the highwall in Phase 3. Sparse vegetation has established on the stockpile and it appears the topsoil stockpile has been damaged (see Photos 16-19, 21, and marker 2 on Map 1). The topsoil pile is directly above the northernmost highwall in the Phase 3 area. Additionally, the topsoil pile is almost entirely placed within the 200' buffer area that needs to be backfilled and reclaimed. Because the topsoil pile will need to be re-located, and because of its proximity to mining operations, this problem is cited for failure to comply with Rule 3.1.9(3). Pursuant to Rule 3.1.9(3) topsoil must be stockpiled in places and configurations to minimize erosion and located in areas where disturbance by ongoing mining operations will be minimized. Once the topsoil pile is in a new location within the approved affected boundary, and is placed separately from on-going mining activities, pursuant to Rule 3.1.9(1), the pile will need to be seeded/re-seeded. The Operator shall submit evidence to the Division that the topsoil pile has been re-located and stabilized prior to the corrective actions date. Or, the Operator may submit a technical revision revising the mining plan to allow the stockpiling of topsoil in this location to comply with the applicable requirements of Rule 3.1.9 and Rule 6.4.19 as discussed above.

Photo 16: Looking east at the topsoil pile on site. This is located along the northern edge of the Phase 3 pit area. The area circled in the photo indicates where the topsoil pile has sustained damage from mining activities.

CORRECTIVE ACTIONS: The Operator shall relocate the stockpile into an area approved for mining and in a location that it will be unaffected by ongoing mining operations, or revise the approved mining plan to reflect the storage of topsoil at this location. Once relocated or repaired, the Operator shall seed the stockpile with the seed mix that was submitted as part of the approved Reclamation Plan. The Operator shall demonstrate compliance by submitting seed tags, a bill of sale or photographs of seeding activities.

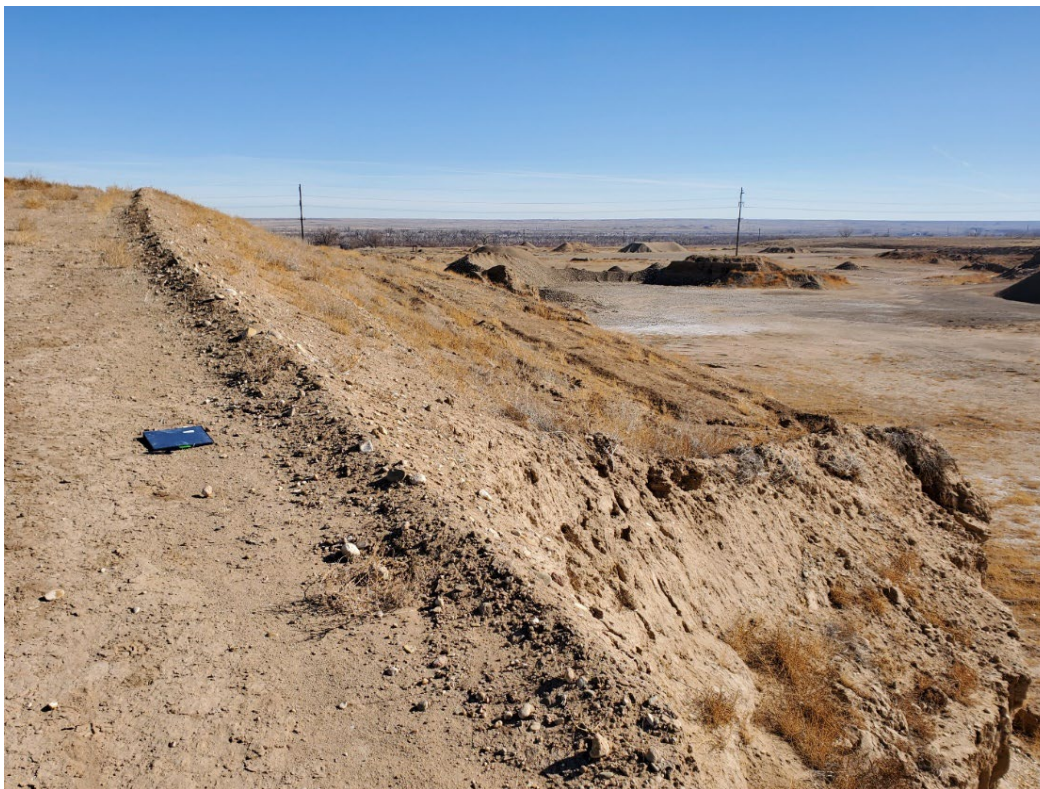
Photo 17: Binder (11.5" x 10") for scale. Topsoil pile.

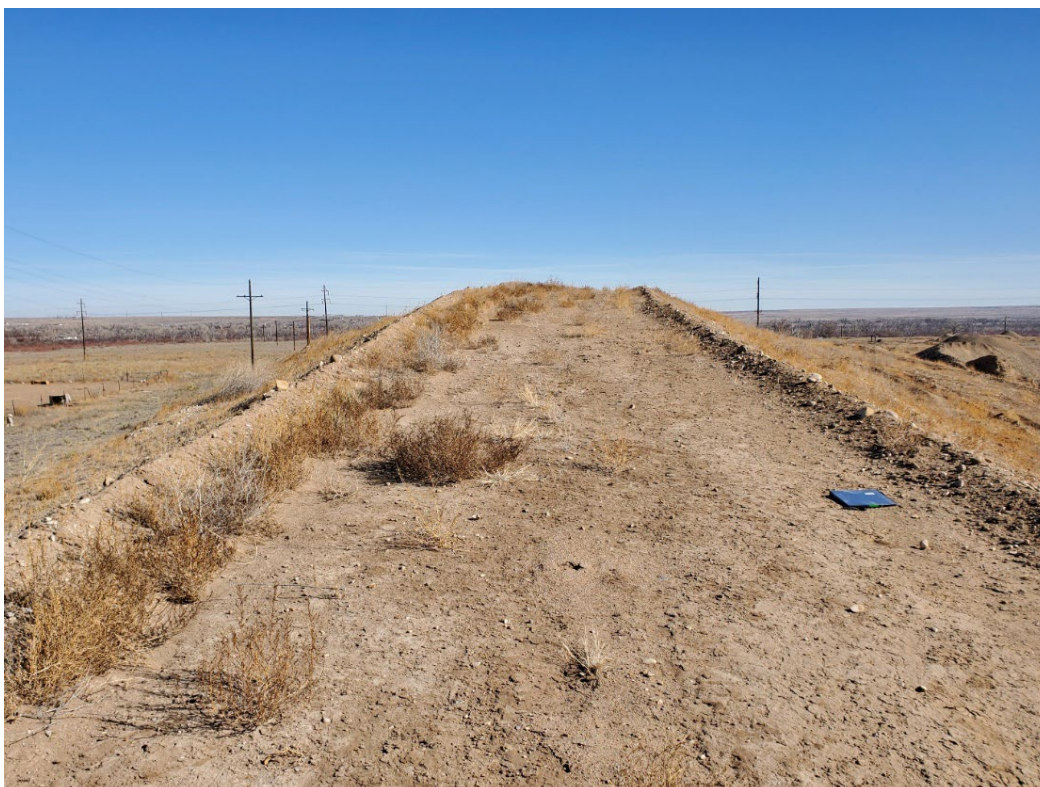
Photo 18: Looking east at the topsoil pile on site. This is located along the northern edge of the Phase 3 pit area. Binder (11.5" x 10") for scale. *Marker 2 on Map 1.*

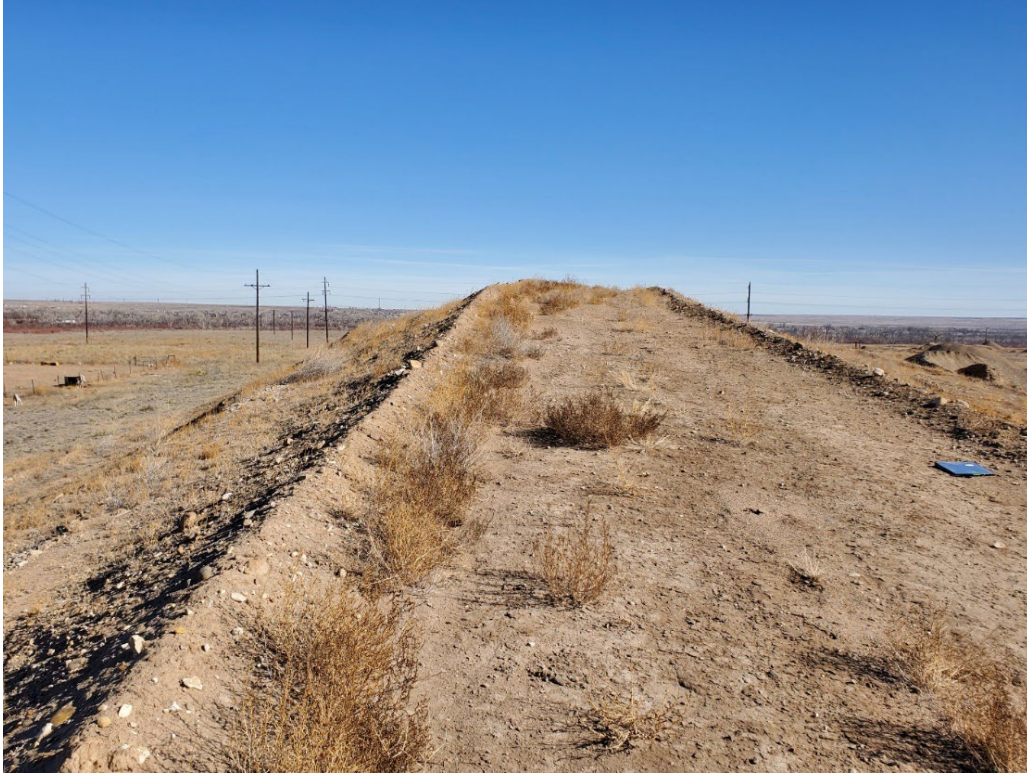
Photo 19: Looking east at the topsoil pile on site. This is located along the northern edge of the Phase 3 pit area. Binder (11.5" x 10") for scale.

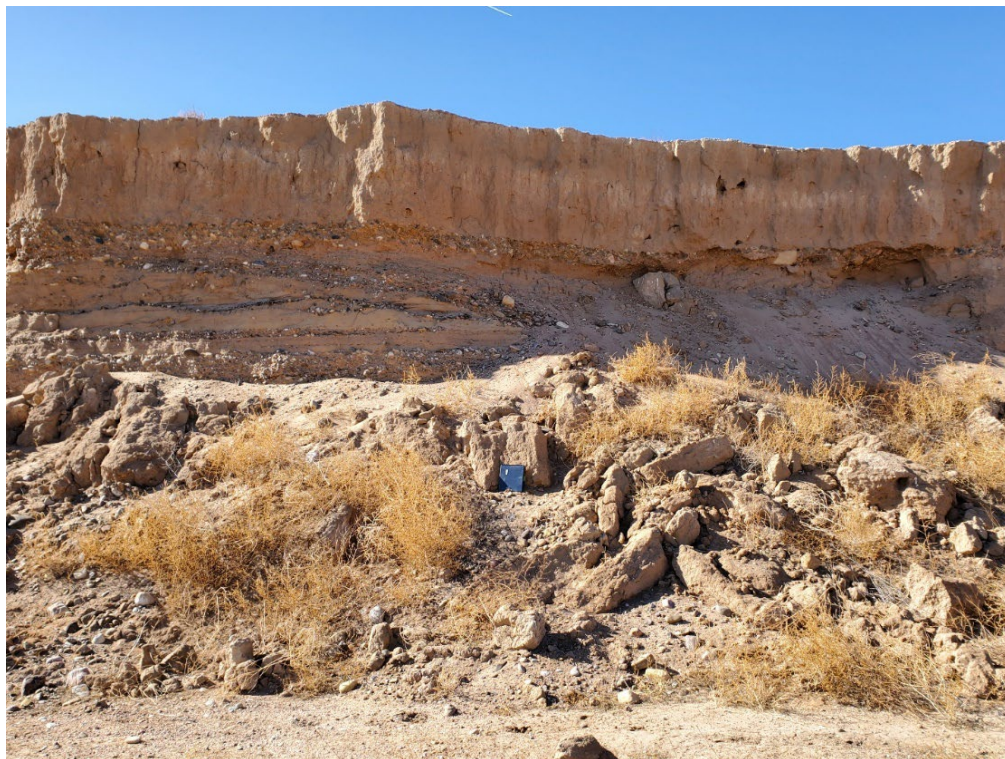
Photo 20: Looking West at maximum highwall height. Binder (11.5" x 10") for scale. Highwall is approximately 20' tall.

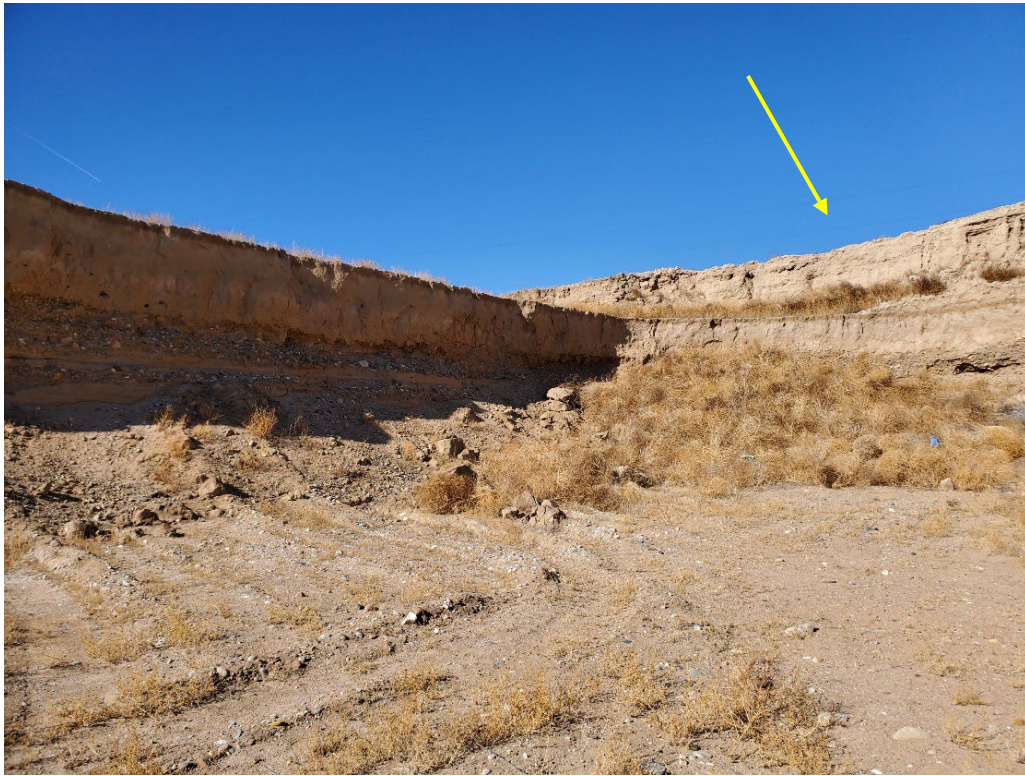
Photo 21: Looking at north-west corner of the Phase 3 pit. The arrow points to the topsoil pile.

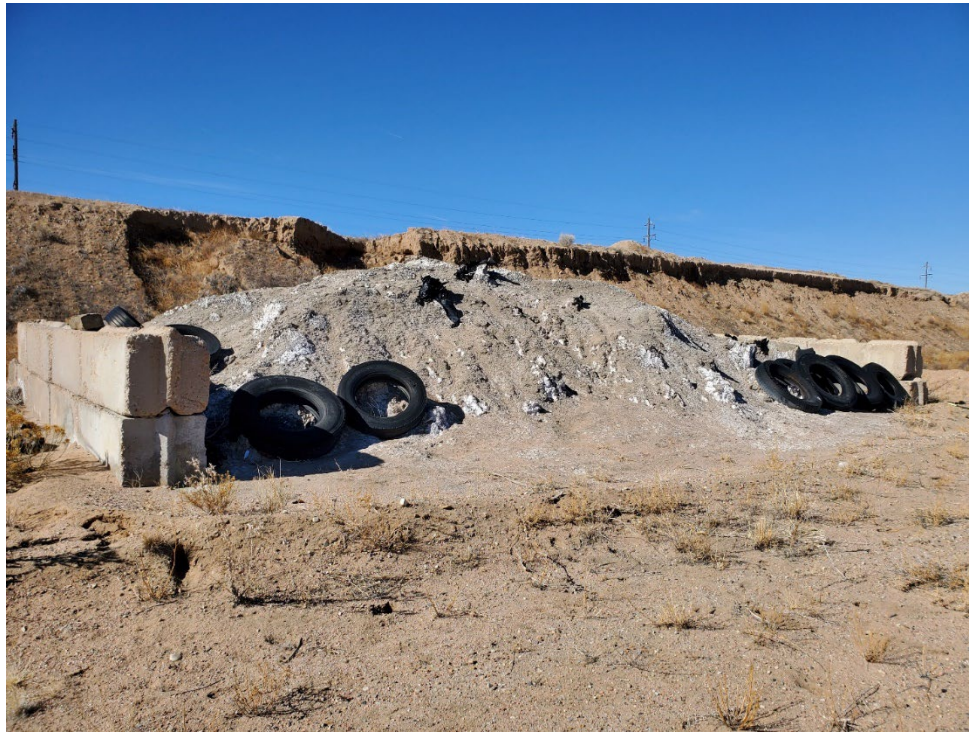
PROBLEM: An unknown substance was observed in the Phase 2 area. It is unclear how the Operator will handle this material in accordance with Rule 3.1.5.

A problem was stated above pertaining to a containment area consisting of fine grey material observed in the Phase 2 area (see Photo 23 and Marker 4 in Map 1). When asked about this, the prospective Successor said that they believe this to be 'salt-fines' or 'salt-sand' used in combination with mining product for the use in CDOT projects. The prospective Successor will be required to adhere to the corrective actions requirements listed in the problem above prior to the corrective actions deadline.

Photo 23: Looking south-west at 'salt-fines' or 'salt-sand' used to combine with product for CDOT project (according to Mr. Ausmus). Contained onsite in with cement berms encasing three sides of the pile located in the Phase 2 area. *Marker 4 on Map 1.*

CORRECTIVE ACTIONS: Please provide a written explanation explaining what this material is, how it is used, why it is stored onsite, and how it will be disposed of by the corrective action date.

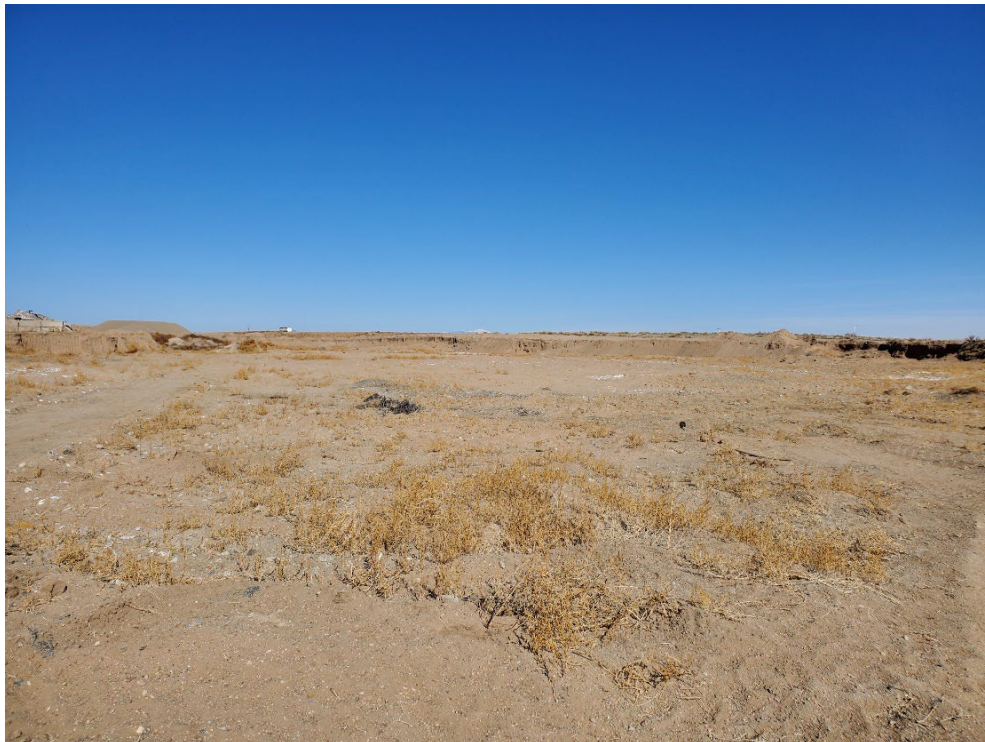
Photo 24: Looking east across the Phase 2 area of the site at the eastern side of the northern-most Phase 2 highwall.

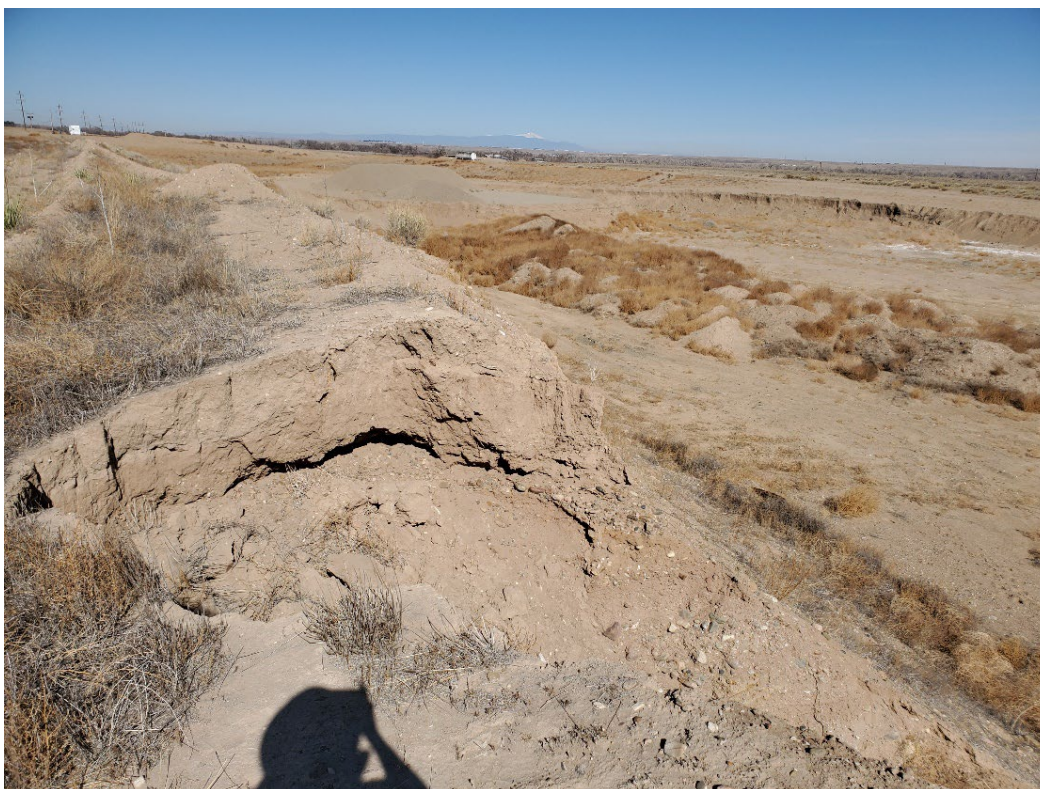
Photo 30: On top of the southern-most highwall in the Phase 2 area, looking at an erosional feature in the highwall.

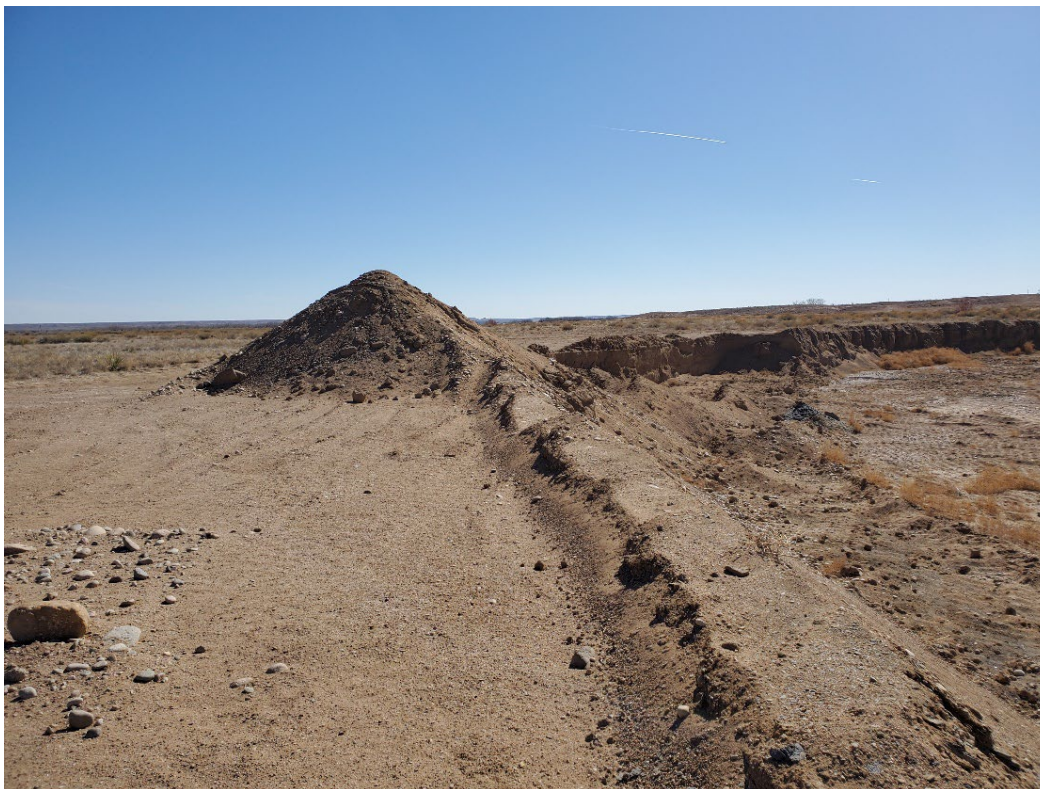
Photo 37: Looking east across the southern-most highwall in the Phase 2 area at excess material that may help with backfilling the highwalls.

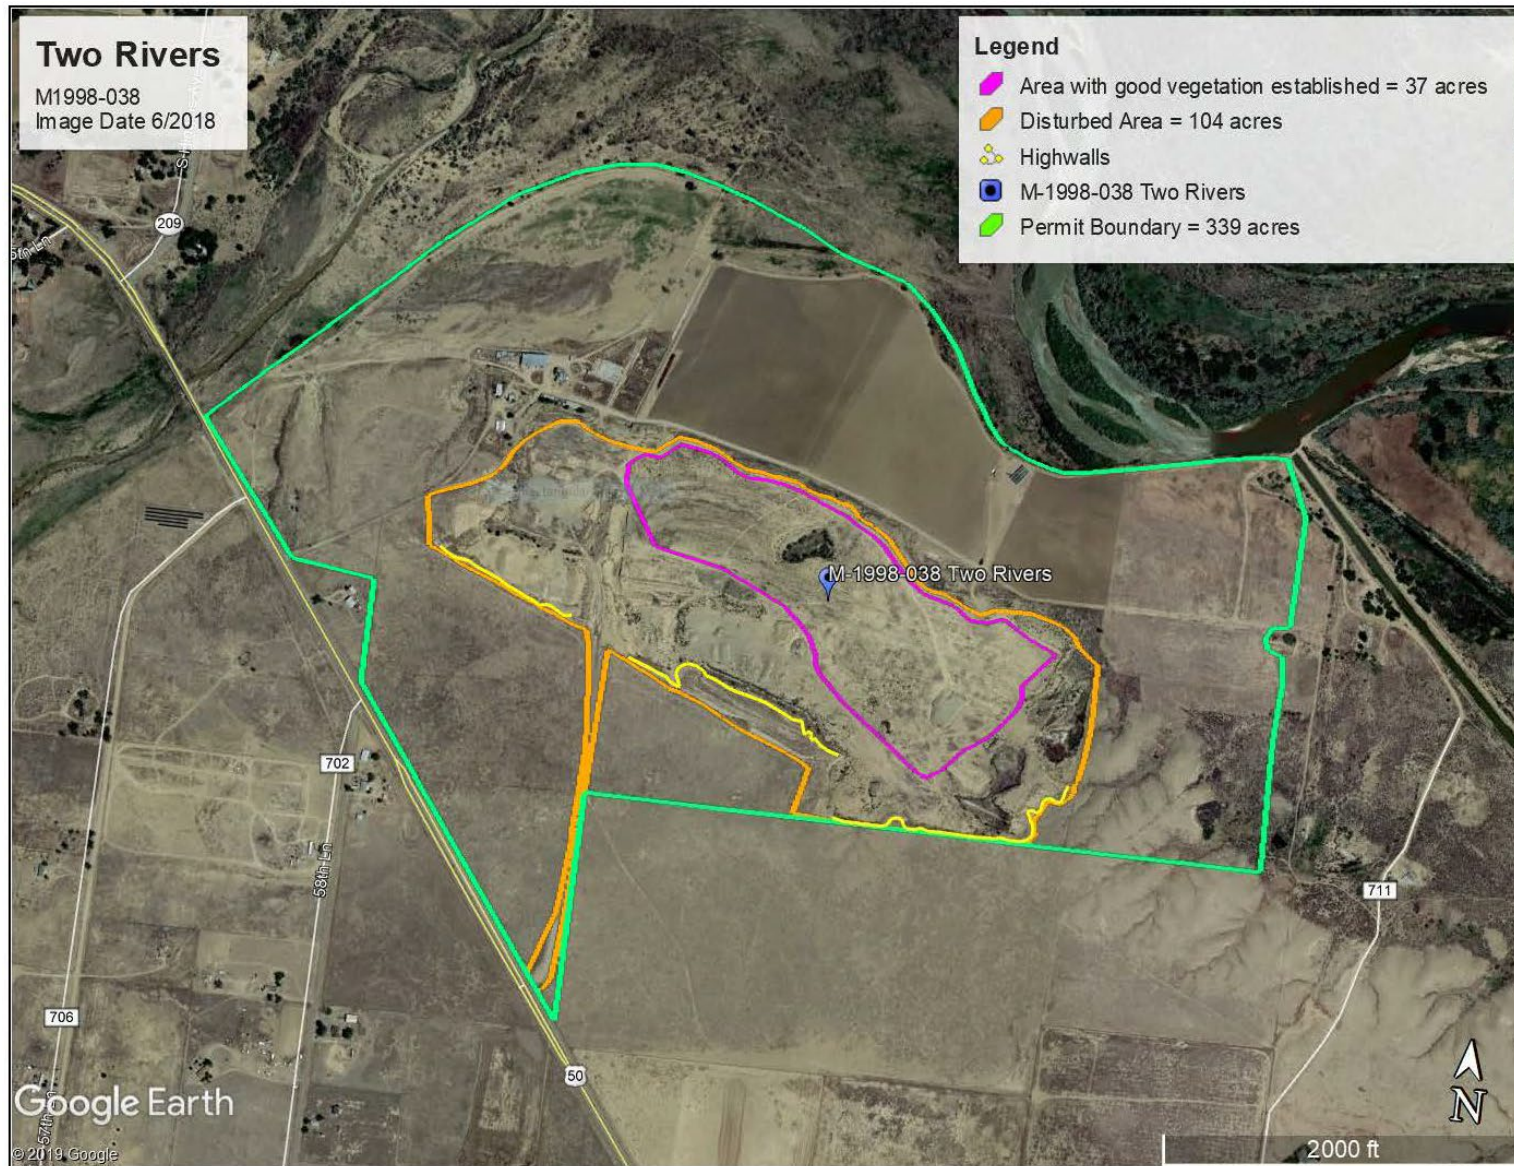
Map 2: Map generated in Google Earth Pro from the Division's January 2020 Inspection Report. The highwalls identified above differ from those observed during the March 2023 inspection. Portions of the area described as having good vegetation (see pink polygon above) have been disturbed through recent mining activities (see Map 1).

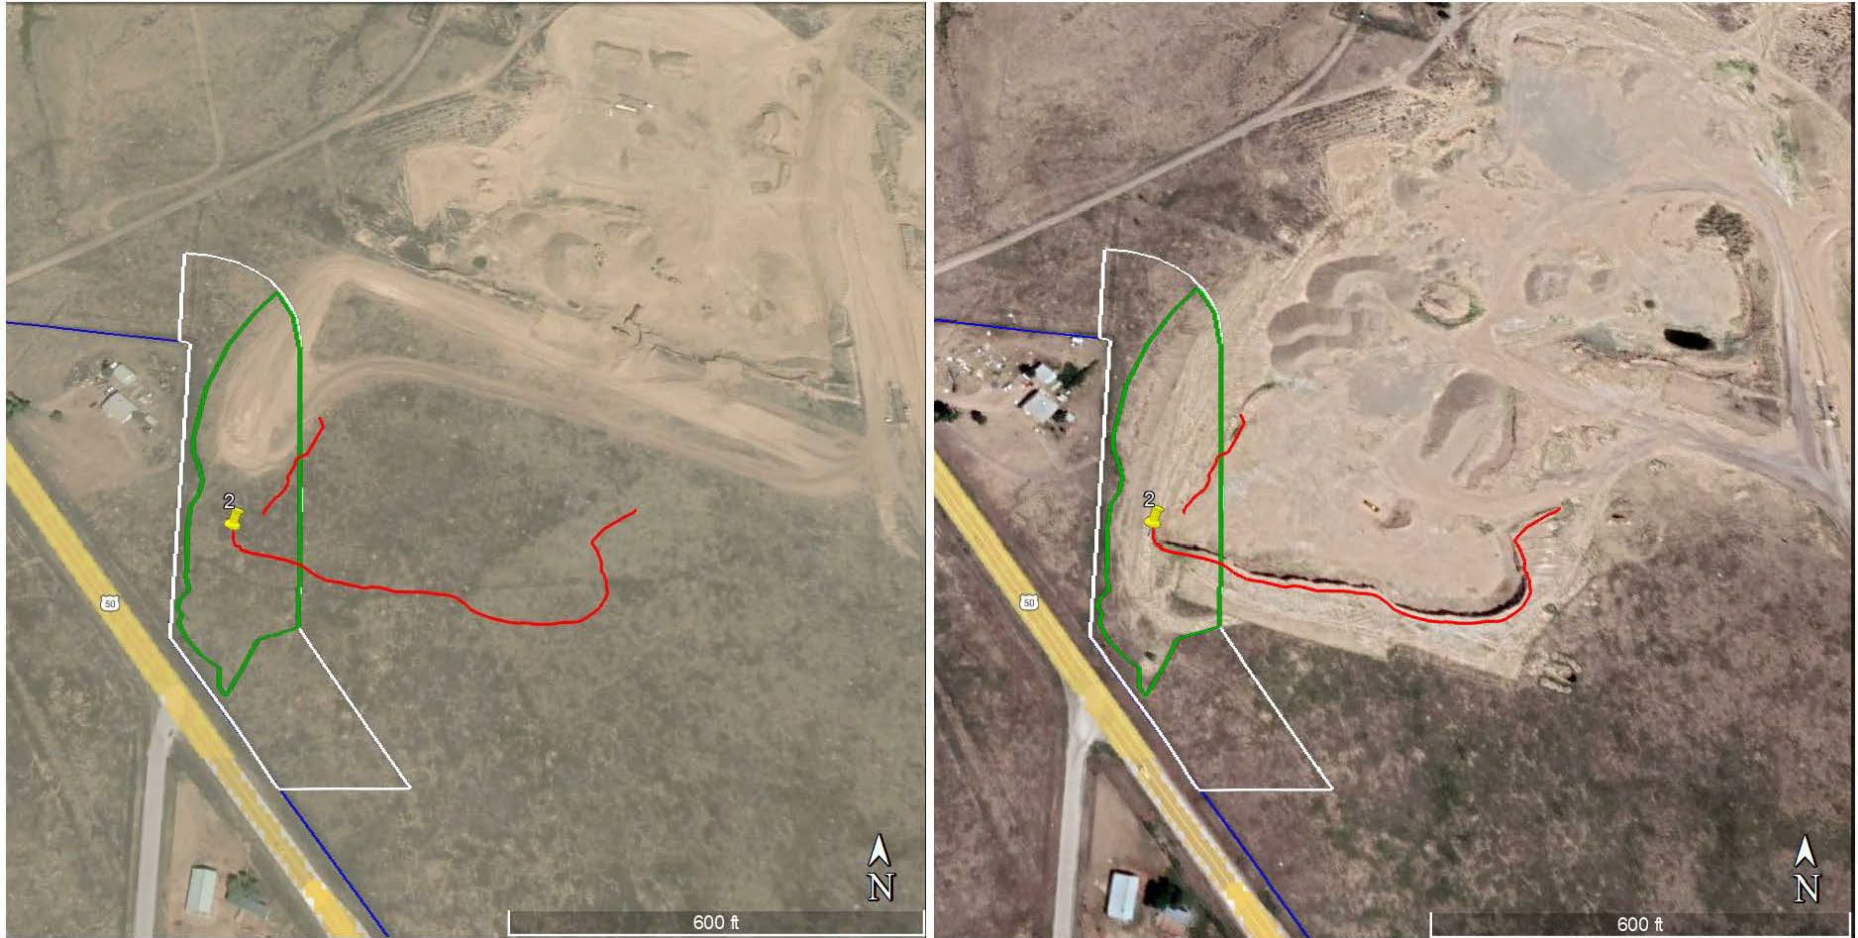
Acreage affected within the 200' buffer zone in 2020 and 2022

Map 5: Images taken from Google Earth Pro. The white polygon represents a roughly representation of the approved 200' buffer zone in the currently approved mining plan. The google earth image on the left was taken in September 2020, and it represents the first record of the Operator affecting land within the 200' buffer zone. The image on the right, taken in June 2022, is the most recent Google Earth image available showing the extent of the land affected by mining within the 200' buffer zone. The surface area within the green polygon measures 2.37 acres and approximates the acreage within the 200' zone affected by mining as of 2022. **Red lines are the highwalls measured during the 2023 inspection, the blue line is the Division's permit boundary estimate, the push pin represents the south-west face of the topsoil pile in Photo 18.*
