**MINERALS PROGRAM INSPECTION REPORT**  
**PHONE: (303) 866-3567**

<b>MINE NAME:</b> Two Rivers	<b>MINE/PROSPECTING ID#:</b> M-1998-038	<b>MINERAL:</b> Gravel	<b>COUNTY:</b> Pueblo
<b>INSPECTION TYPE:</b> Monitoring	<b>WEATHER:</b> Clear	<b>INSP. DATE:</b> April 5, 2023	<b>INSP. TIME:</b> 12:00
<b>OPERATOR:</b> Kirkland Construction, R.L.L.P.	<b>OPERATOR REPRESENTATIVE:</b> Jodi Schreiber	<b>TYPE OF OPERATION:</b> 112c - Construction Regular Operation	
<b>REASON FOR INSPECTION:</b> Surety Related	<b>BOND CALCULATION TYPE:</b> Complete Bond	<b>BOND AMOUNT:</b> No Bond Held	
<b>DATE OF COMPLAINT:</b> NA	<b>POST INSP. CONTACTS:</b> None	<b>JOINT INSP. AGENCY:</b> None	
<b>INSPECTOR(S):</b> Amber Michels	<b>INSPECTOR'S SIGNATURE:</b>

**INSPECTION TOPIC:** Backfilling & Grading

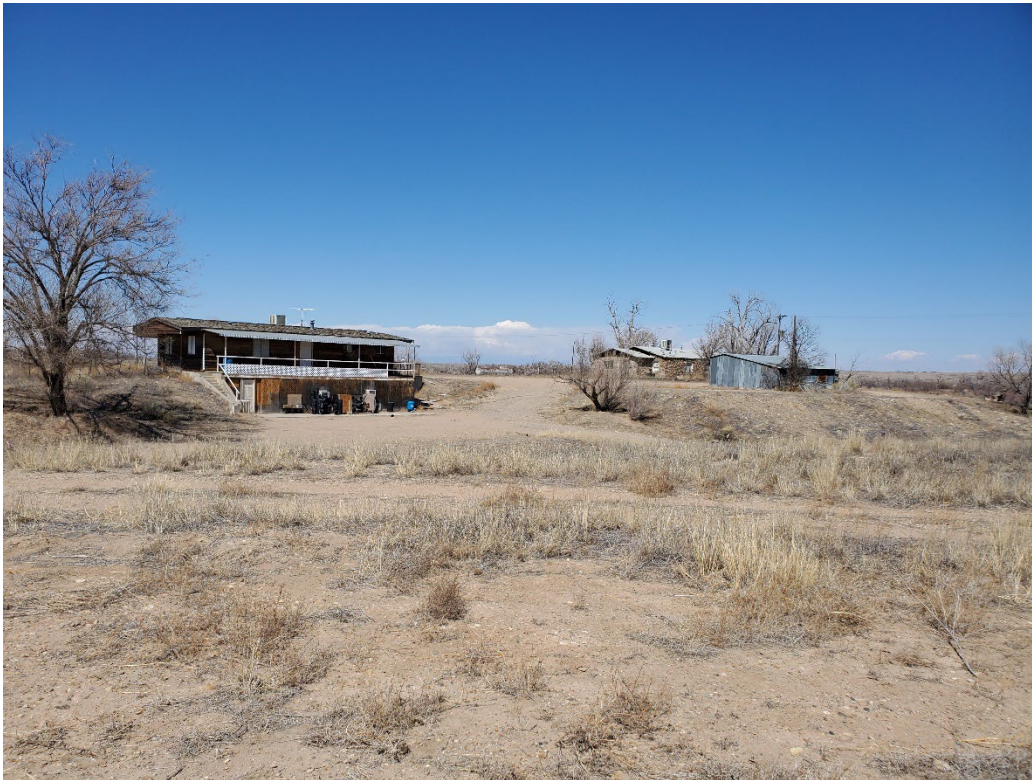
The prospective Successor has purchased the majority of the property within the existing permit areas. Some of this property includes abandoned houses, previous landowner's growing facilities, and wells. The majority of the structures on the property are north of the Phase 3 permit area. Photos 1-7 highlight a few of these structures. At the inspection, the prospective Successor was asked what their plan was for these structures upon acquiring the reclamation permit, to which they answered they are not yet certain. The prospective Successor believes they may tear the structures down, or they may mine around them. Either way, they are aware that they will need to update their mining plan prior to affecting this area.

**Photo 1:** Abandoned houses north of the Phase 3 area of the permit on the un-mined land.

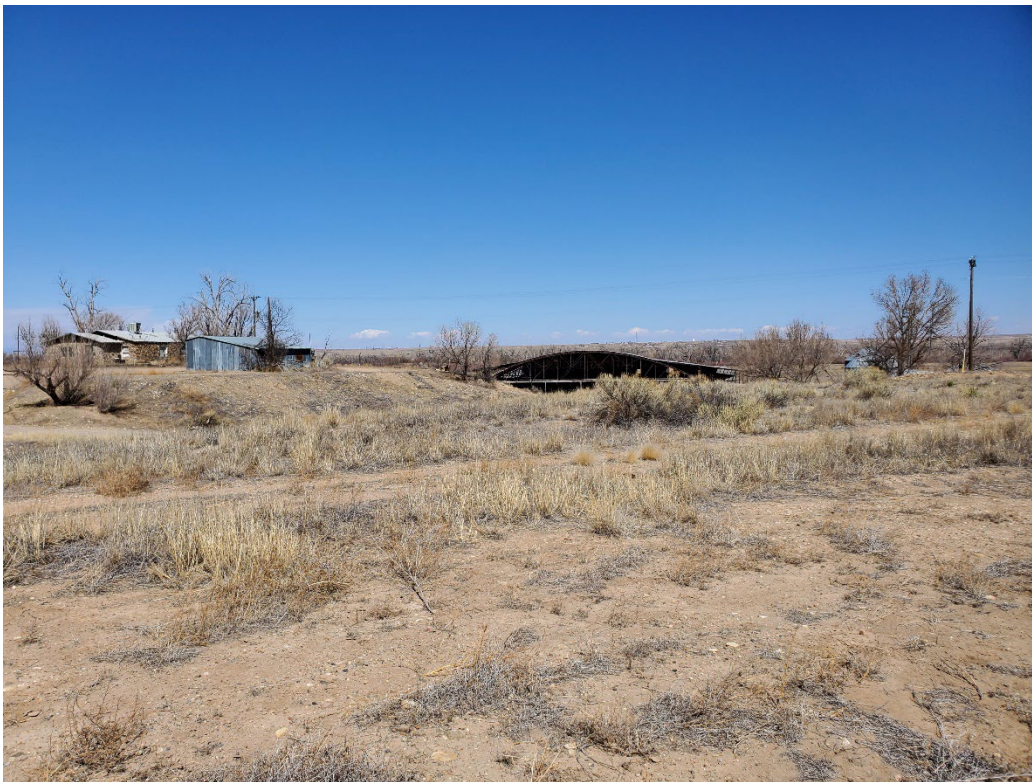
**Photo 2:** Abandoned growing facility north of the Phase 3 area of the permit on the un-mined land.

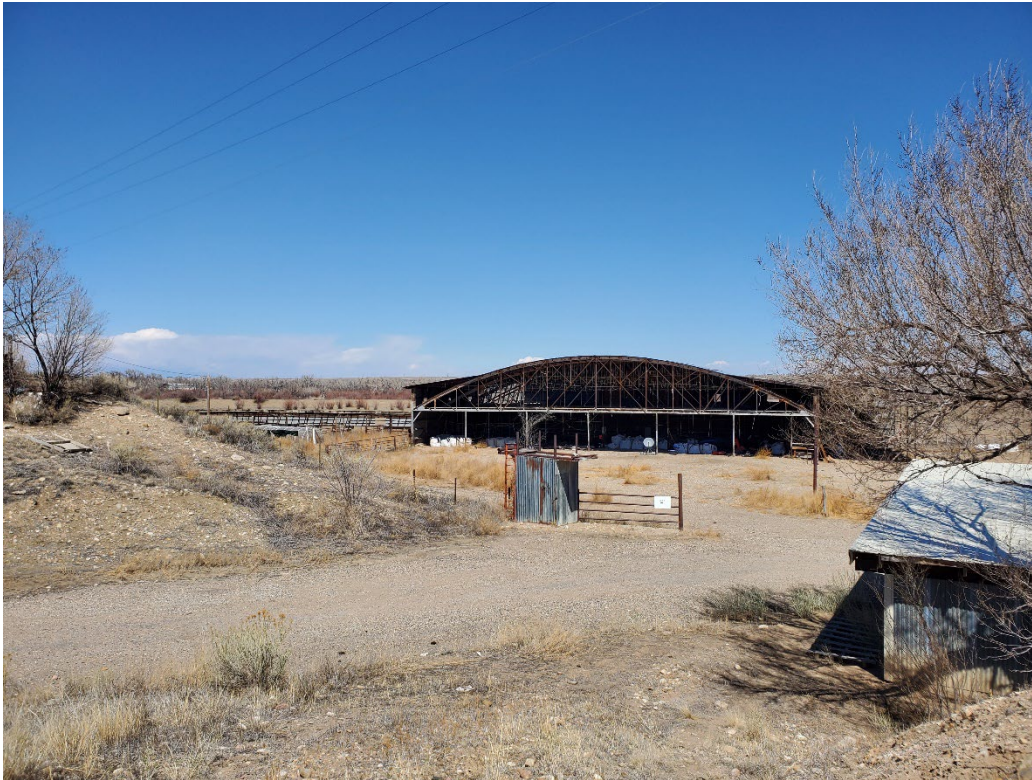
**Photo 3:** Abandoned growing facility north of the Phase 3 area of the permit on the un-mined land.

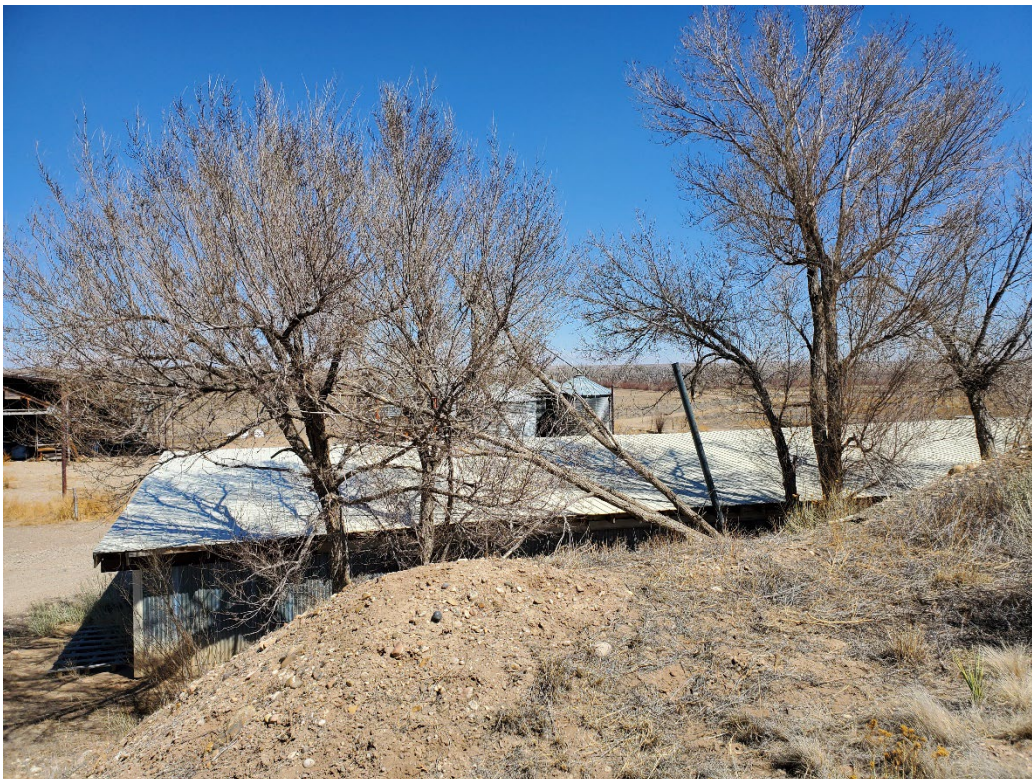
**Photo 4:** Abandoned structure and silos north of the Phase 3 area of the permit on the un-mined land.

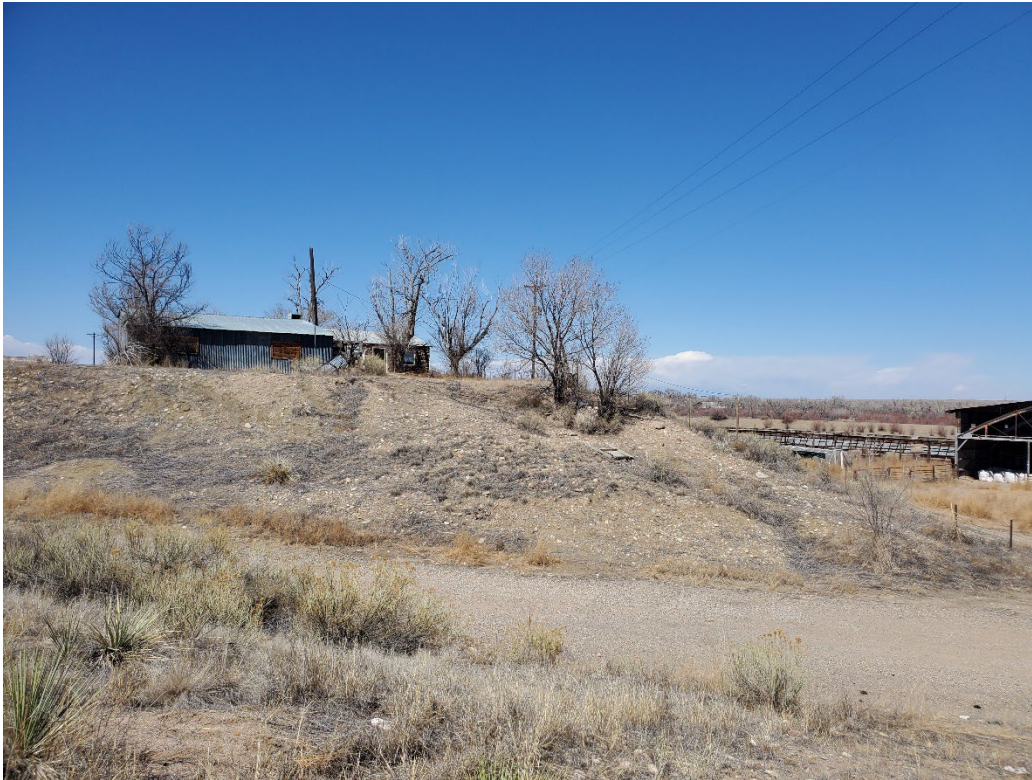
**Photo 5:** Looking west at the abandoned structures from the internal road.

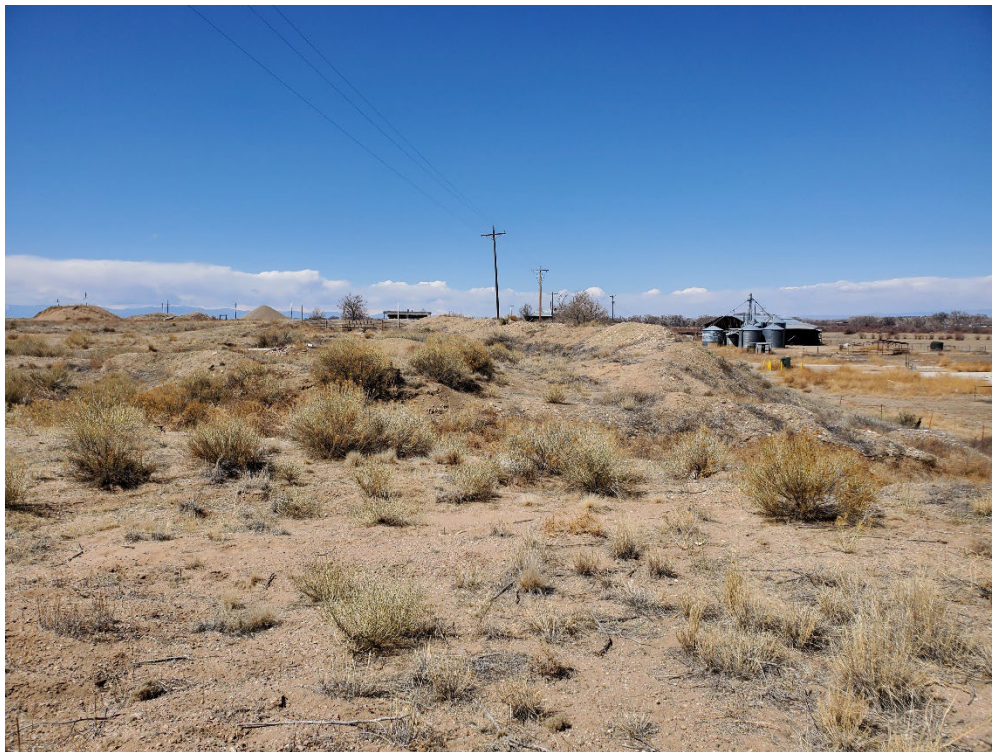
**Photo 6:** Looking west from the internal road at the abandoned structures and the product stockpiles near the Phase 3 area.

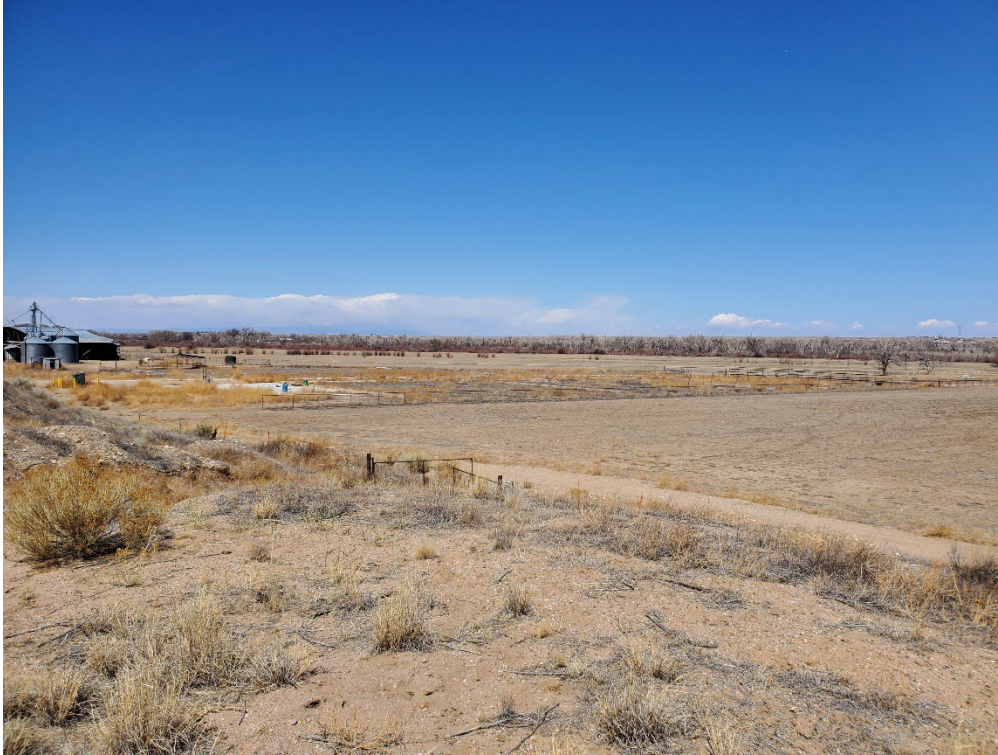
Currently, the area north of the internal road is primarily composed of a lowland floodplain area (see Photos 7, 8, and 20). When asked if this area was currently being used for farming the prospective Successor said that it is not. The prospective Successor also said that they may decide to mine that area eventually. Prior to doing so, the prospective Successor would be required to submit an amendment requesting the approval to mine in

**Photo 7:** Looking north-west from the internal road to the existing fields in the flood plain area extending to the Huerfano and Arkansas Rivers that follow closely with the estimated north portion of the permit boundary.

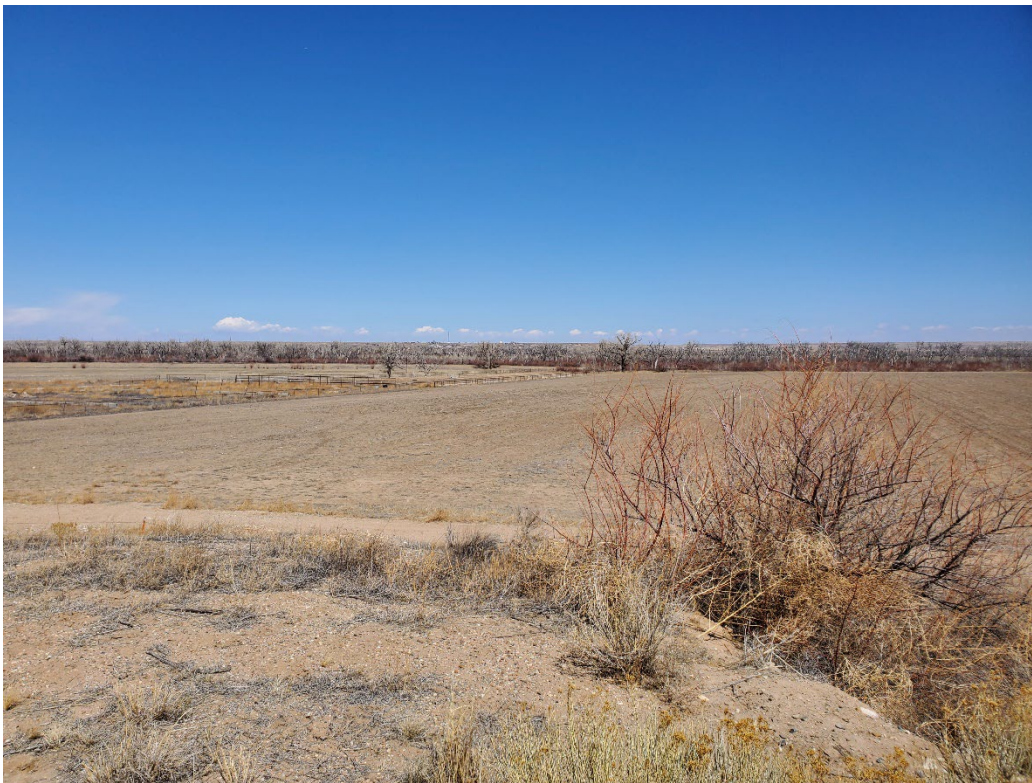
**Photo 8:** Looking north from the internal road to the existing fields in the flood plain area.

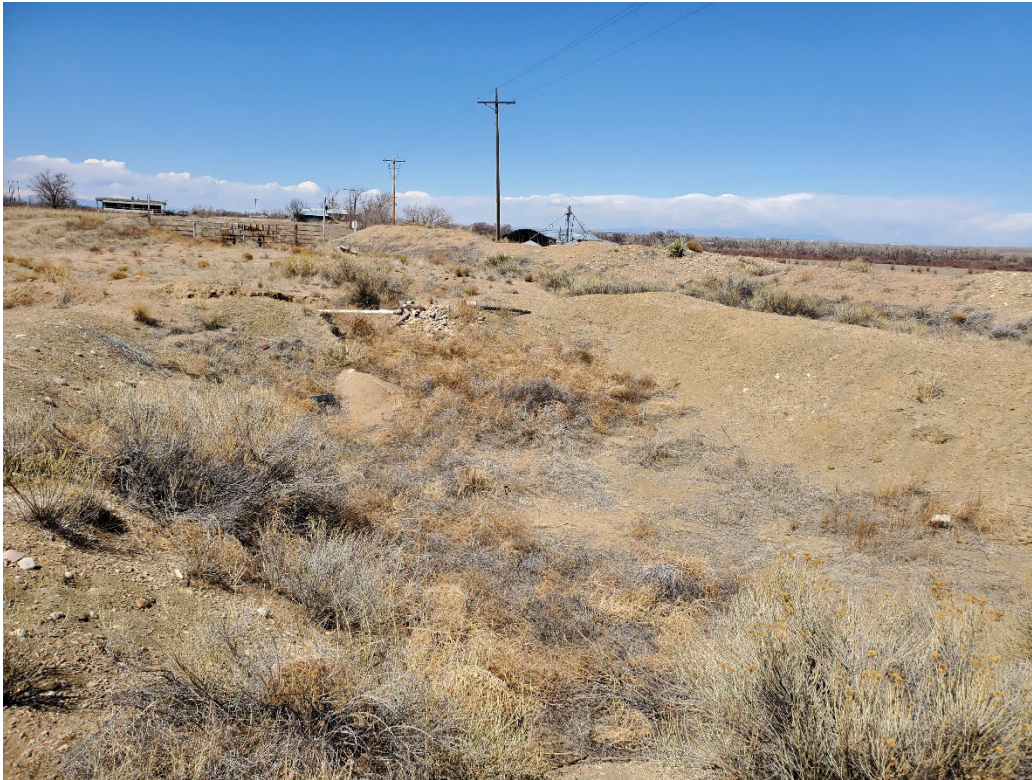
this area. An old depression located to the east of some abandoned structures, and north of the internal road (see Marker 1 on Map 1) appears to be an old water retaining structure (Photos 9-11). A pipe that appears to have allowed water to flow into the depression was also observed (Photo 9). The prospective Successor stated that they believe this was created by previous owners of this portion of the property that used this area for farming purposes. During post-inspection evaluation, the Division agrees that this area was likely created independent of mining activities (see Map 2).

**Photo 9:** Looking west from the internal road, along the powerlines, at a depressed bermed in area with an abandoned pipe.

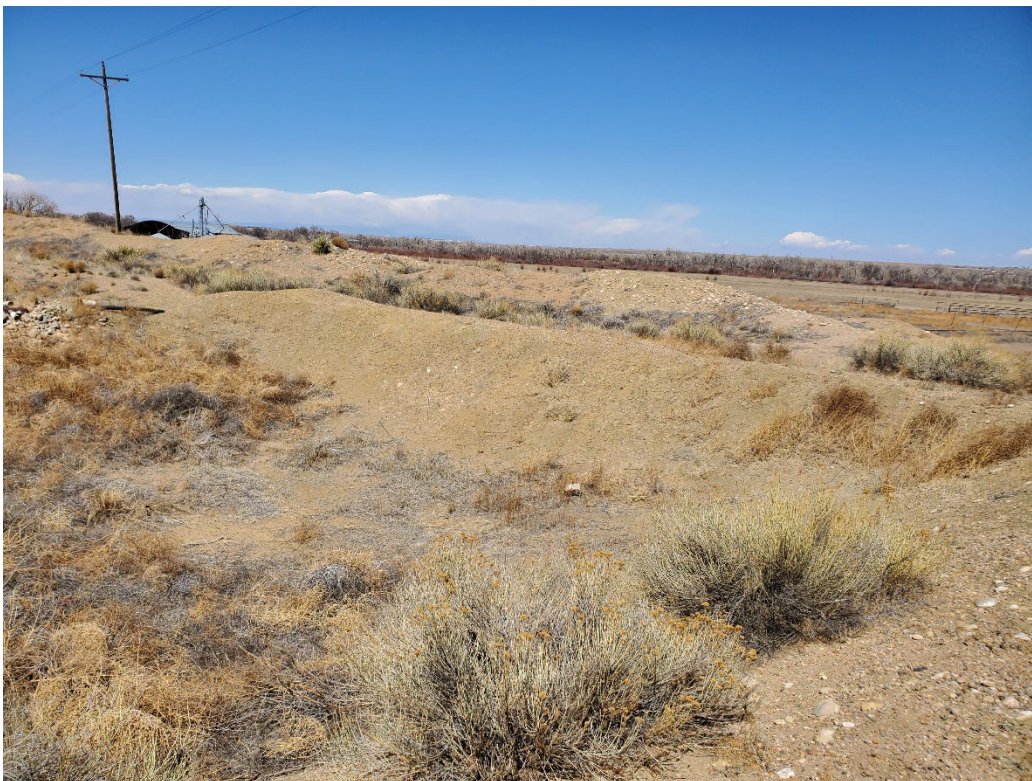
**Photo 10:** Standing at the west edge of the depressed bermed area looking north-west.

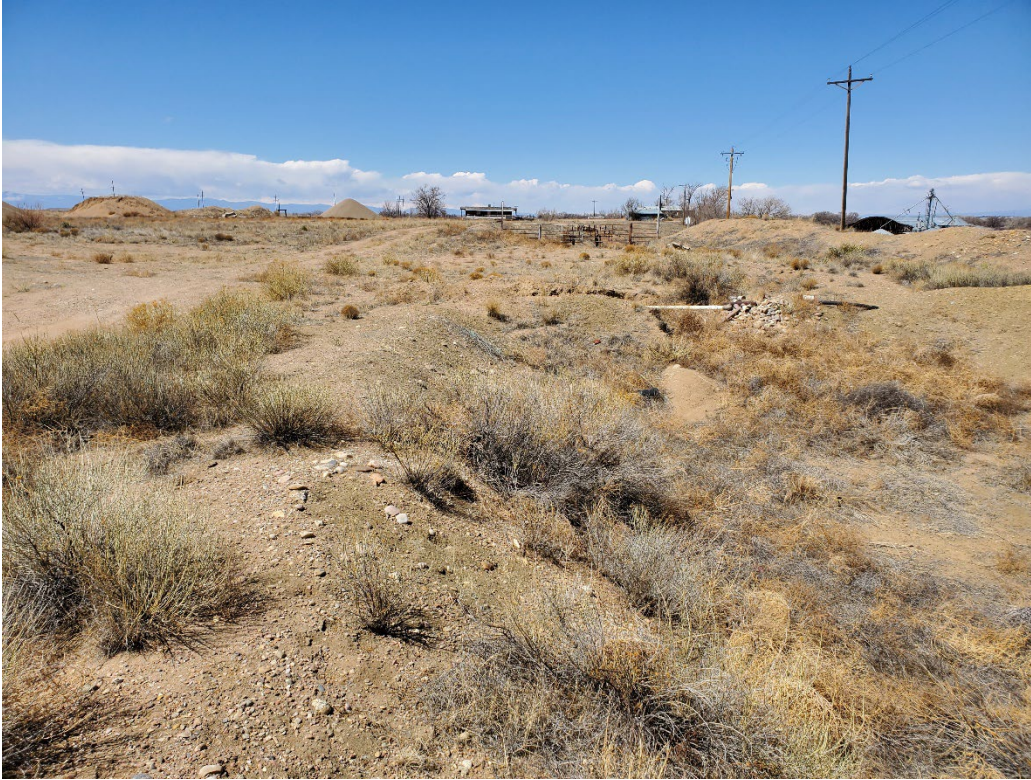
**Photo 11:** Standing at the west edge of the depressed bermed area looking south-west.

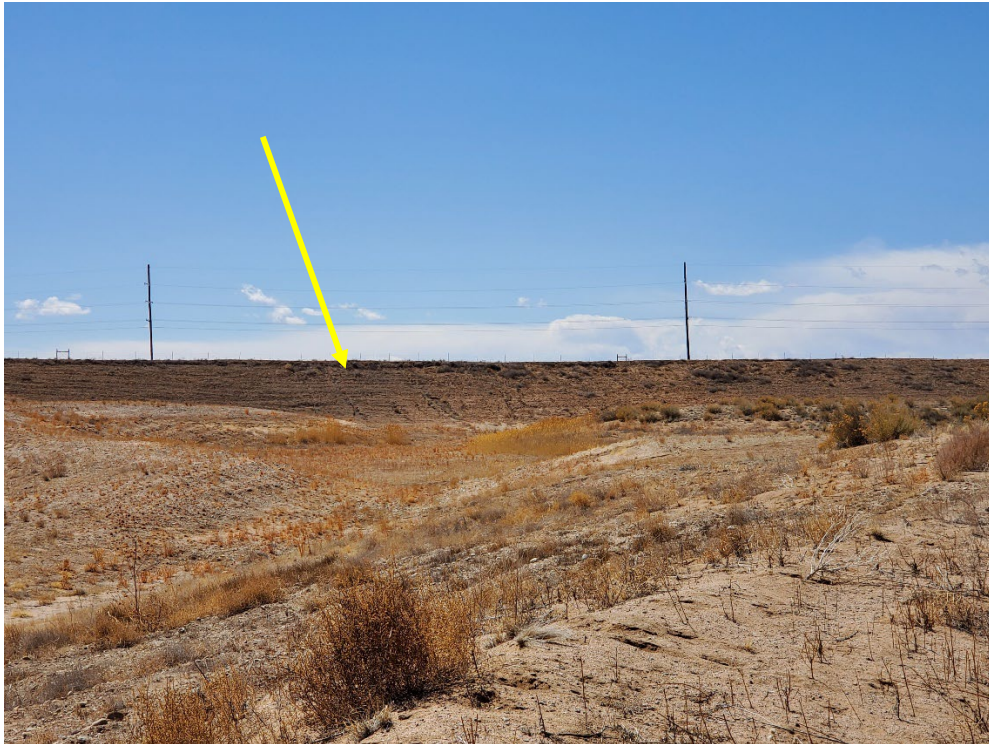
The location where highwalls existed along the southern permit boundary, cited in the Division's January 2020 inspection and were reported to have been reclaimed, were observed during this inspection (see Marker 4 on Map 1). The slopes appear to have been returned to 3H:1V slopes, but rills were observed on the north facing side (Photo 13). These slopes, as well as the other slopes in the Phase I area will need to be stabilized from erosion and revegetated prior to being eligible for acreage release.

**Photo 13:** Standing on the western edge of the Phase 1 area, looking south at regraded slopes. The yellow arrow points to a slope that is the regraded highwall near the southern boarder from the 2020 Inspection Report. Some rilling was observed on this slope.

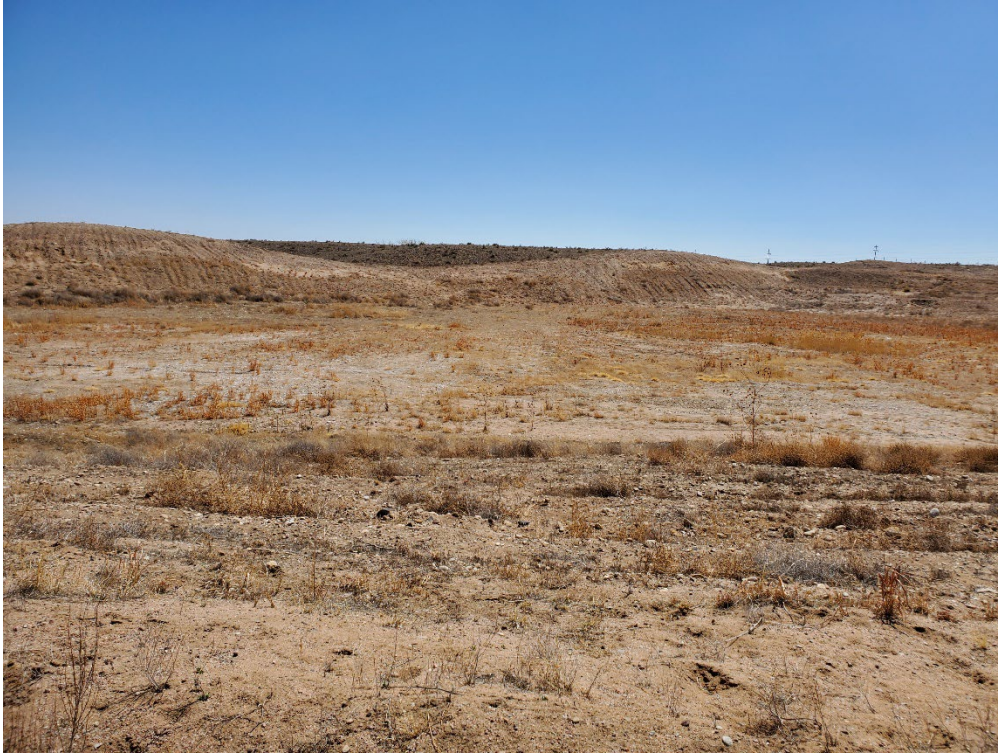
The highwalls located in the Phase I area cited in the Division's January 2020 inspection and reported to have been reclaimed (mentioned in Part One of the 2023 inspection series), were observed during this inspection. The highwalls in the Phase I area have been returned to 3H:1V slopes. The slopes on the west side of the Phase I area appears to have been seeded, and are growing sparse vegetation (Photos 24 and 25). The slopes on the east side of the Phase I area possess rills, and have very little vegetation established on them (Photos 14-17). It is difficult to determine whether or not they have been seeded. Along the northern border of the Phase I pit, there is an earthen berm that stretches from west to east. Near the center of this berm (see Marker 3 on Map 1), there is a deep erosional feature (Photos 18-20, and 22). There is vegetation growing within this eroded section, and it does not appear to be affecting the area downslope and to the north.

**Photo 15:** Standing on the western edge of the Phase 1 area, looking east across the seeded pit area and at regraded slopes. Rilling is seen on the west facing sides of the re-graded slopes.

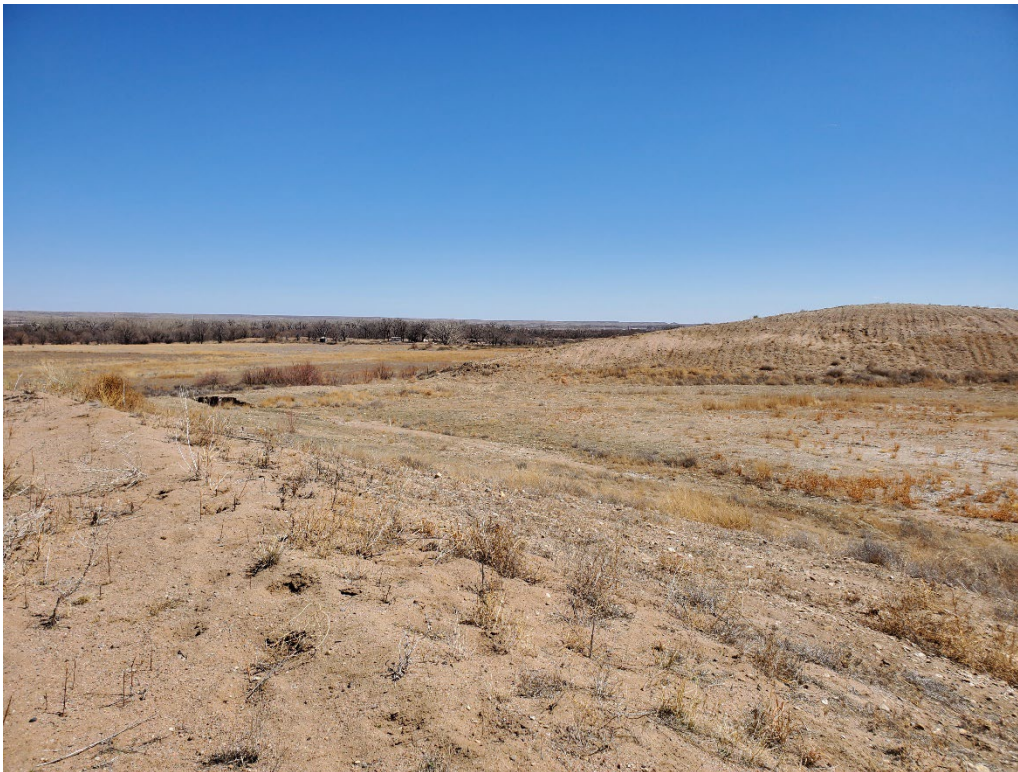
**Photo 16:** Standing on the western edge of the Phase 1 area, looking north-east at a regraded slope with rilling.

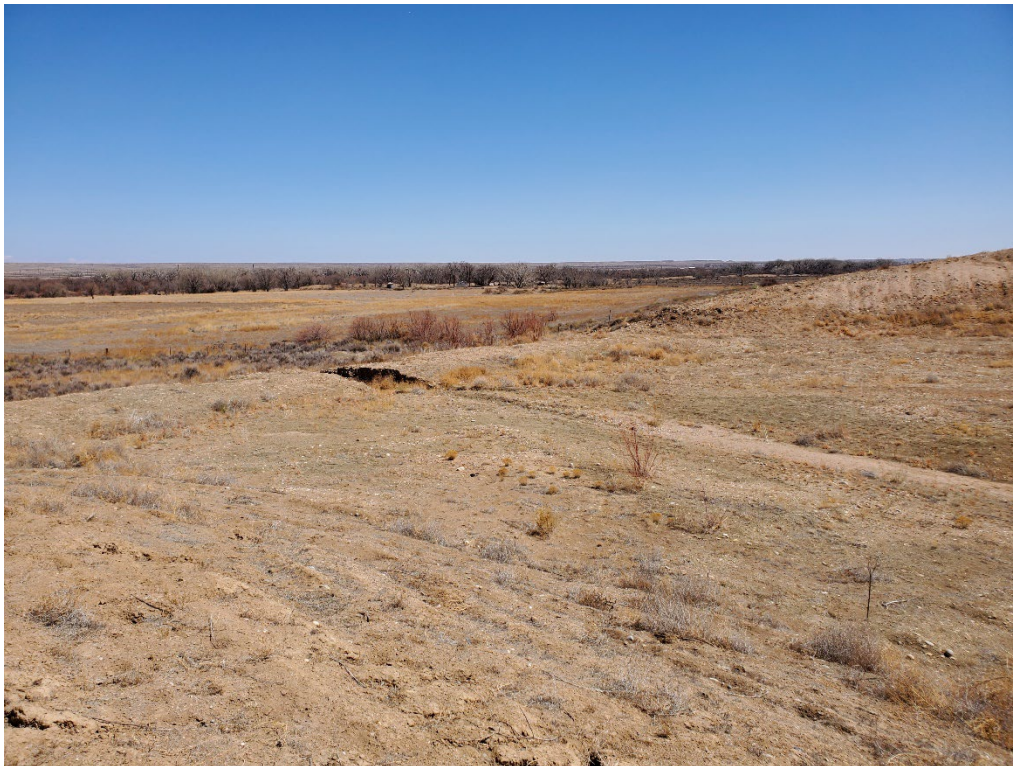
**PROBLEM:** An erosion gully was observed on-site. This is a problem at this time for failure to protect the affected land from erosion pursuant to C.R.S. 34-32.5-116 (4) (j).

A problem has been cited above for the deep erosional feature, or gully, located in the earthen berm at the northern border of the pit in Phase 1. Because the berm separates Phase I from the lowland area to the north that is currently not approved to be affected by mining, the prospective Successor will be responsible for repairing the gully by the corrective action date. The prospective Successor is also advised to monitor the rills observed on the highwalls in the Phase I area through ensuring that they remain stable and that they do not deepen or subsequently cause substantial erosion to occur.

**Photo 18:** Looking north-east at the edge of the reclaimed Phase 1 area at an erosional feature in a bordering berm.

**CORRECTIVE ACTIONS:** The operator shall provide photo documentation to the Division verifying the erosion gully has been repaired, and that the site has have been reconstructed and stabilized to prevent erosion damage by the corrective action date.

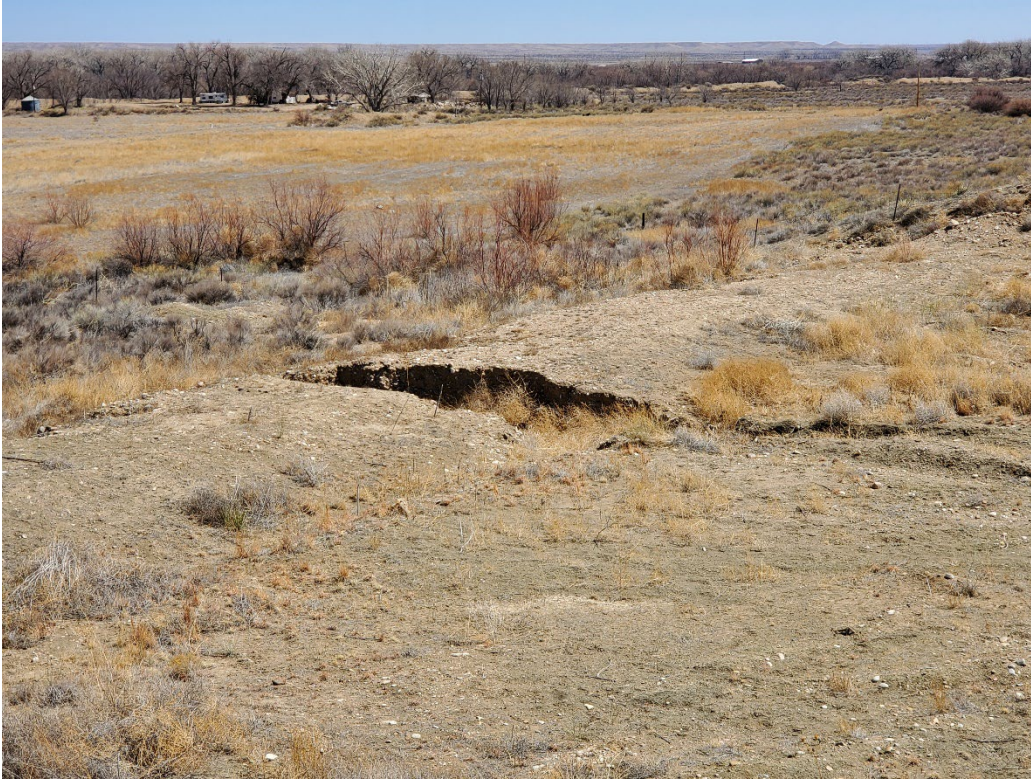
**Photo 19:** Looking north-east at the edge of the reclaimed Phase 1 area at an erosional feature in a bordering berm.

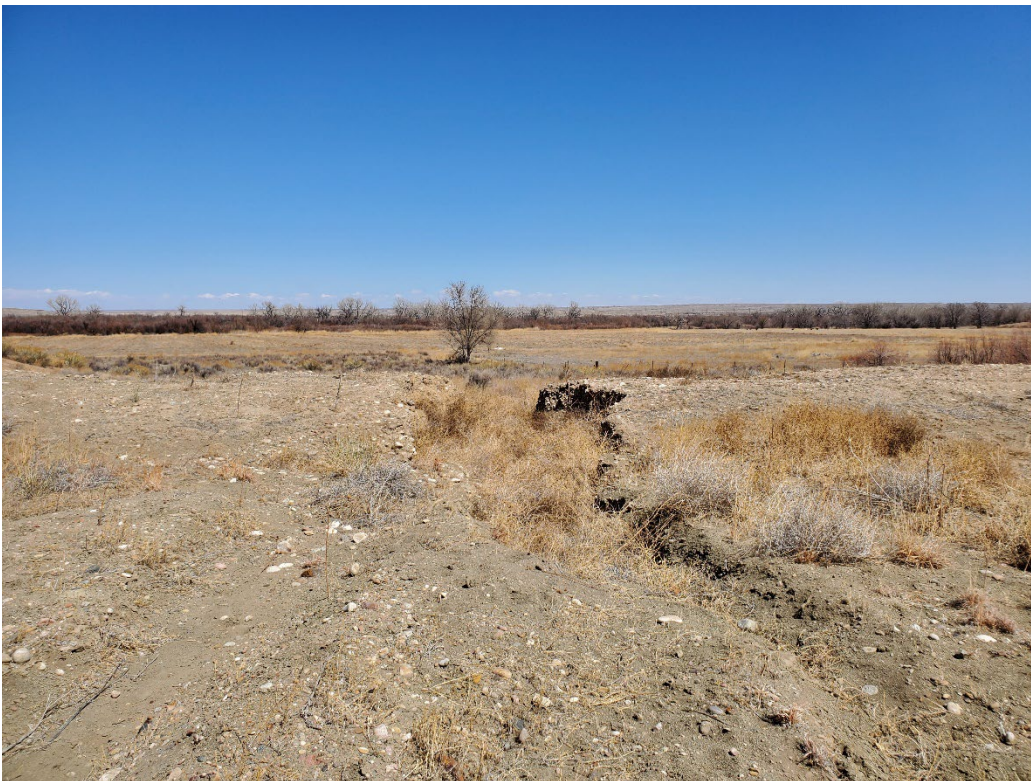
**Photo 20:** Standing in the Phase I reclaimed pit, looking north at the eroded berm and at the flood plain beyond it.

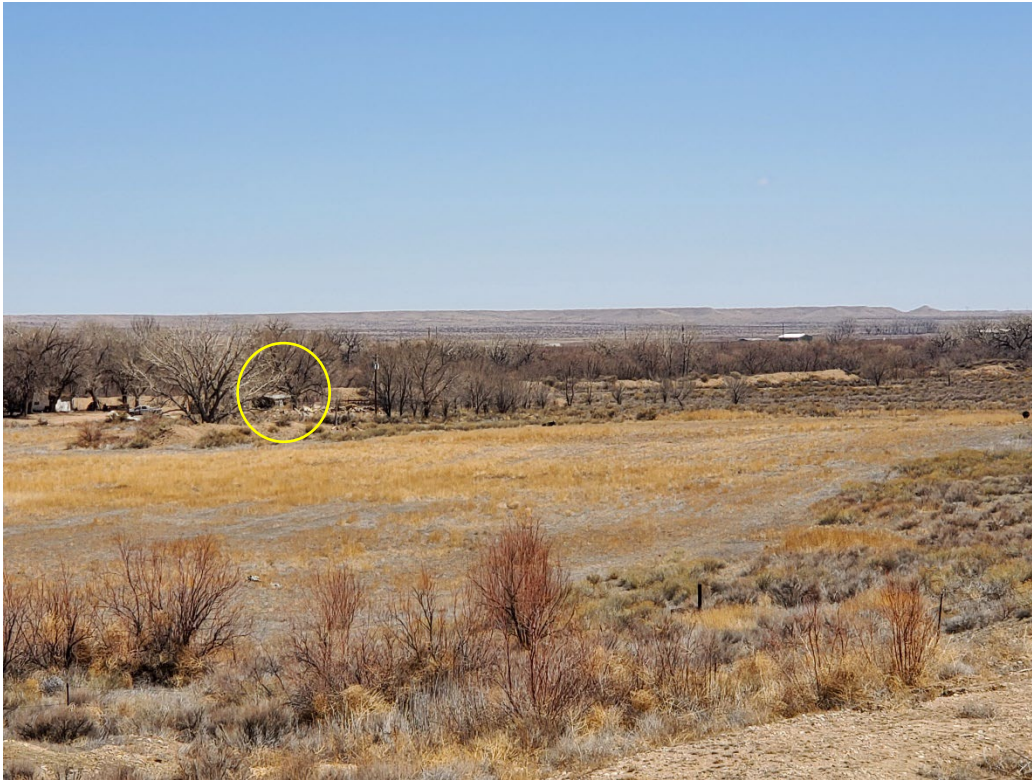
The prospective Successor pointed to the location of Gary Fillmore's well. Mr. Fillmore had an easement with the current Operator and now with the prospective Successor to allow his well and water line to run through the permit boundary. The prospective Successor stated that neither the currently approved map, nor the Division of Water Resources' website accurately depicts the location of Mr. Fillmore's well. Photo 21 shows the structure located above the well. The prospective Successor stated that Mr. Fillmore confirmed this to be the actual location of the well. The water line for this well goes underneath the Phase I area and under County Road 50, into the area south of County Road 50. The prospective Successor stated that upon the approval of SO1, they would maintain the buffer zone currently approved around this well and around this water line to protect this structure.

**Photo 21:** Standing on the berm, looking north-east at the adjacent property and well owned by Gary Fillmore. The circle indicates the well location.

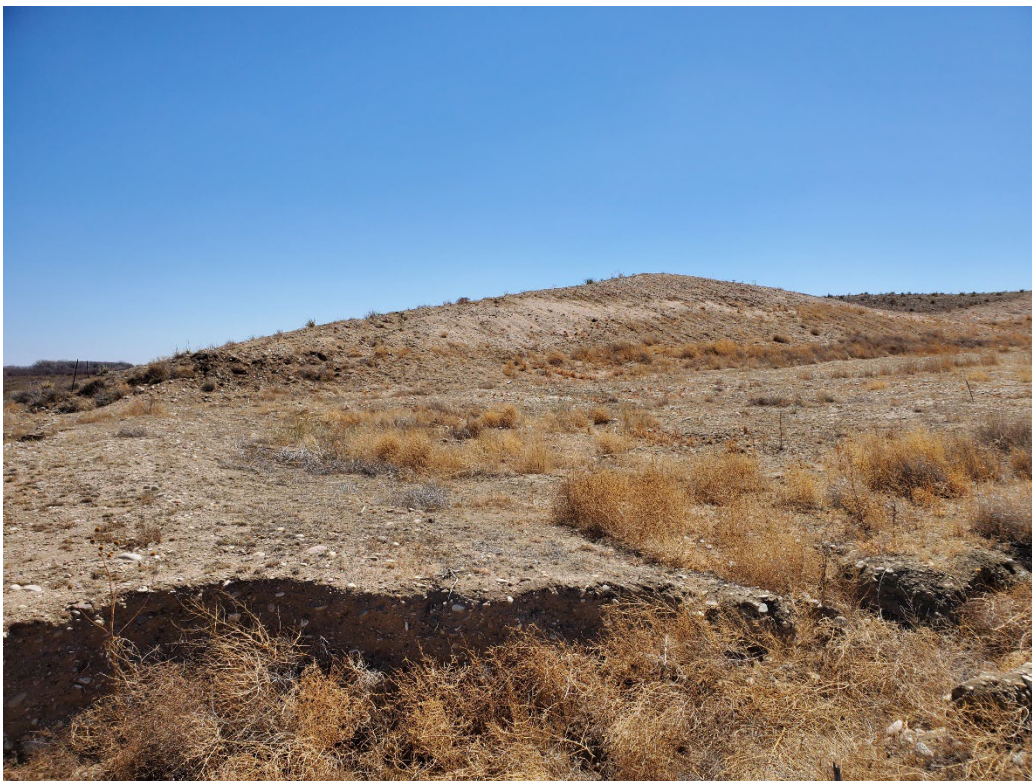
**Photo 22:** Standing in the erosional feature seen in Photo 21, looking south-east at a reclaimed slope in Phase 1.

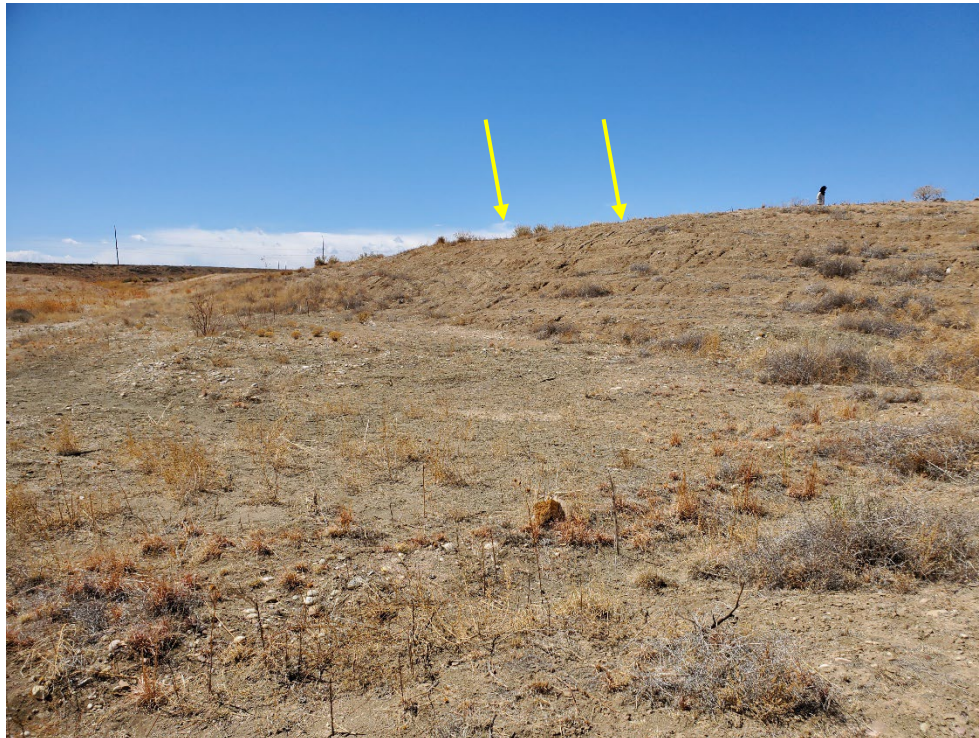
**Photo 24:** Standing on eroded berm in the north portion of Phase I, looking south-west across the reclaimed pit at the eastern face of the western slope. Yellow arrows point to slight rilling. This western slope has a greater quantity of stable vegetation growing than the eastern slopes.

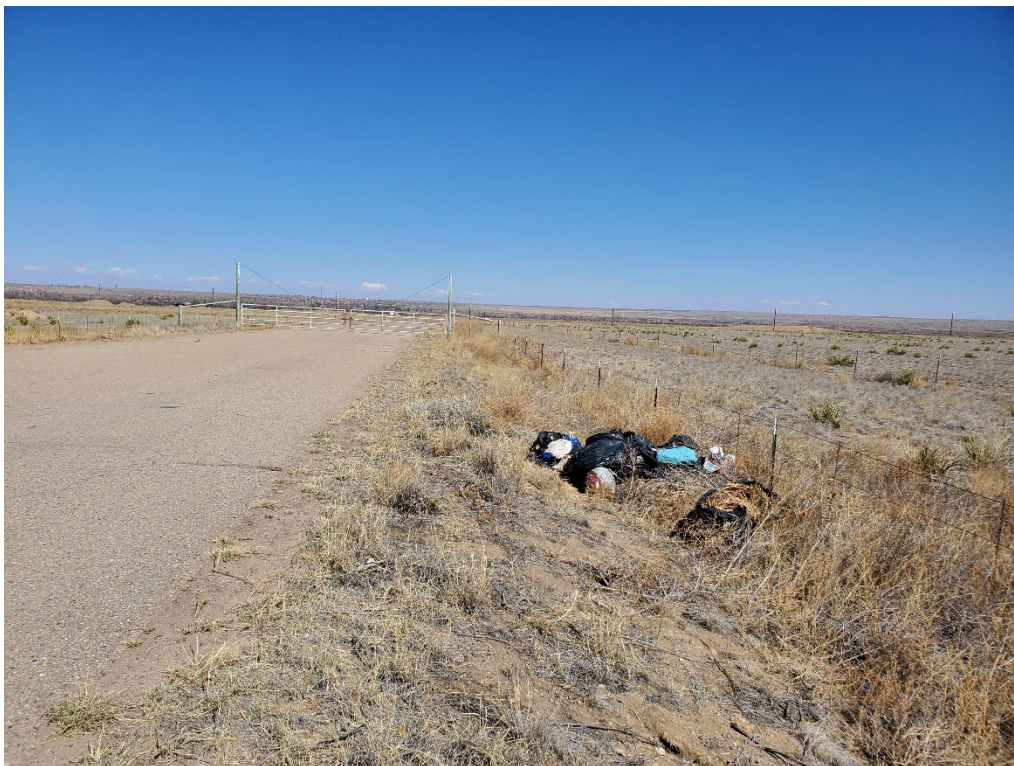
Trash was observed to the east of the entrance road during Part One of the 2023 SO1 Inspection. The prospective Successor representative at that time stated that it was likely due to trespassers dumping their waste at the site's entrance. Upon arrival at the site location for Part Two of the inspection, the trash observed during Part One was still present (Photo 26). Upon approval of SO1, the prospective Successor will be responsible for removing this waste from the site.

**Photo 26:** Trash left to the west of the entrance road by trespassers.

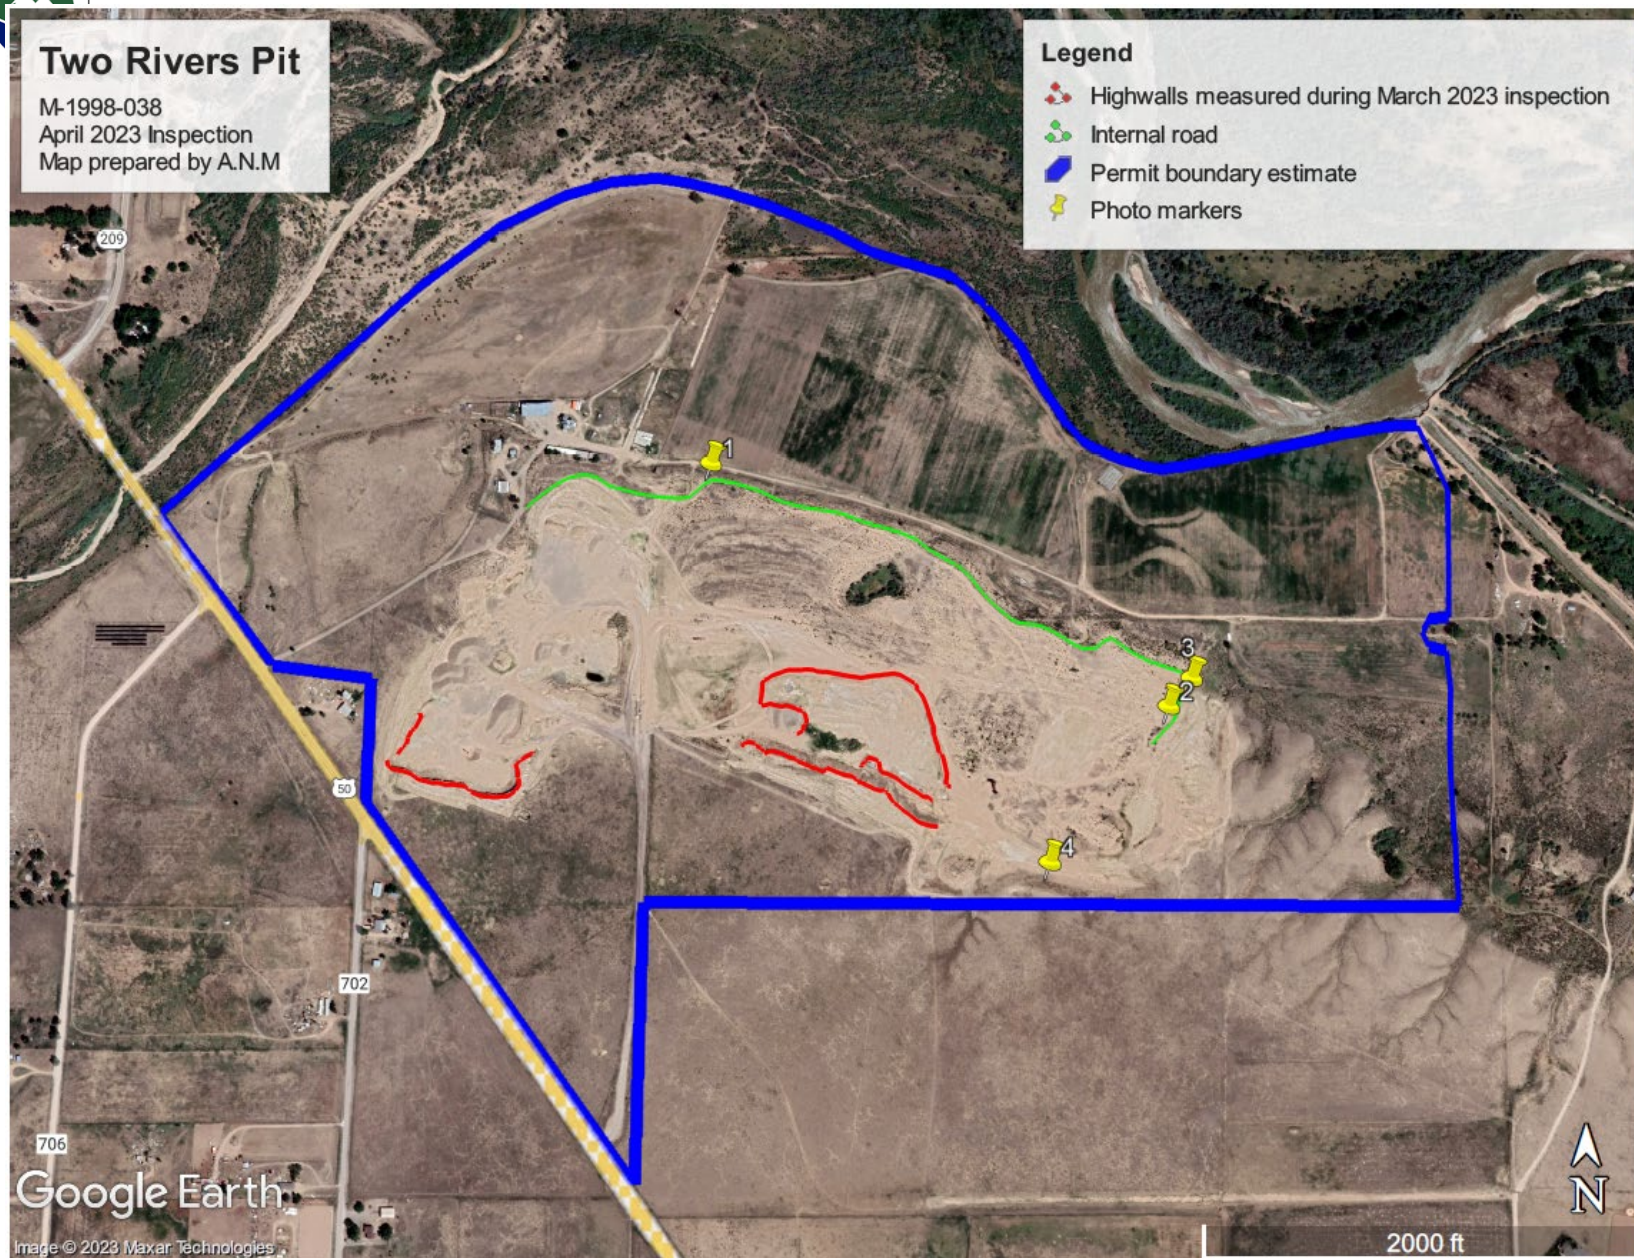
An internal road begins in the west side of the permitted area, within the processing area, and expands to the eastern border of the previously affected land in the Phase I mining area (see Map 1). During the Division's January 2020 inspection, the Operator stated that they wanted to keep this road upon reclamation. At the time, the Operator was advised to submit a technical revision stating that the road may remain upon the release of the permit. However, a technical revision to retain the road was never submitted. The prospective Successors will need to address in their amendment package whether they plan to reclaim this road or if it shall remain upon reclamation.

**Map 1:** Map created in Google Earth Pro of features observed during Part One and Part Two of the 2023 SO-1 inspection series. The photo markers correspond to photos taken during Part Two of the Two Rivers Pit 2023 SO-1 Inspection.
