**MINERALS PROGRAM INSPECTION REPORT**  
**PHONE: (303) 866-3567**

<b>MINE NAME:</b> Two Rivers	<b>MINE/PROSPECTING ID#:</b> M-1998-038	<b>MINERAL:</b> Gravel	<b>COUNTY:</b> Pueblo
<b>INSPECTION TYPE:</b> Monitoring	<b>WEATHER:</b> Clear	<b>INSP. DATE:</b> April 5, 2023	<b>INSP. TIME:</b> 12:00
<b>OPERATOR:</b> Kirkland Construction, R.L.L.P.	<b>OPERATOR REPRESENTATIVE:</b> Jodi Schreiber	<b>TYPE OF OPERATION:</b> 112c - Construction Regular Operation	
<b>REASON FOR INSPECTION:</b> Surety Related	<b>BOND CALCULATION TYPE:</b> Complete Bond	<b>BOND AMOUNT:</b> No Bond Held	
<b>DATE OF COMPLAINT:</b> NA	<b>POST INSP. CONTACTS:</b> None	<b>JOINT INSP. AGENCY:</b> None	
<b>INSPECTOR(S):</b> Amber Michels	<b>INSPECTOR'S SIGNATURE:</b>

**INSPECTION TOPIC:** Backfilling & Grading

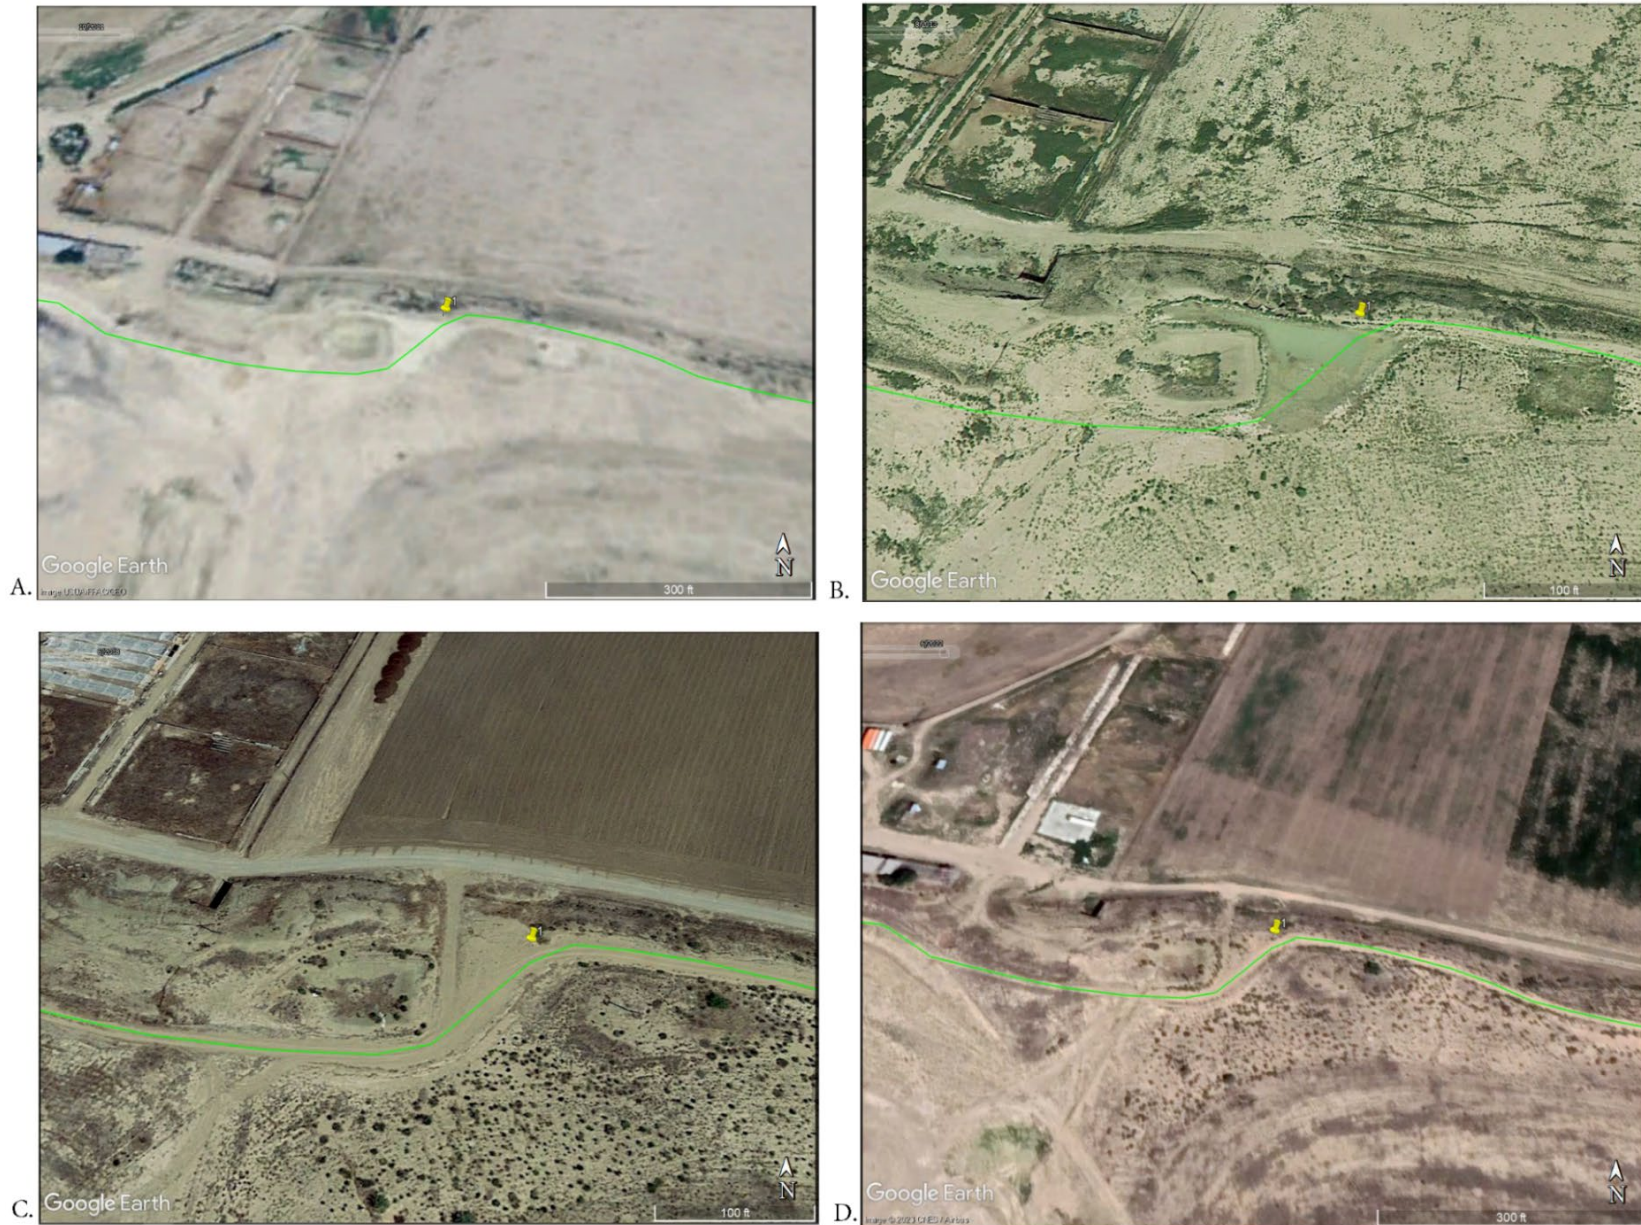
this area. An old depression located to the east of some abandoned structures, and north of the internal road (see Marker 1 on Map 1) appears to be an old water retaining structure (Photos 9-11). A pipe that appears to have allowed water to flow into the depression was also observed (Photo 9). The prospective Successor stated that they believe this was created by previous owners of this portion of the property that used this area for farming purposes. During post-inspection evaluation, the Division agrees that this area was likely created independent of mining activities (see Map 2).

**Map 2:** Images A-D taken from Google Earth Pro, represent the depression area marked by photo marker 1 from Map 1 from the years 2011 (A), 2013 (B), 2018 (C), and 2022 (D). The green line delineates the current location of the internal road identified on Map 1. Water appears to be retained in the marker 1 location

in 2013, but appears to not be in the years surrounding this time period.
