**MINERALS PROGRAM INSPECTION REPORT**  
**PHONE: (303) 866-3567**

<b>MINE NAME:</b> Rifle Gravel Pit #1	<b>MINE/PROSPECTING ID#:</b> M-2021-052	<b>MINERAL:</b> Gravel and sand	<b>COUNTY:</b> Garfield
<b>INSPECTION TYPE:</b> Preoperation Inspection	<b>WEATHER:</b> Cloudy	<b>INSP. DATE:</b> April 12, 2023	<b>INSP. TIME:</b> 15:00
<b>OPERATOR:</b> IHC Scott, Inc.	<b>OPERATOR REPRESENTATIVE:</b> Chris Adrian	<b>TYPE OF OPERATION:</b> 112c - Construction Regular Operation	
<b>REASON FOR INSPECTION:</b> Preoperation Inspection	<b>BOND CALCULATION TYPE:</b> None	<b>BOND AMOUNT:</b> \$0.00	
<b>DATE OF COMPLAINT:</b> NA	<b>POST INSP. CONTACTS:</b> DRMS	<b>JOINT INSP. AGENCY:</b> None	
<b>INSPECTOR(S):</b> Amy Yeldell	<b>INSPECTOR'S SIGNATURE:</b>

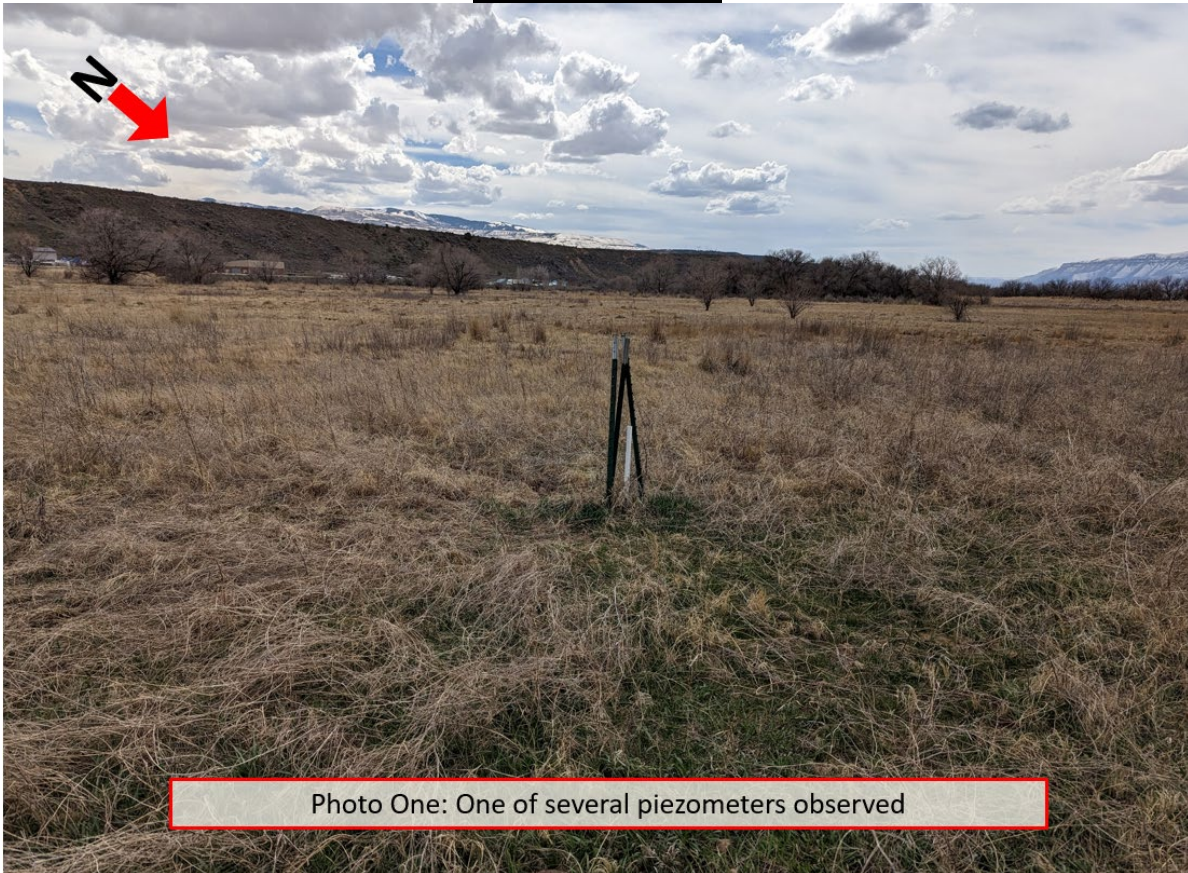
Hydrologic Balance: Six groundwater level locations (piezometers) were identified throughout the site (Photo One). There are four adequacy questions regarding these features in adequacy review #4. Little to no disturbance was observed from their installation.

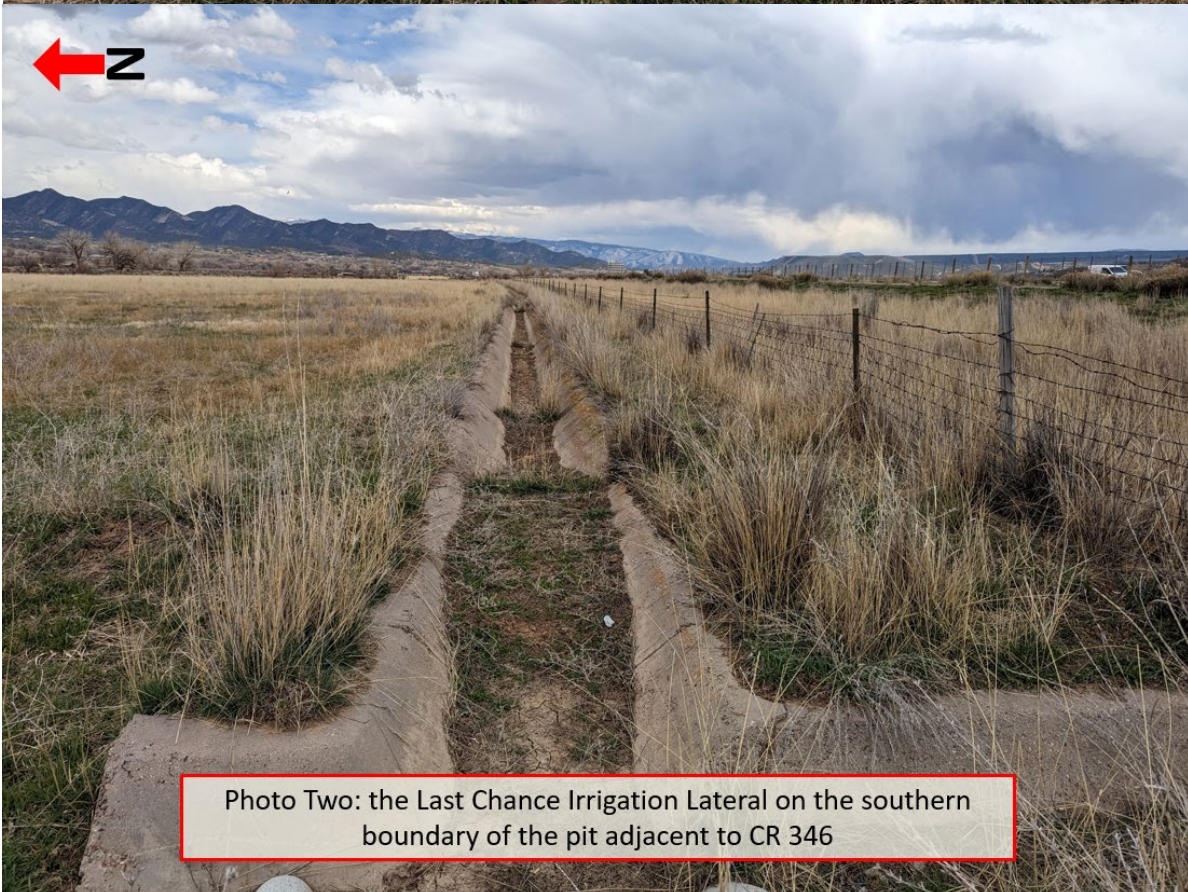
Other: A cement irrigation ditch (the Last Chance Irrigation Lateral) was observed on the southern boundary of the pit adjacent to CR 346 (Photo Two). No building or other similar above ground permanent manmade structures were observed, besides the property boundary perimeter fence. The structures identified in the application correspond to field conditions. The main ditch/ channel (Last Chance Ditch Tailwater Channel) was inundated at the time of the inspection (Photo Three). Water did not appear to have a current. The other smaller ditches or depressions located throughout the property were dry or no physical water flowing was observed.

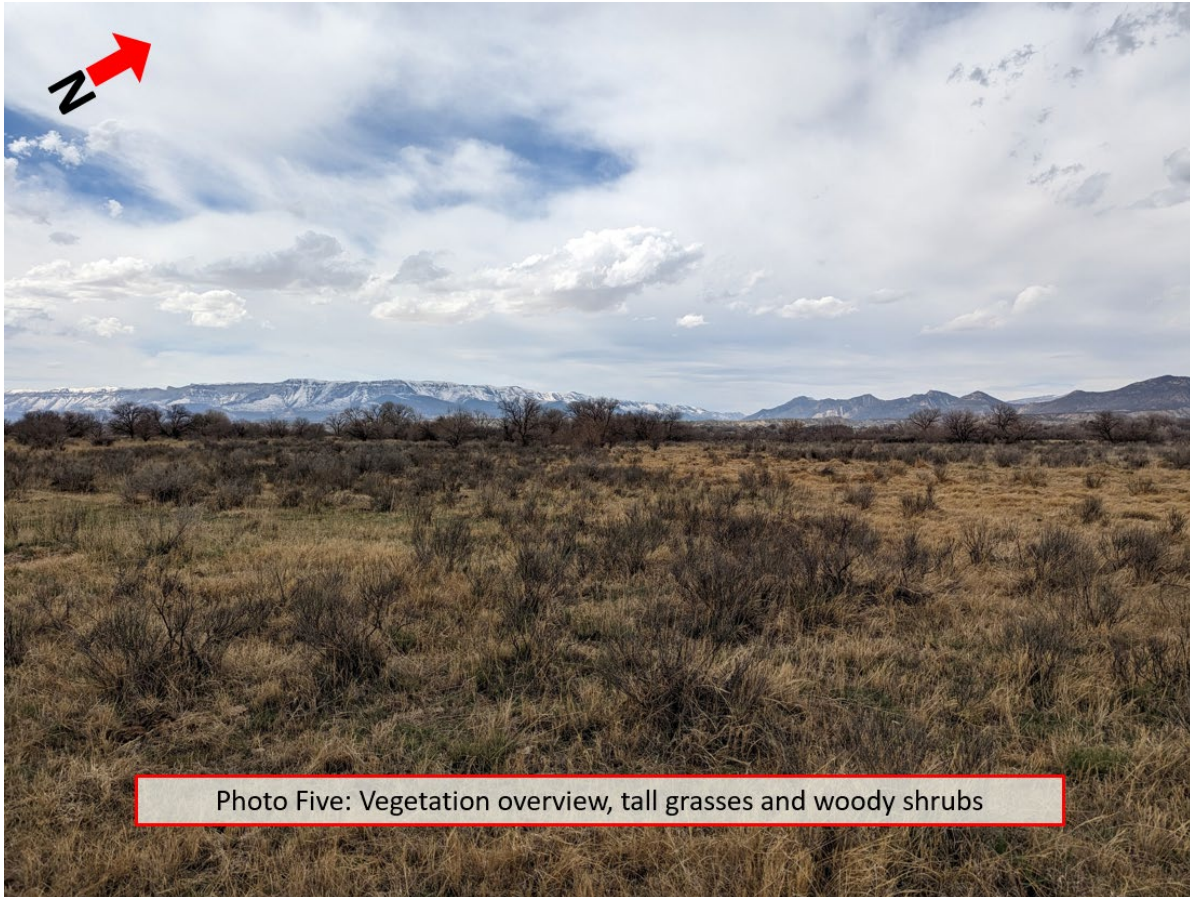
Photo Five: Vegetation overview, tall grasses and woody shrubs

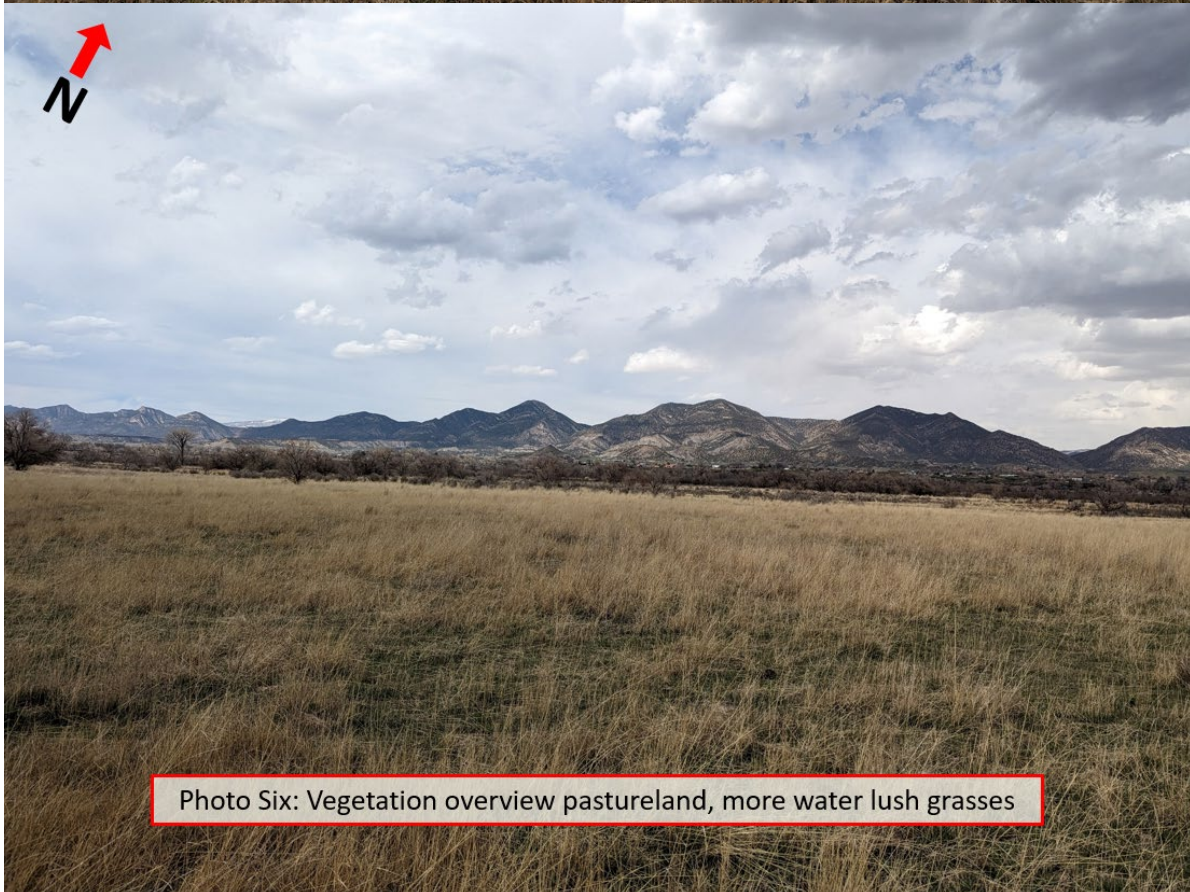
Photo Six: Vegetation overview pastureland, more water lush grasses

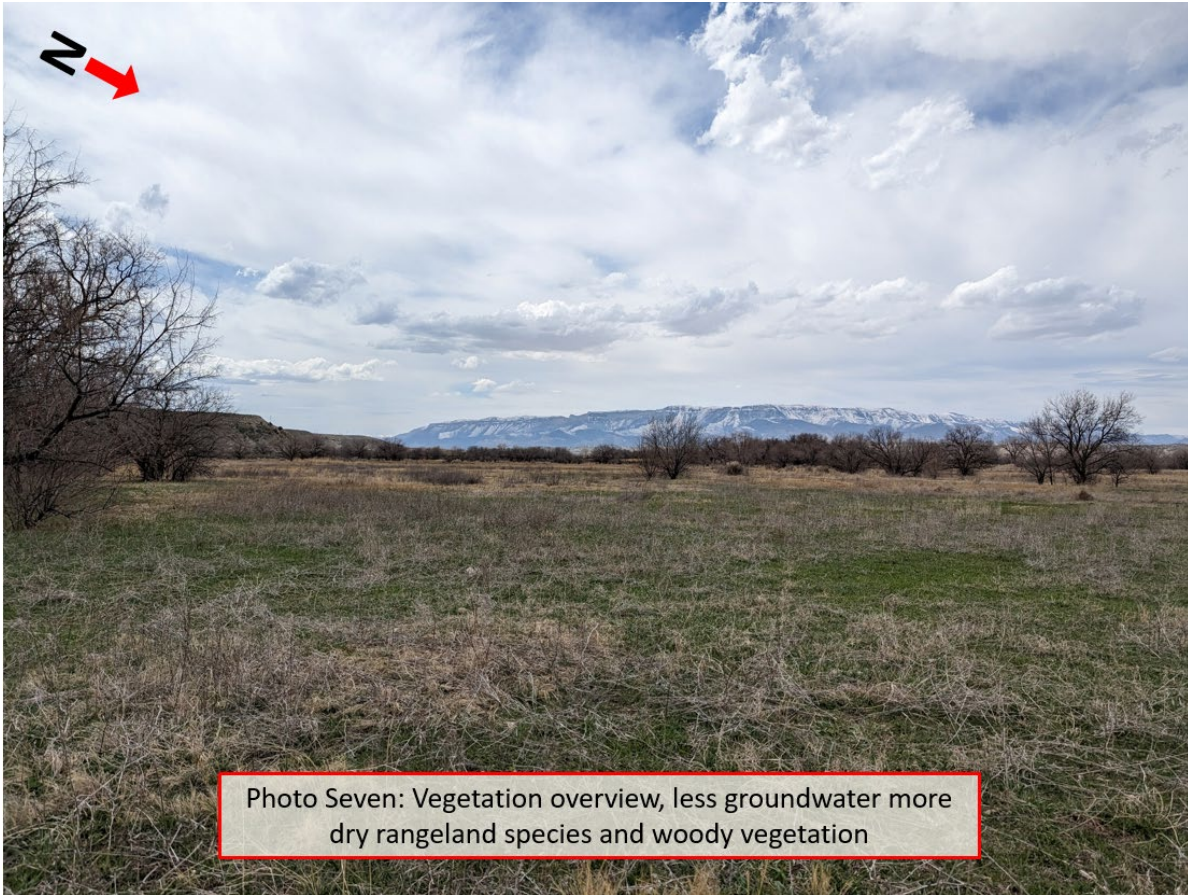
Photo Seven: Vegetation overview, less groundwater more dry rangeland species and woody vegetation

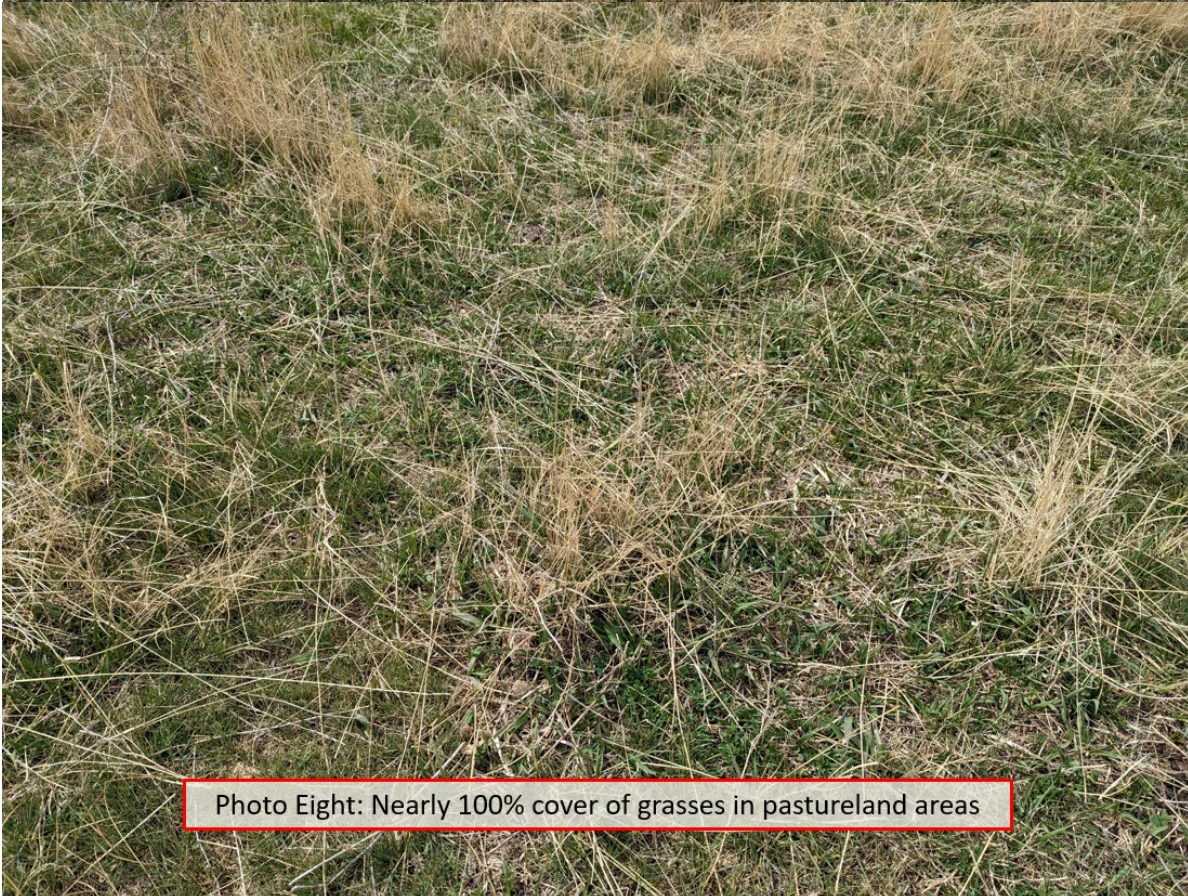
Photo Eight: Nearly 100% cover of grasses in pastureland areas

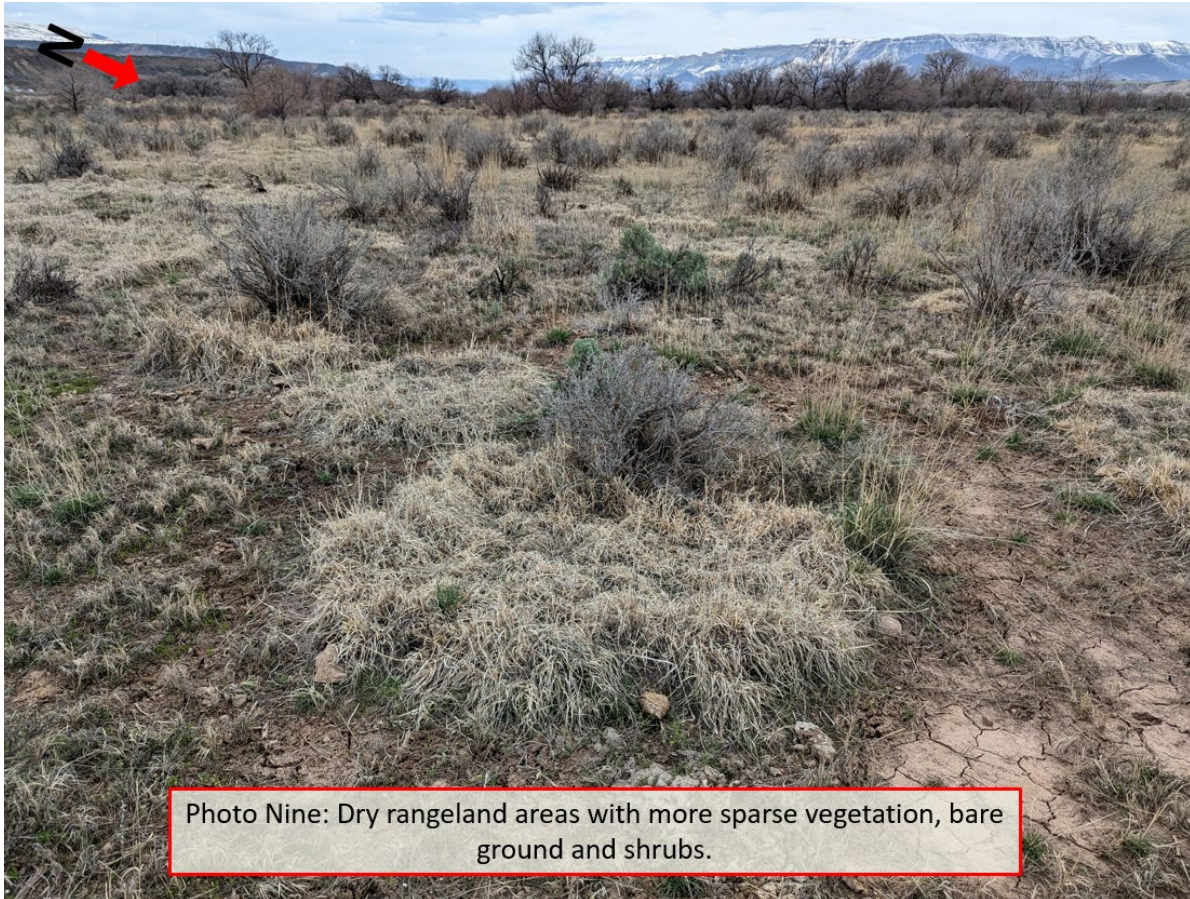
Photo Nine: Dry rangeland areas with more sparse vegetation, bare ground and shrubs.

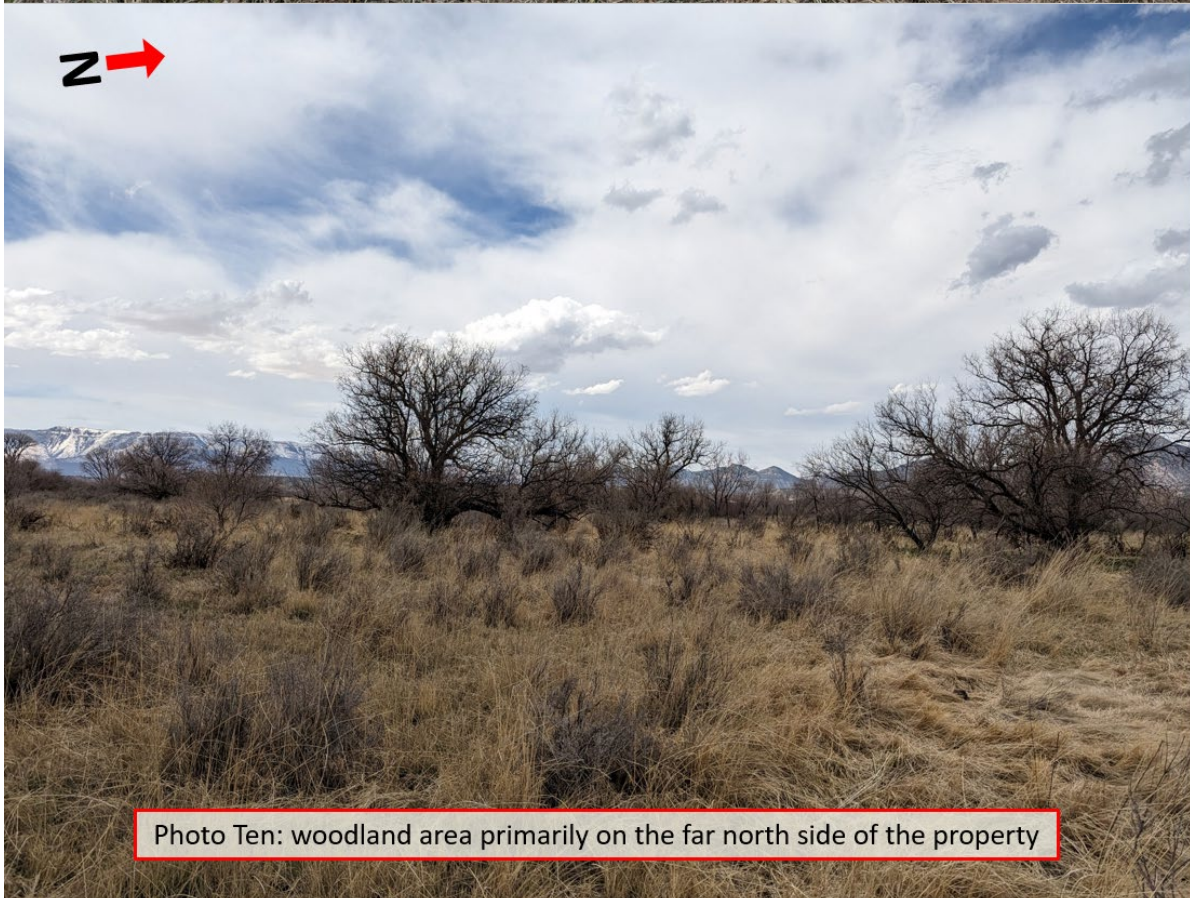
Photo Ten: woodland area primarily on the far north side of the property

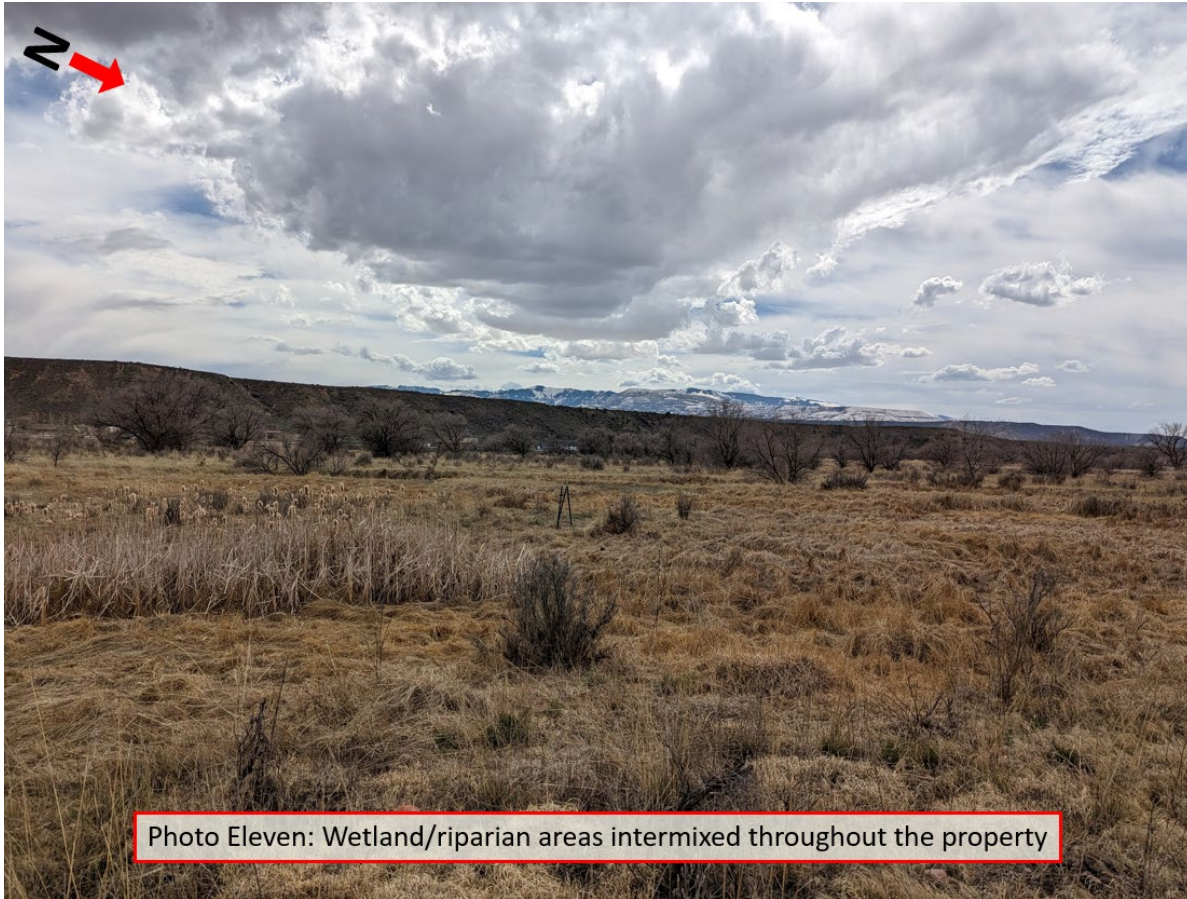
Photo Eleven: Wetland/riparian areas intermixed throughout the property

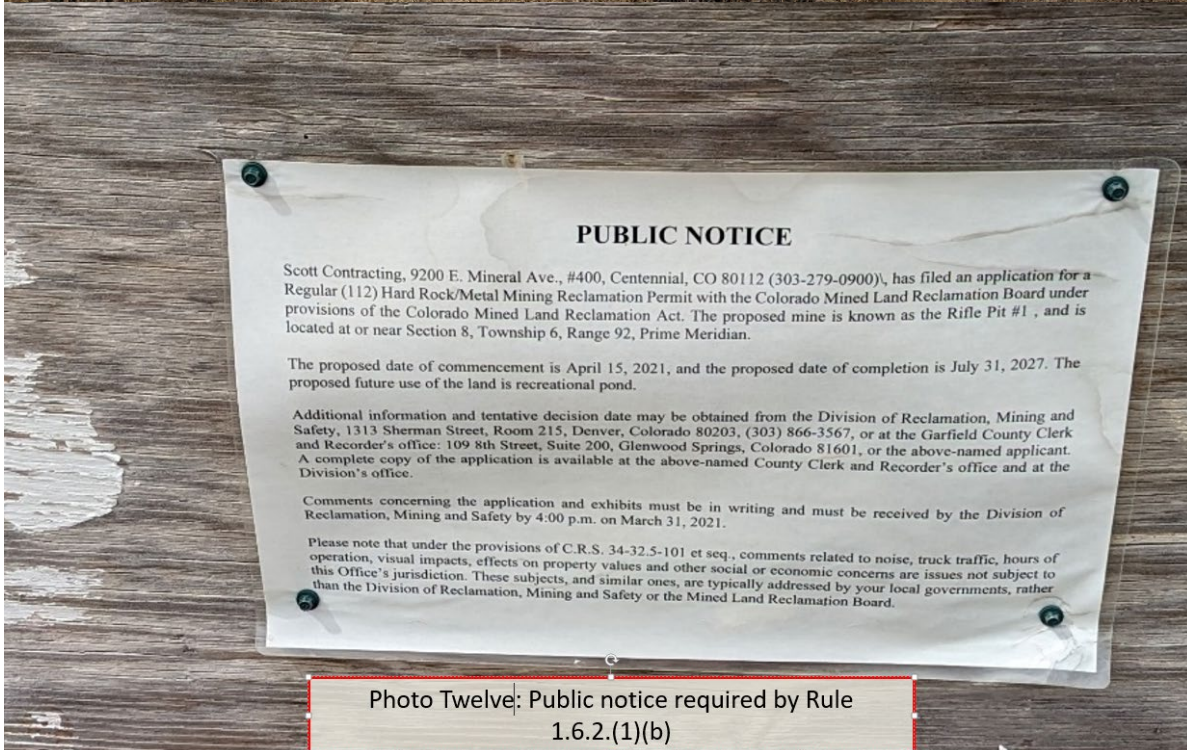
Signs and Markers: As required by Rule 1.6.2(1)(b) a mine identification sign for the public notice requirement was posted at the gate to enter the property (Photo Twelve). Unfortunately the sign did not meet the requirements of Rule 1.6.2(1)(b) as information presented was incorrect. The Applicant name and phone number does not match the application materials. The address listed is no longer current. The application type listed is incorrect, the application is for a Construction Materials Regular 112c Operation Reclamation Permit, not a Regular (112) Hard Rock/Metals Mining Reclamation Permit. The site name does not match the application materials. Lastly the comment period date referenced is for a different application, not the amended application (AM-1) currently under review. To date the Division has yet to receive an affidavit that such notice was posted. This was identified as a deficiency item number 72 of adequacy review #4. When addressing this requirement please provide the Division with documentation that a corrected sign which meets the requirements of Rule 1.6.2(1)(b) was posted.

Photo Twelve: Public notice required by Rule 1.6.2.(1)(b)
