Bowie #1 Inspection Report, 12 April 2023

| Permit Number: C-1981-038 Mine Name: Bowie No. 1 Mine Operator: Bowie Resources, LLC Operator Address: Mr. Basil R Bear | County: Delta Operation Type: Underground Permit Status: Active Ownership: Private | | | |

| Inspection Start Date: April 12, 2023 Inspection Start Time: 07:30 Inspection End Date: April 12, 2023 Inspection End Time: 09:00 | | | Inspection Type: Coal Partial Inspection Inspection Reason: Normal I&E Program Weather: Clear | |

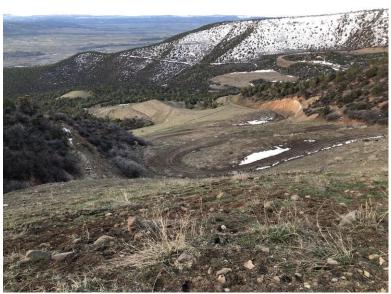
Lower portion of East Mine, from road above

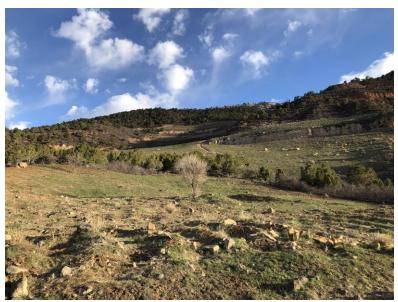
East Mine, from Old Waste Disposal Area

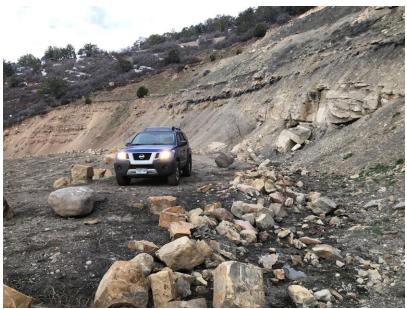
A significant slide was seen at the East Mine (see photograph). It was a circular shape, approximately 10-foot radius, with a resulting face of two feet high. It is in the same location as a slide from 2017. Large rocks were seen on the road to the portals at the East Mine. The steep slope above appears to be generally stable, but these rocks have fallen from this area and pose a hazard, especially during and after rain and snow events.

East Mine – rocks below steep slope

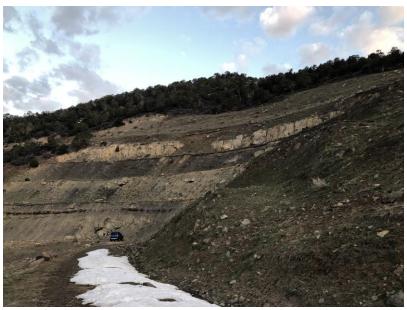
East Mine steep slope

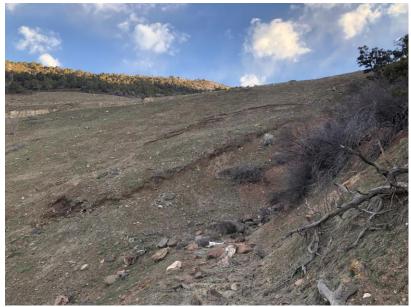
Slide at East Mine

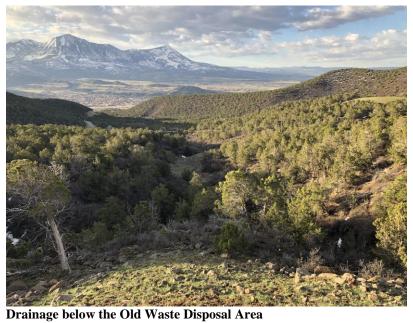
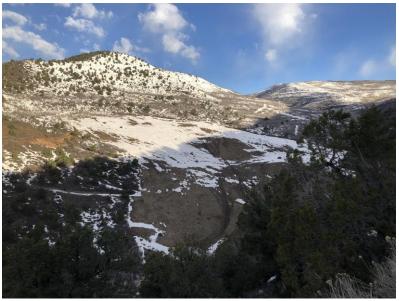
A large number of rills were seen at the West Mine. Most of the impacted area was released with SL-08, but the sediment from the rills is impacting the unreclaimed area near East Roatcap Creek.

Rills on West Mine

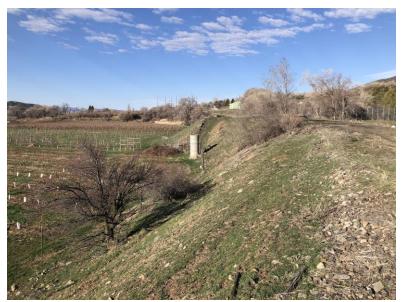
No erosion was seen at the loadout, including the steep slope between the loadout and the orchard below. The trestle across the river appears stable.

Slope below the loadout

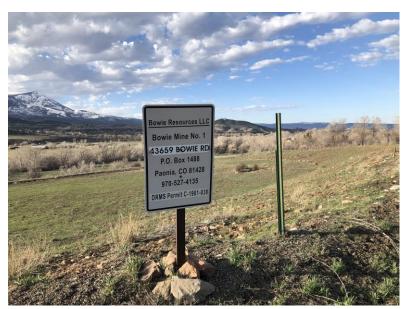
No problems were seen with the Coal Storage Area by Black Bridge Road.

Coal Storage by Highway and Black Bridge Road

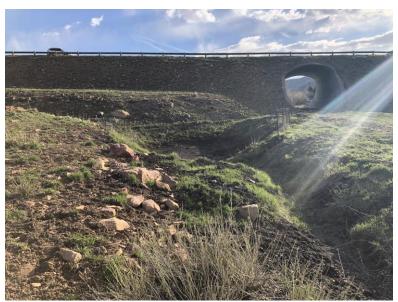
The ponds at the loadout and the Coal Storage Area (near Black Bridge Road) were dry, and no problems were identified with these ponds.

Pond at Coal Storage by Highway and Black Bridge Road
