## Keenesburg Strip Mine inspection report

<b>Permit Number:</b> C-1981-028 <b>Mine Name:</b> Keenesburg Strip Mine <b>Operator:</b> Coors Energy Company <b>Operator Address:</b> Mr. Ben Moline P.O. Box 4030 Golden, CO 80402	<b>County:</b> Weld <b>Operation Type:</b> Surface <b>Permit Status:</b> Permanent Cessation <b>Ownership:</b> Private
	<b>Operator Representative Present:</b>  None
<b>Operator Representative Signature:</b> (Field Issuance Only)

<b>Inspection Start Date:</b> April 13, 2023 <b>Inspection Start Time:</b> 08:15 <b>Inspection End Date:</b> April 13, 2023 <b>Inspection End Time:</b> 09:20		<b>Inspection Type:</b> Coal Partial Inspection <b>Inspection Reason:</b> Normal I&E Program <b>Weather:</b> Cloudy	
<b>Joint Inspection Agency:</b>  None		<b>Joint Inspection Contacts:</b>	
<b>Post Inspection Agency:</b>  None		<b>Post Inspection Contacts:</b>	
<b>Inspector(s):</b>  Robert Zuber, P.E.	<b>Inspector's Signature:</b>  <i>Robert D. Zuber</i>		<b>Signature Date:</b>  4/20/2023

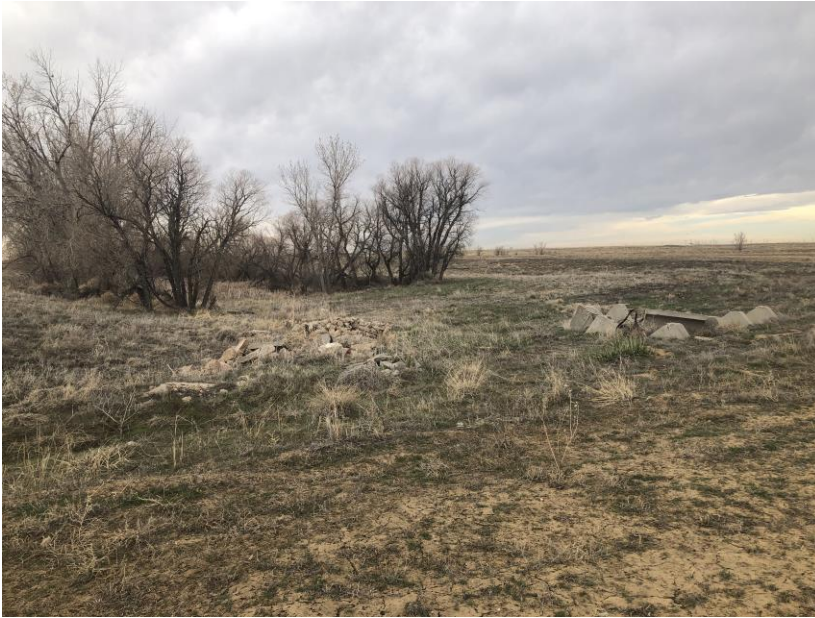
Sediment Pond 2 and the Dugout Pond contained little to no water (thick vegetation obscures the bottoms). They were not discharging during the inspection. There were no signs that either pond had discharged recently. No problems were observed with spillways or other aspects of the ponds.

**Spillway of Dugout Pond**

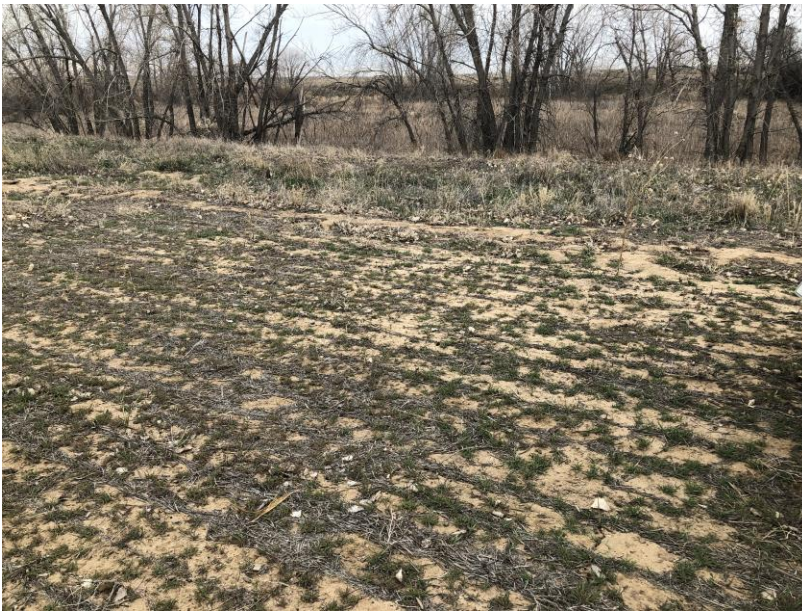
Emerging grasses were seen in Area 42 (reclaimed road by Sediment Pond 2 and larger area to west) and Area 36. The older reclamation continues to look good. In particular, the southwest corner of the site (namely Area 32) looks good.

**Emerging grass on reclaimed road by Sediment Pond 2 (part of Area 42)**

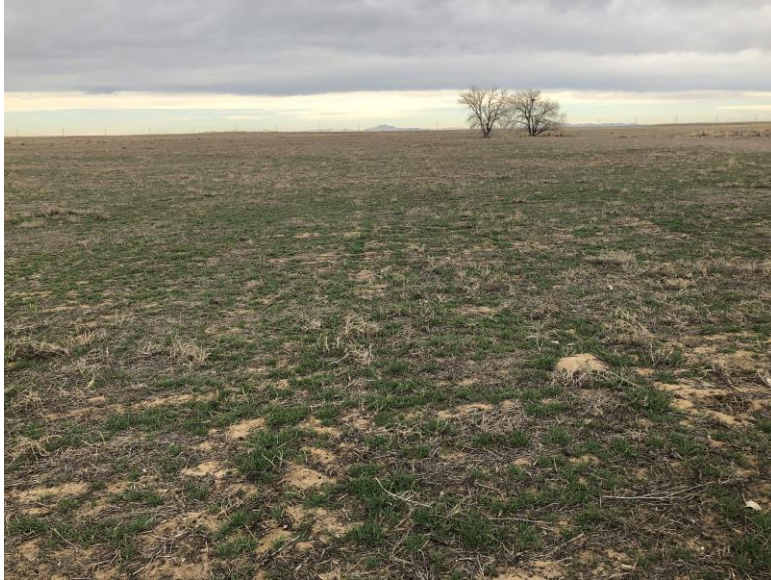
**Emerging grass in Area 42**

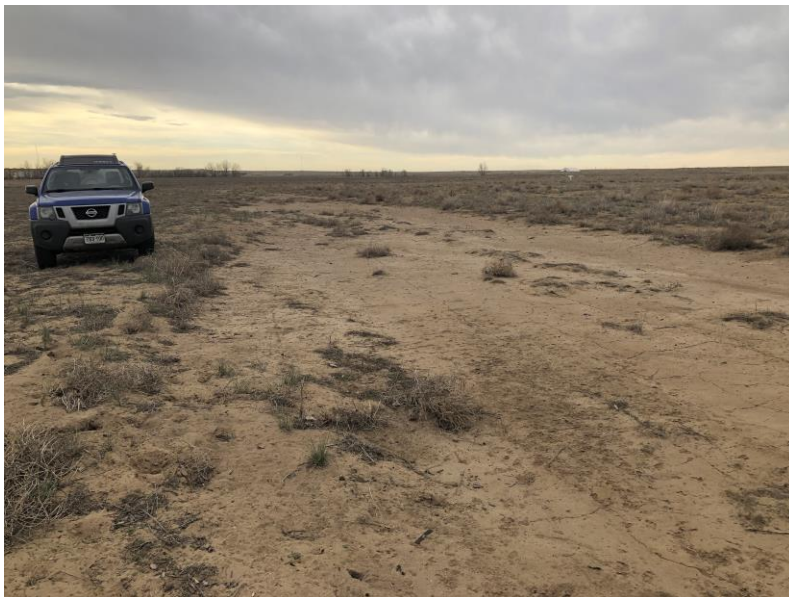
No erosion problems were seen onsite, and nearly the entire site was inspected. Bare spots were seen in some areas, namely Area 37 and the east side of Area 35. The steep area east of the Dugout Pond was stable.

**Large bare spot in Area 37**
