Keenesburg Mine Site Inspection Report

1st Quarter

2/14/2023

Inspected By: Matt Clark

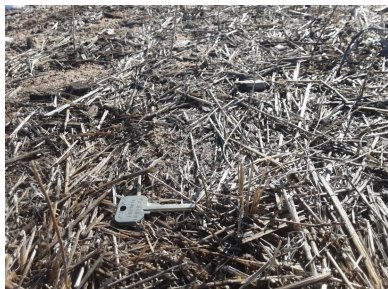
Some desirable cool season grasses beginning to establish (photo 1)

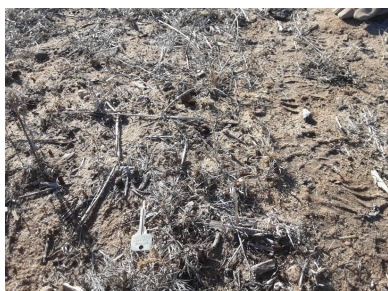
Wide spread and densely populated Buffalo grass and other perennial grasses noted in the area. Continue to monitor and avoid disturbing area if possible by not overseeding (photo 2).

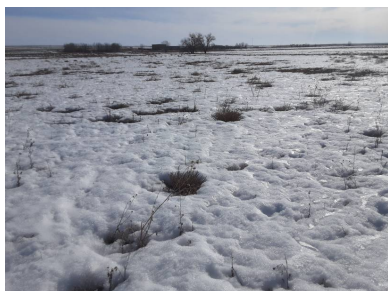
Much of the recently revegetated areas were covered with 4-5 inches of snow (photo 3).

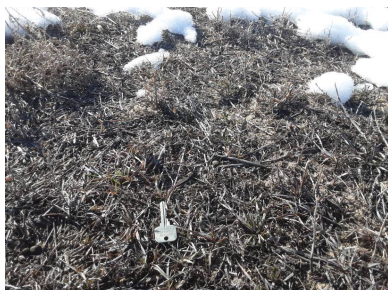
Densely populated and widely spread cheatgrass establishment in the area. Continue to monitor and low mow late May or early June prior to seed set. Monitor area for overseeding (photo 4).

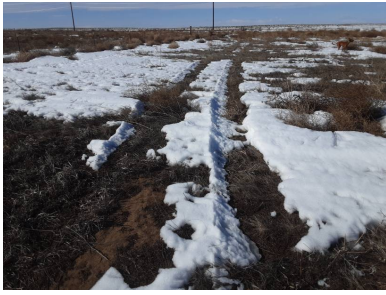
Signs of vehicle(s) accessing property through western gate. Gate not locked (photo 5).

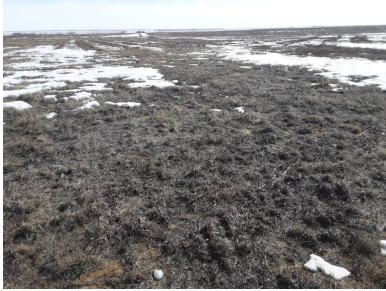
Area mowed in summer 2022. Continue to monitor and mow summer 2023 (photo 6).

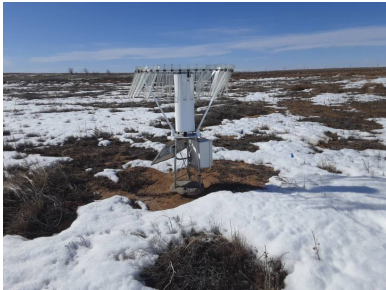
Weather station appears in operational condition (photo 7).

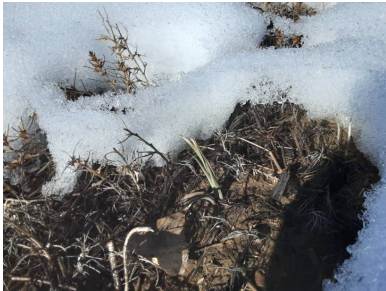
Perennial shrubs establishing in revegetated areas. Continue to monitor and avoid disturbing areas if possible (photo 8).

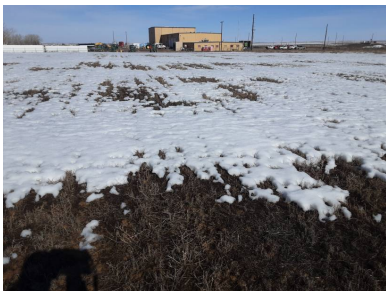
Minimal desirable vegetation establishment in area. Continue to monitor and mow and overseed if necessary (photo 9).

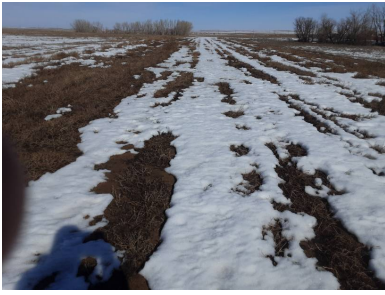
No disturbance noted on old haul road from main entrance gate (photo 10).
