**MINERALS PROGRAM INSPECTION REPORT**  
**PHONE: (303) 866-3567**

<b>MINE NAME:</b> N Farm Rd Pit No 1	<b>MINE/PROSPECTING ID#:</b> M-1977-140	<b>MINERAL:</b> Sand and gravel	<b>COUNTY:</b> Rio Grande
<b>INSPECTION TYPE:</b> Monitoring	<b>WEATHER:</b> Clear	<b>INSP. DATE:</b> April 11, 2023	<b>INSP. TIME:</b> 13:00
<b>OPERATOR:</b> Mathias Concrete, Inc.	<b>OPERATOR REPRESENTATIVE:</b> Marshall Mathias	<b>TYPE OF OPERATION:</b> 112c - Construction Regular Operation	
<b>REASON FOR INSPECTION:</b> Normal I&E Program	<b>BOND CALCULATION TYPE:</b> Partial Bond	<b>BOND AMOUNT:</b> \$32,864.00	
<b>DATE OF COMPLAINT:</b> NA	<b>POST INSP. CONTACTS:</b> None	<b>JOINT INSP. AGENCY:</b> None	
<b>INSPECTOR(S):</b> Todd Jesse	<b>INSPECTOR'S SIGNATURE:</b>

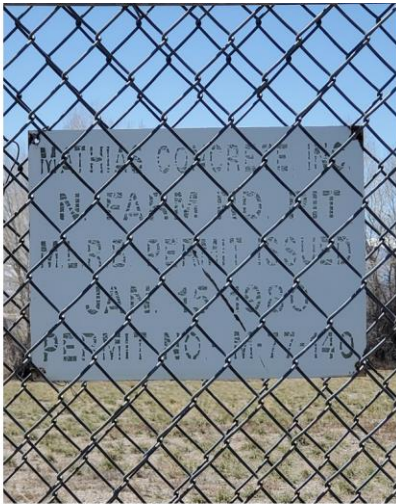
The mine identification sign and the affected area boundary markers are in place and in compliance with rule 3.1.12. The sign is posted by the gate off of North Farm Road. The permit boundary is marked with orange posts and fence line that are easily identifiable. There is currently no mining in the permit area - only processing. Material for the processing plant comes from the North Farm Road Gravel Pit (m2000110) which is located along the eastern boarder of the permit boundary.

View to the west showing the proper Mine ID signage at the entrance to the site

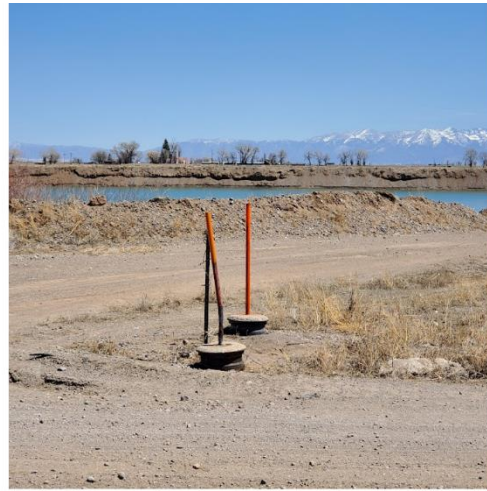
View to the east showing markers that delineate the permit area.

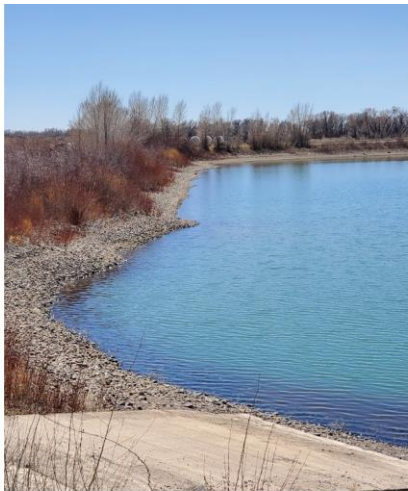
The western section of the permit boundary consists of an undisturbed permit block and reclaimed pond. The reclamation pond does not show any signs of erosion along the banks, has good shrub vegetation, and is stocked with fish. All processing activity occurs in the eastern section of the permit boundary. The processing area consists of a batch plant facility with shop areas and yard. In addition to the batch plant there are also material stockpiles with screening/conveyor equipment. There was no evidence of state listed noxious weeds on stockpiles or anywhere else within the affected area.

View to the south showing banks of reclaimed pond and vegetation that has established.

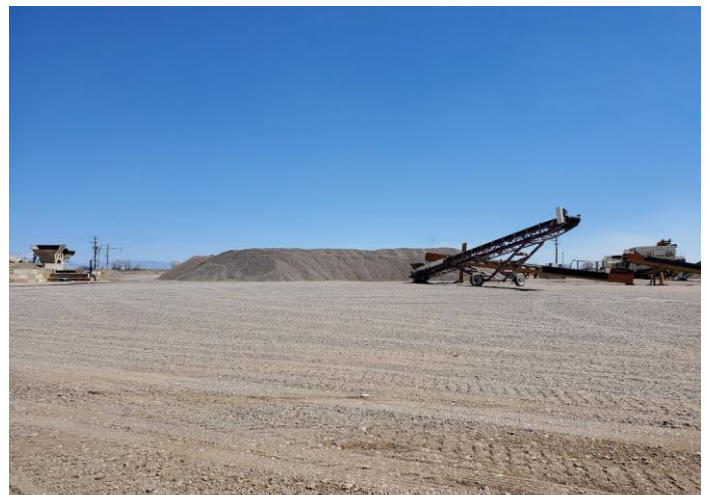
View to the east showing product stockpile with conveyor equipment.

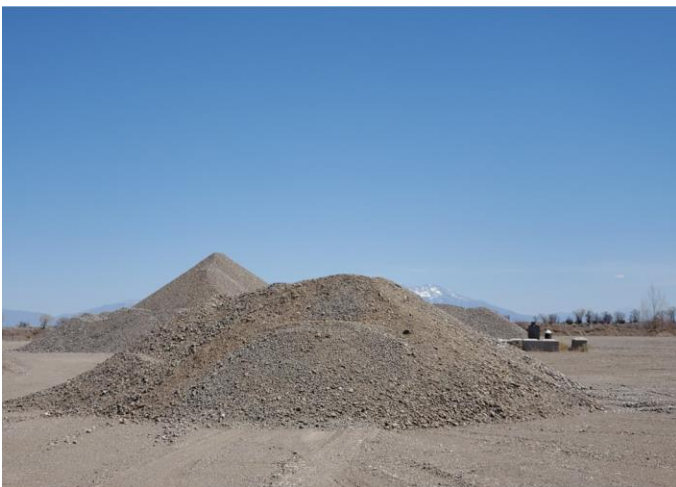
View to the east showing material stockpiles in the processing area

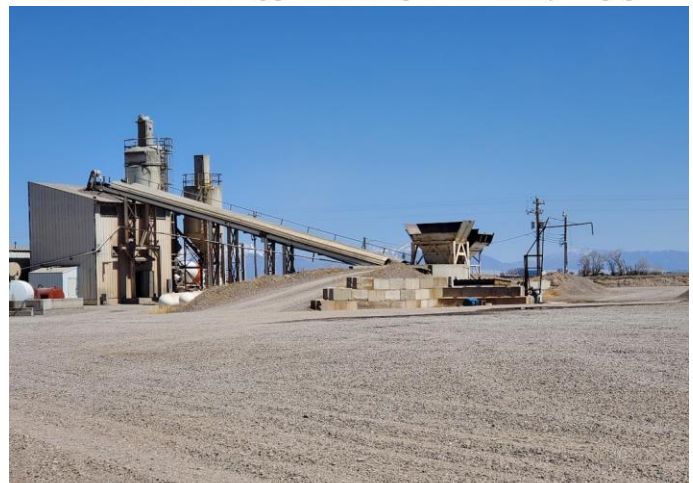
View to the northeast showing processing facilities on site.

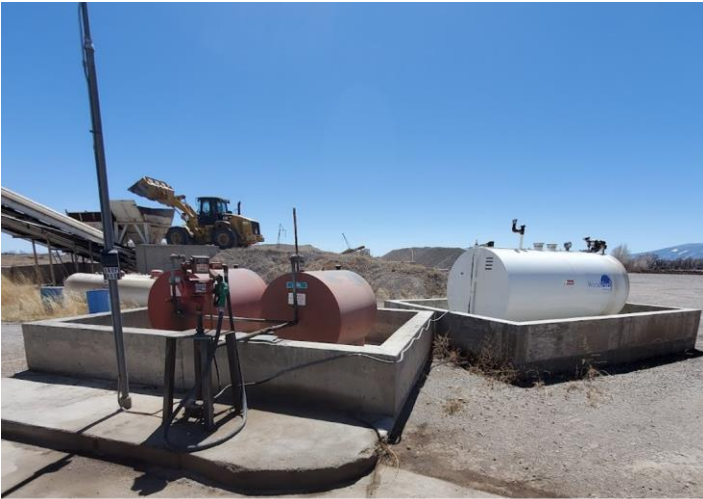
View to the south showing fuel tanks in secondary containment.

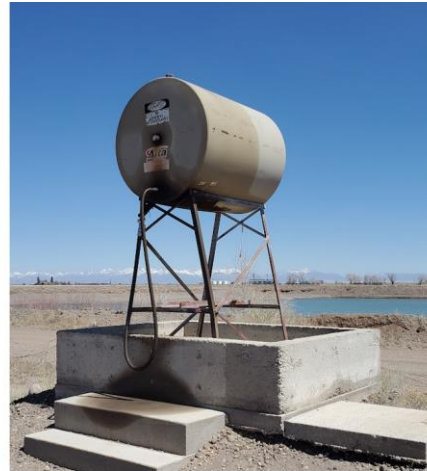
View to the east showing fuel tank along eastern boundary in concrete secondary containment.

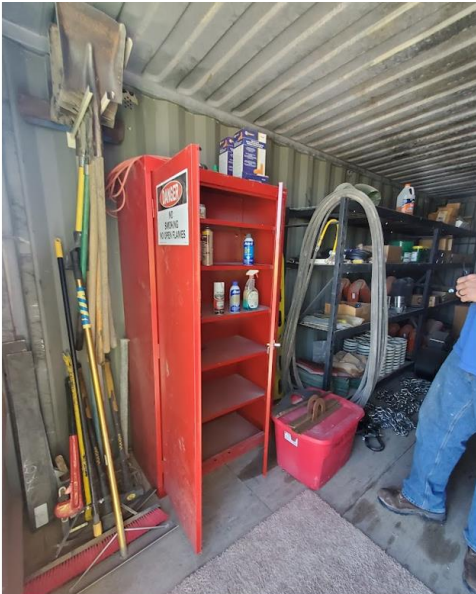
View of equipment/tool storage area with flammable cabinet

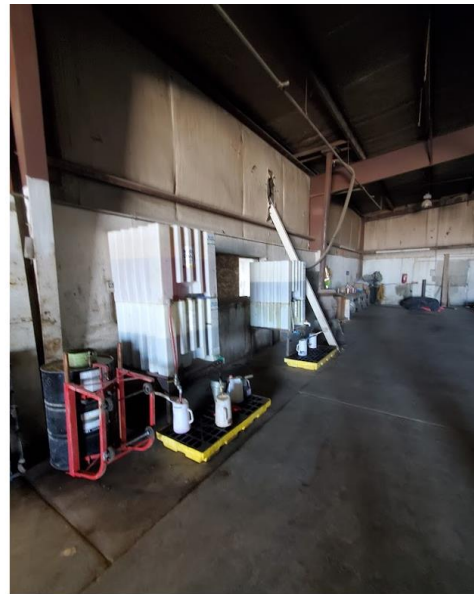
View of the shop area with lubricant storage
