MINERALS PROGRAM INSPECTION REPORT
PHONE: (303) 866-3567

MINE NAME: Cresson Project	MINE/PROSPECTING ID#: M-1980-244	MINERAL: Gold and silver	COUNTY: Teller
INSPECTION TYPE: Monitoring	WEATHER: Clear, sunny	INSP. DATE: March 13, 2023	INSP. TIME: 10:30
OPERATOR: Cripple Creek & Victor Gold Mining Co	OPERATOR REPRESENTATIVE: Tony Matarrese, Brian Doering	TYPE OF OPERATION: 112d-3 - Designated Mining Operation

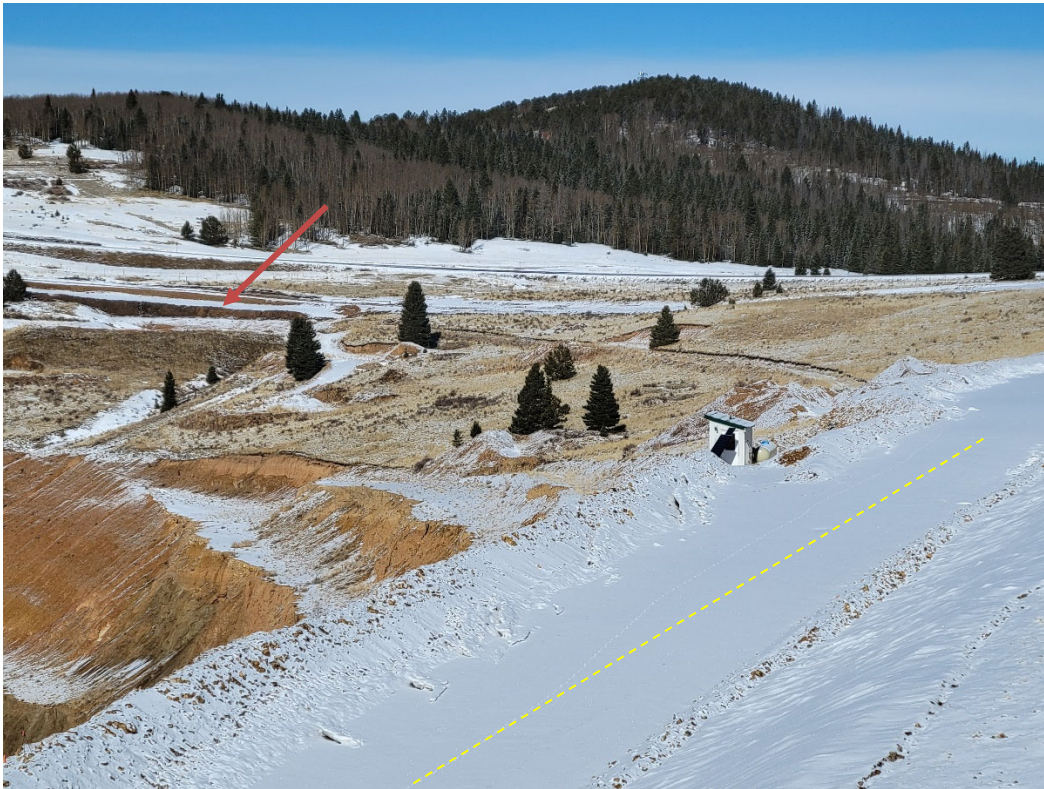
Prior to meeting with the representatives from CC&V, the Division stopped at the Grassy Valley overlook and observed the completed Ironclad access road approved in TR128 and the Whex Clay Borrow Pit location, recently approved in TR133. As of this inspection, no material has been excavated from the borrow pit.

Photo 1. View looking west from the mine overlook off Co Rd 82. New Ironclad access road in the foreground. Arrow points to location of Whex Clay Borrow Pit approved in TR 133. No material has been excavated from the pit.

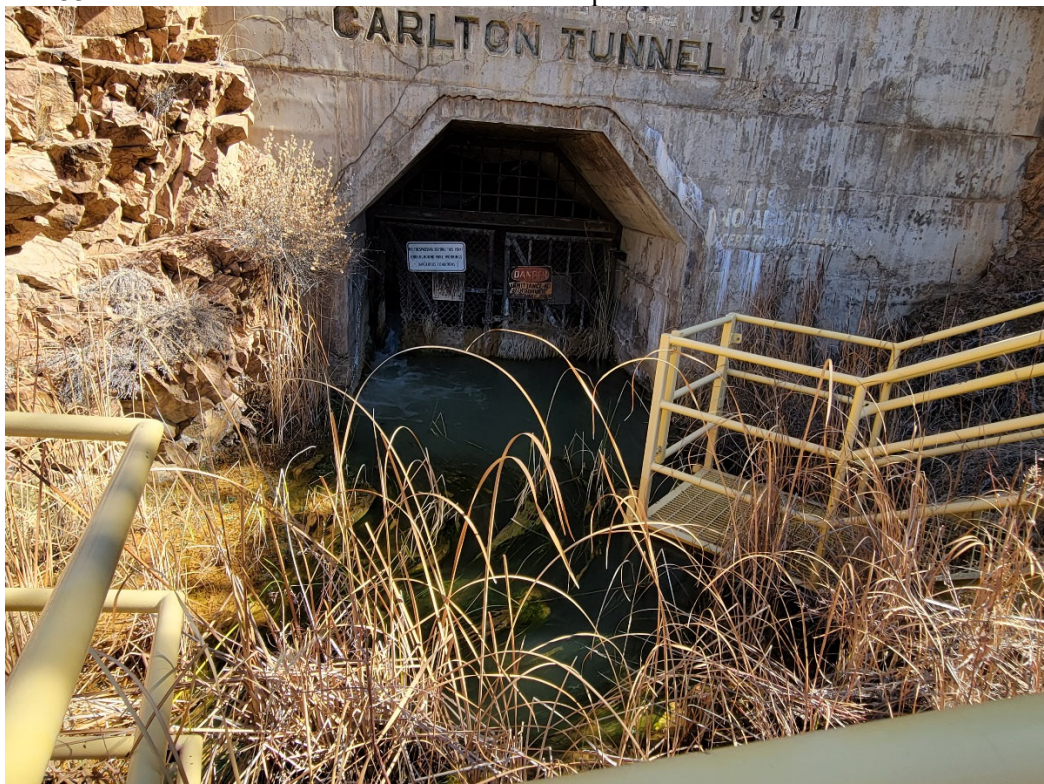
The Division conducted an inspection of the Carlton Tunnel permit area. Water was flowing from the tunnel and the sediment ponds were operational. Wetland vegetation surrounds the ponds and no evidence of erosion or overflow into the surrounding area was observed.

Photo 2. Carlton Tunnel discharge point.

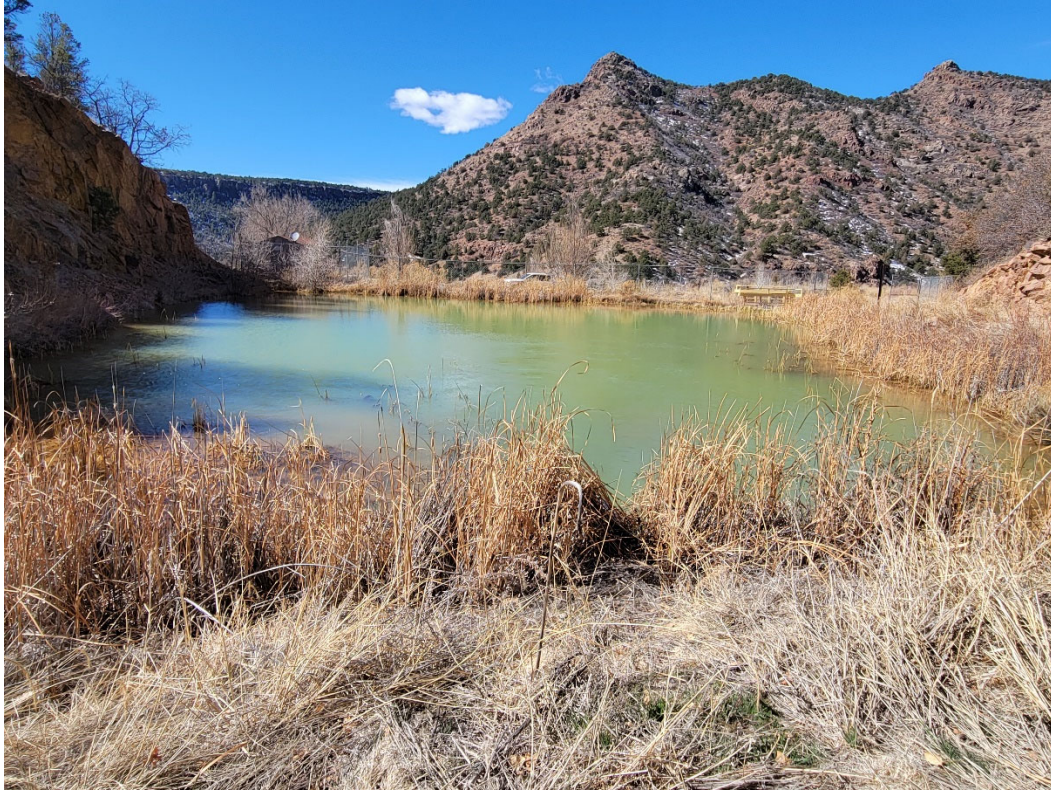
Photo 3. Sedimentation pond #1.

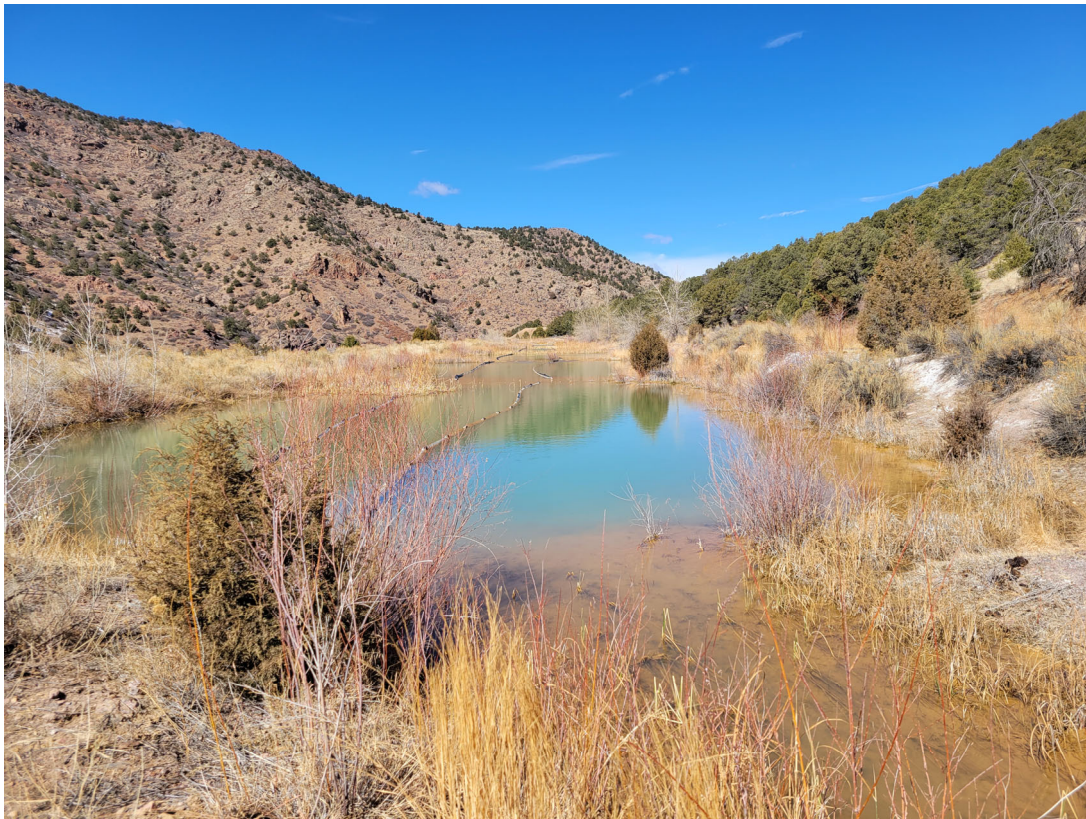
Photo 4. Sedimentation ponds 2-6. Baffles in pond to lengthen flow path and distribute sediment.

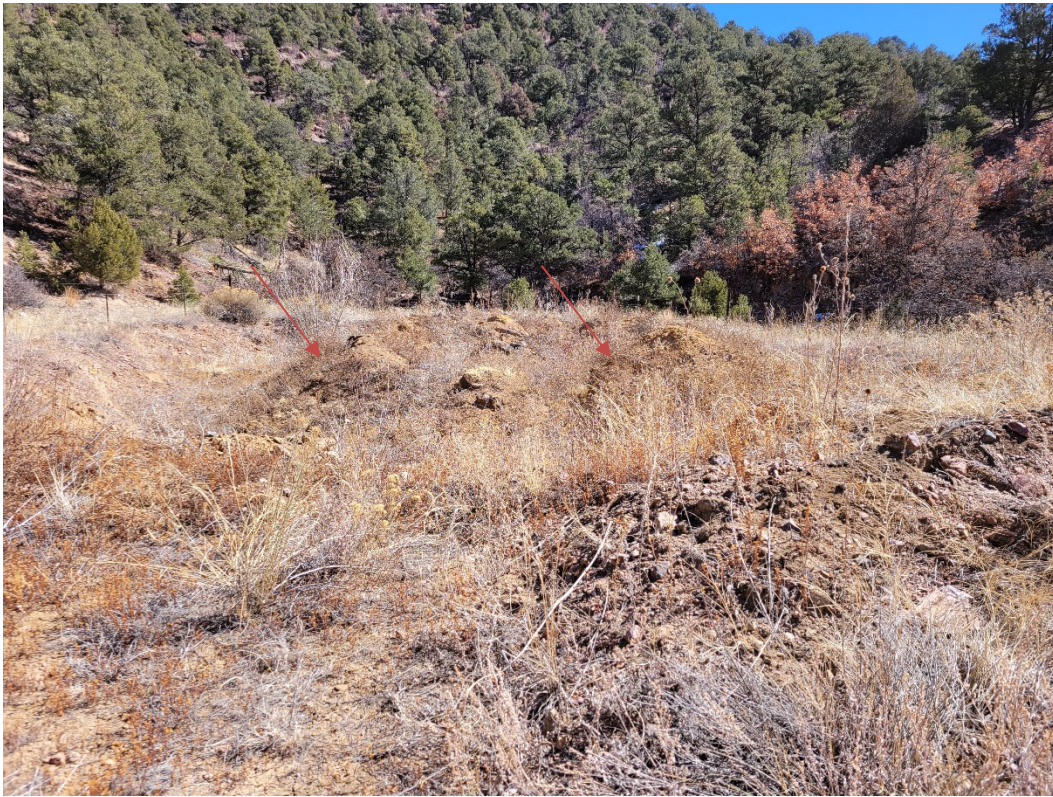
PROBLEM/POSSIBLE VIOLATION: Problem: Sludge removed from the passive treatment ponds at the Carlton Tunnel is stored in an excavated pit on the southern end of the permit area. The current mine plan does not contain information regarding the storage and handling of this material. The current mine plan also does not contain information regarding the characterization of this material.

The Division observed a pit containing sediment within the fenced permit boundary south of the tunnel. According to Mr. Doering, the passive treatment ponds are occasionally cleaned out and the sludge material is placed in the excavated pit on the southern end of the permit area. The ponds were last cleaned out in 2018.

In a review of the permit history, the sludge storage area was previously noted in a June 19, 2020 inspection report, which cited a problem with the boundary markers around the Carleton Tunnel. During this inspection the Division measured the sludge storage area to be 0.14 acres in size. In November 2020, the Division approved TR124 for an adjustment to the Carlton Tunnel permit boundary in this area. The submittal for TR124 provides a cost estimate for 20 years of maintenance by excavating 10 percent of the sediment ponds (96 cubic yards) every five years. However, TR124 and the current mine plan do not address any other details of the handling and storage of the material removed from the ponds. The Division has cited a compliance problem requiring the Operator to submit a report detailing the current clean-out process and storage of Carlton Tunnel treatment pond sludge; please see Page 1 of this report for more details.

Photo 5. Disposal area containing sludge removed from ponds in 2018.

CORRECTIVE ACTIONS: The Operator shall submit a report detailing the Carlton Tunnel pond clean out process within 60 days of this report. This report shall include a characterization of the material in the ponds by providing sample results of a TAL metals analysis, the handling procedures used to prevent impacts to the hydrologic balance, and the design details and location of the excavated pit. The sample should be a minimum of a 5-point composite at multiple locations and depths greater than 12 inches of the excavated material stored in the existing pit.

CORRECTIVE ACTION DUE DATE: 6/20/23

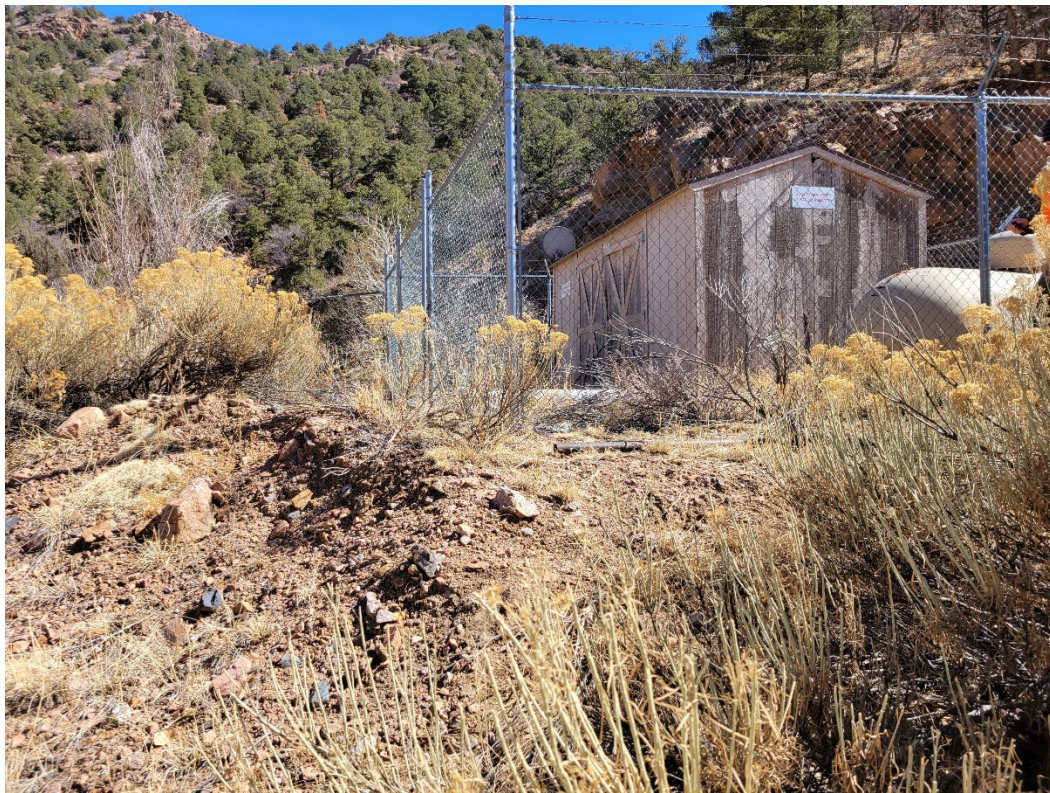
Photo 6. Equipment storage shed at Carlton Tunnel.

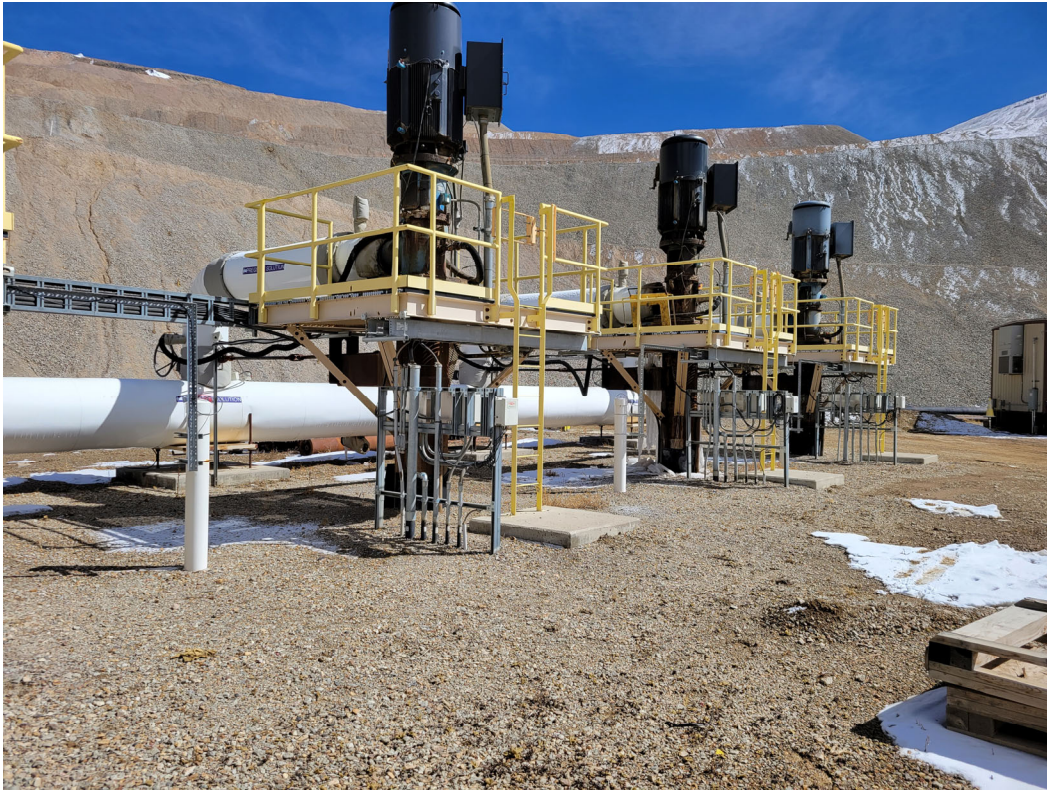
VLF2 Water levels & Leak Detection sumps: The physical readouts for the high volume solution collection system (HVSCS) water levels in the VLF2 process solution storage area (PSSA) were checked. HVSCS water levels in the VLF2 PSSA are required to be less than 80 percent storage capacity which is at a level of 94 feet. Water levels were checked in all four riser pipes (all between 61.2-62.0 feet) as well as the piezometer (outside the influence from the draw down due to pumping in the risers) where the water level was at 70.6 feet. The water levels in the low volume solution collection system (LVSCS) were also checked. LVSCS water

Photo 8. VLF2 high volume solution collection system pumps (HVSCS).

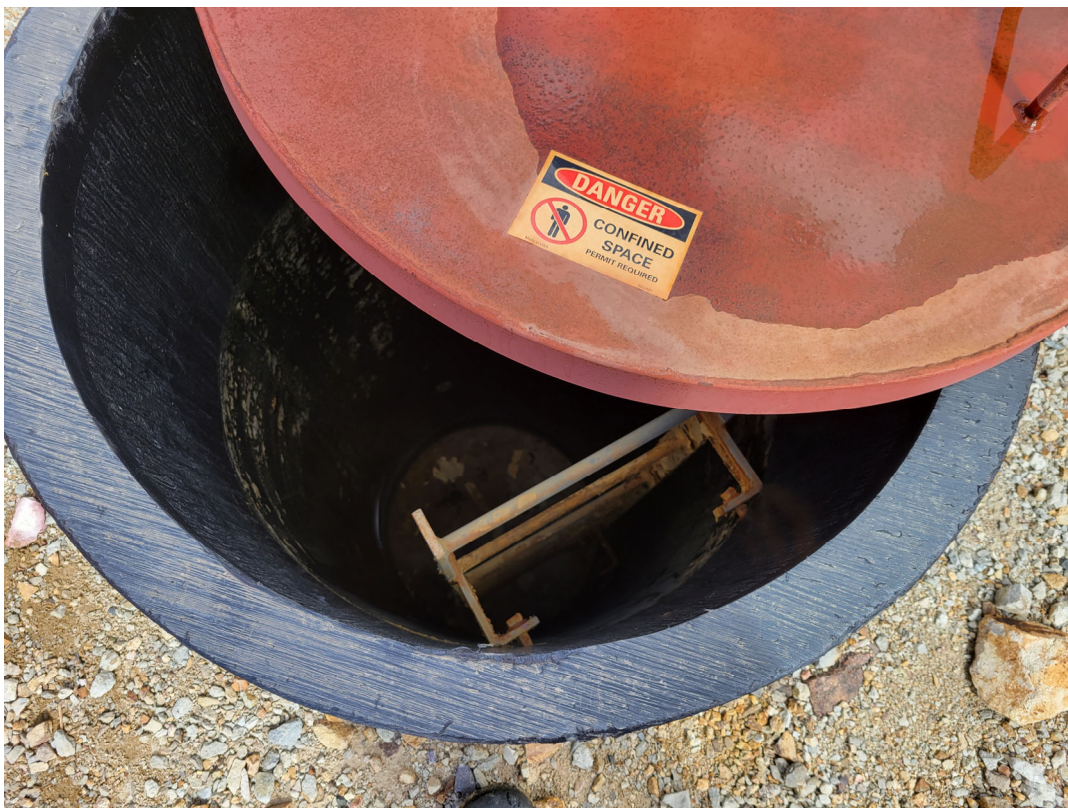
levels are required to be less than 24 inches. The water levels of both pumps were observed to be at 11.8 and 12.7 inches. Both HVSCS and LVSCS water levels were within operating limits. Two of the VLF leak detection sumps near ADR2 (VLF2-LDS-1 and VLF2-LDS-2) were checked and found to be dry (see Photo 8). Additionally, the high volume and low volume solution levels in VLF1 and VLF2 were checked remotely from the office with the help of Mr. Dylan Noble (CC&V). All levels were within normal operating limits and no issues were noted (see Attachment A).

Photo 8. VLF2 storage area leak detection sumps checked for compliance with permit.

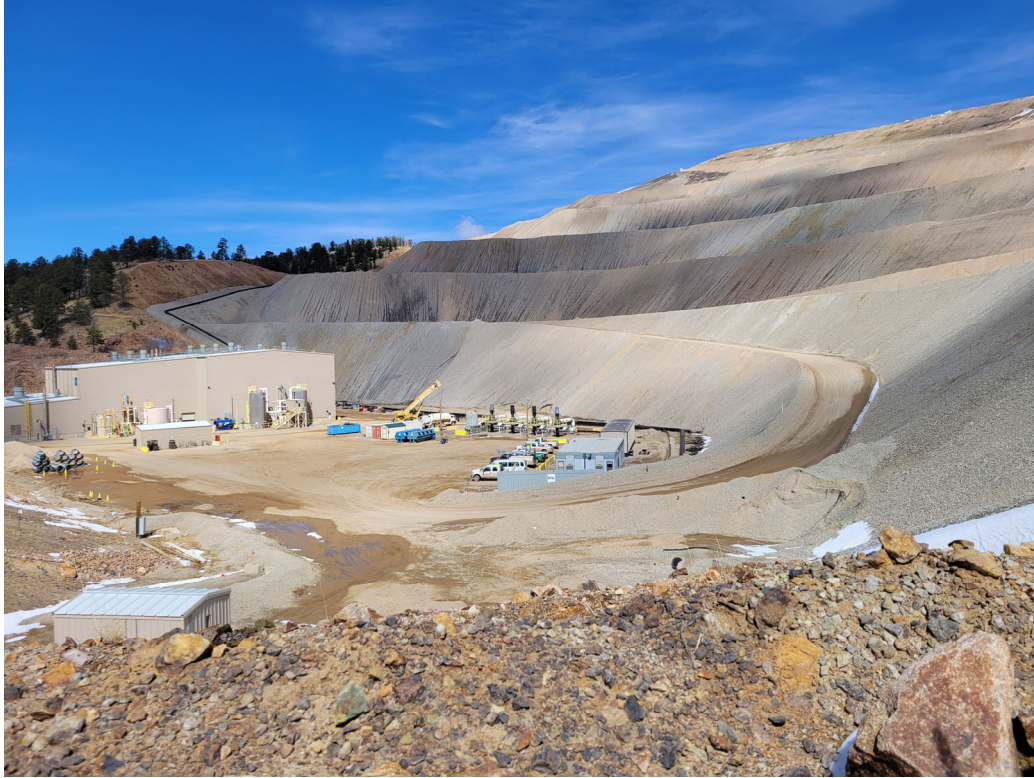
The Division, along with CC&V representatives, conducted an interior and exterior inspection of the ADR2. No signs of leaks, spills or secondary containment problems were noted.

Photo 8. View of VLF2 and ADR2.
