MINERALS PROGRAM INSPECTION REPORT
PHONE: (303) 866-3567

| MINE NAME: North Farm Road Gravel Pit | MINE/PROSPECTING ID#: M-2000-110 | MINERAL: Sand and gravel and material for construc | COUNTY: Rio Grande |
| INSPECTION TYPE: Monitoring | WEATHER: Cloudy | INSP. DATE: April 11, 2023 | INSP. TIME: 13:30 |

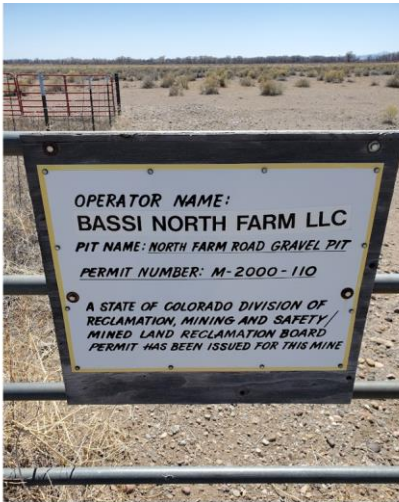
The mine identification sign and the affected area boundary markers are in place and in compliance with rule 3.1.12. The sign is posted by the gate off of North Farm Road. The permit boundary is marked with fence line that is easily identifiable. Groundwater is exposed in the pit floor and the pit will remain a pond post reclamation. Waterfowl were seen utilizing the pond during the inspection. There was no evidence of state listed noxious weeds within the affected area.

View to the south showing proper Mine ID signage at the entrance to the site

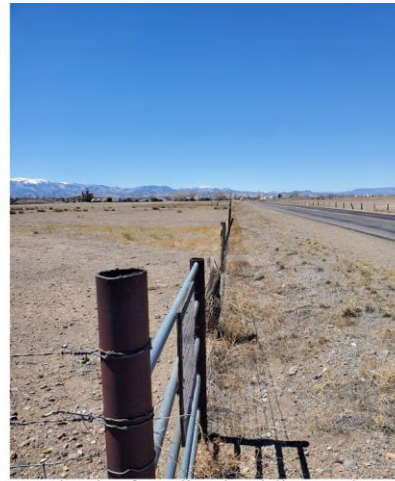
View to the west showing fence line that delineates the northern permit boundary

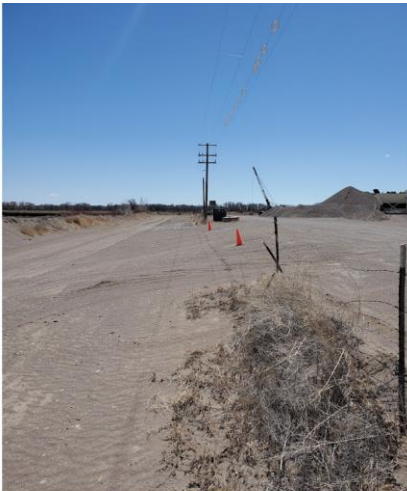
View to the south showing fence line that delineates the western permit boundary with access to neighboring permit

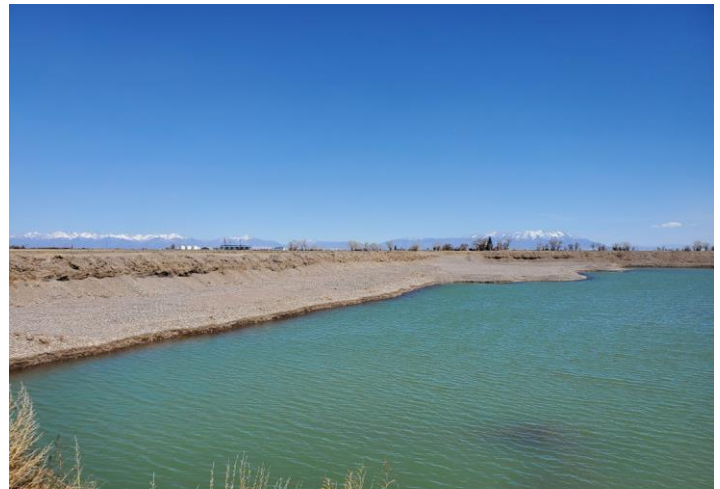
View to the northeast showing the platform in the pit where equipment extracts material.

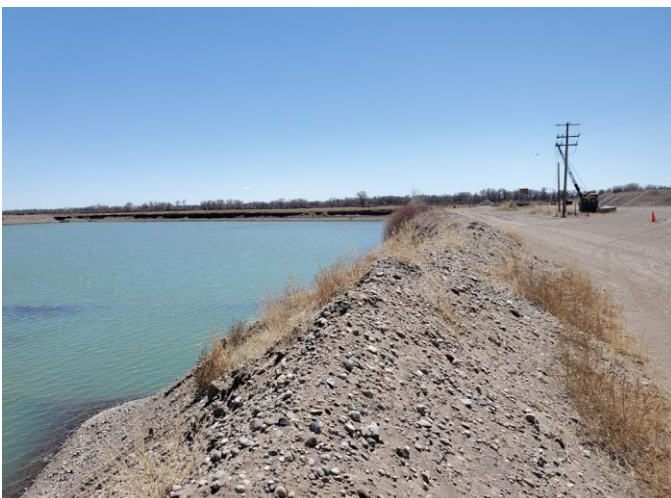
View to the south showing berm along the edge of the pit

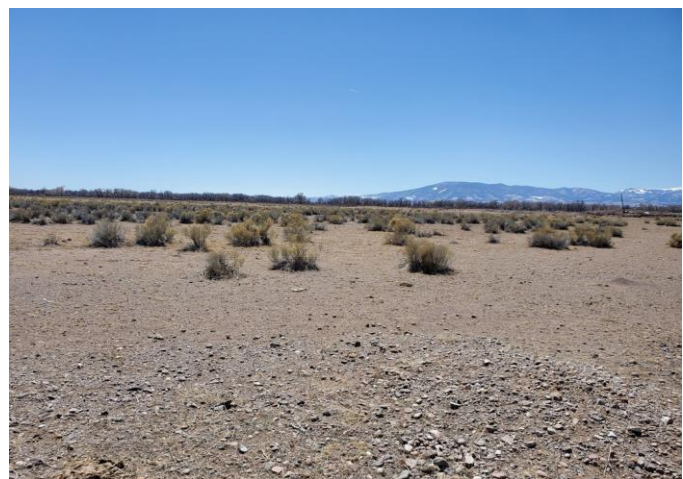
View to the southeast showing Cell #3, an undisturbed cell in the permit boundary
