**MINERALS PROGRAM INSPECTION REPORT**  
**PHONE: (303) 866-3567**

<b>MINE NAME:</b> NCCI Pit #1	<b>MINE/PROSPECTING ID#:</b> M-2001-107	<b>MINERAL:</b> Sand and gravel	<b>COUNTY:</b> Weld
<b>INSPECTION TYPE:</b> Monitoring	<b>WEATHER:</b> Clear	<b>INSP. DATE:</b> April 20, 2023	<b>INSP. TIME:</b> 10:30
<b>OPERATOR:</b> Northern Colorado Constructors, Inc. Aggreg	<b>OPERATOR REPRESENTATIVE:</b> Chris Zadel	<b>TYPE OF OPERATION:</b> 112c - Construction Regular Operation	
<b>REASON FOR INSPECTION:</b> Normal I&E Program	<b>BOND CALCULATION TYPE:</b> Partial Bond	<b>BOND AMOUNT:</b> \$486,745.00	
<b>DATE OF COMPLAINT:</b> NA	<b>POST INSP. CONTACTS:</b> None	<b>JOINT INSP. AGENCY:</b> None	
<b>INSPECTOR(S):</b> Peter Hays Amber Michels Hunter Ridley	<b>INSPECTOR'S SIGNATURE:</b>

April 20, 2023 Clay Liner Inspection Map

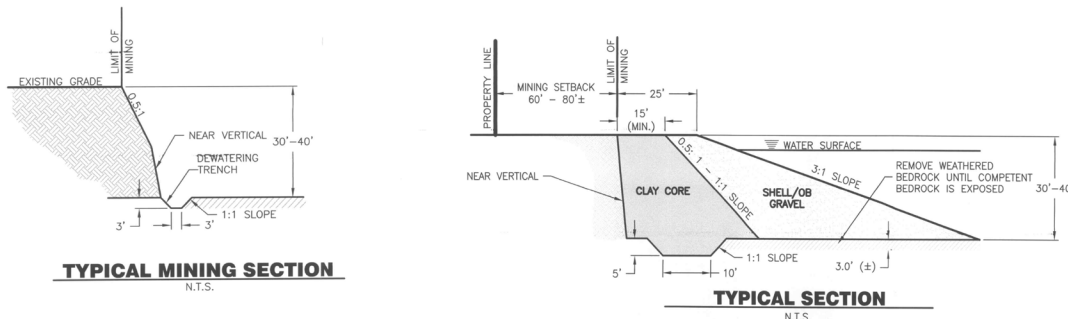
The liner was being constructed as depicted in the approved Mining and Reclamation Plans. The typical mining and reclamation cross-section are below:

The perimeter highwall was excavated at a nearly vertical to a 1.5H:1V slope with a dewatering trench at the base of the highwall. The clay liner keyway was excavated inward of the dewatering trench at a 1H:1V slope to a depth of 5 feet. The moisture conditioned clay core material was placed in horizontal lifts with scrapers and compacted by a sheepsfoot compactor at a 1H:1V outer slope. The perimeter slope of the liner (shell) was backfilled with sand and gravel to protect the liner from the effects of rapid drawdown during the operation of the reservoir. The area between the clay core and the highwall (Zone 4) was backfilled with overburden along the south, east and west sides to create an additional impermeably water barrier. Zone 4 was backfilled with sand along the south side to allow groundwater to migrate east to the river along the boundary. The clay liner construction is expected to be complete by May or June of this year. The SEO required leak testing will start after the completion of the liner.

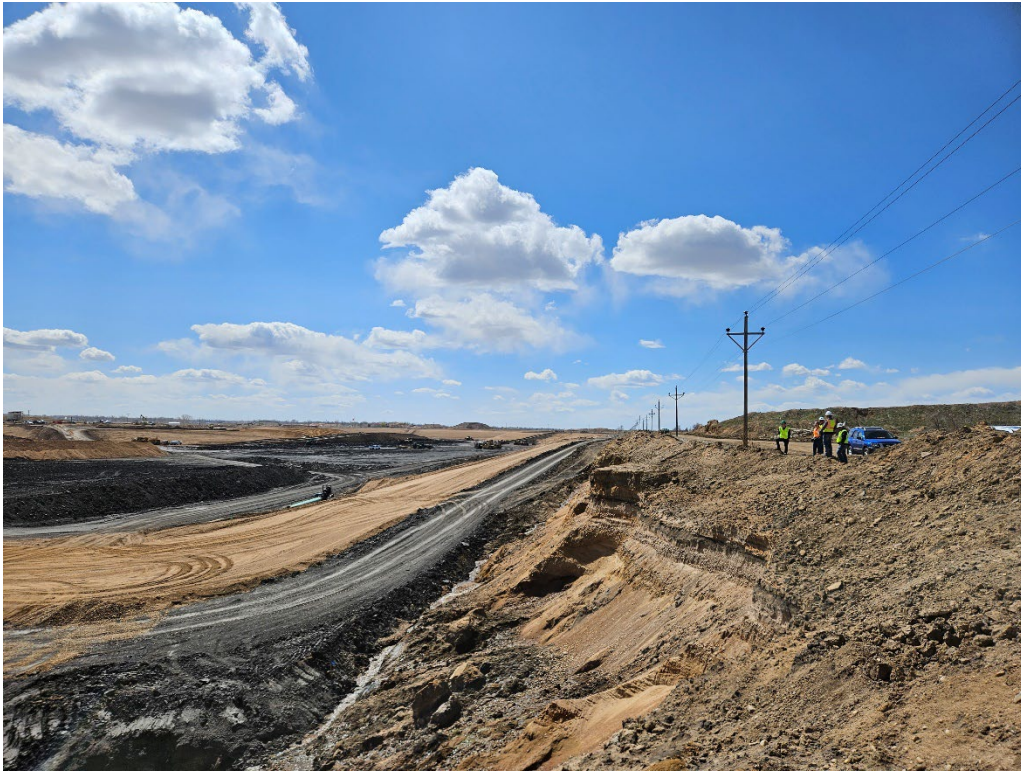
View of the southern portion of the site from the northwest corner looking south

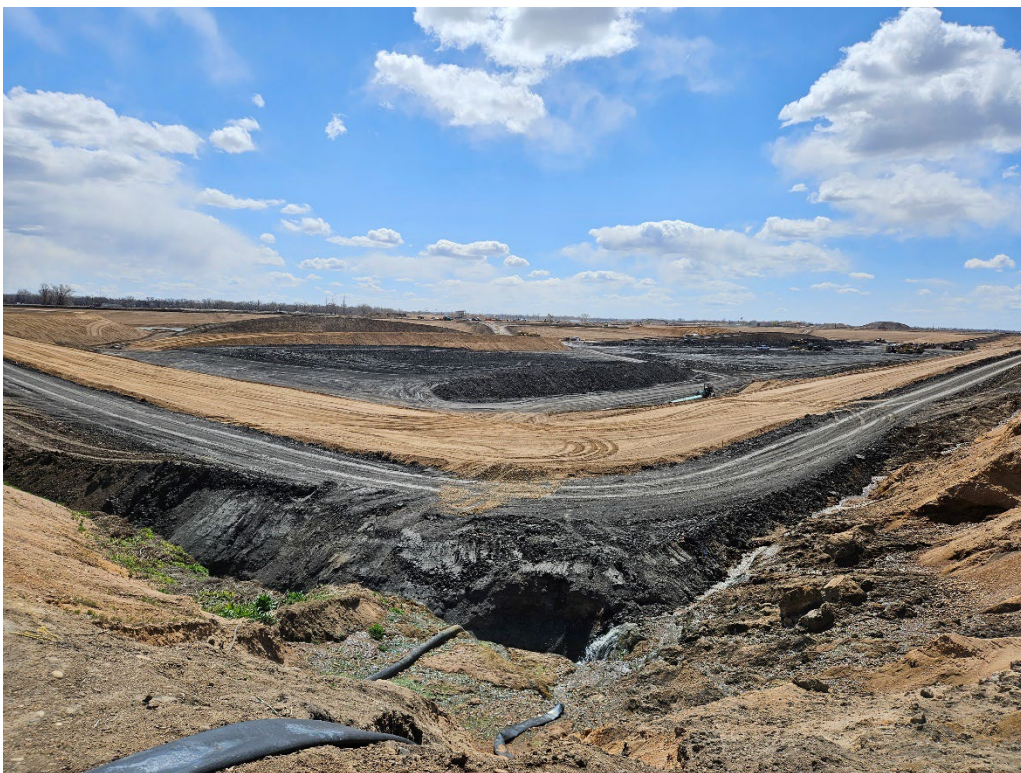
View of the southern portion of the site from the northwest corner looking southeast

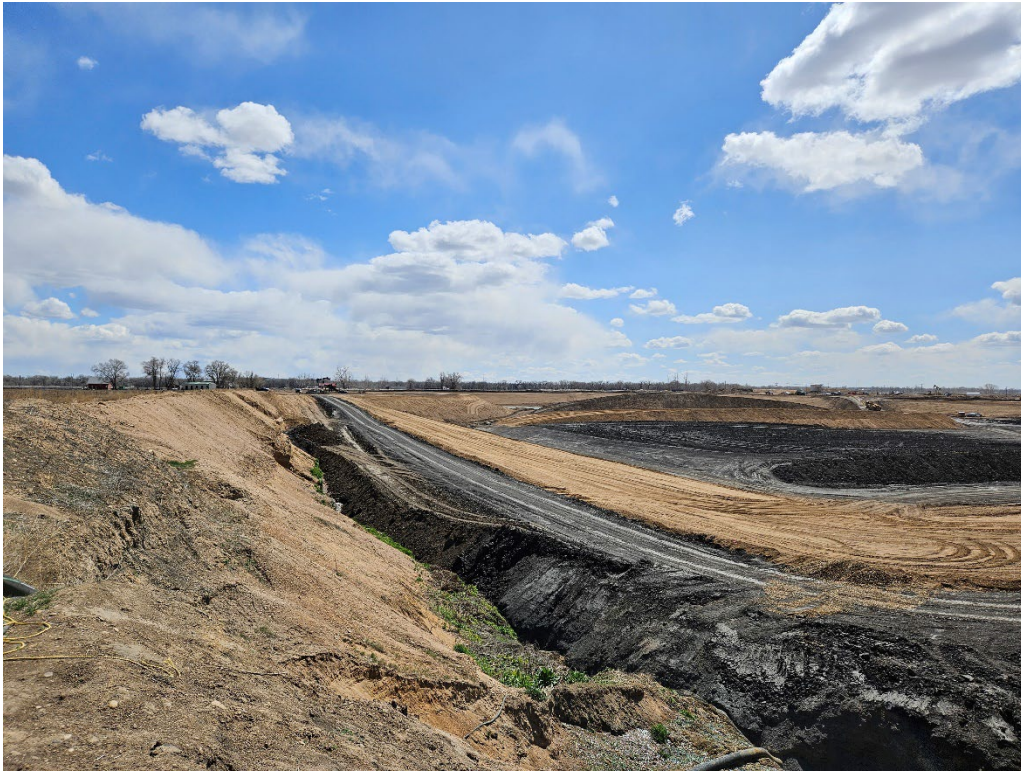
View of the southern portion of the site from the northwest corner looking east

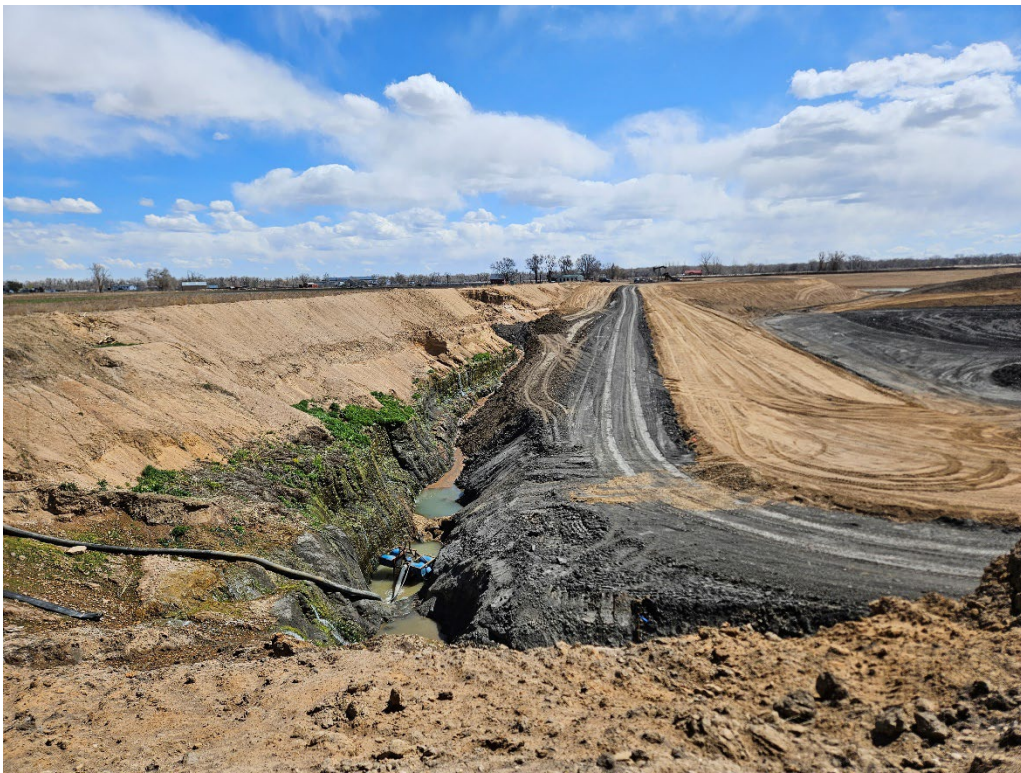
View of the southern portion of the site from the northwest corner looking east

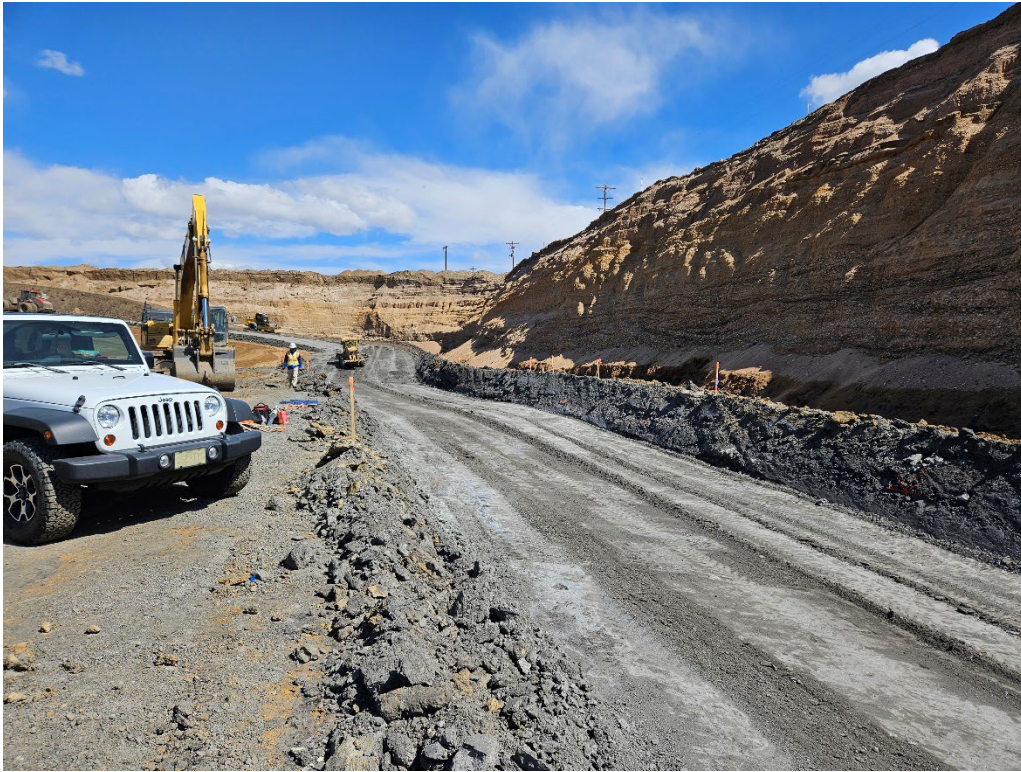
View of the keyway construction looking north

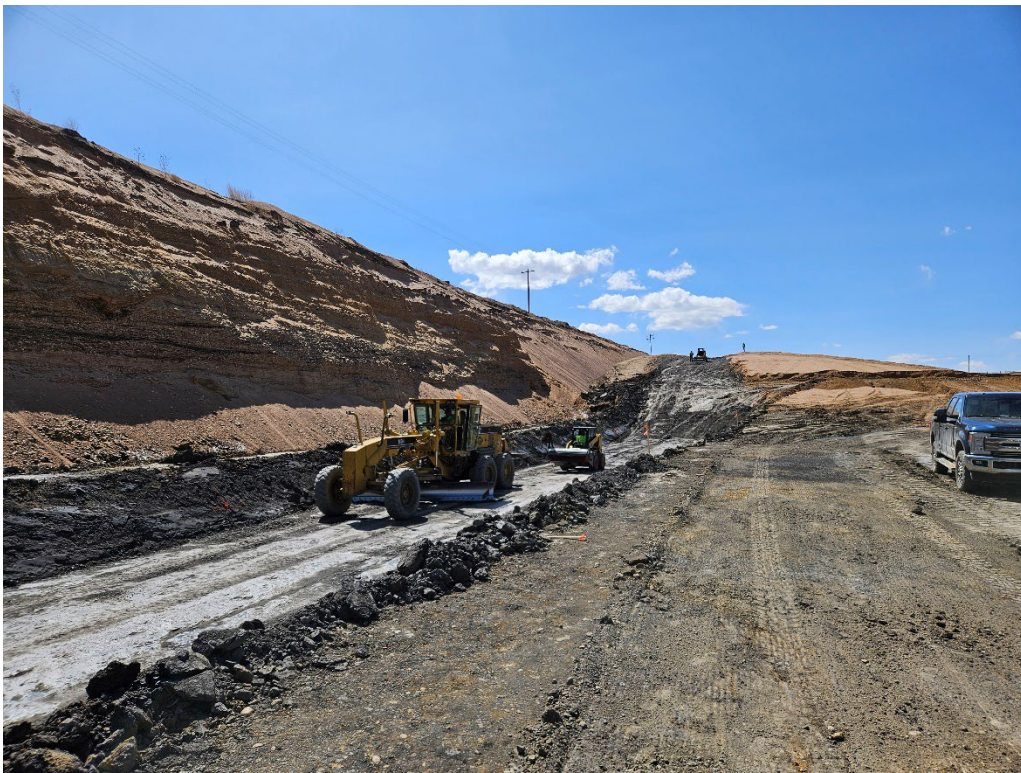
View of the keyway construction looking south

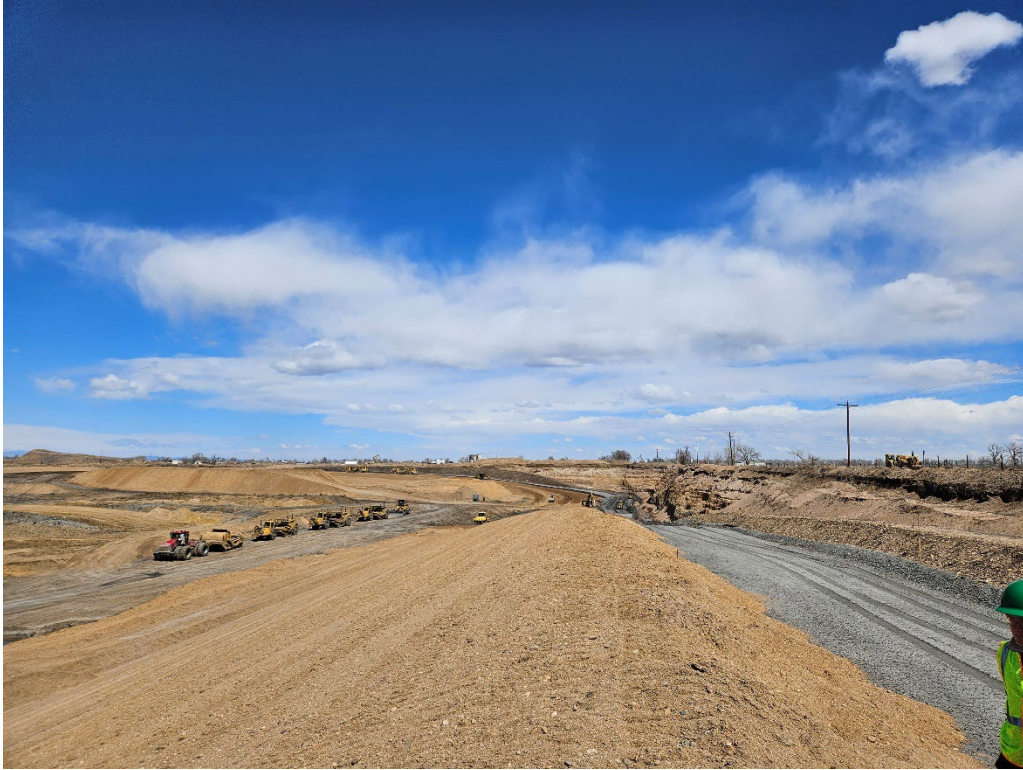
View of the southern portion of the site from the southeast corner looking north

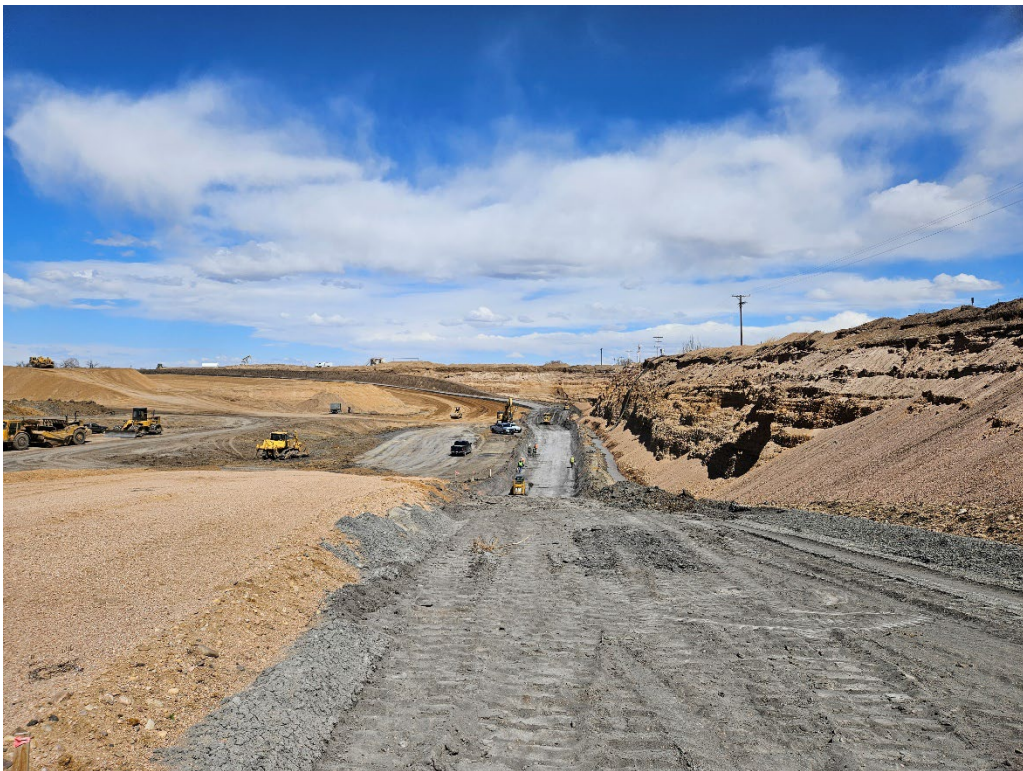
View of the keyway construction from the south side looking north
