MINERALS PROGRAM INSPECTION REPORT
PHONE: (303) 866-3567

MINE NAME: Climax Mine	MINE/PROSPECTING ID#: M-1977-493	MINERAL: Molybdenum	COUNTY: Lake, Summit
INSPECTION TYPE: Monitoring	WEATHER: Snowing	INSP. DATE: April 20, 2023	INSP. TIME: 13:00
OPERATOR: Climax Molybdenum Company	OPERATOR REPRESENTATIVE: Eric Detmer	TYPE OF OPERATION: 112d-3 - Designated Mining Operation	
REASON FOR INSPECTION: Normal I&E Program	BOND CALCULATION TYPE: None	BOND AMOUNT: \$91,011,850.00	
DATE OF COMPLAINT: NA	POST INSP. CONTACTS: None	JOINT INSP. AGENCY: None	
INSPECTOR(S): Dustin Czapla	INSPECTOR'S SIGNATURE:

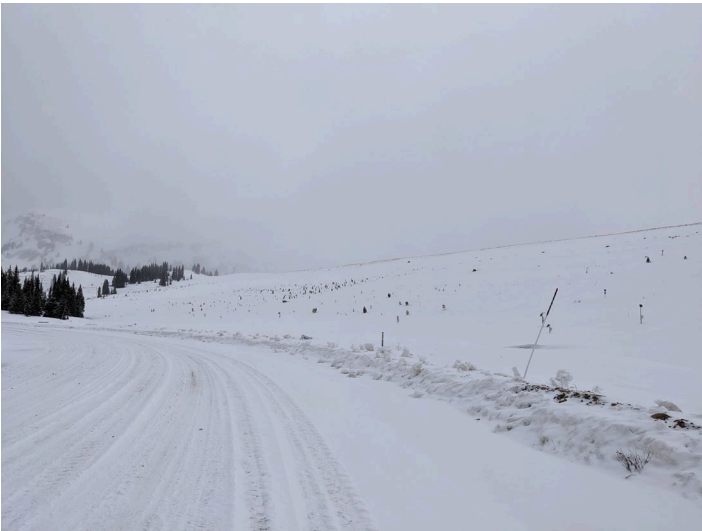
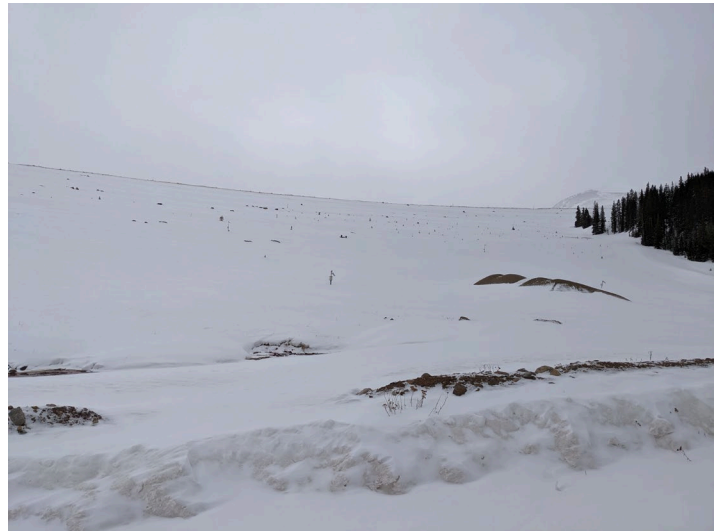
The Robinson TSF and pond are an EPF and function as the primary process water storage facility for the site. The reservoir stores process water that is collected from the Tenmile and Mayflower TSFs and delivered through the Tenmile Tunnel. Water collected from the Tenmile TSF is decanted through the Tenmile Decant to the Tenmile Tunnel and water collected from the Mayflower TSF is pumped by the Mayflower barge system to the Tenmile Tunnel. Robinson Pond also collects seepwater and toe drain discharge from 1 Dam as well as seepwater pumped from the Robinson Dam and 4 Dam seepage collection systems. The reservoir primarily contains industrial process water, TSF seepwater and 4 Dam seepwater, along with unintercepted storm water from the surrounding area and overflow from Chalk Mountain Reservoir. 2 Dam is partially inundated by the upstream portion of the Tenmile TSF in the Tenmile Creek drainage. The area was covered by snow during this inspection. No problems were noted.

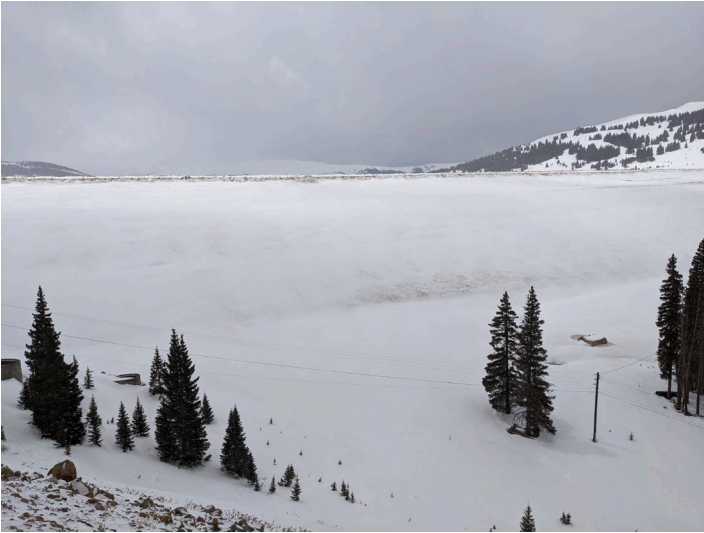
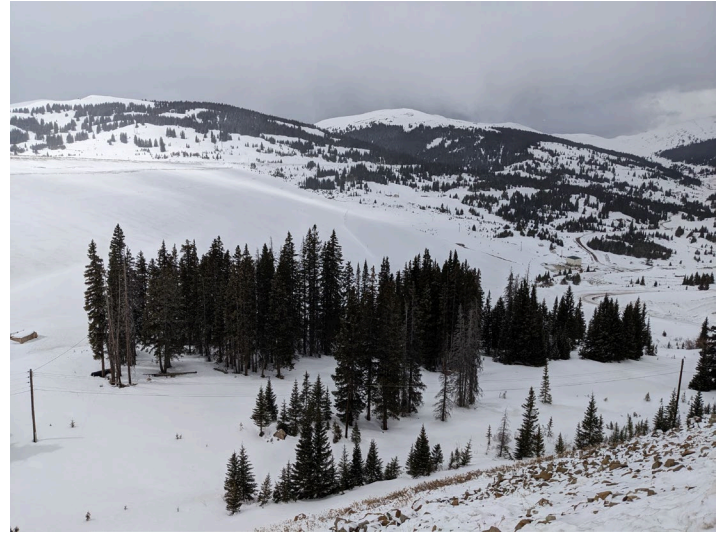
The Tenmile TSF and 3 Dam are an EPF. The TSF contains acid-generating material. Mill tailing is delivered to the TSF through the tailings delivery line. A water pool is maintained at the upstream end of the Tenmile TSF for process water storage, storm water management, and as the first stage in the water treatment system. Seepage from 3 Dam is routed to a collection pond and pumped back by vertical turbine pumps to the Sludge Densification Plant or diverted to the water pool on the Mayflower TSF. The pumping system is located within the 3 Dam Pump Station below the Tenmile TSF. The area was covered by snow during this inspection. No problems were noted.

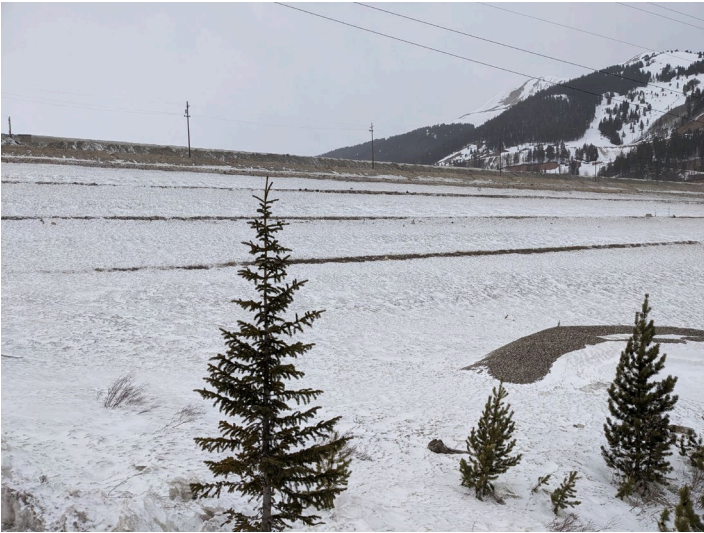
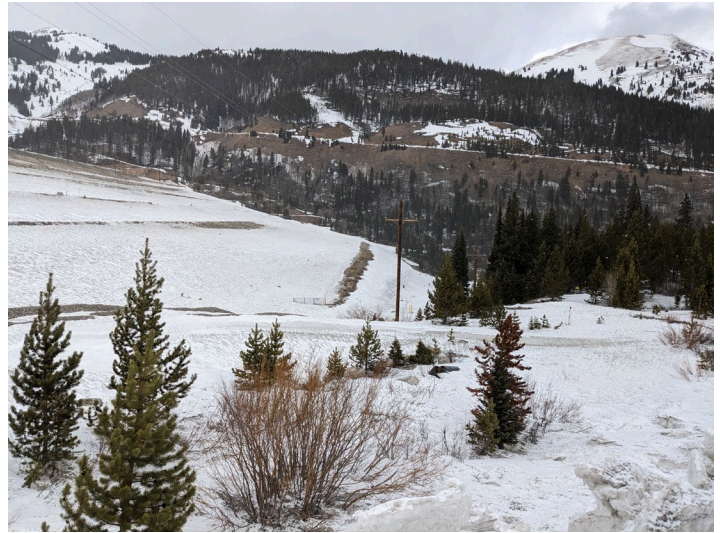
The Mayflower TSF and 5 Dam are the last downstream TSF in the Tenmile Creek Watershed. The TSF contains acid-generating material. To prevent dam failure, the Mayflower TSF includes an emergency flood bypass tunnel. Along with tailings storage, the Mayflower TSF also provides containment of contaminated materials or designated chemicals that might be accidentally released up-gradient of the TSF. Seepage from 5 Dam is routed to concrete ponds. Collected seepage is pumped back by vertical turbine pumps to the 3 Dam Pump Station or the water pool on the Mayflower TSF. The 5 Dam seepwater pumping system is located within the Mayflower Pump Station below the TSF. The area was covered by snow during this inspection. No problems were noted.
