RE: Lakewood Brick and Tile Co.
Church Pit - M-1977-045

On behalf of my client Lakewood Brick and Tile Co. I am submitting the following explanation and photos showing that the corrective actions you noted in the December 19, 2022, inspection report, were completed before the April 28, 2023 deadline. All photos attached were taken on Wednesday - 4/12/23.

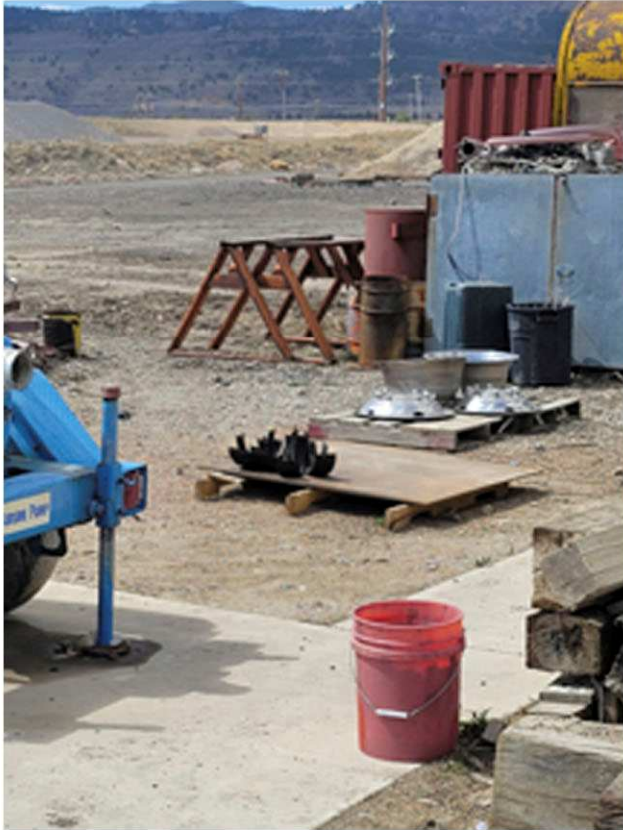
CA#2 - Trash & Waste - Clean up area around supply storage trailers.

CA#2 - Cleaned work area
Photo 4/12/23

All trash and waste has been removed leaving only scrap iron and parts used for maintenance of equipment. The waste was haul to the local land fill and disposed of properly.

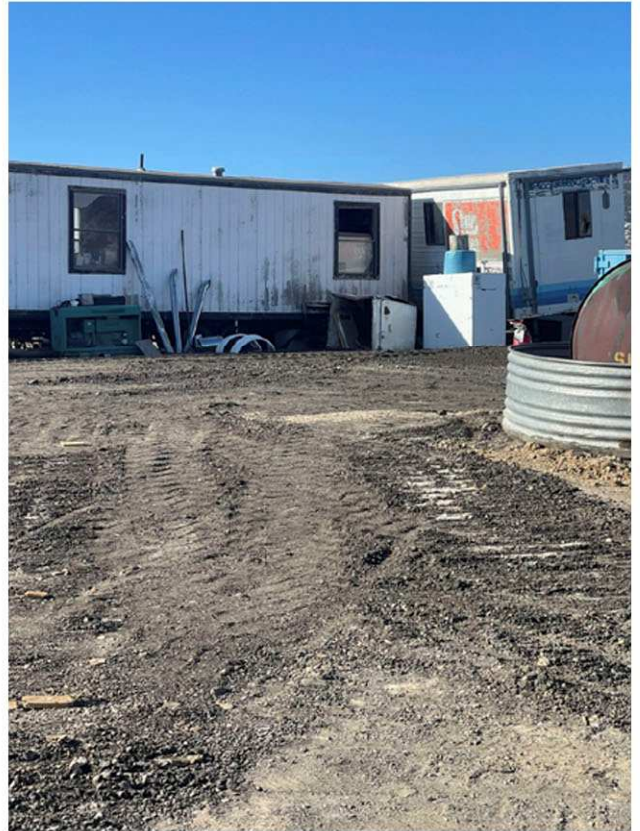
CA#3 - Improper Fuel Storage - Removed obsolete tanks and dirt berms and clean spilled areas.

CA#3 - Cleaned fuel storage area.
Photo 4/12/23

The obsolete fuel tanks have been removed and the contaminated dirt was removed and disposed of properly at a local land fill approved for disposal of the contaminated dirt. The area was cleaned, and resurfaced with recycled crushed asphalt. The remaining fuel tank is in a secondary containment structure sized to contain 110% of fuel tank capacity.

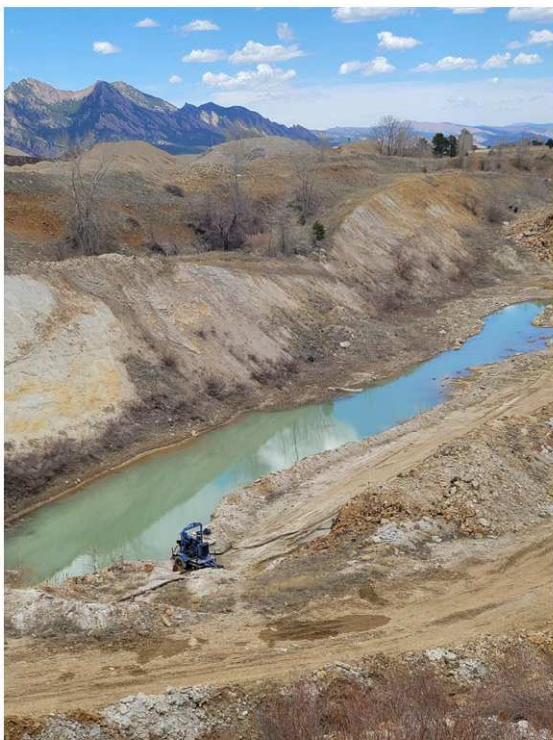
CA #1 - Hydrologic Balance - Noted the standing water in the clay pit that had accumulated during the winter (frozen) and needed to be removed.

The majority of the water is seepage from the wash water pond located south of the ditches. The pond water is purchased from Church Ranch from water they own in Smart Reservoir and is approved for use to wash gravel and dust control. It is pumped into the pond created when the ditches were rerouted to across the pre-law excavated end of the clay pit area. The fill material used was, waste rock and rubble from historic mining and no attempt was made to seal the north end of the pond. Over the years water has been seeping thru the fill into the main operating area of the clay pit and accumulates in on the clay surface and commingles with the minor amount of stormwater that fall on the disturbed area.

This water is pumped back into the pond where over time it leaks out of the pond and back into the mining area. This is not storm or ground water but seepage from the storage pond. Water depth shown in photo is 12" or less and is what had

CA#1 - Reduce water accumulation. Depth 12
inch or less
Photo 4/12/23

accumulated since the last pumping 2 days prior to the photo. The pump runs every 2 day or as needed to return the water to the pond since the loss affects the ability of Burnco to wash gravel. Since this water is purchased any loss from evaporation off the seepage only affects the owner of the water. All attempts are made to removed stormwater from the pit within 72 hours of the storm event.

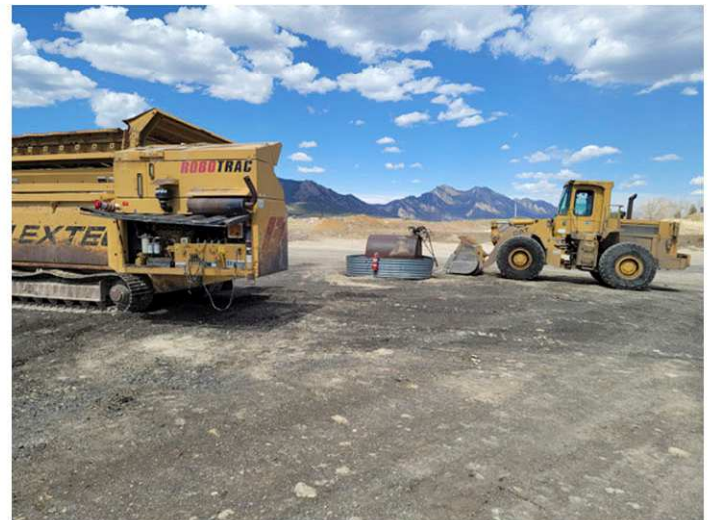
CA#3 - Fuel storage area
Photo 4/12/23
