MINERALS PROGRAM INSPECTION REPORT
PHONE: (303) 866-3567

MINE NAME: Cresson Project	MINE/PROSPECTING ID#: M-1980-244	MINERAL: Gold and silver	COUNTY: Teller
INSPECTION TYPE: Monitoring	WEATHER: Windy	INSP. DATE: March 27, 2023	INSP. TIME: 08:00
OPERATOR: Cripple Creek & Victor Gold Mining Company	OPERATOR REPRESENTATIVE: Brian Doering	TYPE OF OPERATION: 112d-3 - Designated Mining Operation	
REASON FOR INSPECTION: Normal I&E Program	BOND CALCULATION TYPE:	BOND AMOUNT: \$207,491,188.00	
DATE OF COMPLAINT: NA	POST INSP. CONTACTS: None	JOINT INSP. AGENCY: None	
INSPECTOR(S): Patrick Lennberg	INSPECTOR'S SIGNATURE:

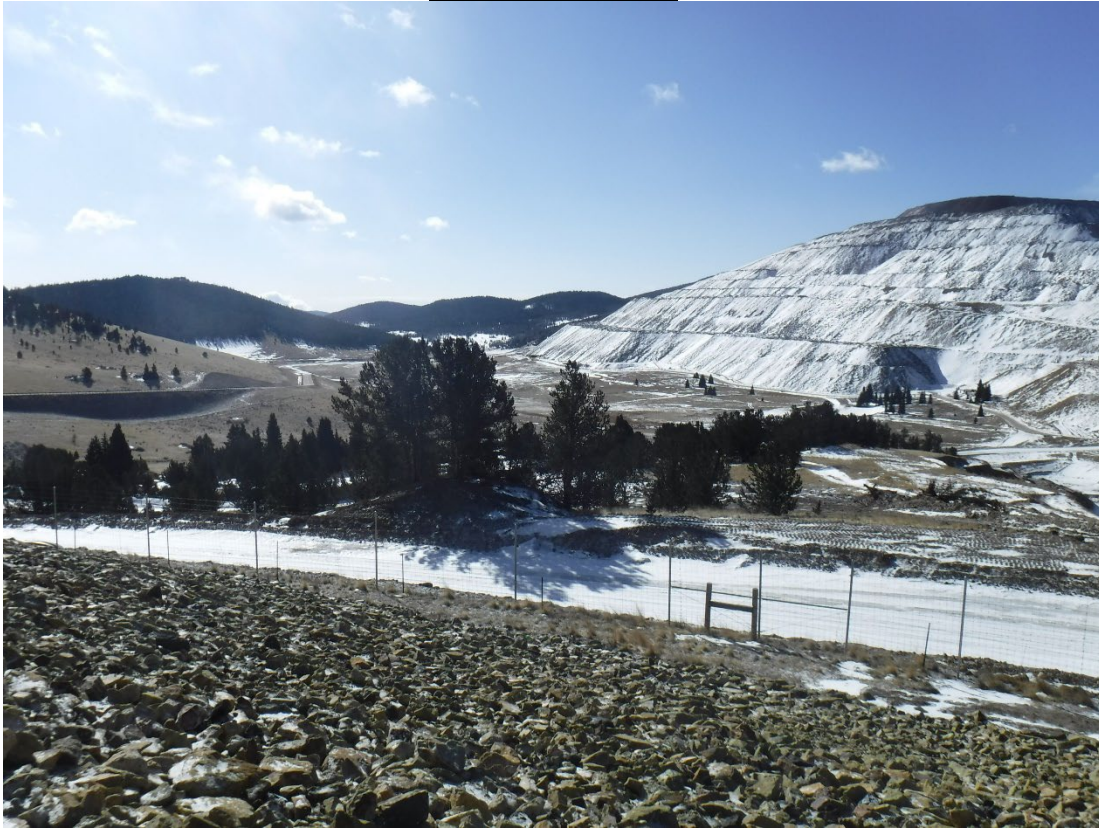
The purpose of the Grassy Valley inspection was to view the potential drilling operations related to the point-of-compliance (POC) monitoring wells installation, GVMW-26. Installation of GVMW-26 was approved through Technical Revision 129. Contained in TR-129 was commitment to sample the well(s) no later than the end of second quarter 2023. Currently, the Operator is evaluating options to access this location in order to try and meet their obligation under TR-129.

Photo 1: Looking at the southeast down Grassy Valley from the dump truck bed overlook

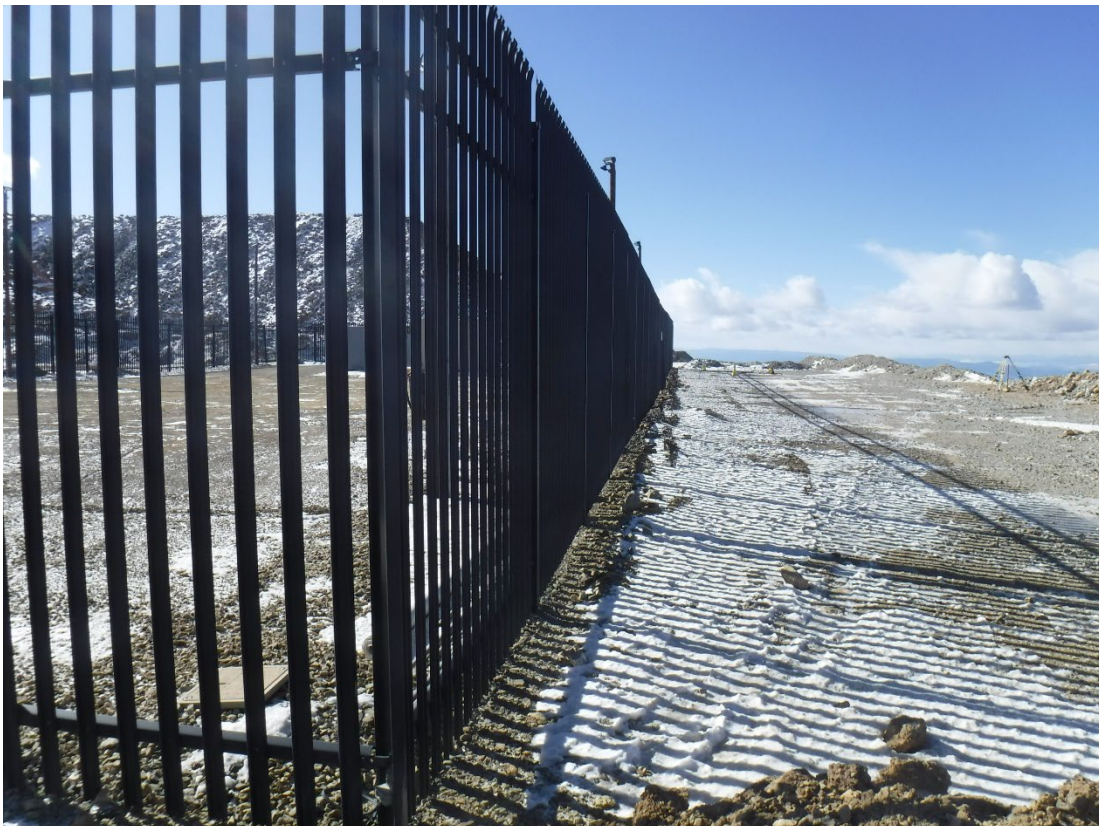
The Division walked the perimeter of the explosives storage area, no problems were observed.

Photo 2: Perimeter fence around the explosives storage area

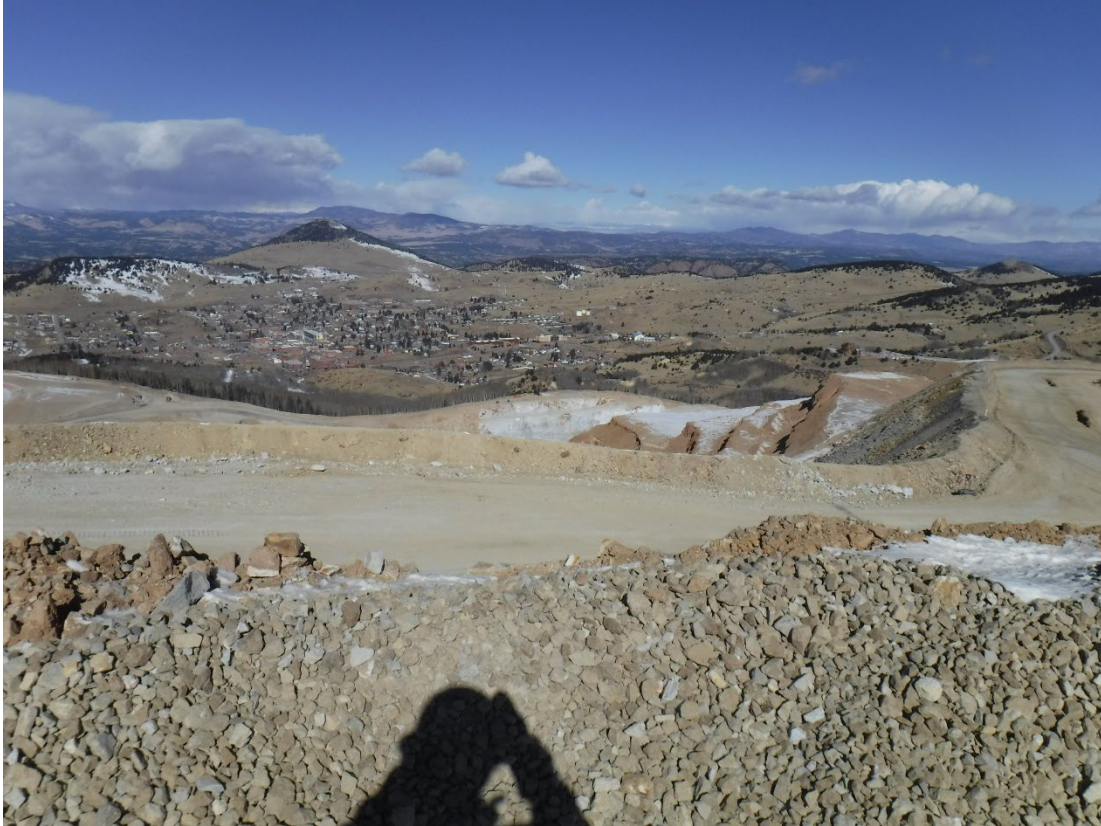
Photo 3: Schist Island mining phase III

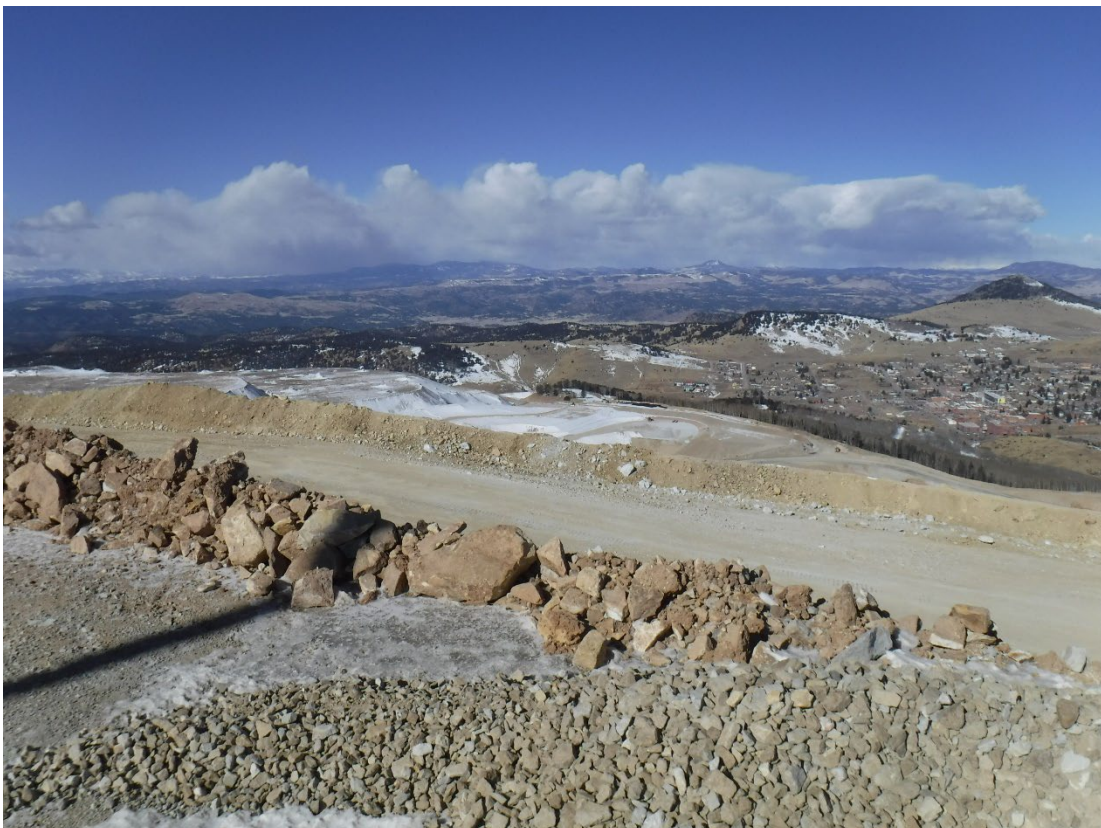
The Division observed, from a distance, the placement of drain rock material that is being placed around the riser pipes. The area observed is the LVF2 Phase III Process Solution Storage Area (PSSA) and is main collection area for leached solution that is then pumped to the ADR. The area is constructed of a multilayered system consisting of; first layer is one foot minimum layer of soil fill (clay), second is a sheet of 100 mil double sided LLDPE, third is a 3 foot thick (minimum) layer of drain cover fill (DCF) material that drains to the low volume solution collection system, forth is another layer of 100 mil LLDPE, and the final layer is 2 feet (minimum) layer of DCF to protect from ore material placement. The Division is currently reviewing TR-136 which is the Valley Leach Facility 2 Phase 3 Stage A.1 Record of Construction Report. Construction within LVF2 Phase 3 Stage A.1 was completed on December 12, 2022.

Photo 4: DCF placement around riser piping at VLF2 Phase 3 PSSA area

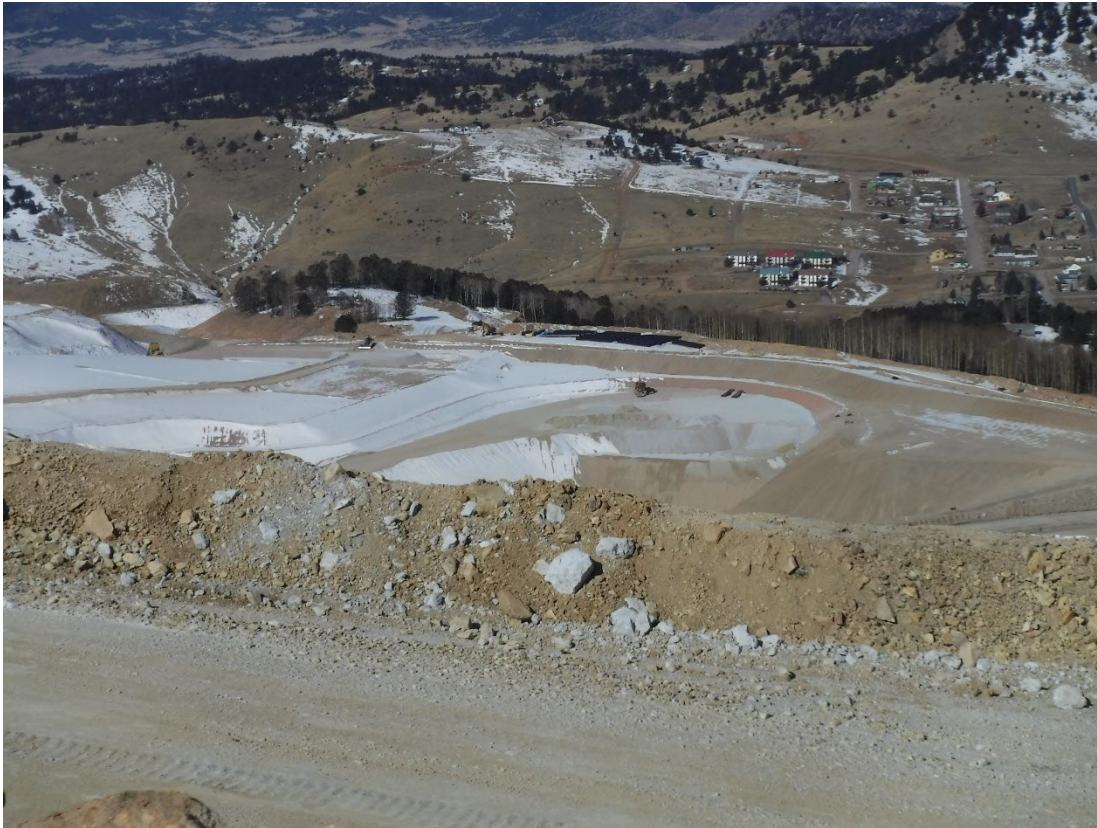
Photo 5: DCF placement around riser piping at VLF2 Phase 3 PSSA area, close-up

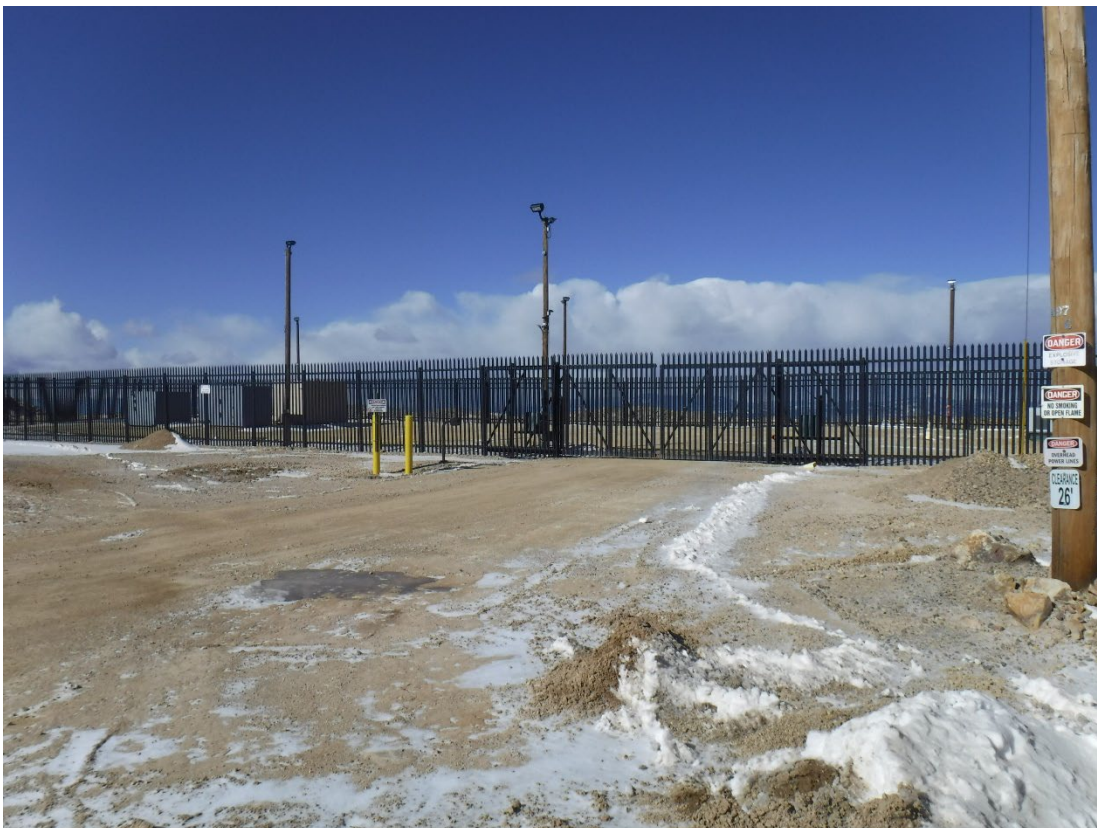
Photo 6: Perimeter fence around the explosives storage area

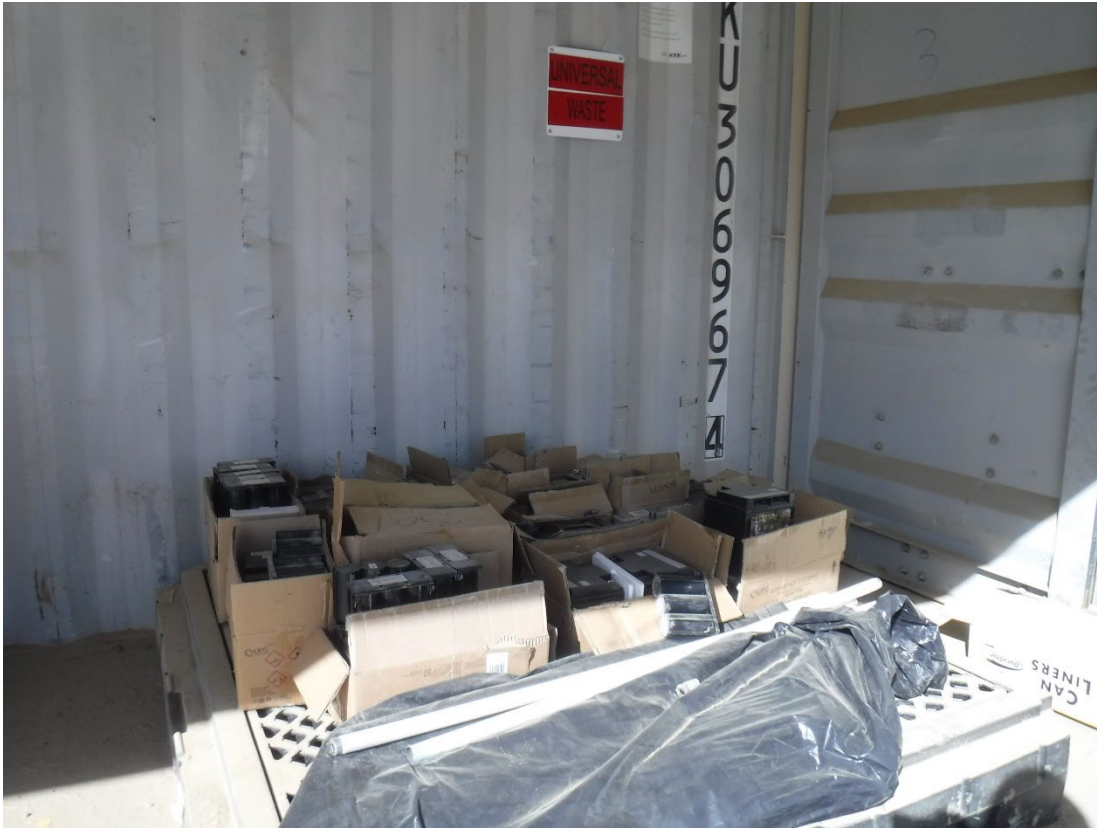
Photo 7: Satellite hazardous waste Conex box area

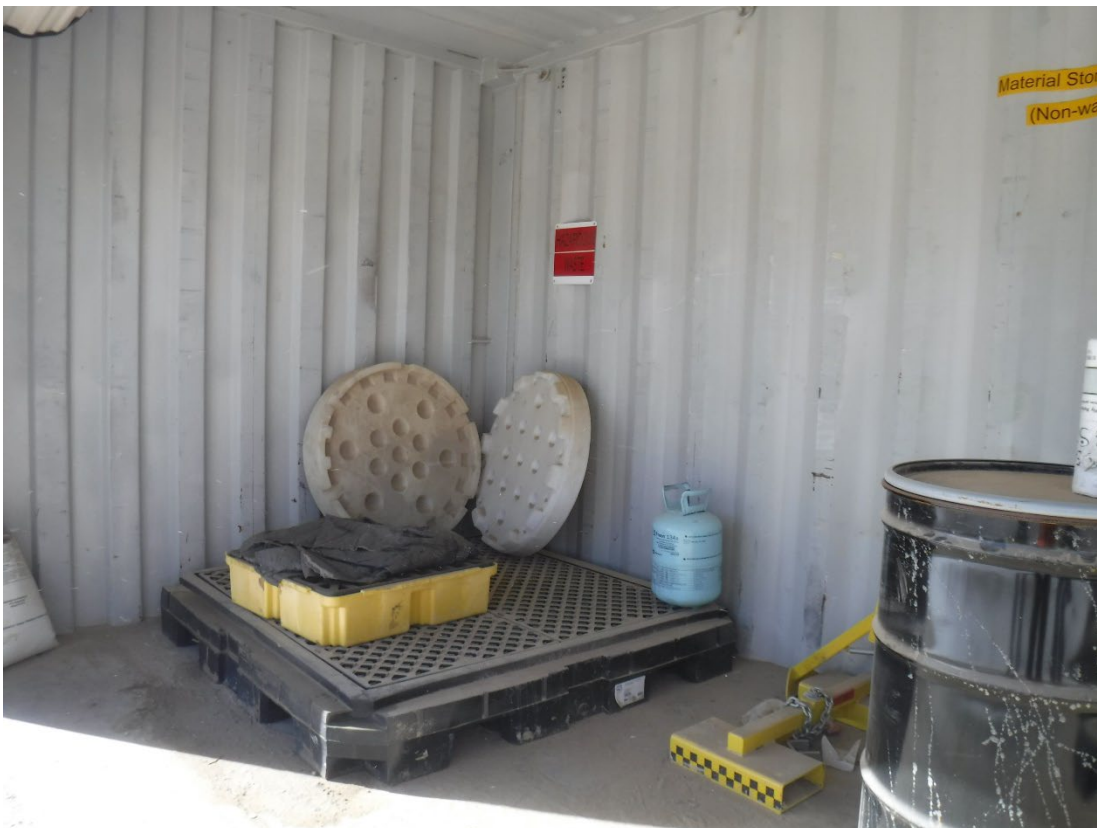
Photo 8: Satellite hazardous waste Conex box area

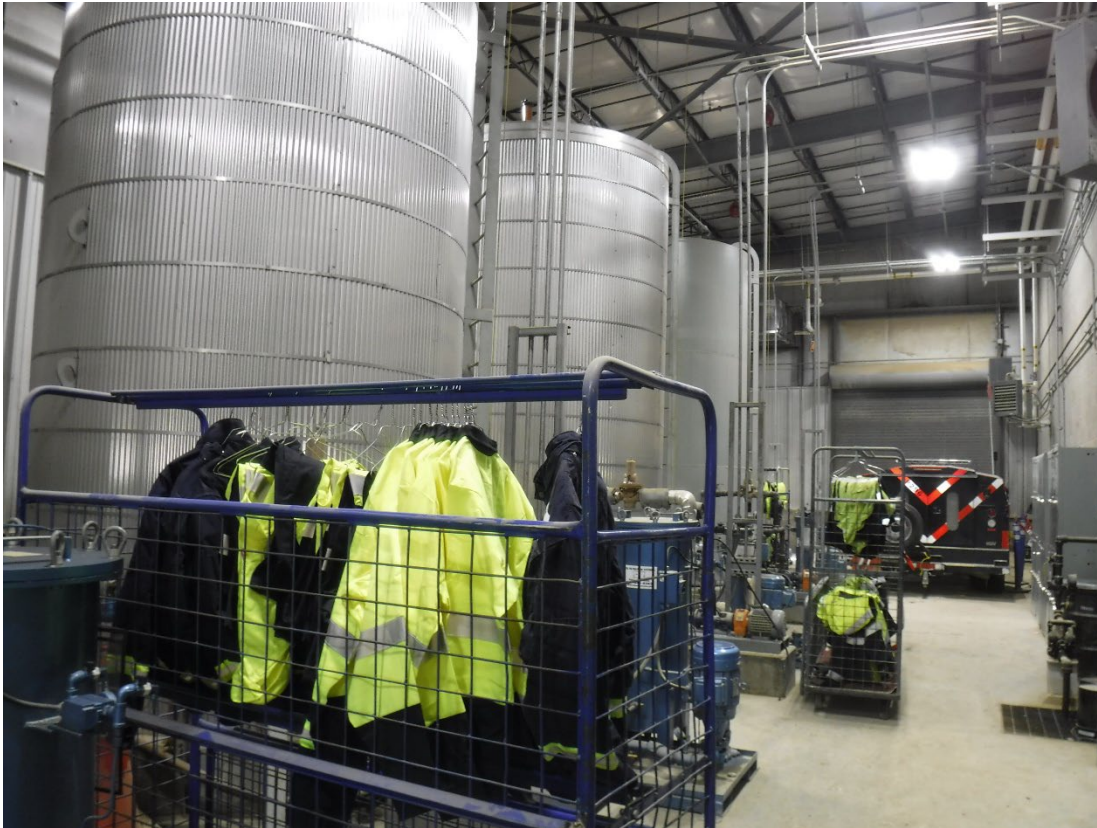
The Division toured the Ironclad Warehouse and Heavy Machinery Maintenance Facility. In the Maintenance Facility the Division observed numerous oil, waste oil, hydraulic fluid, and rock drill fluid in above ground storage tanks (ASTs). The tanks are single-walled ASTs that range in volume from 6,000 to 12,000 gallons. Along the north east end of the building on the outside in the satellite hazardous waste accumulation area. This area is composed of two Conex boxes. Inside the boxes are areas to store hazardous materials for disposal, there were secondary containment vessels on the inside of the boxes where the materials are stored. At the time of inspection the boxes had recently been emptied.

Photo 9: ASTs in Maintenance Facility area

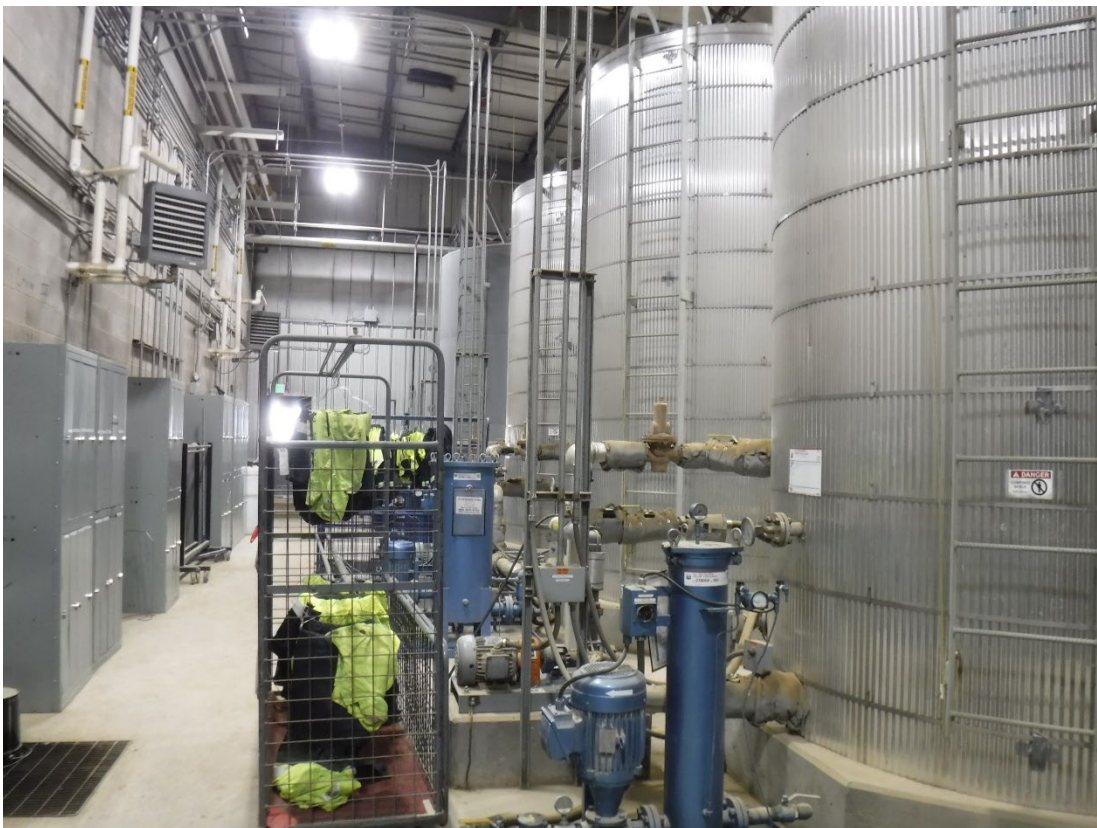
Photo 10: ASTs in Maintenance Facility area

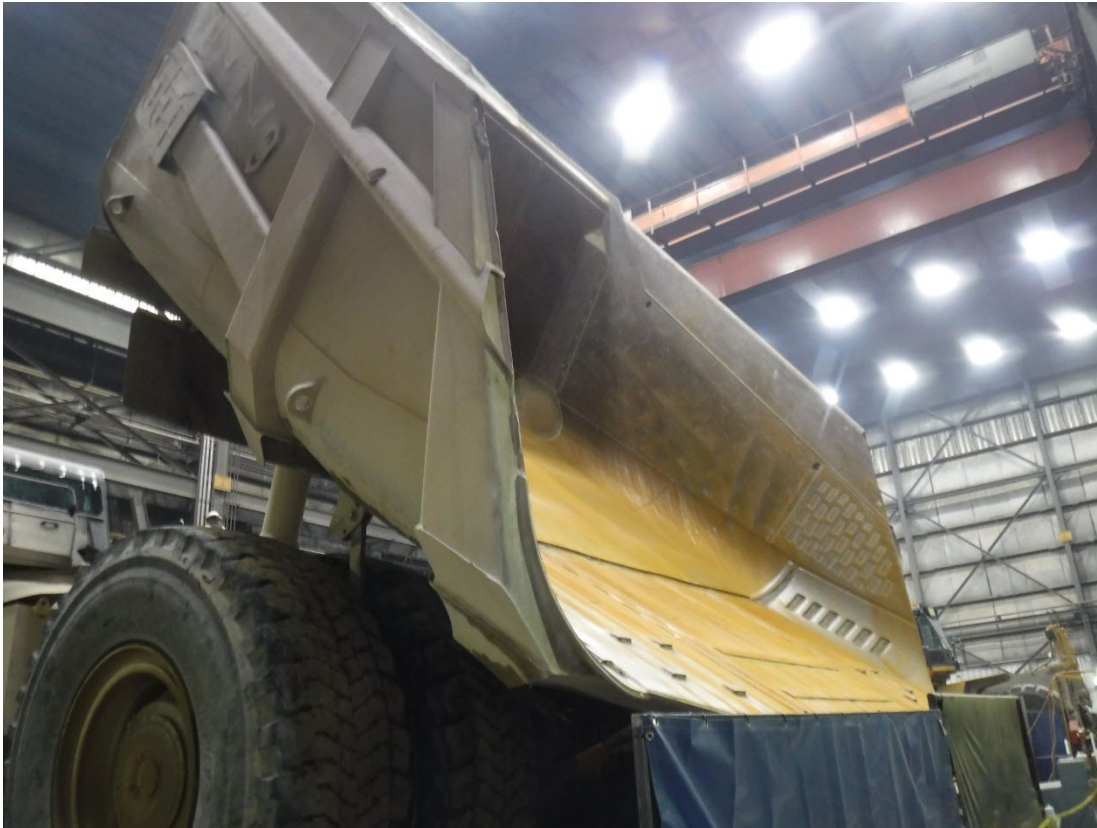
Photo 11: Haul truck undergoing maintenance

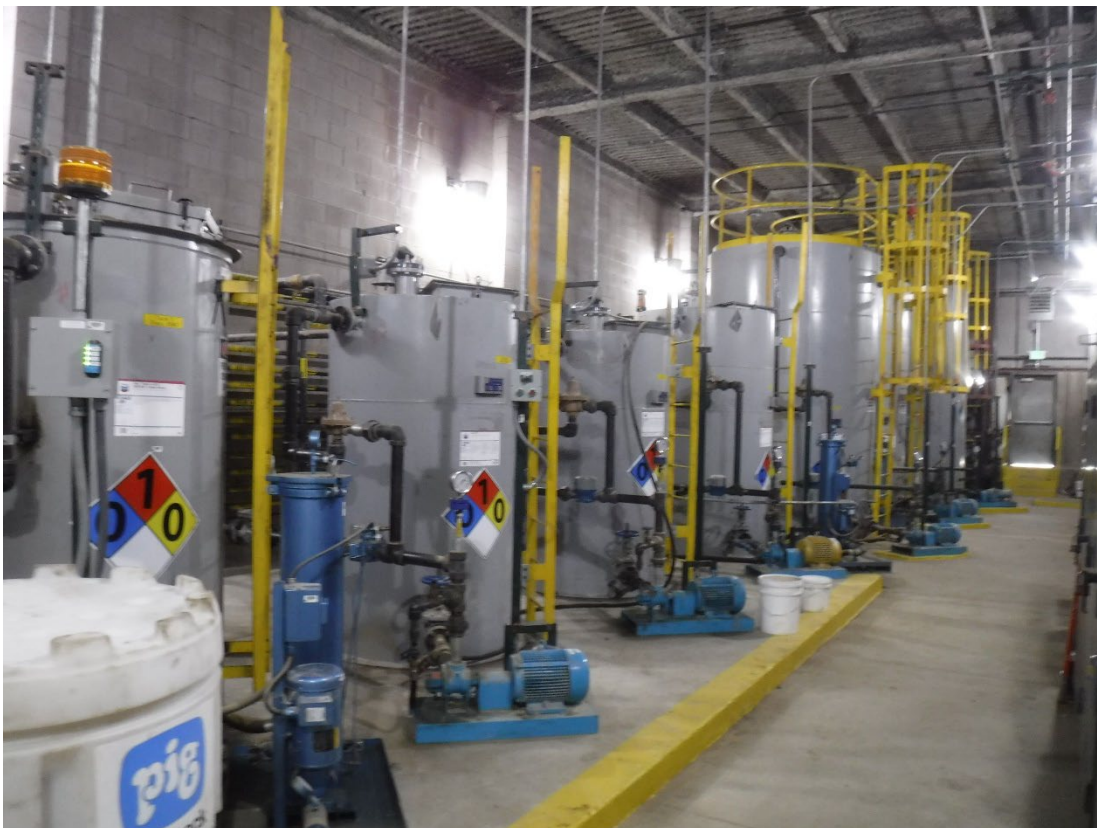
The Division also walked through the Warehouse area that serves as both a warehouse location for mine supplies as well as a welding shop area and light equipment repair area. Similar to the maintenance facility described above AST volumes range from 660 to 11,750 gallons.

Photo 12: ASTs in the warehouse area
